### Conducted RF Spurious Emission

## Appendix B: photographs of test setup

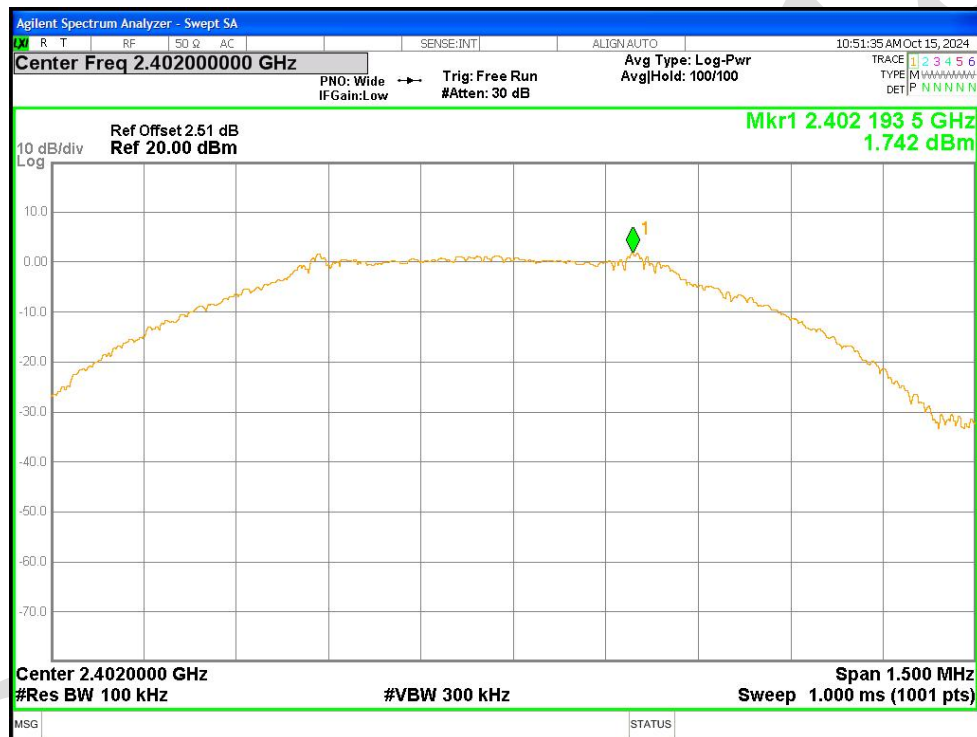
### Tx. Spurious NVNT BLE 1M 2402MHz Ant1 Ref

| Condition | Mode | Frequency (MHz) | Antenna | Max Value (dBc) | Limit (dBc) | Verdict |
|---|---|---|---|---|---|---|
| NVNT | BLE 1M | 2402 | Ant1 | -47.01 | -20 | Pass |

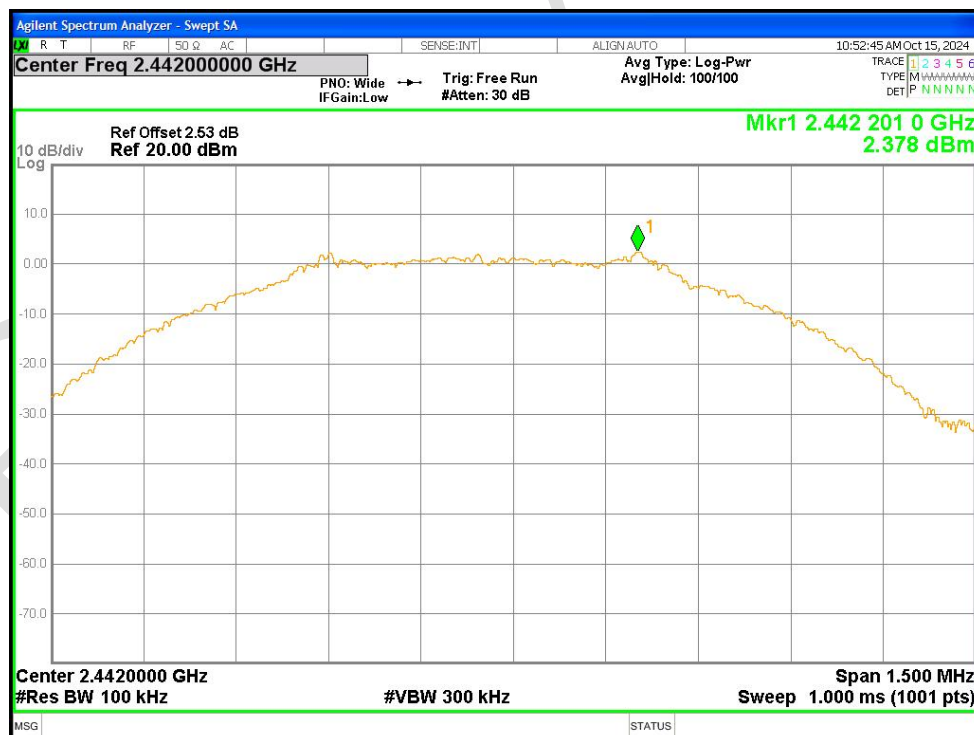
Tx. Spurious NVNT BLE 1M 2442MHz Ant1 Ref

| Condition | Mode | Frequency (MHz) | Antenna | Max Value (dBc) | Limit (dBc) | Verdict |
|---|---|---|---|---|---|---|
| NVNT | BLE 1M | 2442 | Ant1 | -47.38 | -20 | Pass |

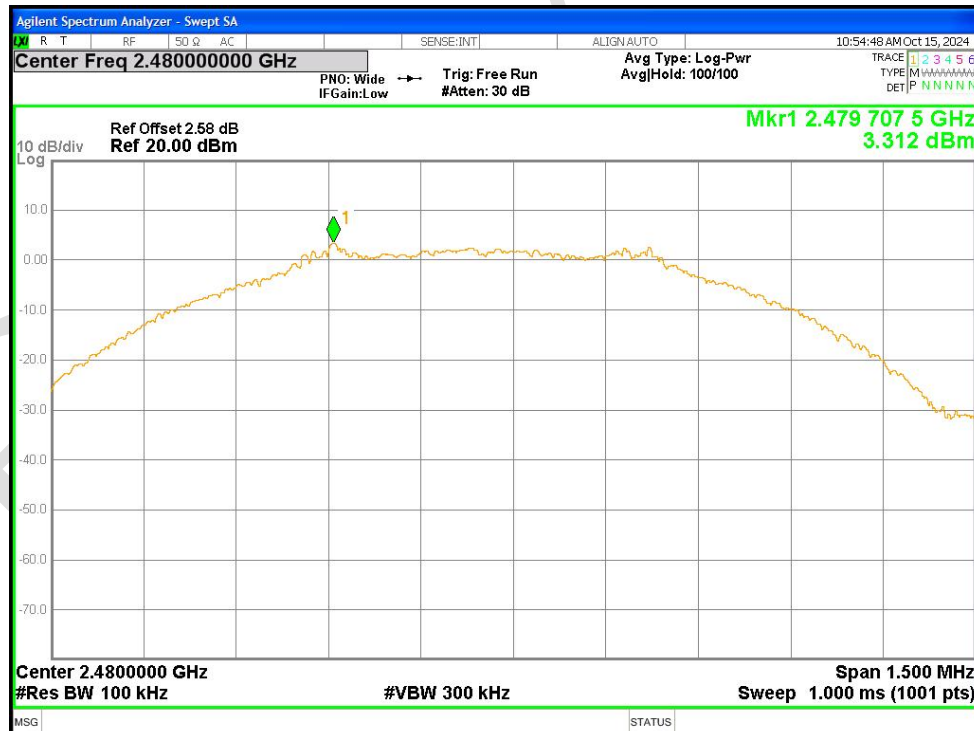
Tx. Spurious NVNT BLE 1M 2480MHz Ant1 Ref

| Condition | Mode | Frequency (MHz) | Antenna | Max Value (dBc) | Limit (dBc) | Verdict |
|---|---|---|---|---|---|---|
| NVNT | BLE 1M | 2480 | Ant1 | -47.82 | -20 | Pass |

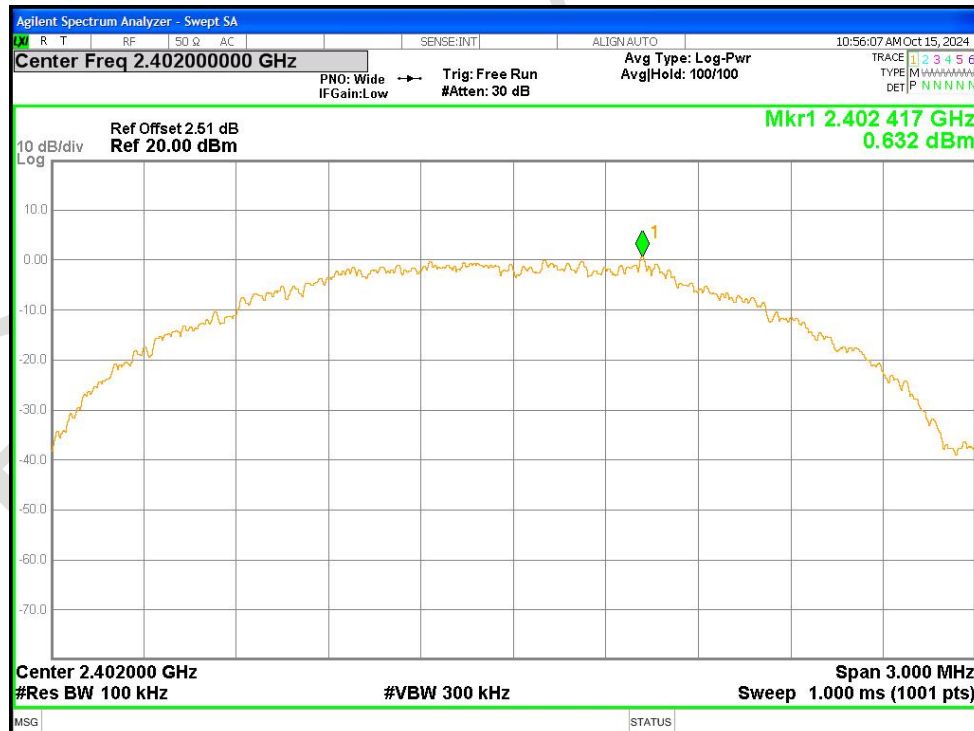
Tx. Spurious NVNT BLE 2M 2402MHz Ant1 Ref

| Condition | Mode | Frequency (MHz) | Antenna | Max Value (dBc) | Limit (dBc) | Verdict |
|---|---|---|---|---|---|---|
| NVNT | BLE 2M | 2402 | Ant1 | -45.79 | -20 | Pass |

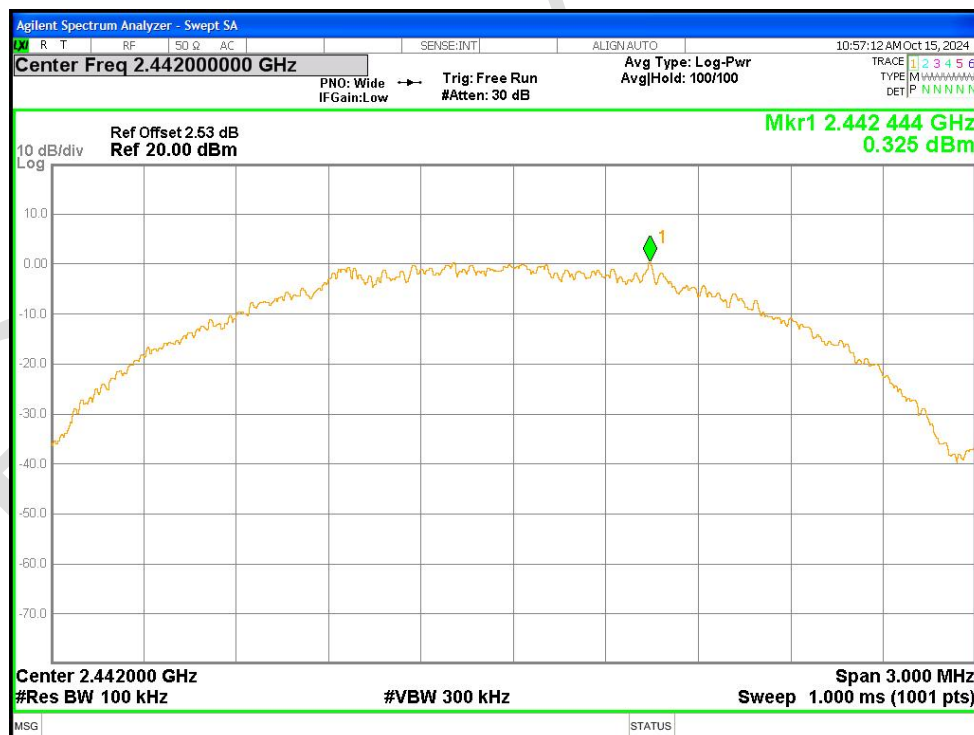
Tx. Spurious NVNT BLE 2M 2442MHz Ant1 Ref

| Condition | Mode | Frequency (MHz) | Antenna | Max Value (dBc) | Limit (dBc) | Verdict |
|---|---|---|---|---|---|---|
| NVNT | BLE 2M | 2442 | Ant1 | -45.15 | -20 | Pass |

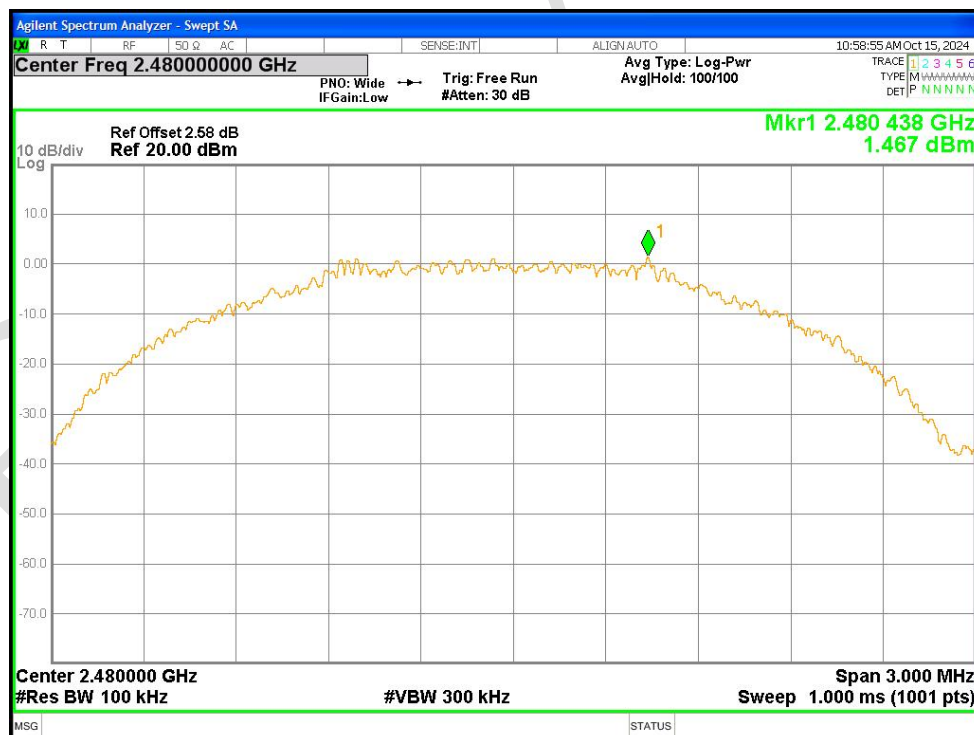
Tx. Spurious NVNT BLE 2M 2480MHz Ant1 Ref

| Condition | Mode | Frequency (MHz) | Antenna | Max Value (dBc) | Limit (dBc) | Verdict |
|---|---|---|---|---|---|---|
| NVNT | BLE 2M | 2480 | Ant1 | -46.54 | -20 | Pass |

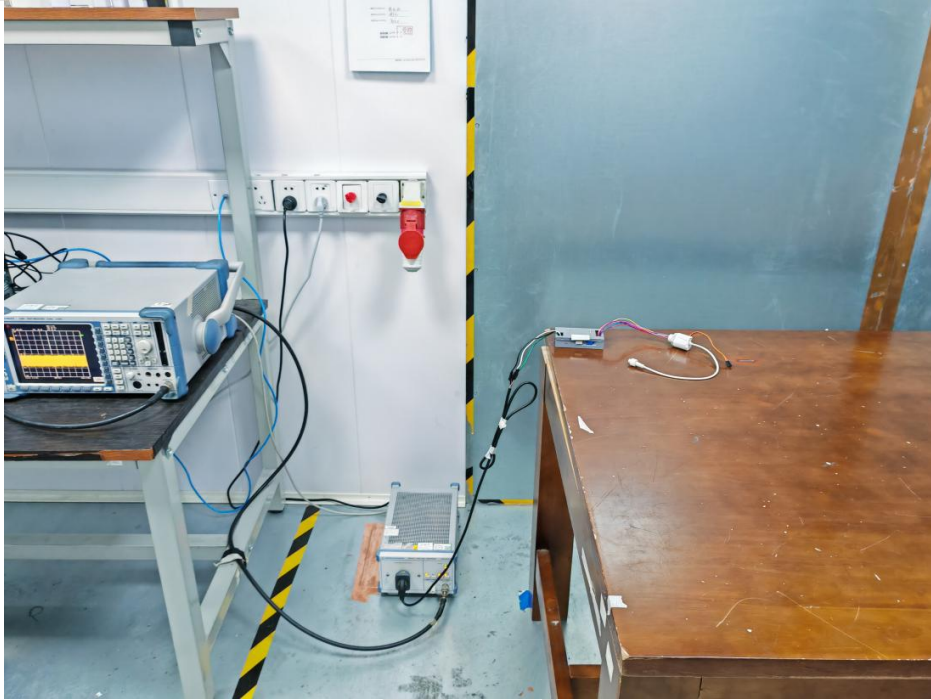
Conducted emissions at AC power line (150kHz-30MHz)

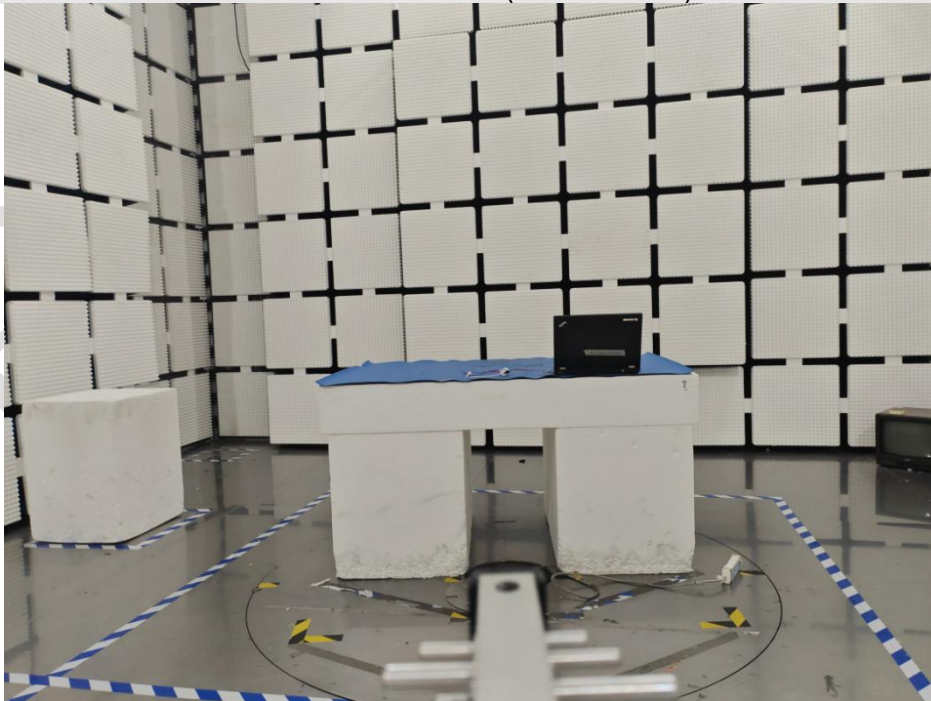
Radiated Emissions (30MHz-1GHz)

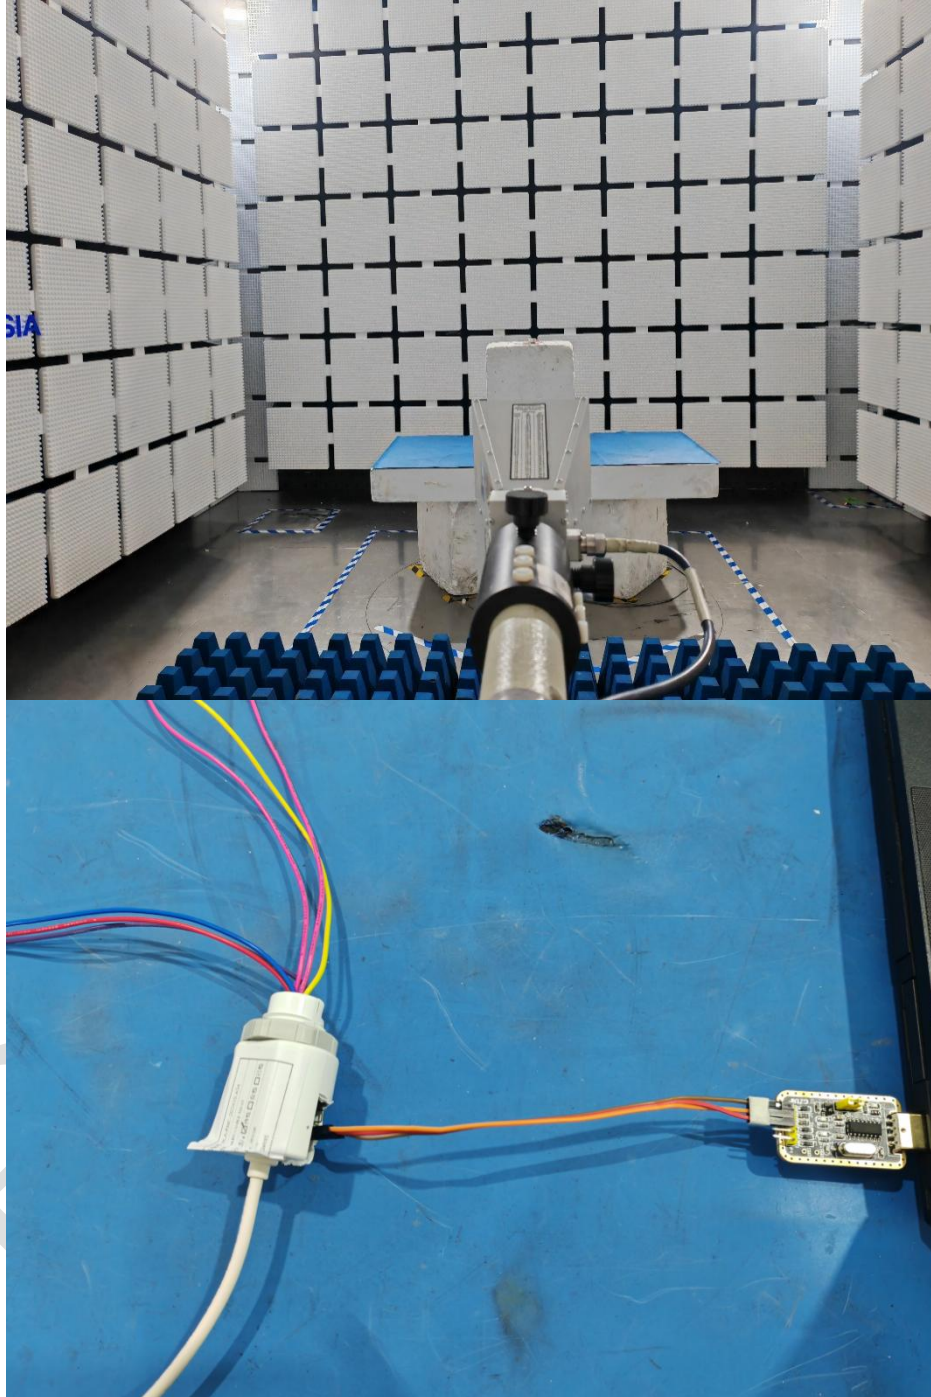
Radiated Emissions (above 1GHz)
