### Conducted RF Spurious Emission

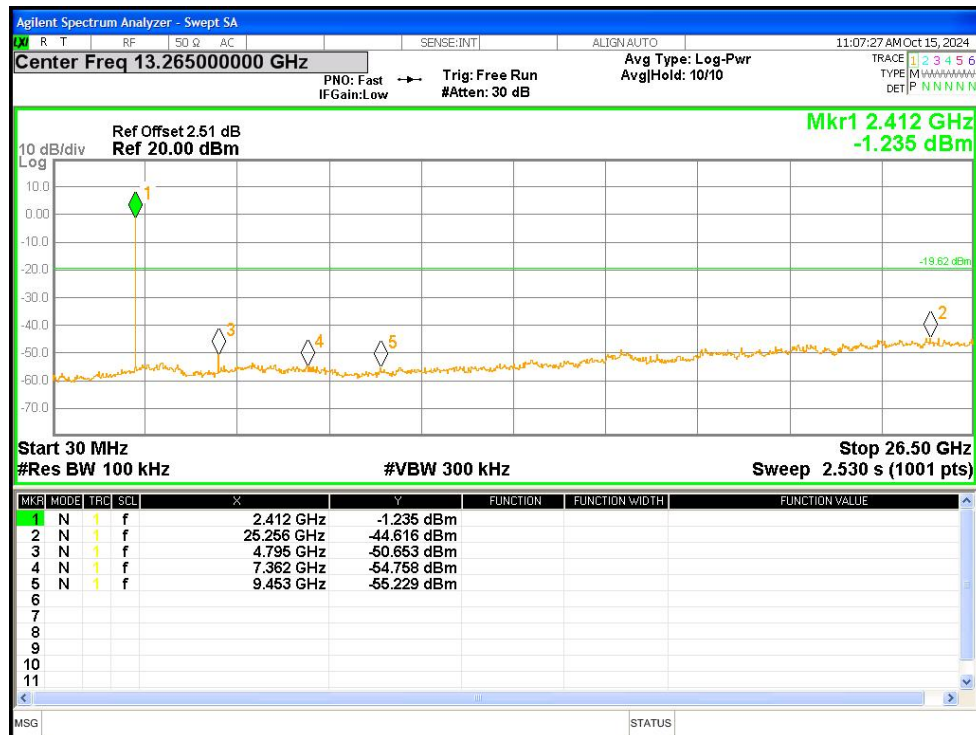
### Tx. Spurious NVNT BLE 1M 2402MHz Ant1 Emission

| Condition | Mode | Frequency (MHz) | Antenna | Max Value (dBc) | Limit (dBc) | Verdict |
|---|---|---|---|---|---|---|
| NVNT | BLE 1M | 2402 | Ant1 | -44.99 | -20 | Pass |

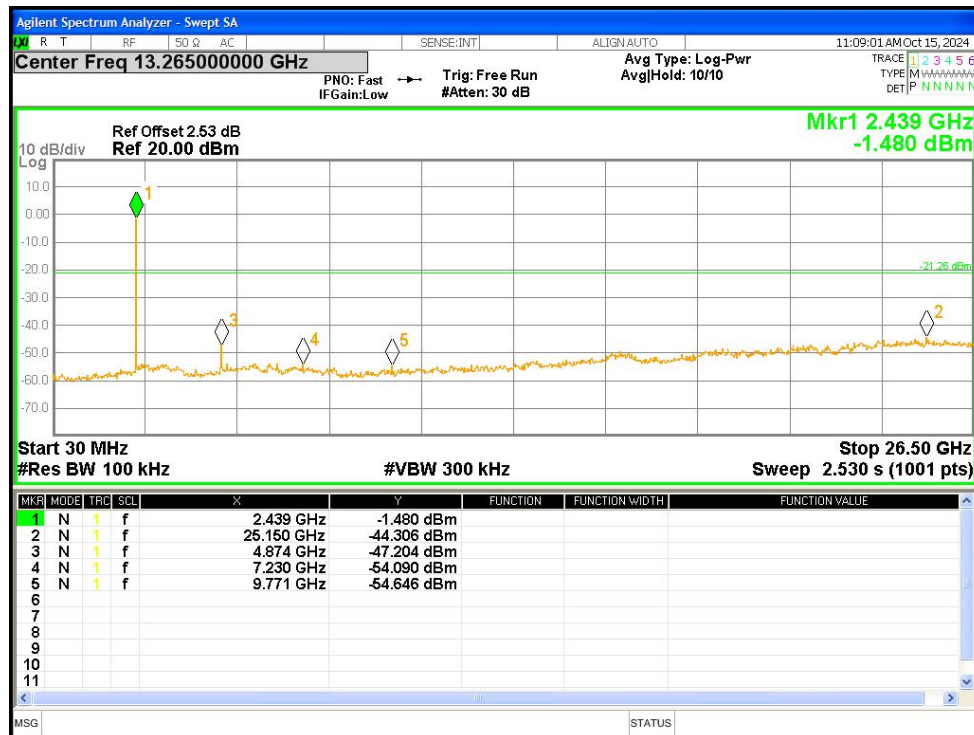
Tx. Spurious NVNT BLE 1M 2442MHz Ant1 Emission

| Condition | Mode | Frequency (MHz) | Antenna | Max Value (dBc) | Limit (dBc) | Verdict |
|---|---|---|---|---|---|---|
| NVNT | BLE 1M | 2442 | Ant1 | -43.04 | -20 | Pass |

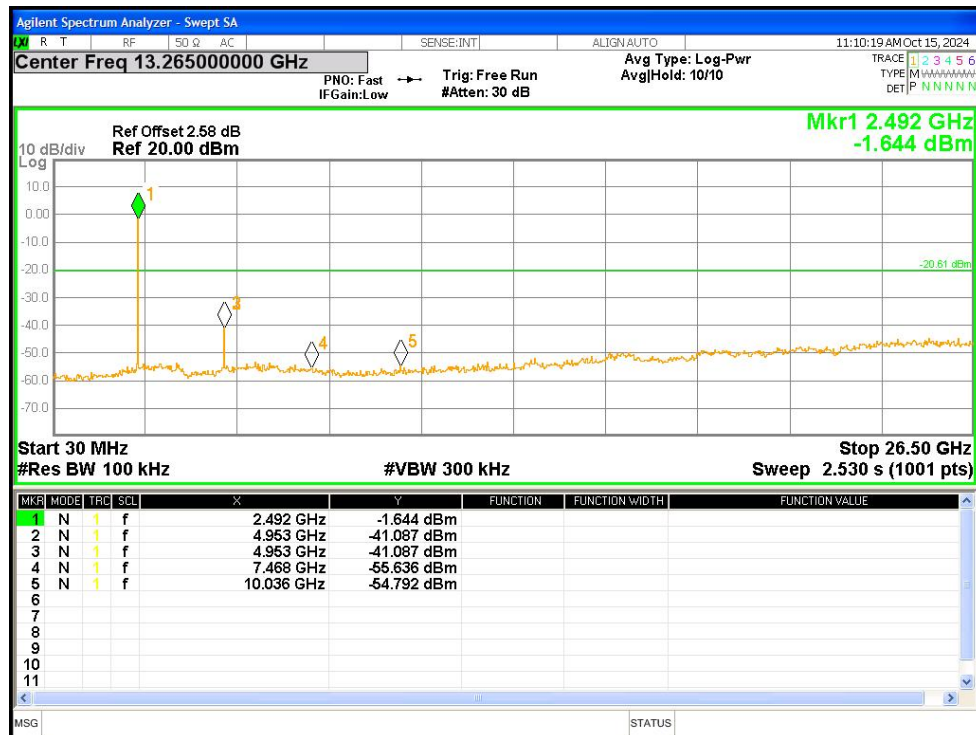
Tx. Spurious NVNT BLE 1M 2480MHz Ant1 Emission

| Condition | Mode | Frequency (MHz) | Antenna | Max Value (dBc) | Limit (dBc) | Verdict |
|---|---|---|---|---|---|---|
| NVNT | BLE 1M | 2480 | Ant1 | -40.47 | -20 | Pass |

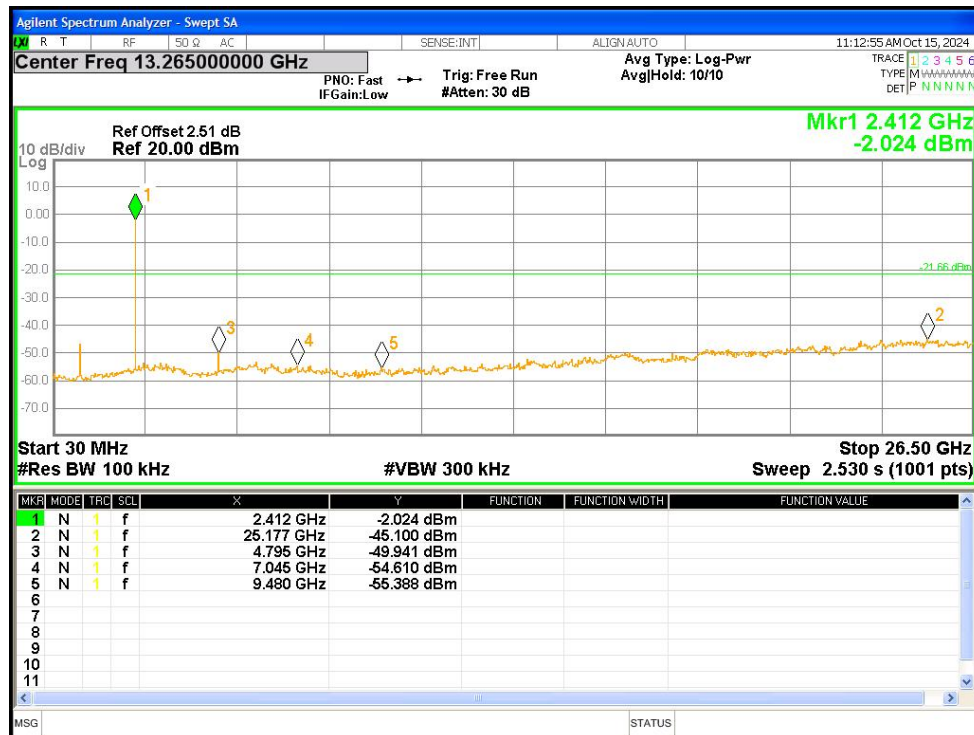
Tx. Spurious NVNT BLE 2M 2402MHz Ant1 Emission

| Condition | Mode | Frequency (MHz) | Antenna | Max Value (dBc) | Limit (dBc) | Verdict |
|---|---|---|---|---|---|---|
| NVNT | BLE 2M | 2402 | Ant1 | -43.43 | -20 | Pass |

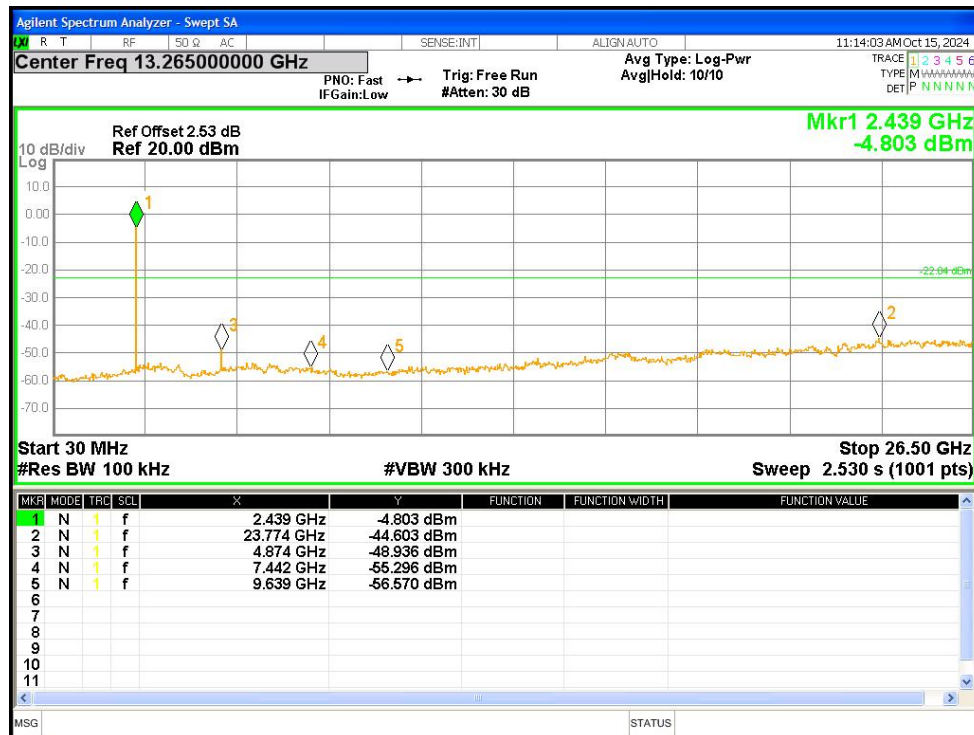
Tx. Spurious NVNT BLE 2M 2442MHz Ant1 Emission

| Condition | Mode | Frequency (MHz) | Antenna | Max Value (dBc) | Limit (dBc) | Verdict |
|---|---|---|---|---|---|---|
| NVNT | BLE 2M | 2442 | Ant1 | -41.76 | -20 | Pass |

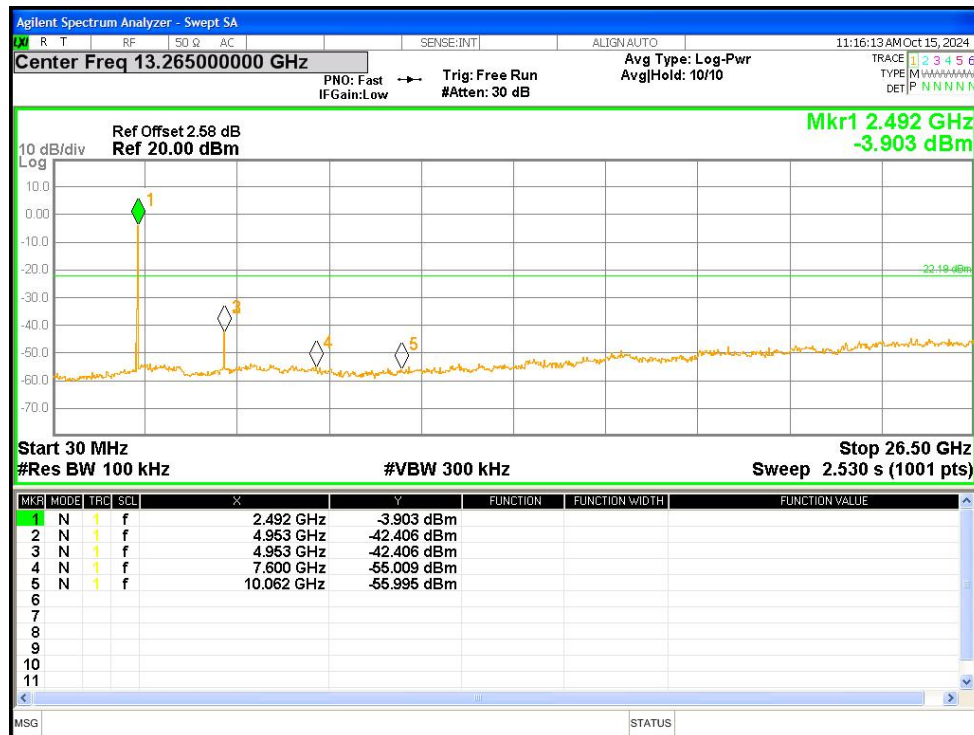
Tx. Spurious NVNT BLE 2M 2480MHz Ant1 Emission

| Condition | Mode | Frequency (MHz) | Antenna | Max Value (dBc) | Limit (dBc) | Verdict |
|---|---|---|---|---|---|---|
| NVNT | BLE 2M | 2480 | Ant1 | -40.21 | -20 | Pass |

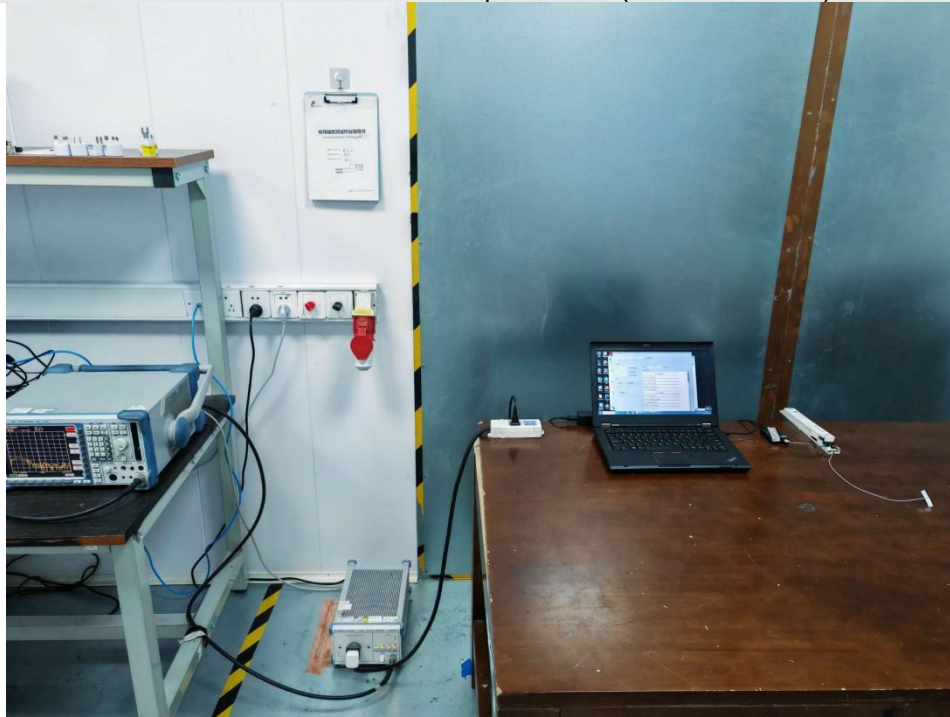
Conducted emissions at AC power line (150kHz-30MHz)

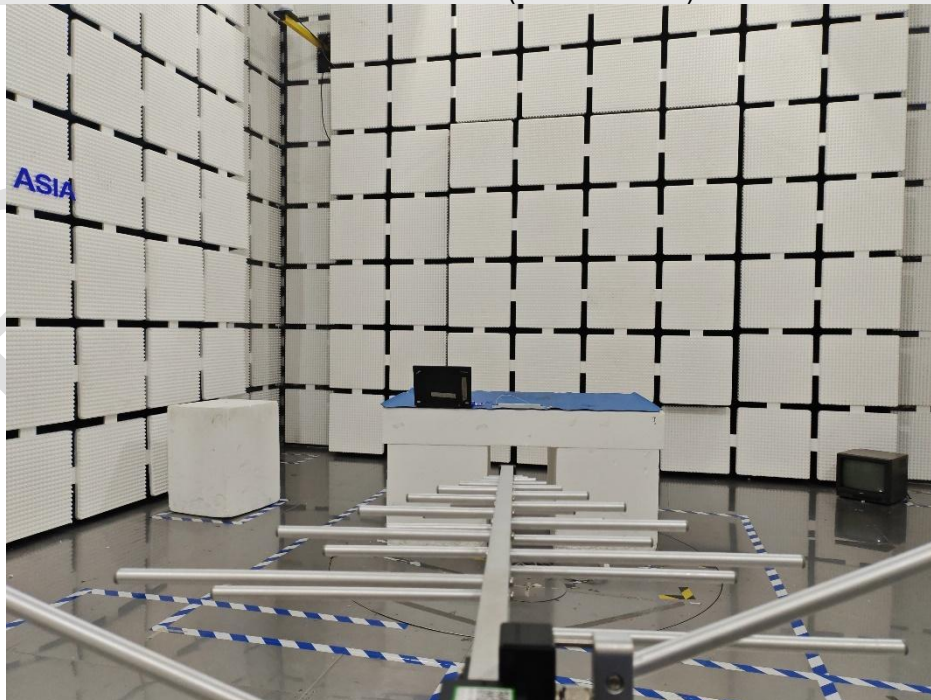
Radiated Emissions (30MHz-1GHz)

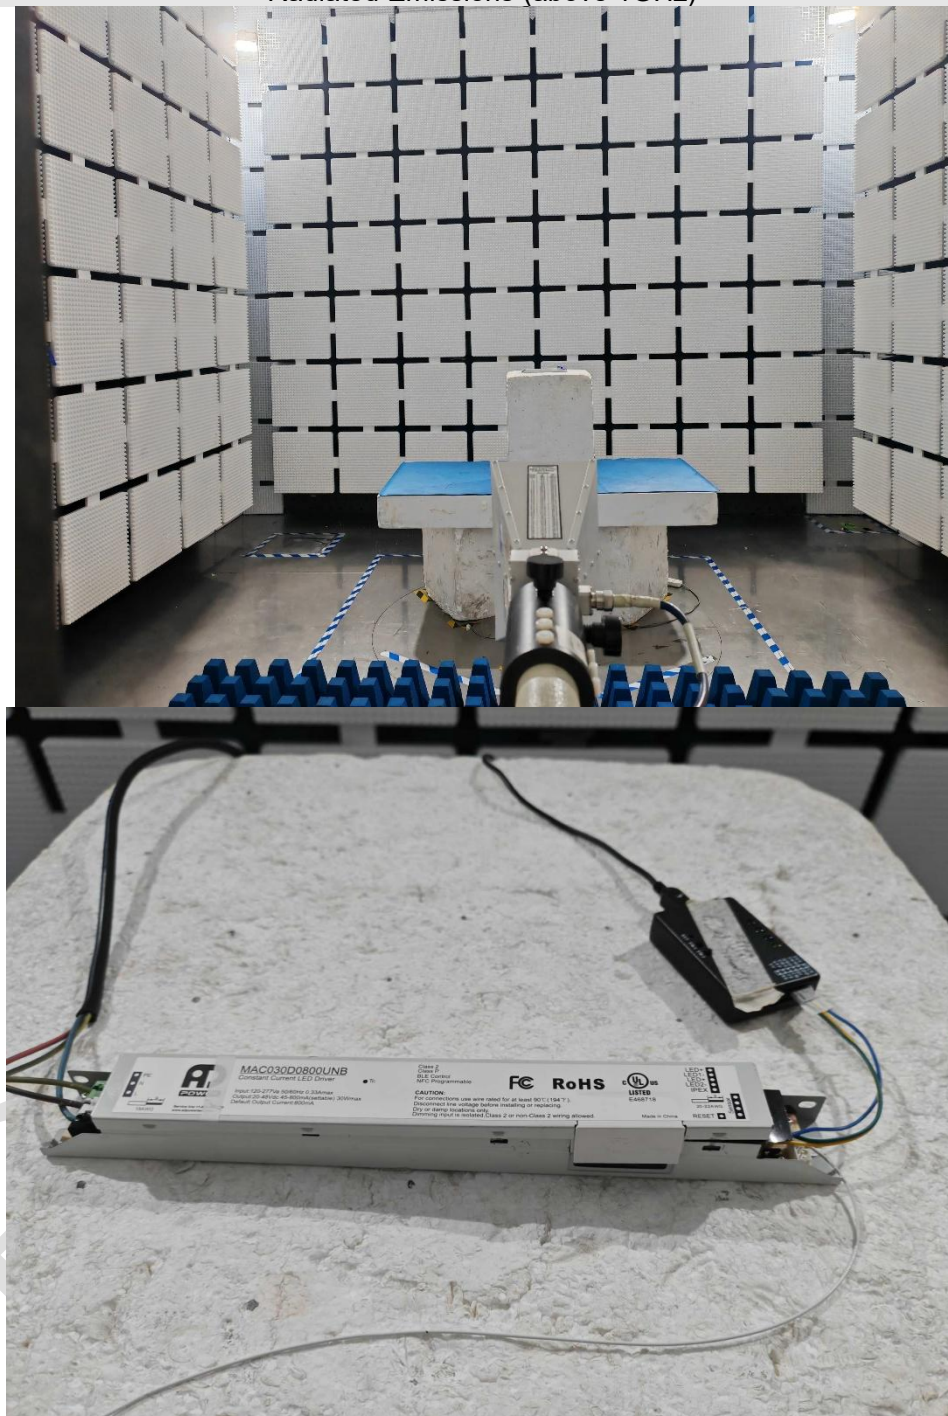
Radiated Emissions (above 1GHz)
