## 6 Conducted RF Spurious Emission

### 6.1 Test Result

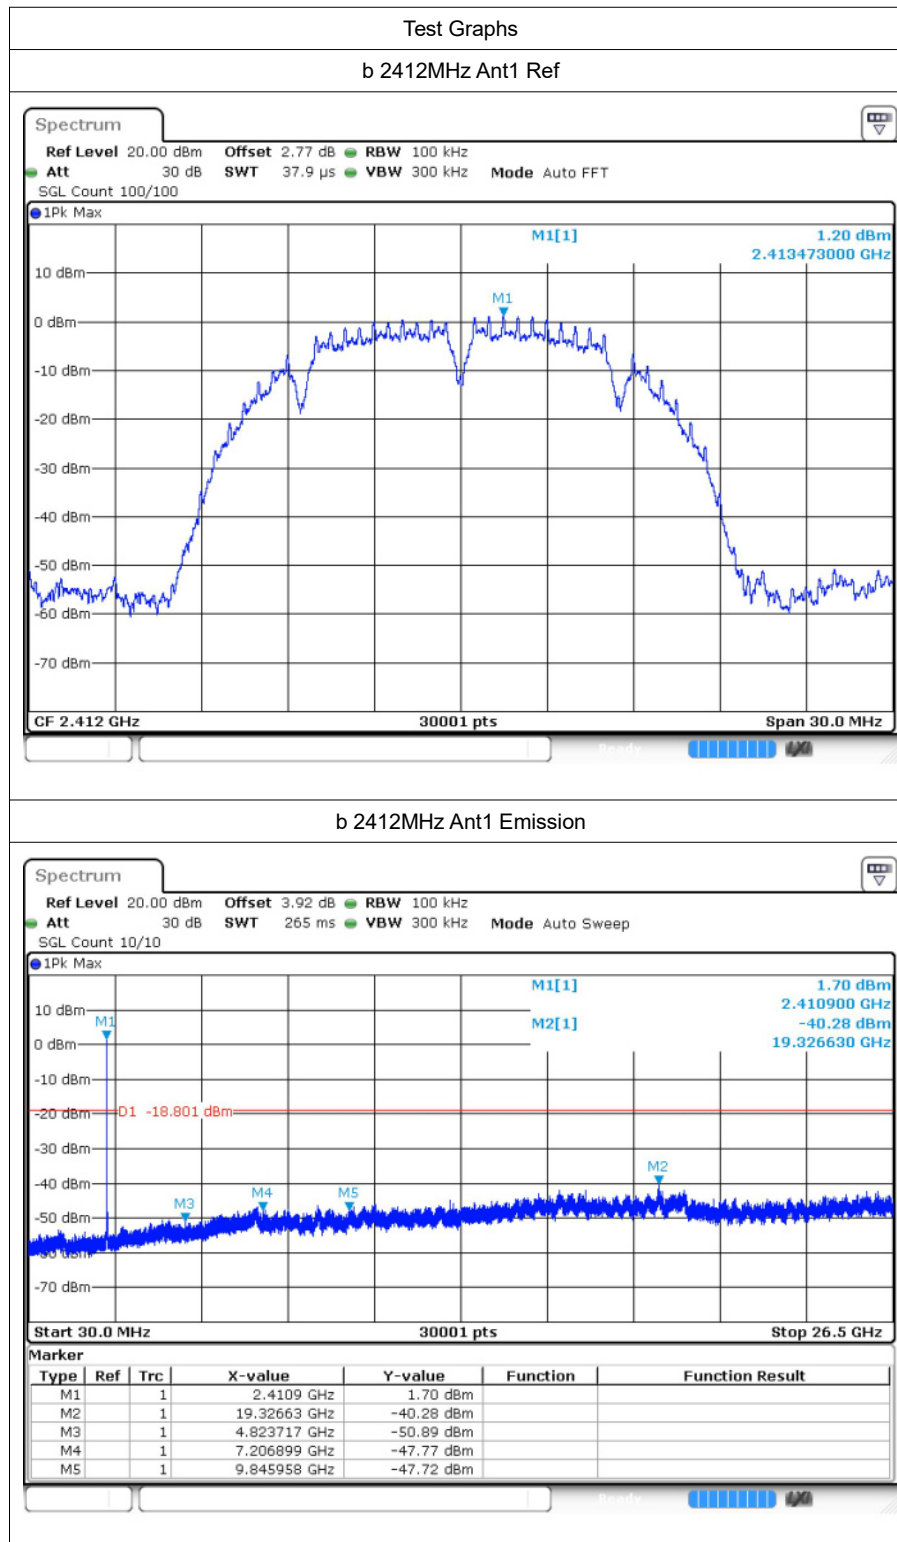
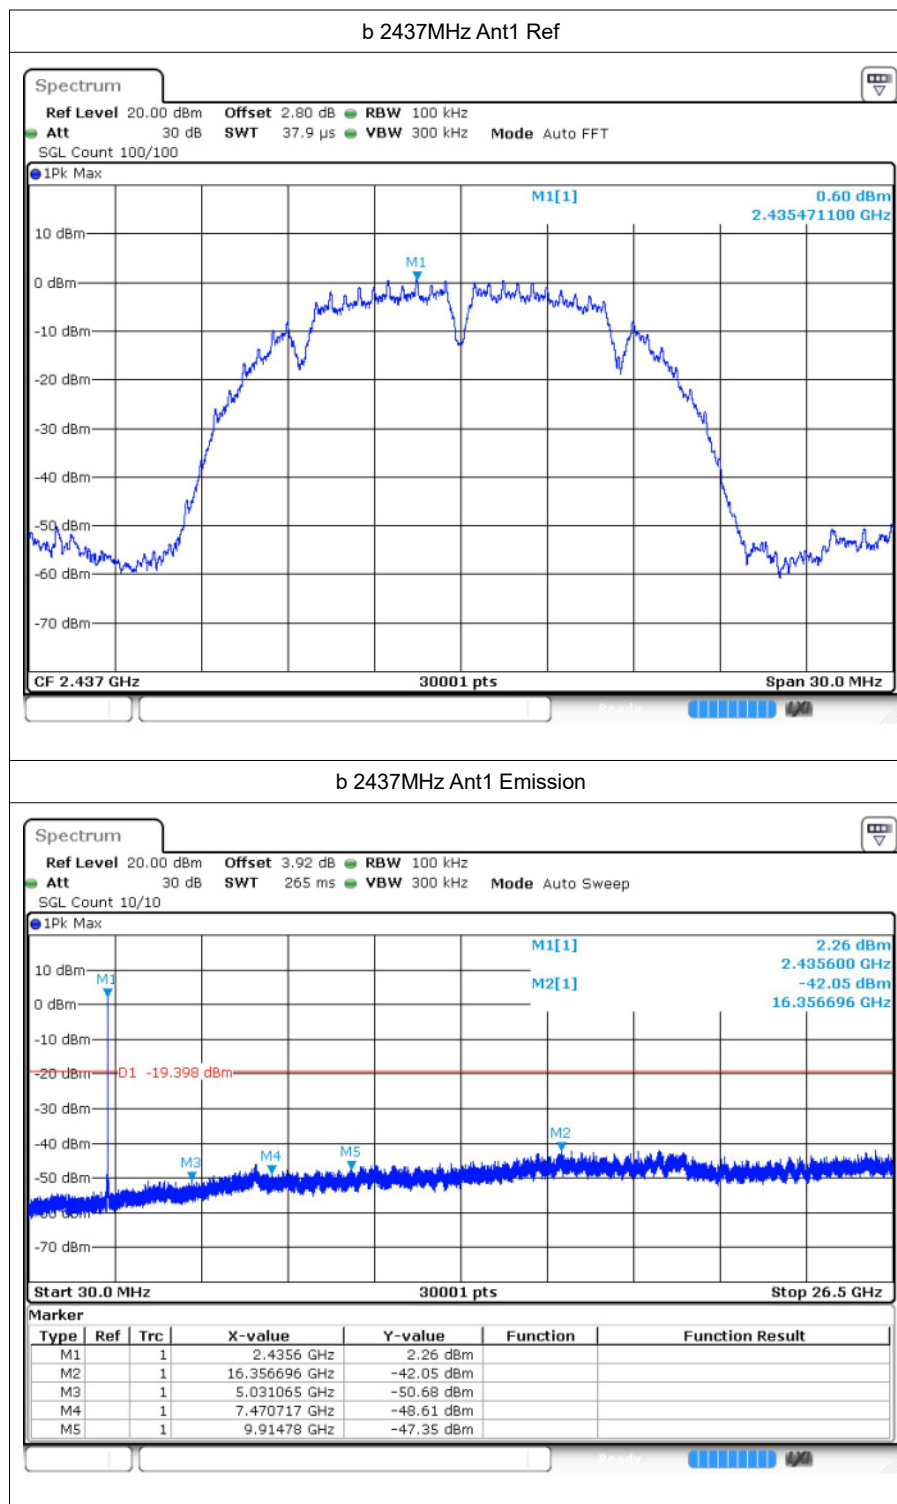
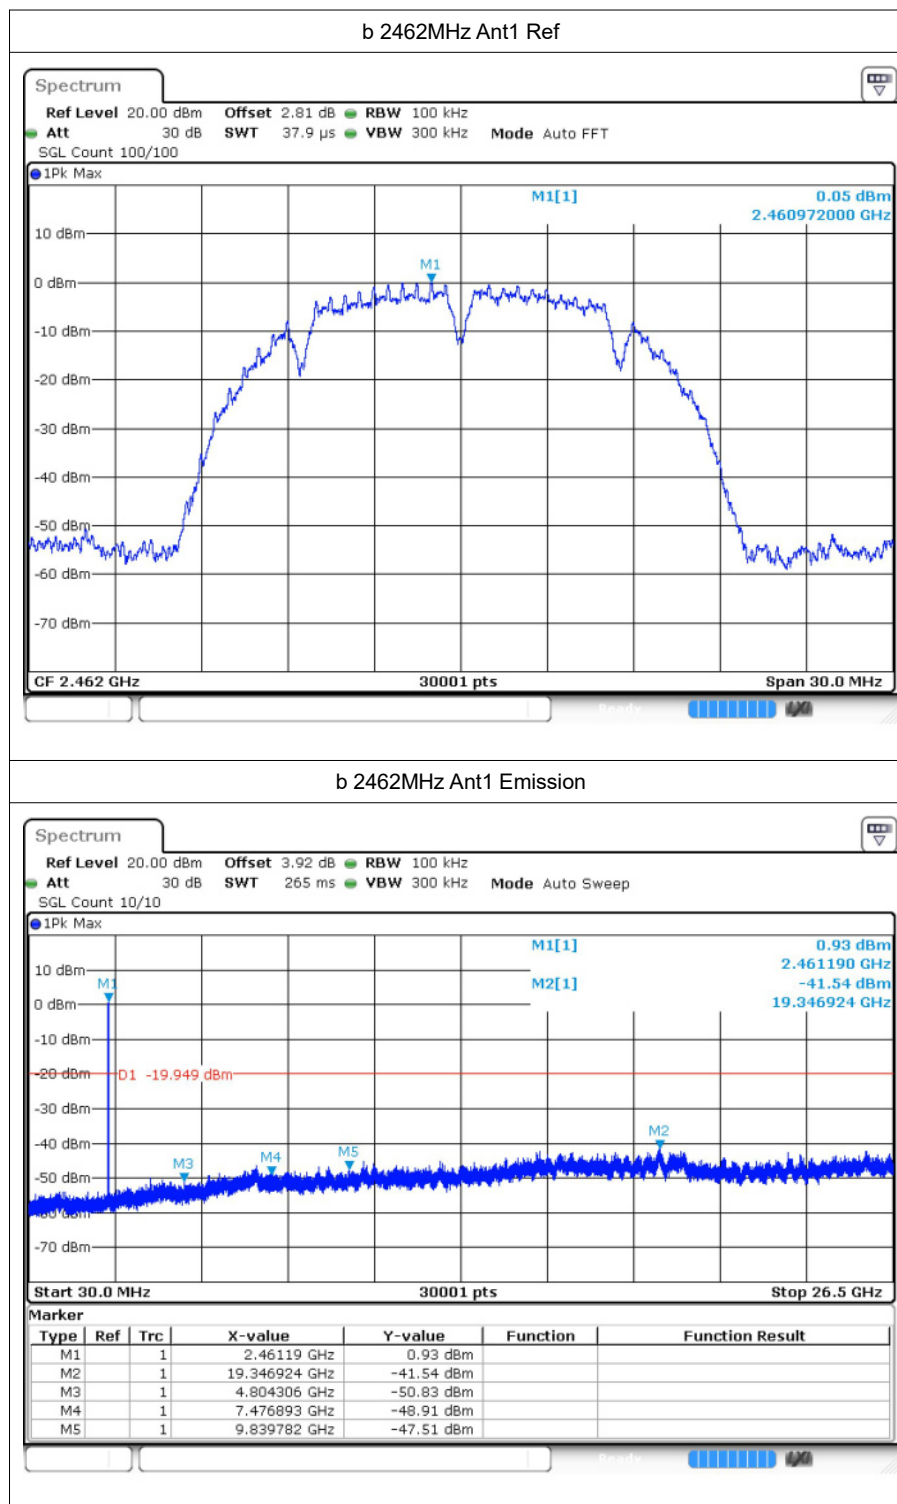
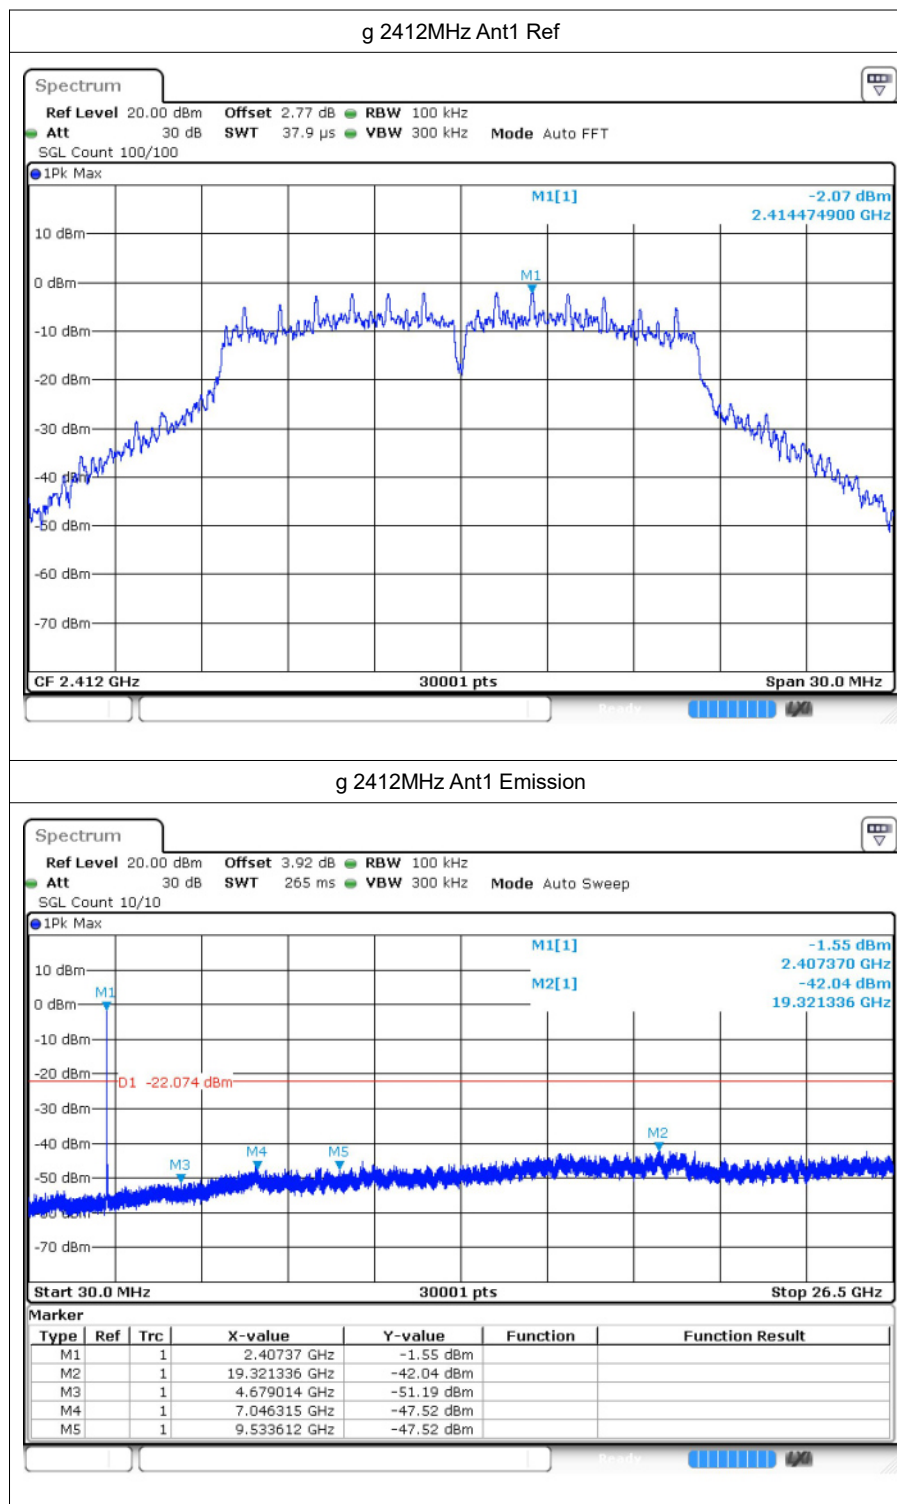
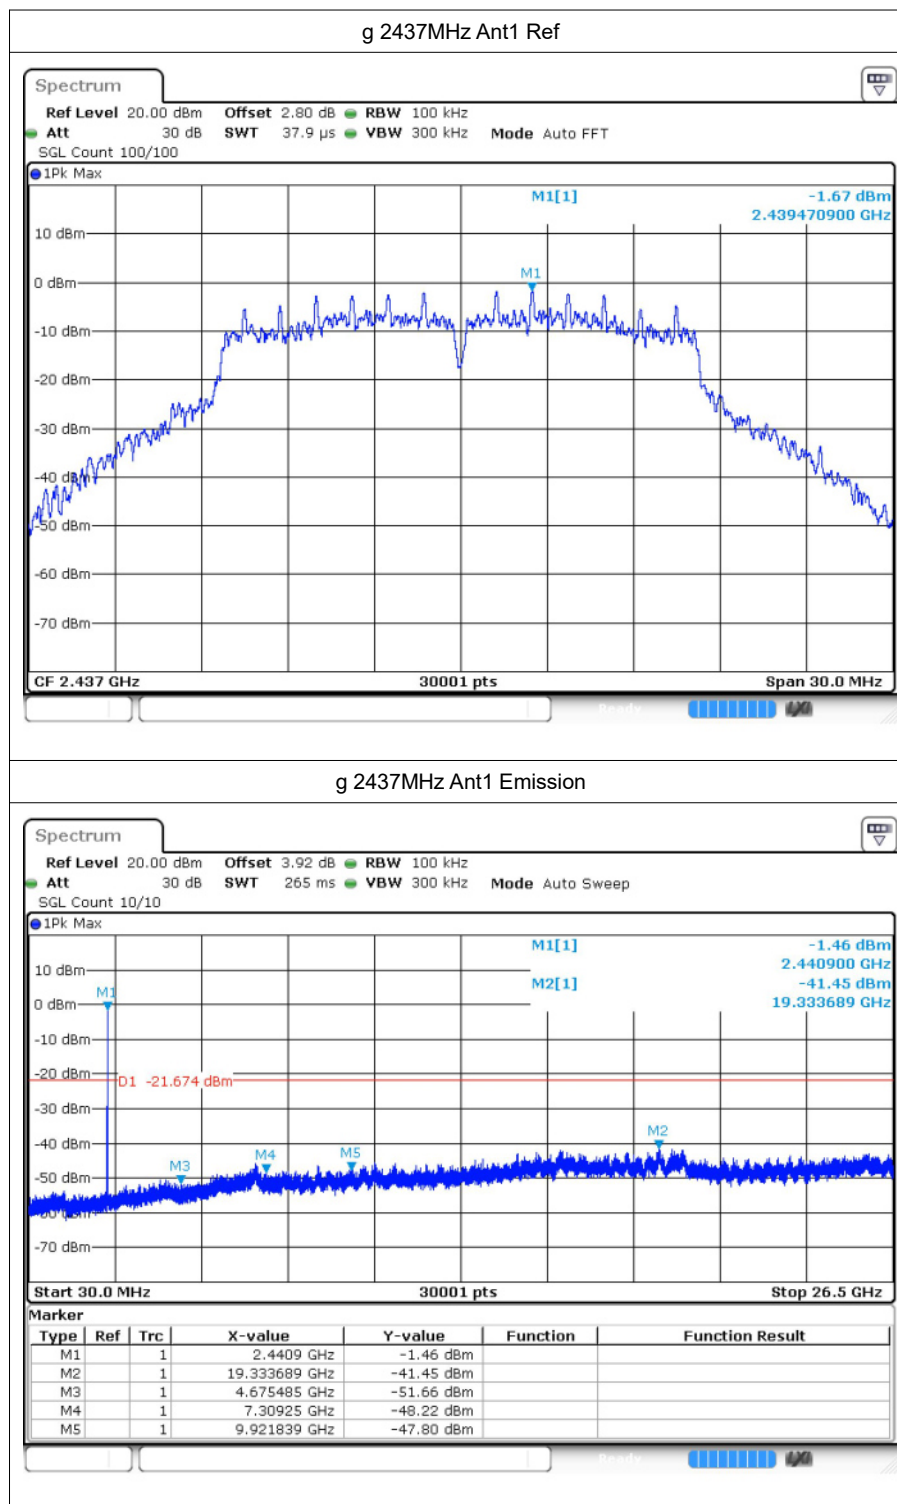
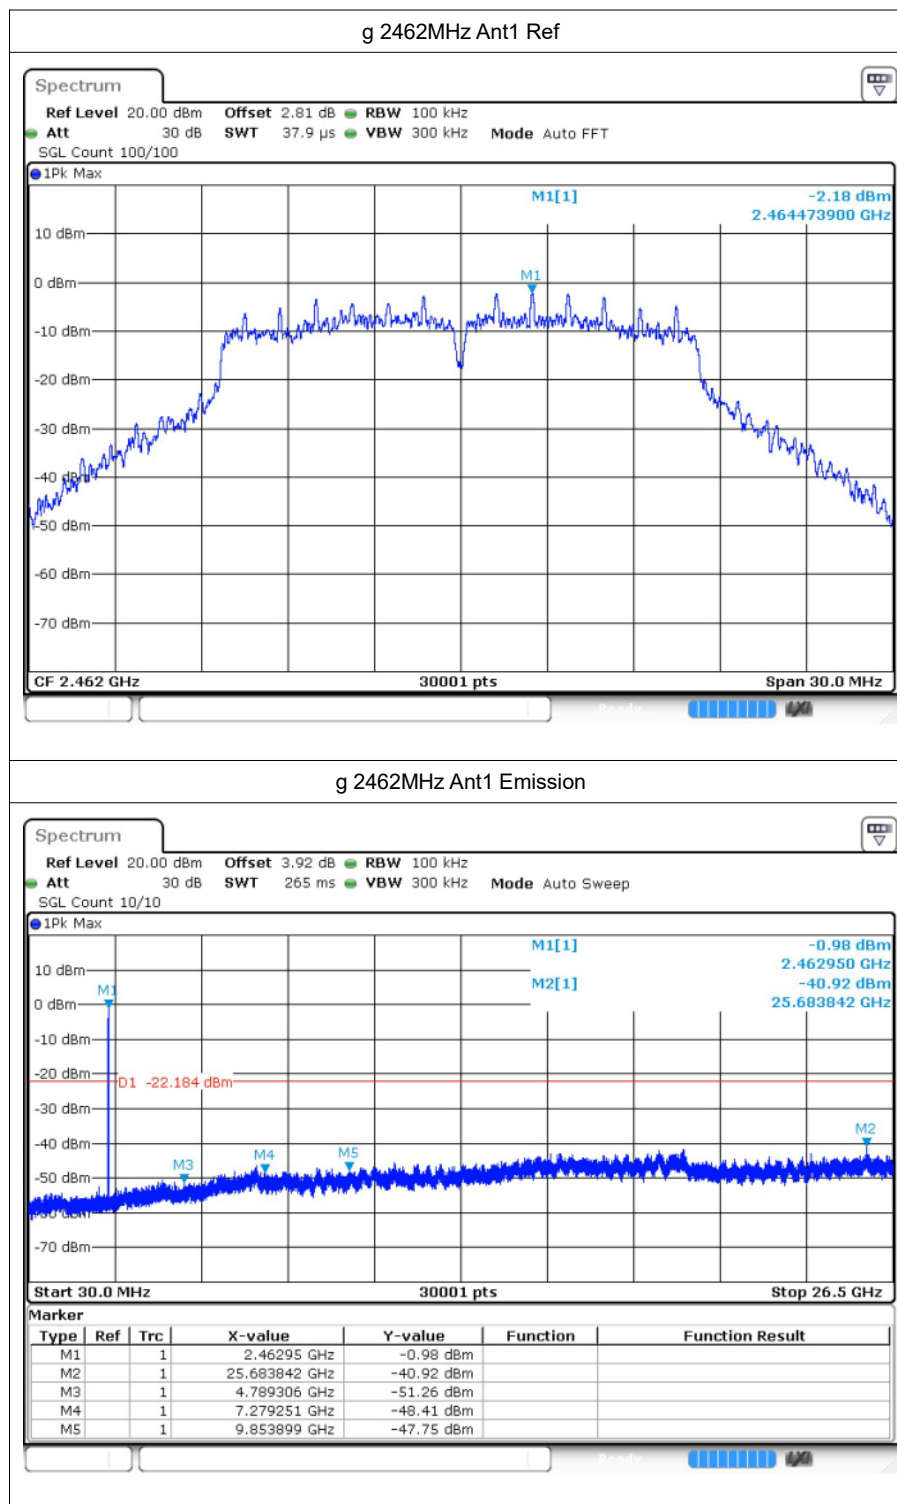
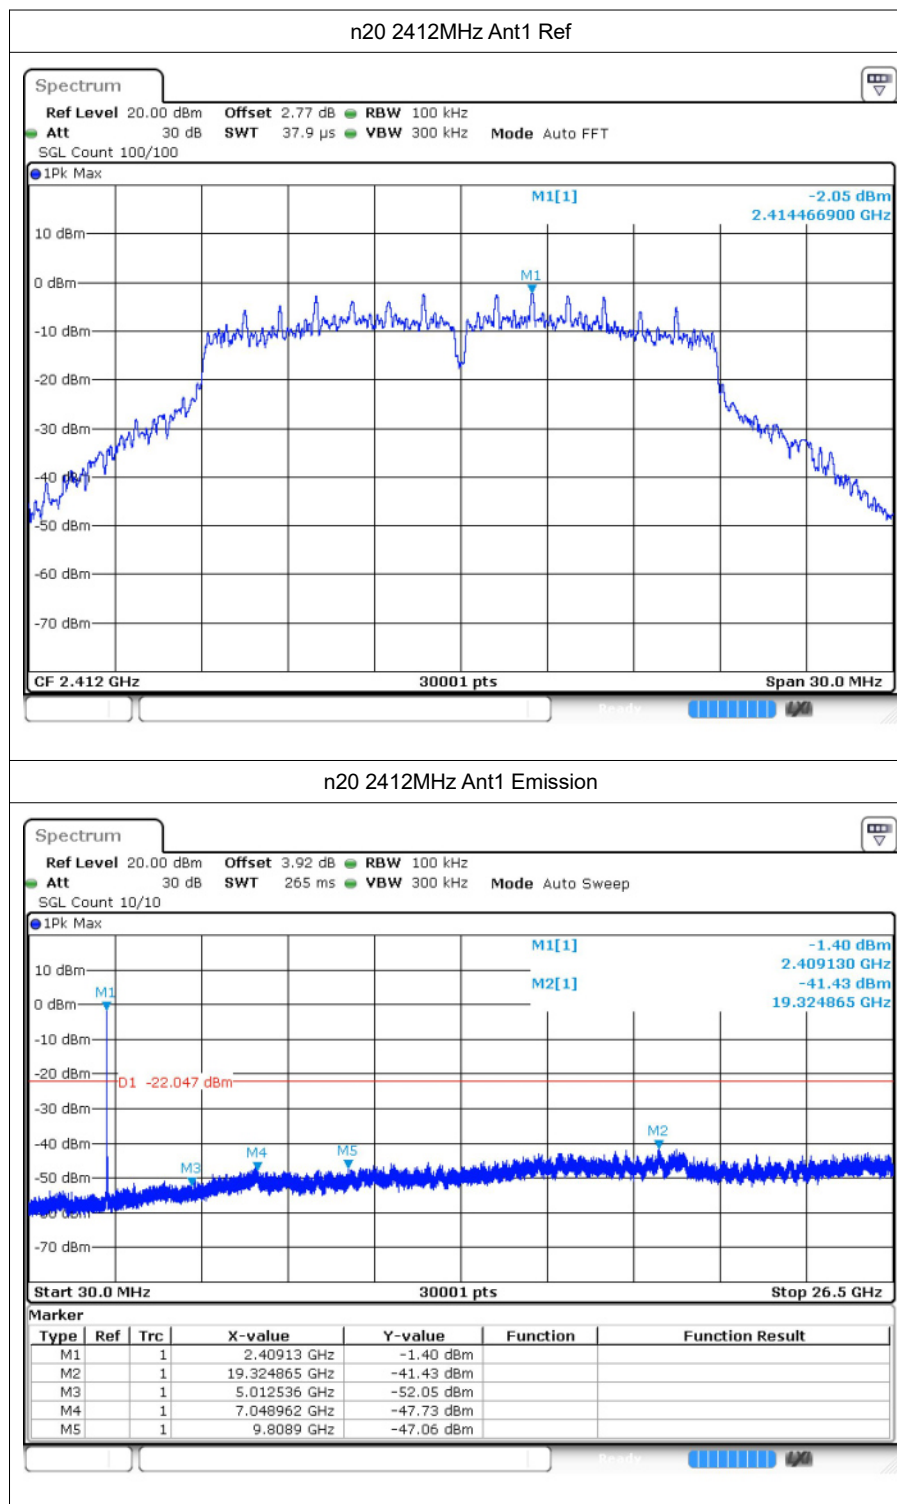
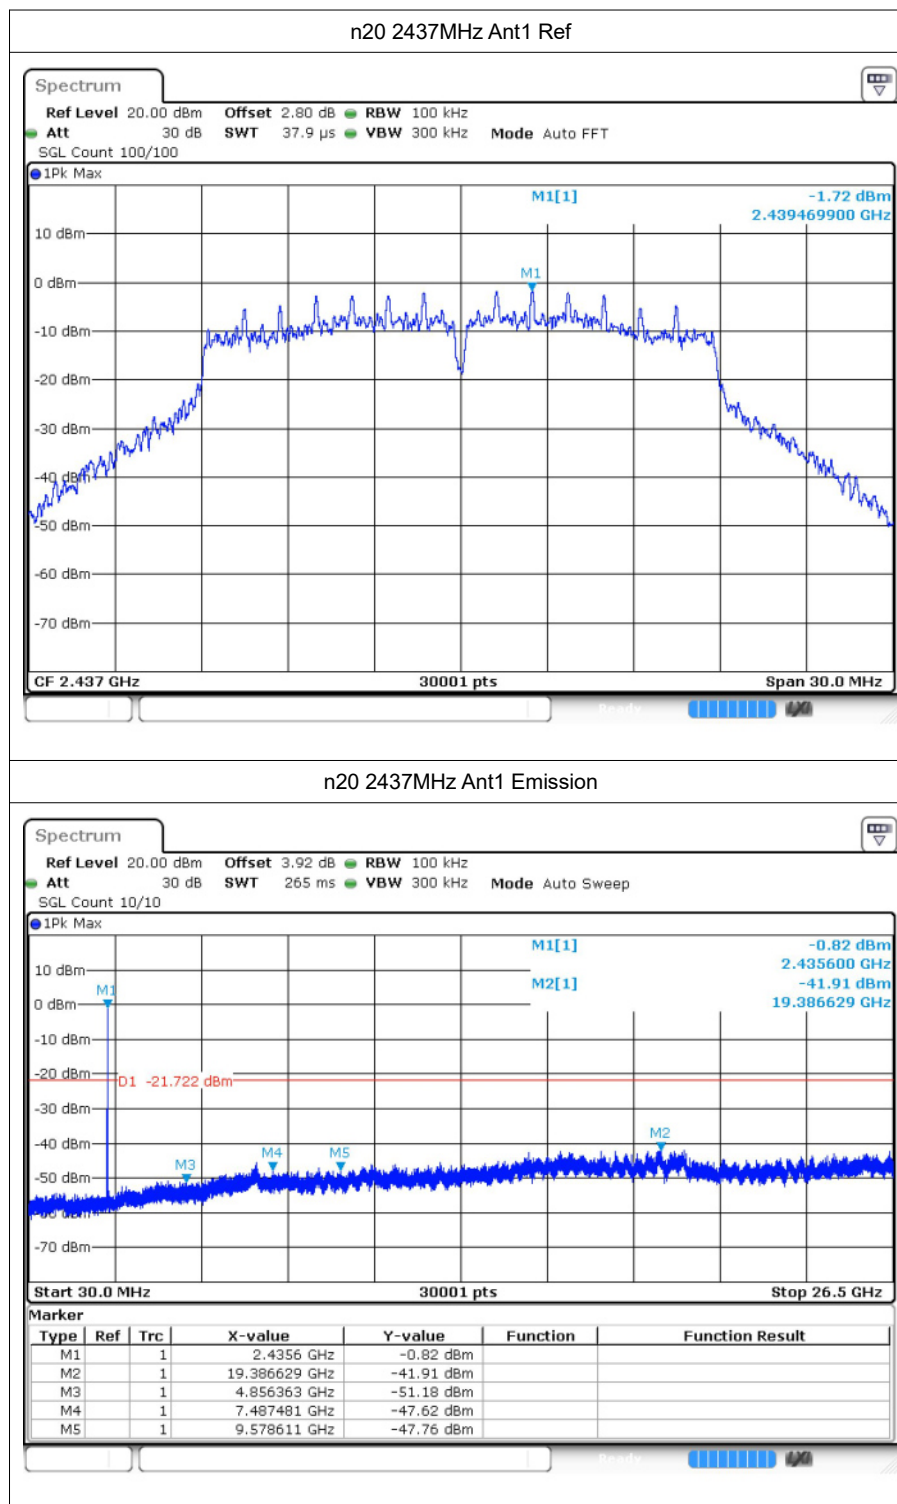
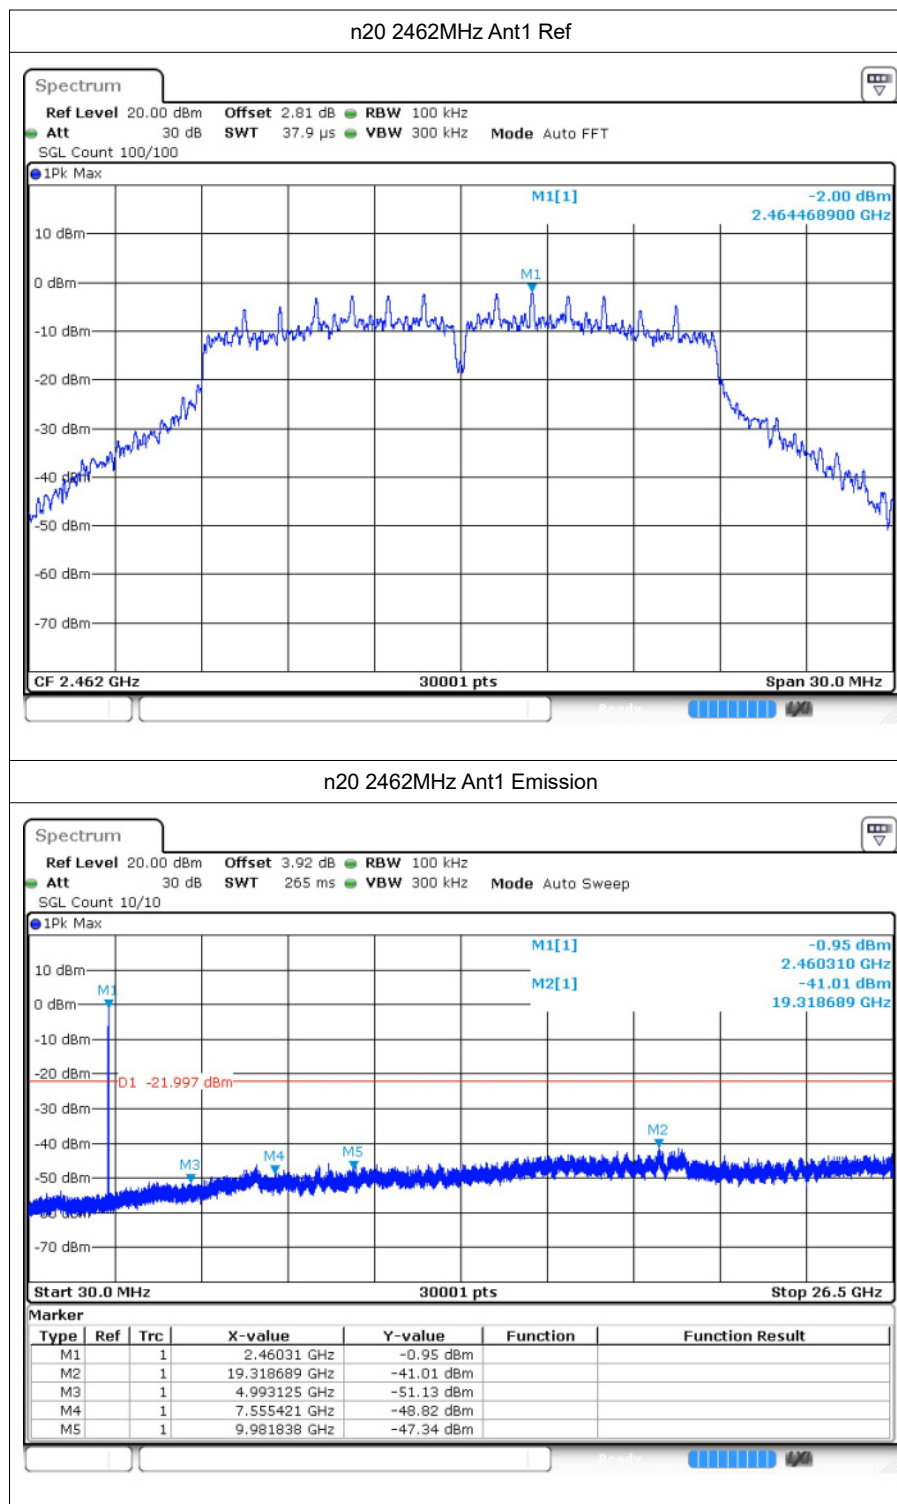
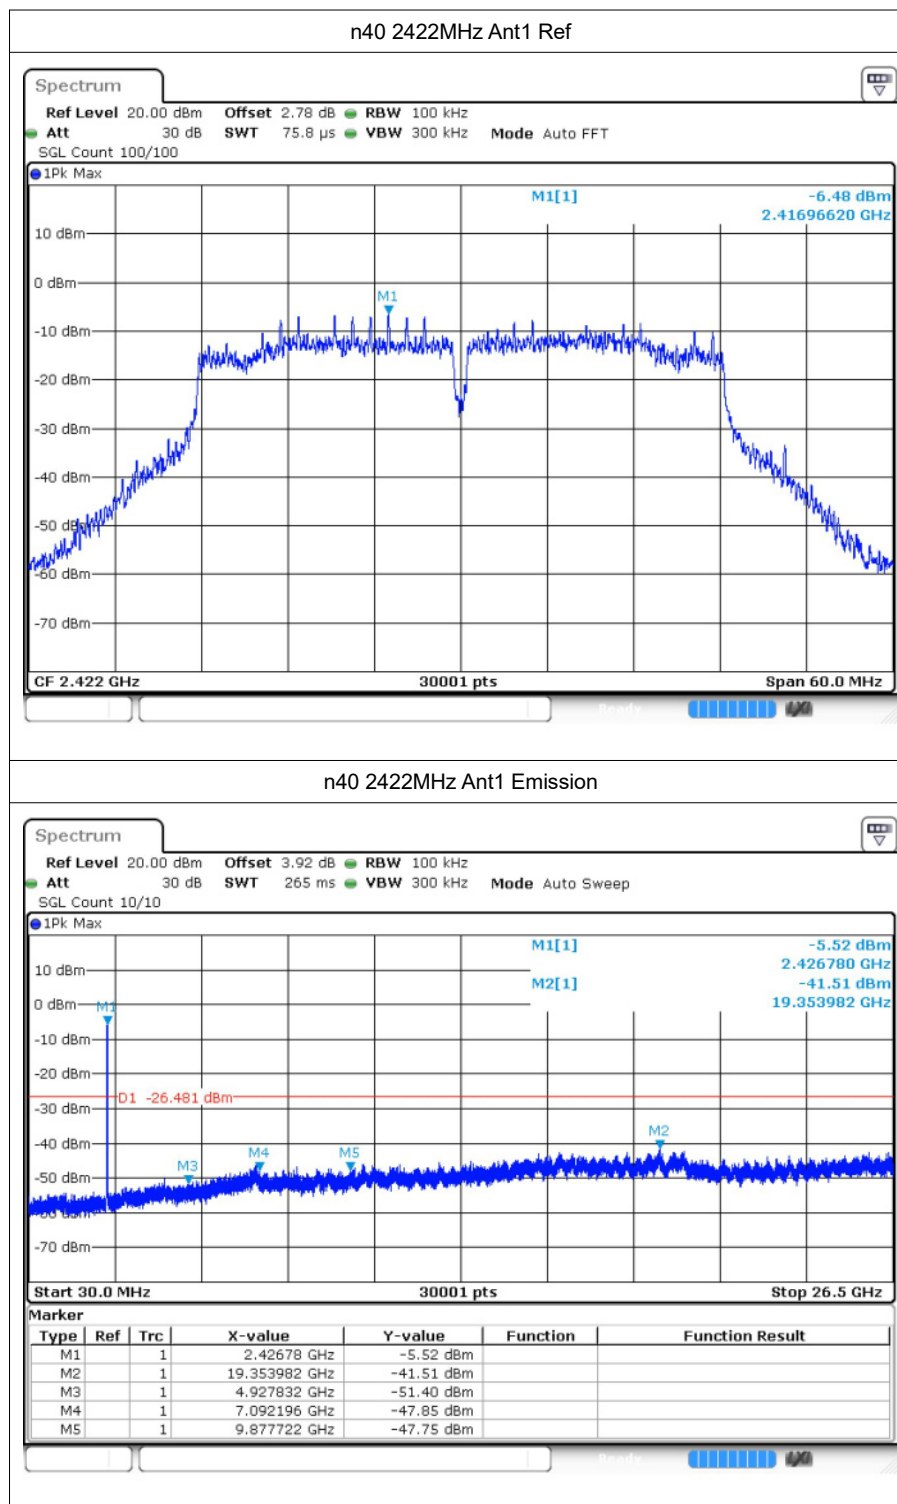
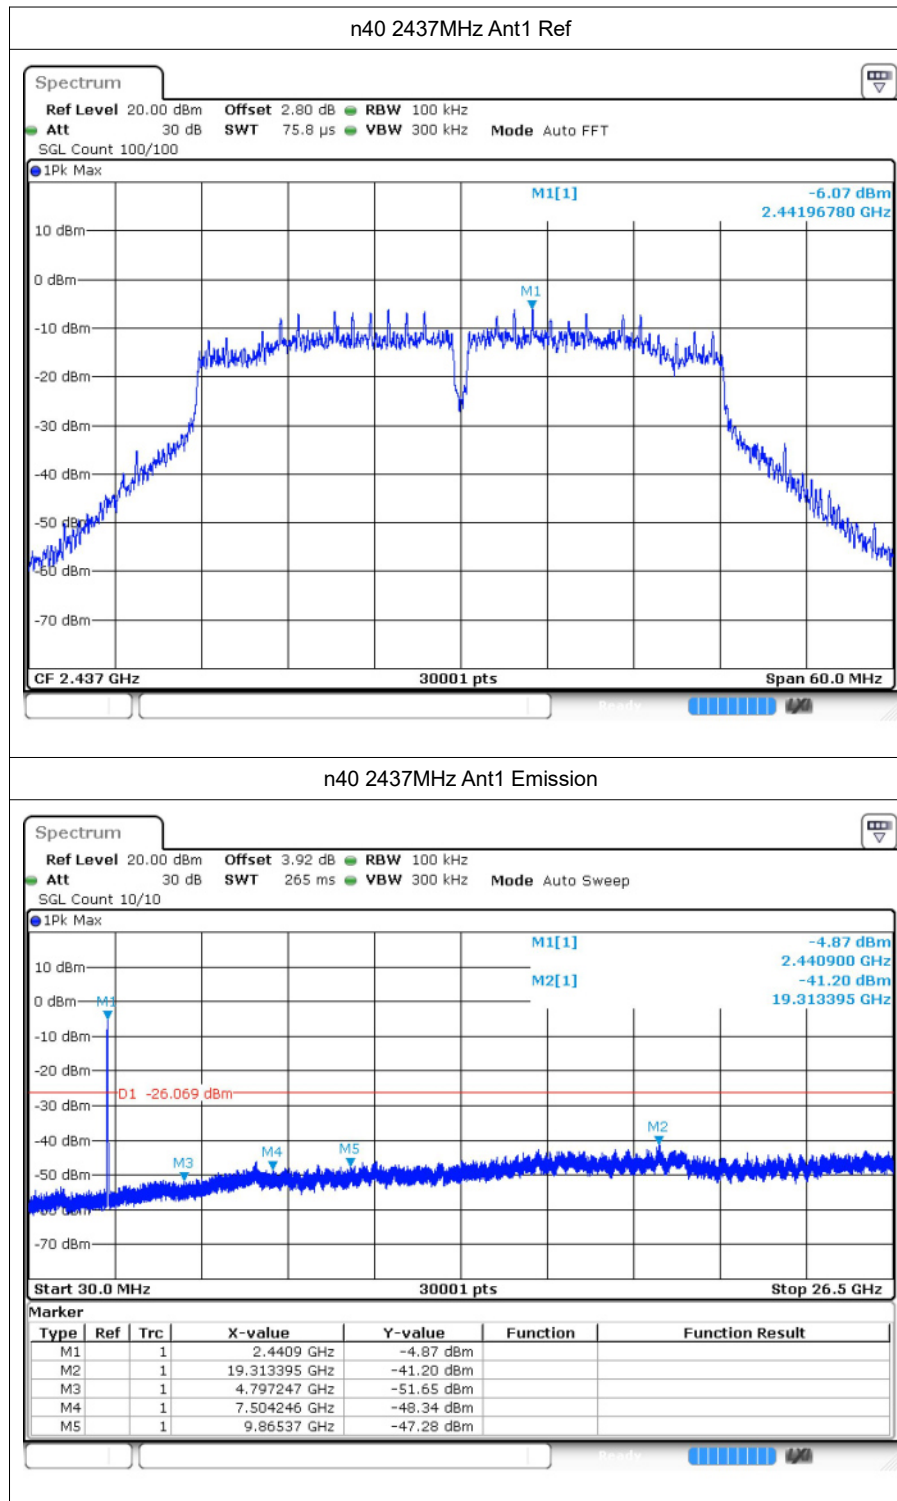
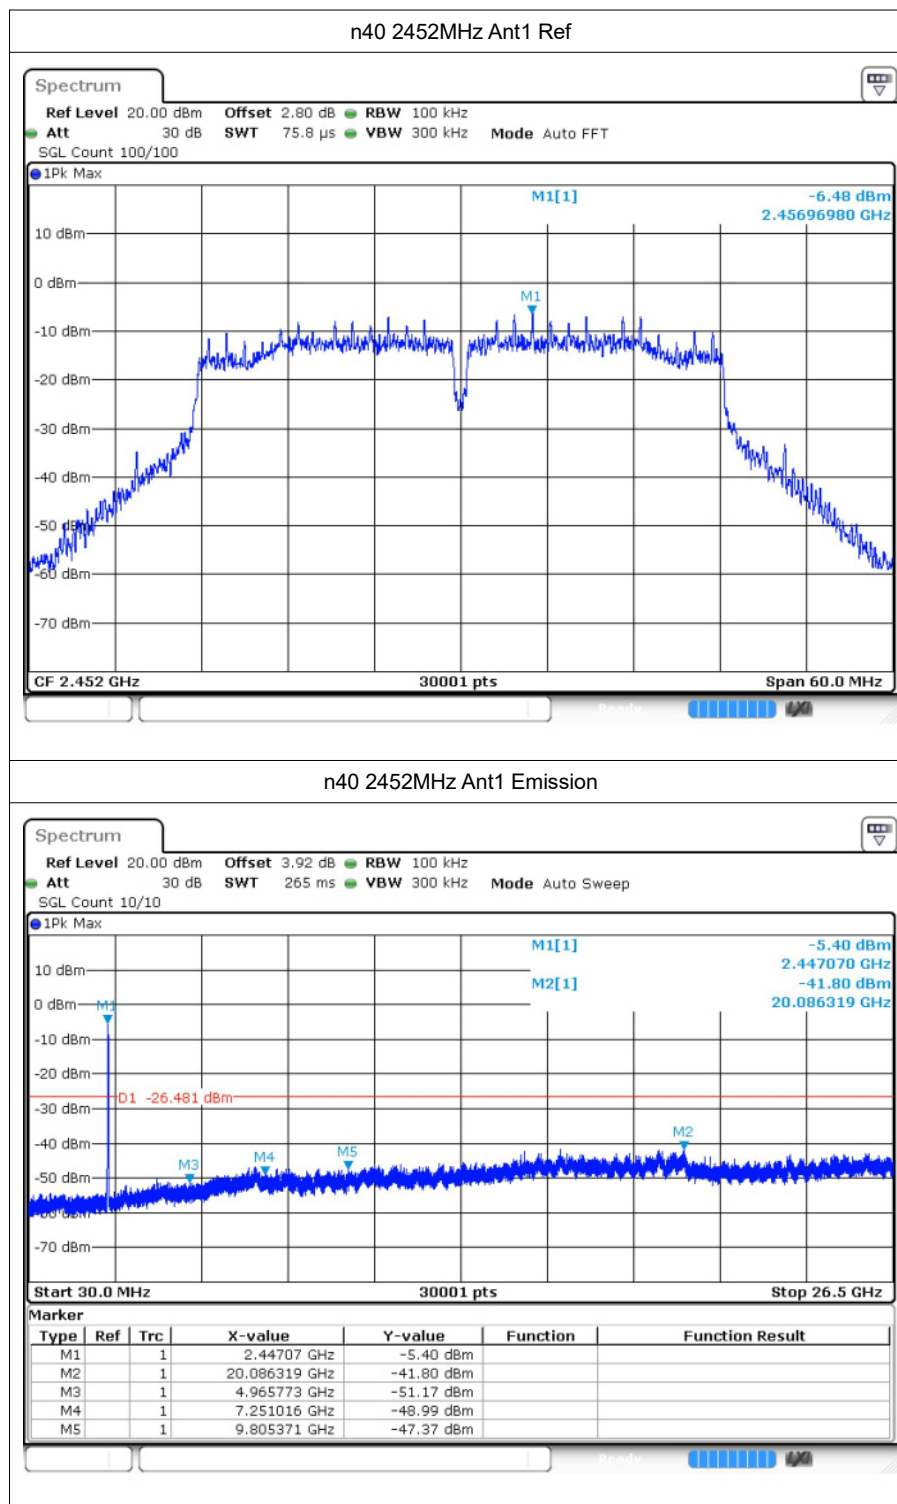
## 6.2 Test Graphs

| Mode | Frequency (MHz) | Antenna | Max Value (dBc) | Limit (dBc) | Verdict |
