## Appendix B: photographs of test setup

## Appendix C: photographs of EUT

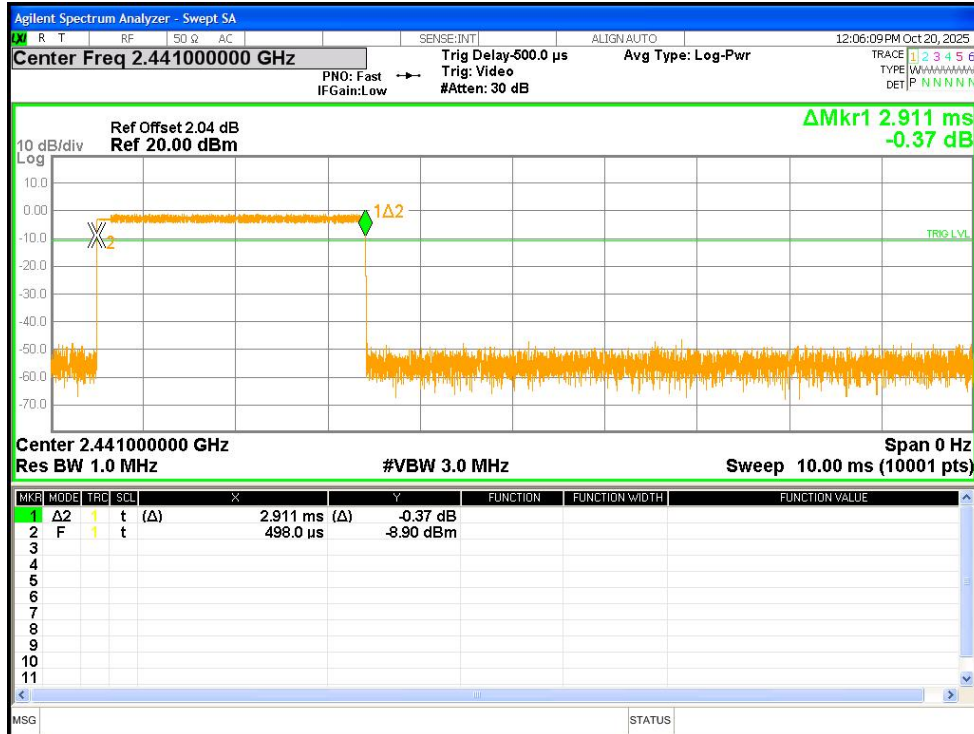
Dwell NVNT 2-DH5 2441MHz Ant1 One Burst

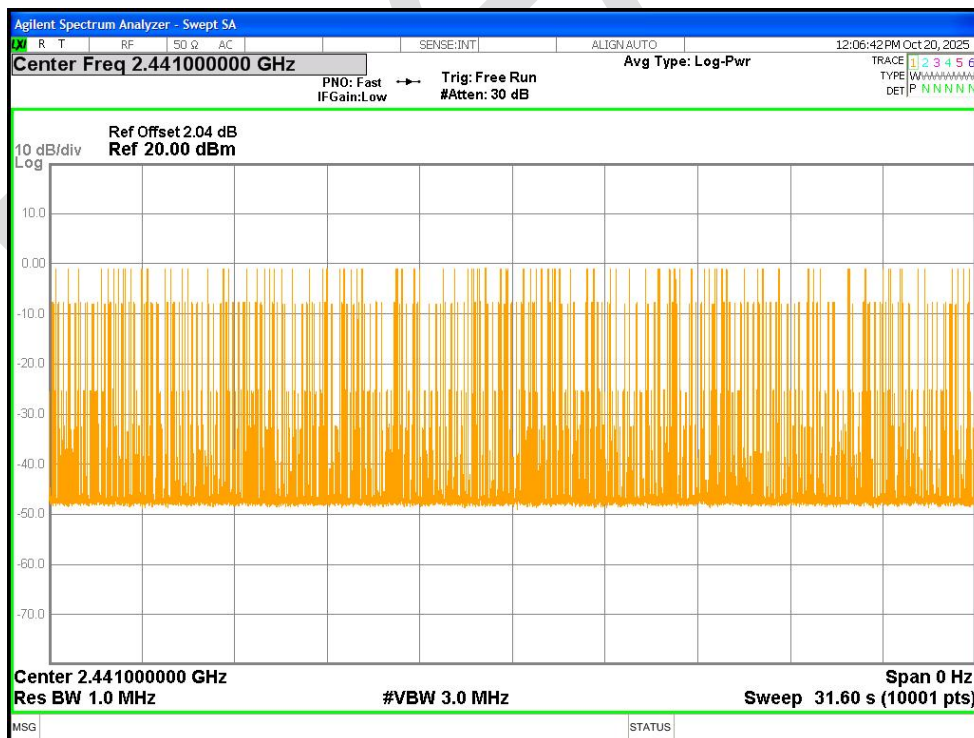
Dwell NVNT 2-DH5 2441MHz Ant1 Accumulated

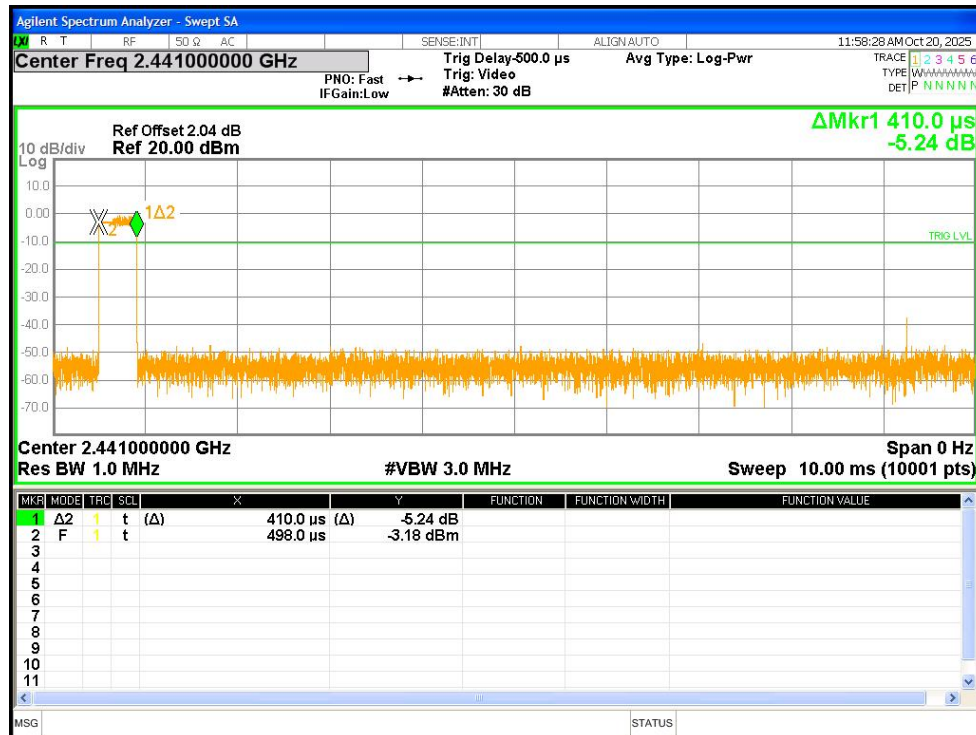
Dwell NVNT 3-DH1 2441MHz Ant1 One Burst

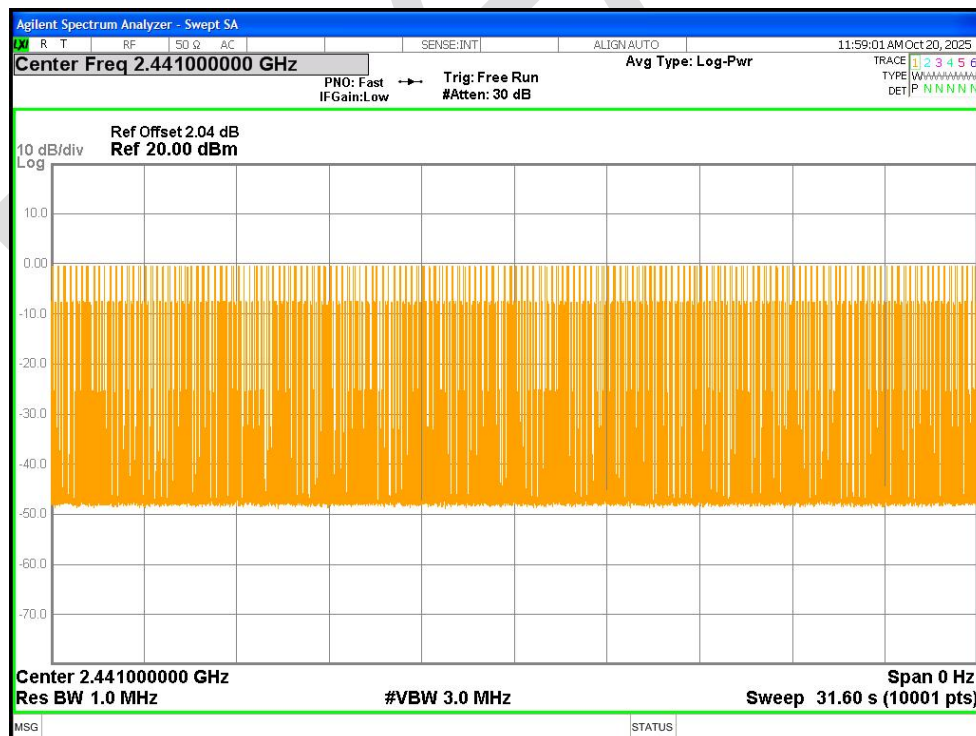
Dwell NVNT 3-DH1 2441MHz Ant1 Accumulated

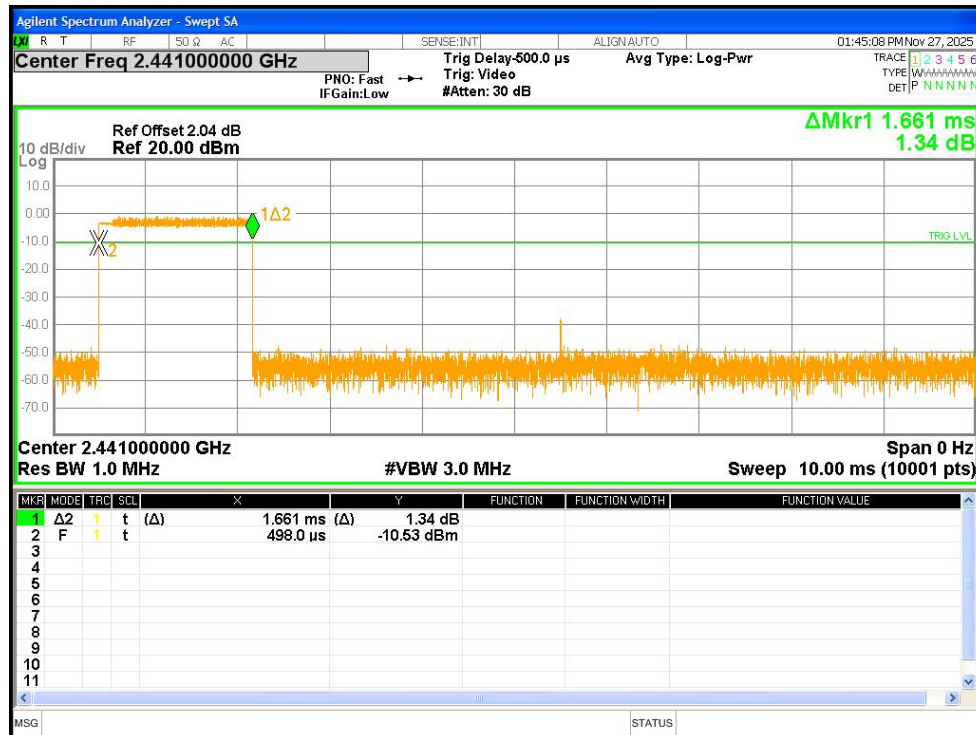
Dwell NVNT 3-DH3 2441MHz Ant1 One Burst

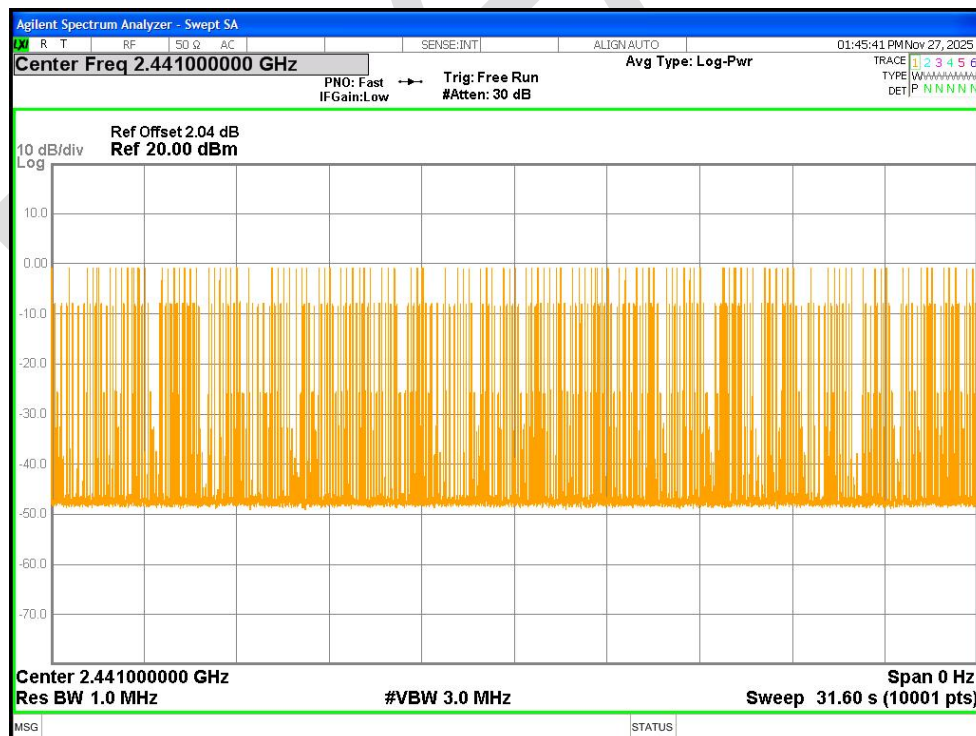
Dwell NVNT 3-DH3 2441MHz Ant1 Accumulated

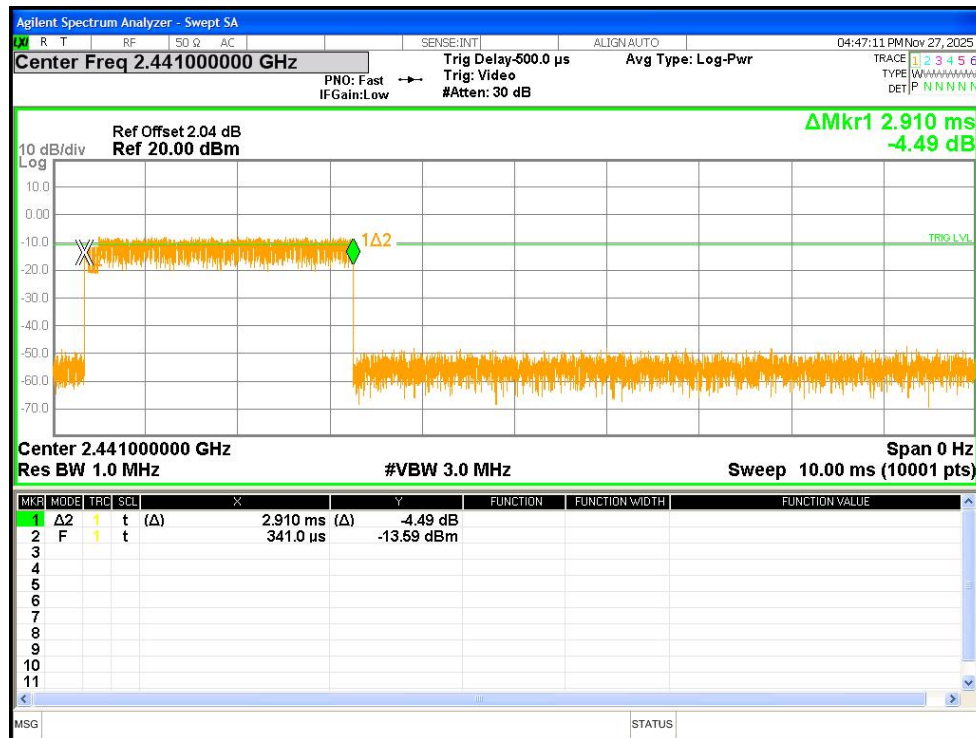
Dwell NVNT 3-DH5 2441MHz Ant1 One Burst

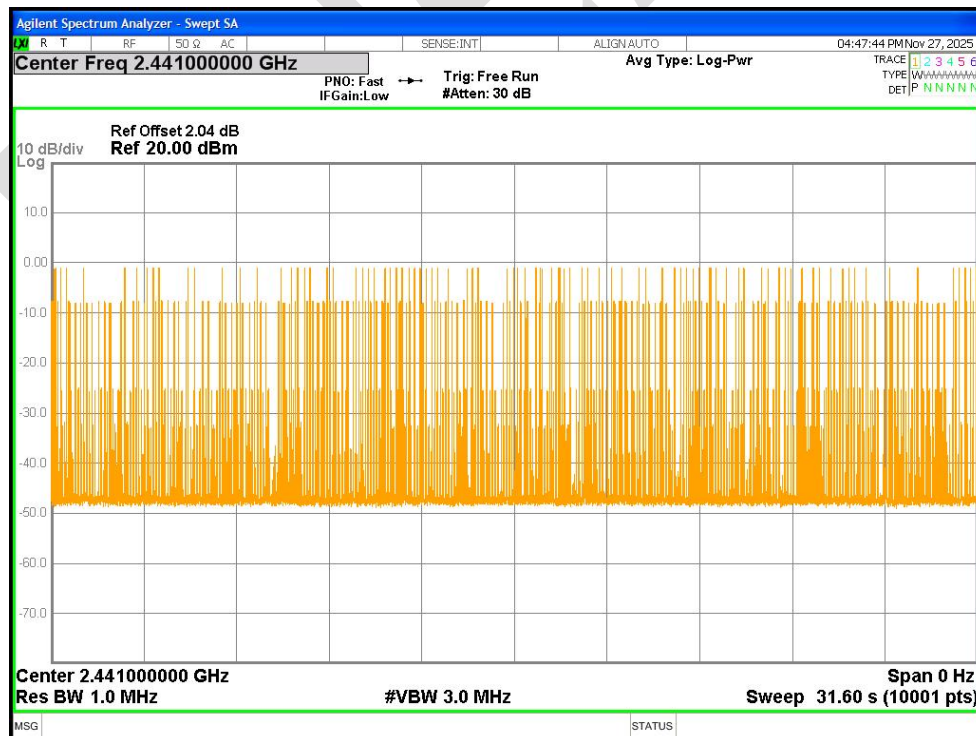
Dwell NVNT 3-DH5 2441MHz Ant1 Accumulated

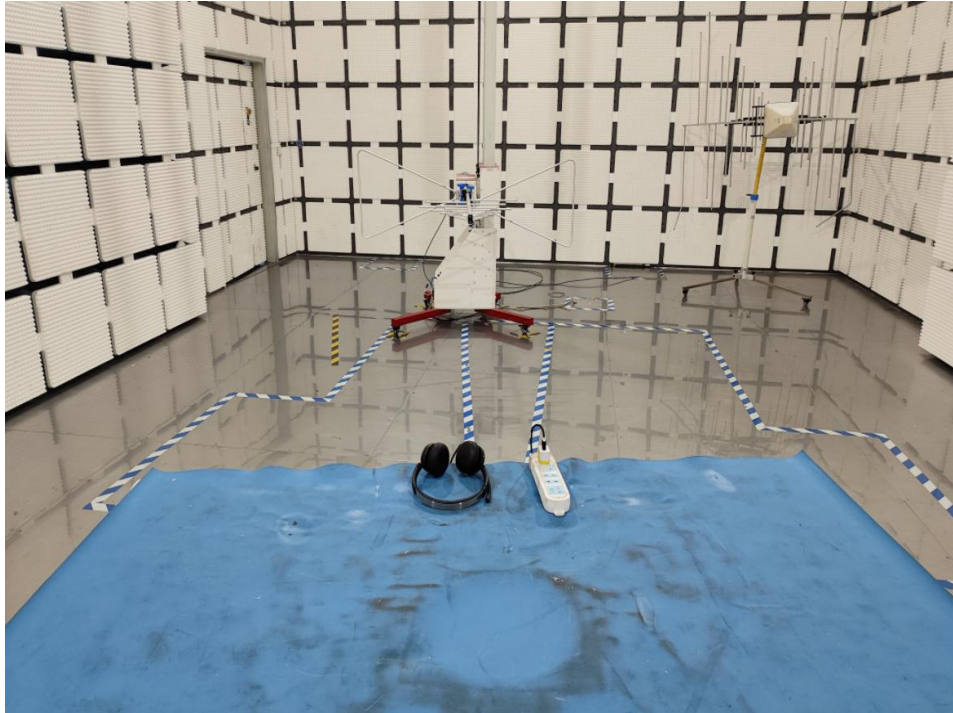
Radiated Emissions (30MHz-1GHz)

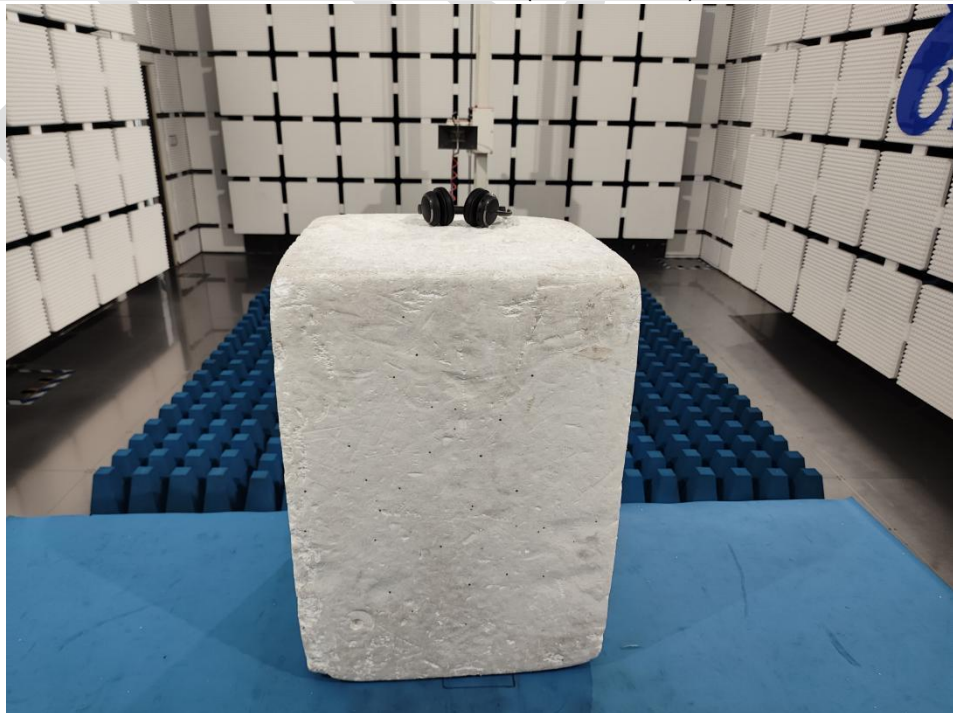
Radiated Emissions (above 1GHz)

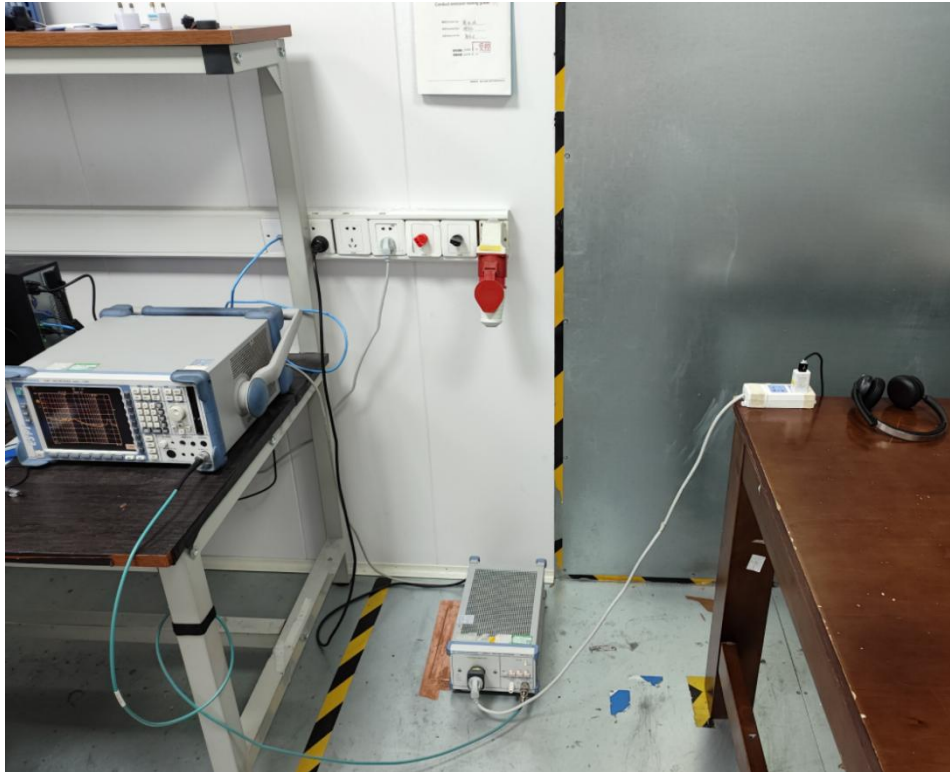
Conducted Emissions at Mains Terminals (150 kHz-30MHz)
