| <b>Report</b><br>OPTIME-LW-C4-R1 | <b>Author:</b> Landry Fandio / SI/HZR-IPD<br><b>Phone:</b> +49240791498004<br><b>E-Mail:</b> landry.fandio@schaeffler.com | <b>Page:</b> 1/4<br><b>Date:</b> 5/12/2025 |

## External Pictures of the Automatic Lubricator

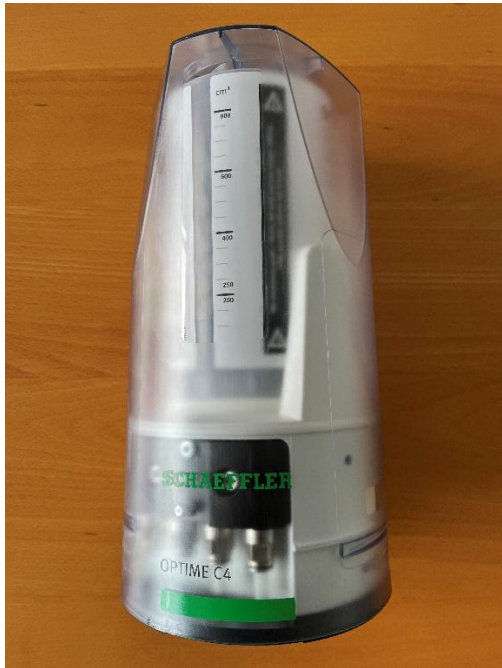
#1

- #1: front view of the device showing the outlet. (please note: the Brand "SCHAEFFLER2 will be replaced with "FAG")
- #2: Rear view of the complete device showing the label location
- #3: bottom view of the complete device showing the M12-interface, through which the device is supplied.
- #4: Top view of the complete device
- #5: Rear view with container mounted and showing label location
- #6 Front view with container mounted and showing the 4 outlets
- #7: Front view: showing the 4 outlets and the container as well as the bonnet
- #8: Top view of the device: Main body + opened container for lubricant + Bonnet
- #9: rear view of the main body showing location of the label
- #10: complete device with the mounting means

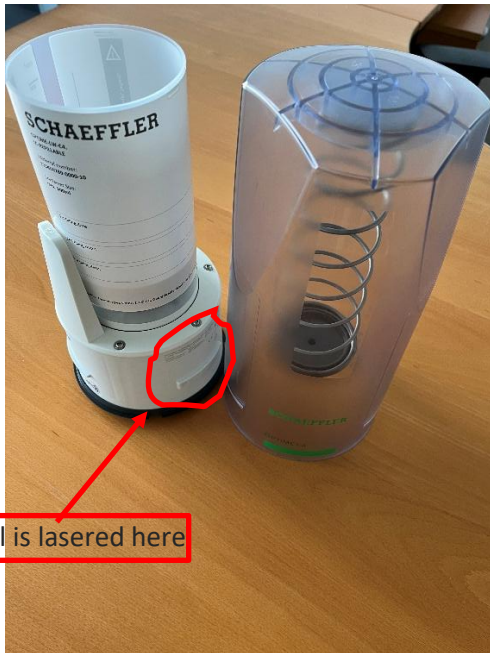
#5

Label is lasered here

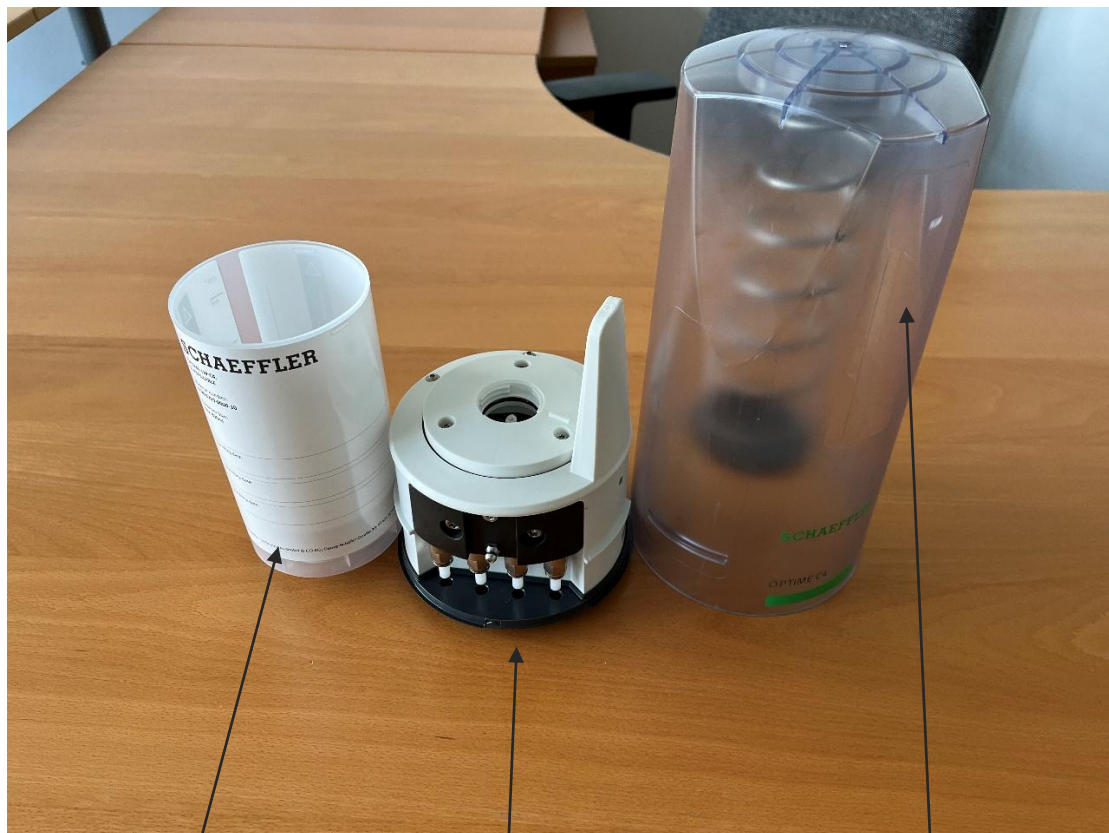
#7

Front view of the main body with 4 outlets, where the lubricant is released

Container for lubricant: empty and opened (without cover)

Bonnet: protects from external forces and contributes to environmental rating

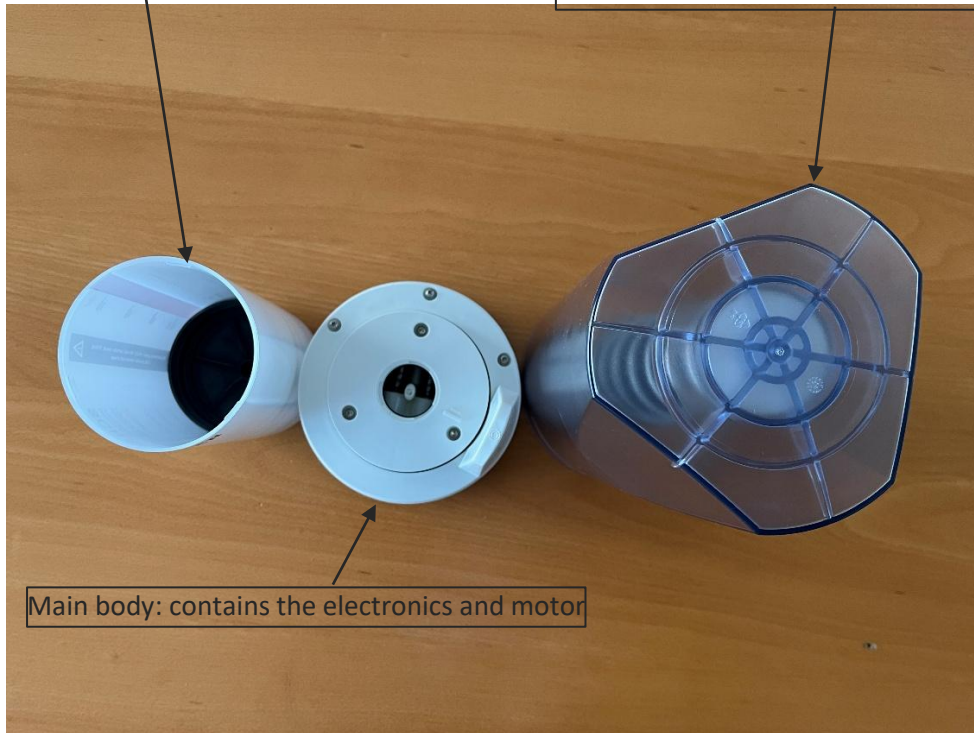
#8

Container for lubricant: empty and opened (without cover)

Bonnet: protects from external forces and contributes to environmental rating

Main body: contains the electronics and motor

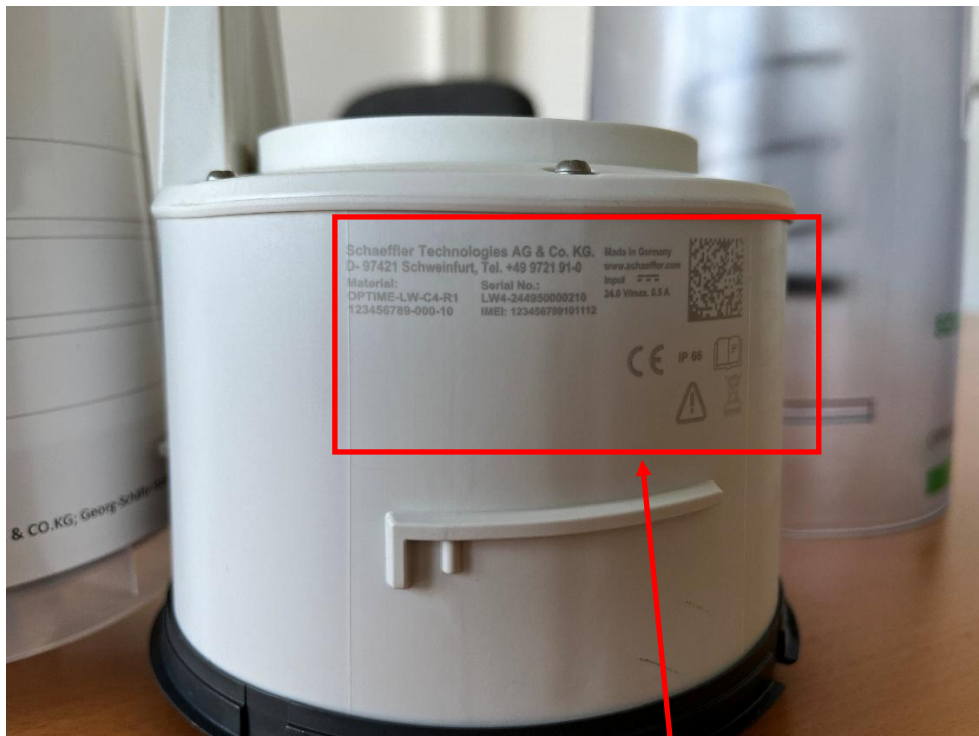
#9

Label will be lasered here
