## Appendix G: Conducted Spurious Emission

The End Report

Dongguan DN Testing Co., Ltd.

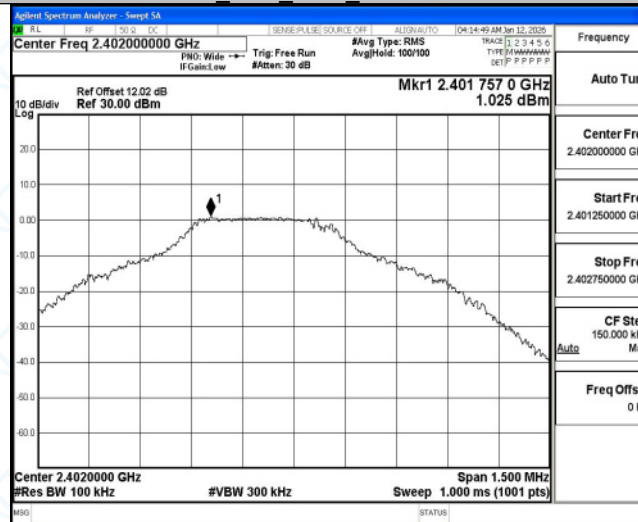
DH5\_Ant1\_2402\_0~Reference

| TestMode | Antenna | Freq(MHz) | FreqRange [MHz] | RefLevel [dBm] | Result [dBm] | Limit [dBm] | Verdict |
|---|---|---|---|---|---|---|---|
| DH5 | Ant1 | 2402 | Reference | 1.03 | 1.03 | --- | PASS |

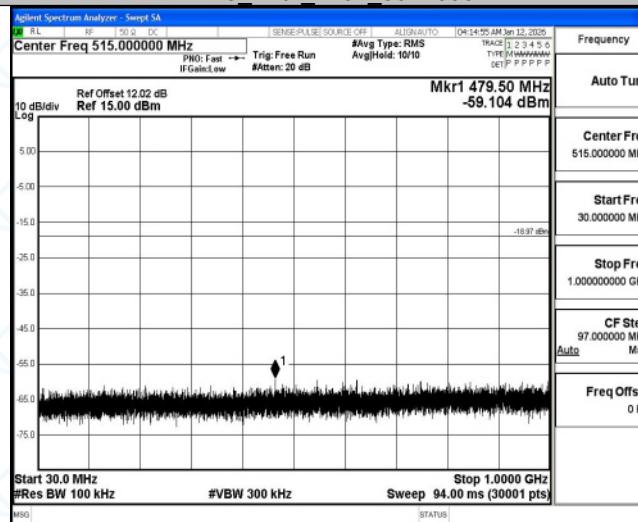
DH5\_Ant1\_2402\_30~1000

| TestMode | Antenna | Freq(MHz) | FreqRange [MHz] | RefLevel [dBm] | Result [dBm] | Limit [dBm] | Verdict |
|---|---|---|---|---|---|---|---|
| | | | 30~1000 | 1.03 | -59.1 | $\leq -18.97$ | PASS |

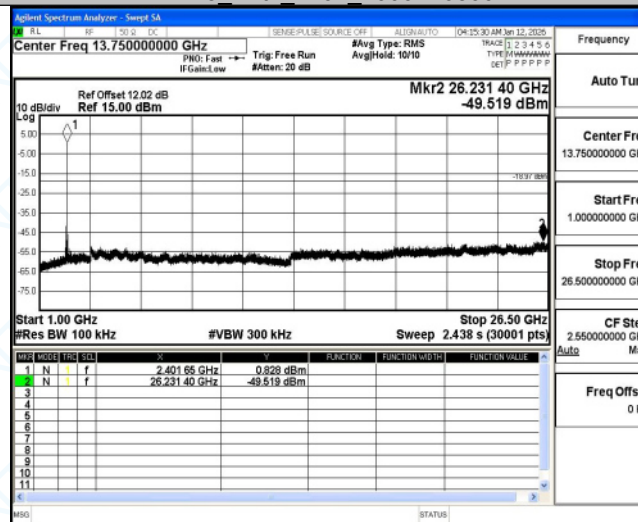
DH5\_Ant1\_2402\_1000~26500

| TestMode | Antenna | Freq(MHz) | FreqRange [MHz] | RefLevel [dBm] | Result [dBm] | Limit [dBm] | Verdict |
|---|---|---|---|---|---|---|---|
| | | | 1000~26500 | 1.03 | -49.52 | $\leq -18.97$ | PASS |

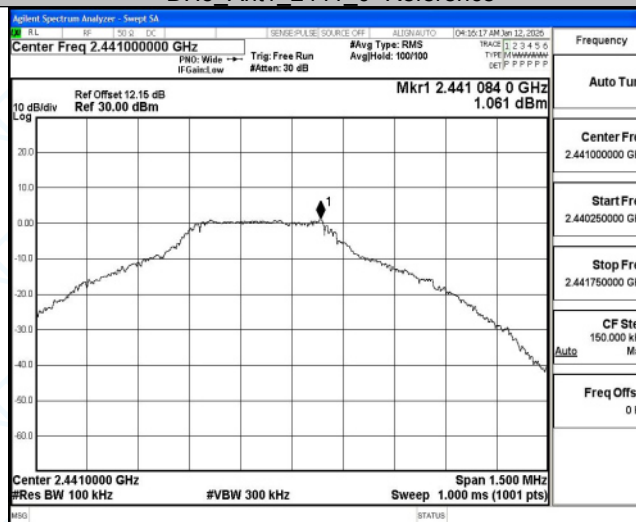
## DH5\_Ant1\_2441\_0~Reference

| TestMode | Antenna | Freq(MHz) | FreqRange [MHz] | RefLevel [dBm] | Result [dBm] | Limit [dBm] | Verdict |
|---|---|---|---|---|---|---|---|
| | | 2441 | Reference | 1.06 | 1.06 | --- | PASS |

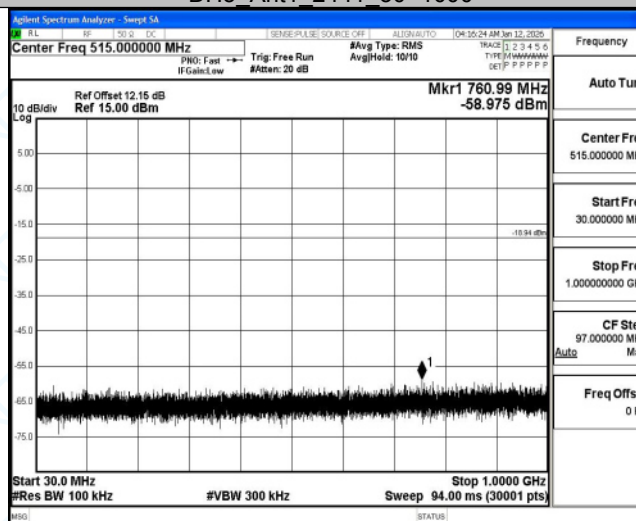
## DH5\_Ant1\_2441\_30~1000

| TestMode | Antenna | Freq(MHz) | FreqRange [MHz] | RefLevel [dBm] | Result [dBm] | Limit [dBm] | Verdict |
|---|---|---|---|---|---|---|---|
| | | | 30~1000 | 1.06 | -58.98 | $\leq -18.94$ | PASS |

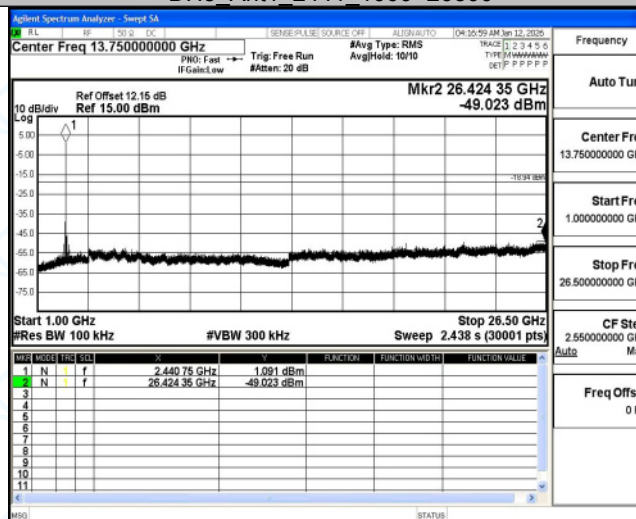
## DH5\_Ant1\_2441\_1000~26500

| TestMode | Antenna | Freq(MHz) | FreqRange [MHz] | RefLevel [dBm] | Result [dBm] | Limit [dBm] | Verdict |
|---|---|---|---|---|---|---|---|
| | | | 1000~26500 | 1.06 | -49.02 | $\leq -18.94$ | PASS |

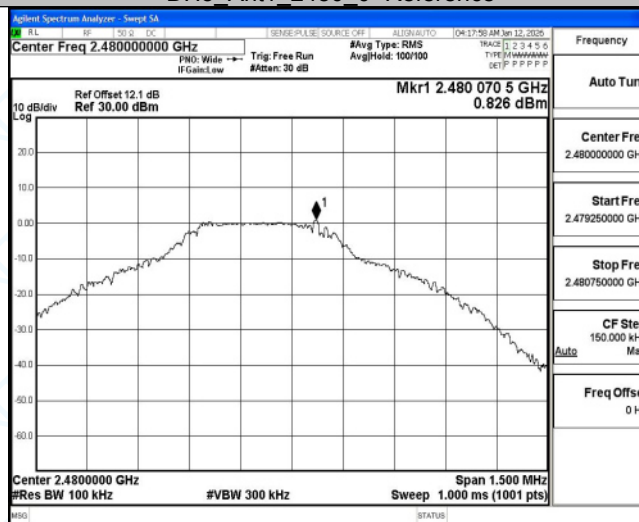
## DH5\_Ant1\_2480\_0~Reference

| TestMode | Antenna | Freq(MHz) | FreqRange [MHz] | RefLevel [dBm] | Result [dBm] | Limit [dBm] | Verdict |
|---|---|---|---|---|---|---|---|
| | | 2480 | Reference | 0.83 | 0.83 | --- | PASS |

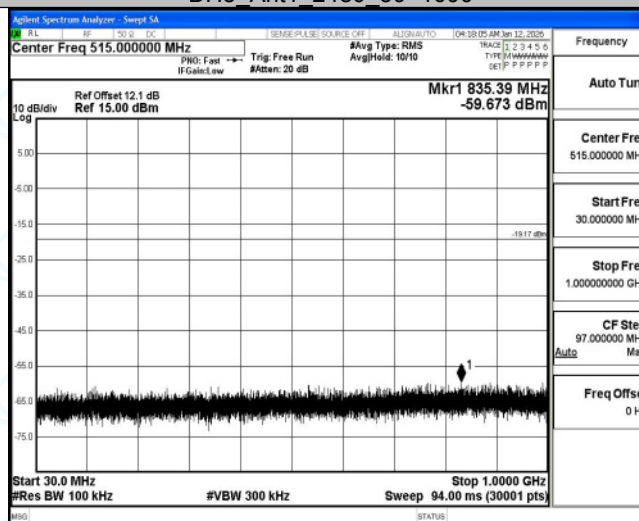
## DH5\_Ant1\_2480\_30~1000

| TestMode | Antenna | Freq(MHz) | FreqRange [MHz] | RefLevel [dBm] | Result [dBm] | Limit [dBm] | Verdict |
|---|---|---|---|---|---|---|---|
| | | | 30~1000 | 0.83 | -59.67 | $\leq -19.17$ | PASS |

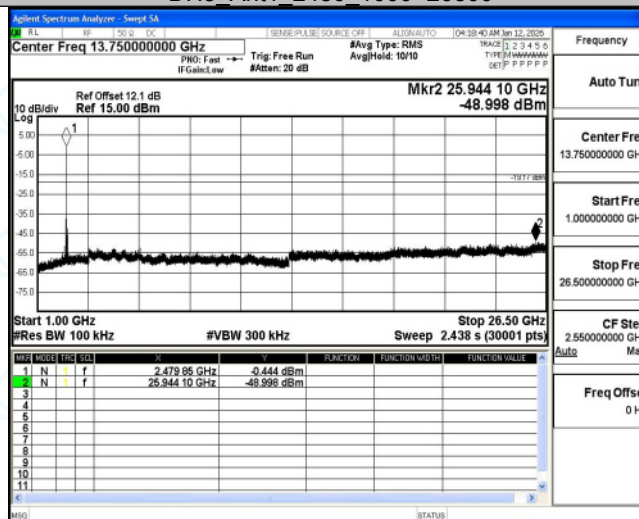
## DH5\_Ant1\_2480\_1000~26500

| TestMode | Antenna | Freq(MHz) | FreqRange [MHz] | RefLevel [dBm] | Result [dBm] | Limit [dBm] | Verdict |
|---|---|---|---|---|---|---|---|
| | | | 1000~26500 | 0.83 | -49 | $\leq -19.17$ | PASS |

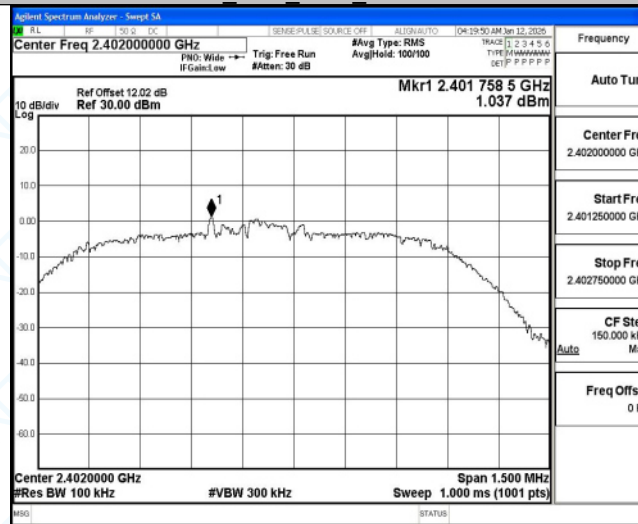
## 2DH5\_Ant1\_2402\_0~Reference

| TestMode | Antenna | Freq(MHz) | FreqRange [MHz] | RefLevel [dBm] | Result [dBm] | Limit [dBm] | Verdict |
|---|---|---|---|---|---|---|---|
| 2DH5 | Ant1 | 2402 | Reference | 1.04 | 1.04 | --- | PASS |

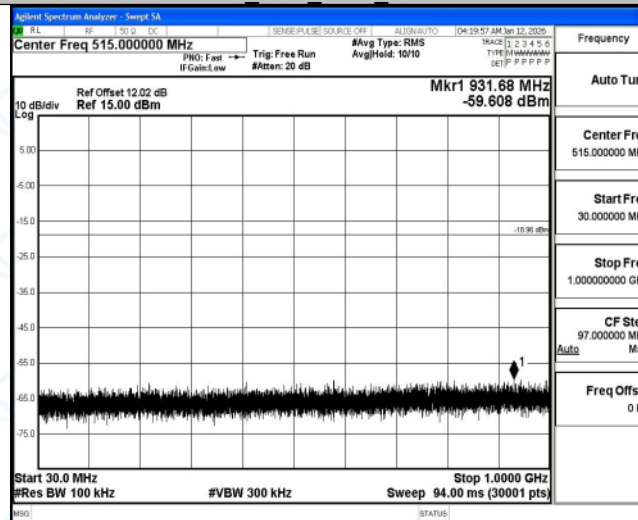
## 2DH5\_Ant1\_2402\_30~1000

| TestMode | Antenna | Freq(MHz) | FreqRange [MHz] | RefLevel [dBm] | Result [dBm] | Limit [dBm] | Verdict |
|---|---|---|---|---|---|---|---|
| | | | 30~1000 | 1.04 | -59.61 | $\leq -18.96$ | PASS |

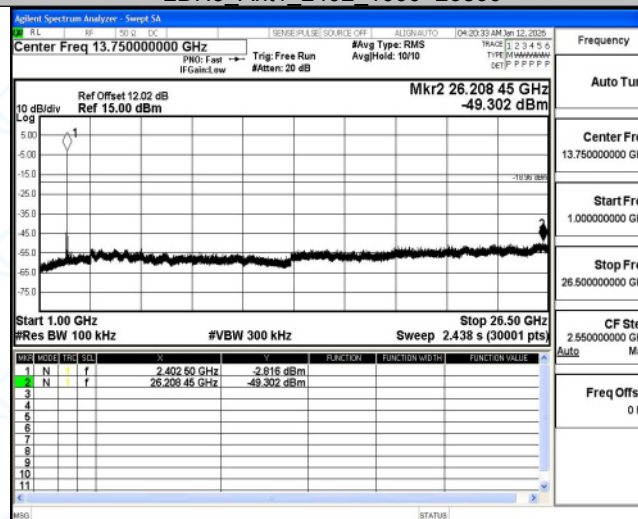
## 2DH5\_Ant1\_2402\_1000~26500

| TestMode | Antenna | Freq(MHz) | FreqRange [MHz] | RefLevel [dBm] | Result [dBm] | Limit [dBm] | Verdict |
|---|---|---|---|---|---|---|---|
| | | | 1000~26500 | 1.04 | -49.3 | $\leq -18.96$ | PASS |

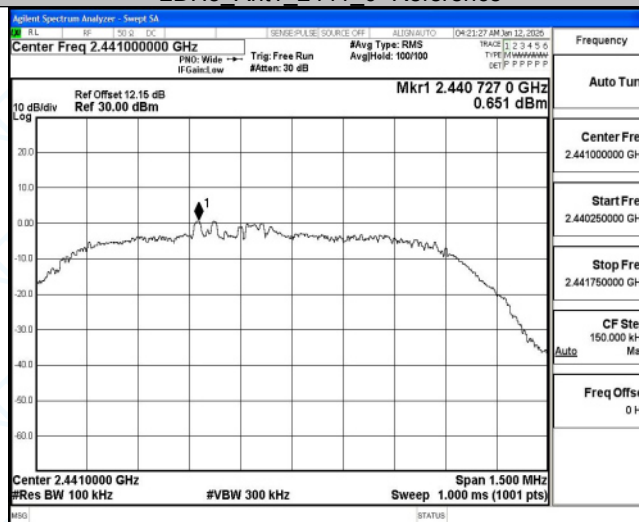
## 2DH5\_Ant1\_2441\_0~Reference

| TestMode | Antenna | Freq(MHz) | FreqRange [MHz] | RefLevel [dBm] | Result [dBm] | Limit [dBm] | Verdict |
|---|---|---|---|---|---|---|---|
| | | 2441 | Reference | 0.65 | 0.65 | --- | PASS |

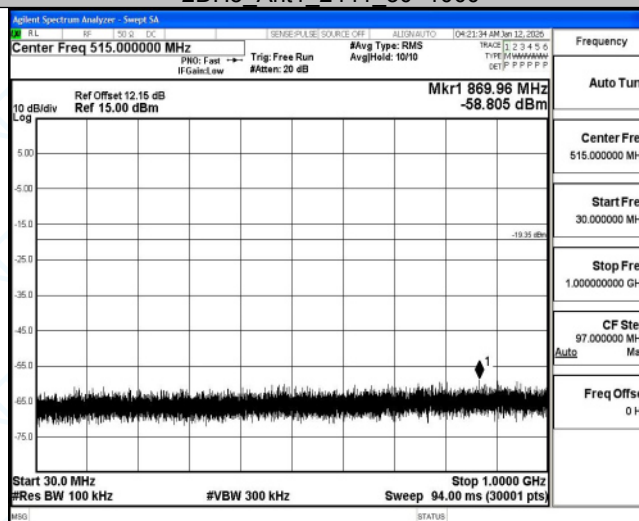
## 2DH5\_Ant1\_2441\_30~1000

| TestMode | Antenna | Freq(MHz) | FreqRange [MHz] | RefLevel [dBm] | Result [dBm] | Limit [dBm] | Verdict |
|---|---|---|---|---|---|---|---|
| | | | 30~1000 | 0.65 | -58.81 | $\leq -19.35$ | PASS |

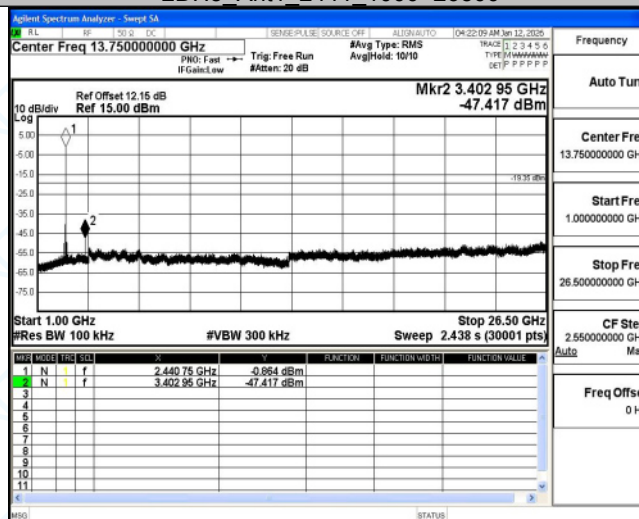
## 2DH5\_Ant1\_2441\_1000~26500

| TestMode | Antenna | Freq(MHz) | FreqRange [MHz] | RefLevel [dBm] | Result [dBm] | Limit [dBm] | Verdict |
|---|---|---|---|---|---|---|---|
| | | | 1000~26500 | 0.65 | -47.42 | $\leq -19.35$ | PASS |

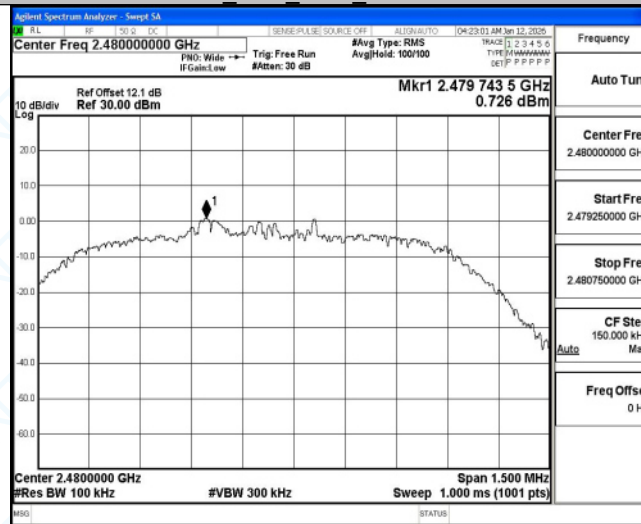
## 2DH5\_Ant1\_2480\_0~Reference

| TestMode | Antenna | Freq(MHz) | FreqRange [MHz] | RefLevel [dBm] | Result [dBm] | Limit [dBm] | Verdict |
|---|---|---|---|---|---|---|---|
| | | 2480 | Reference | 0.73 | 0.73 | --- | PASS |

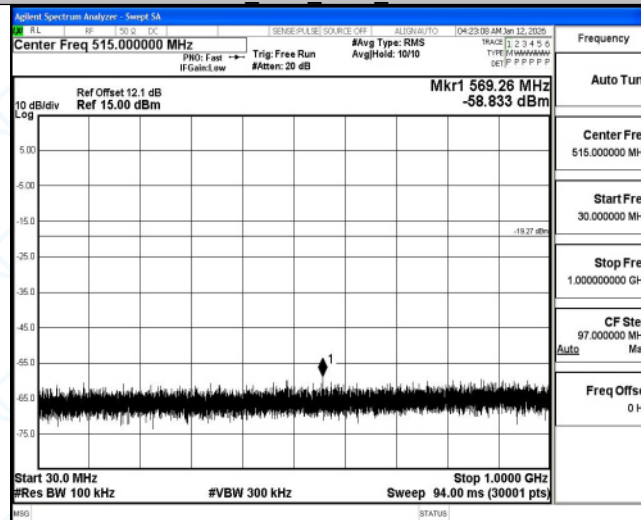
## 2DH5\_Ant1\_2480\_30~1000

| TestMode | Antenna | Freq(MHz) | FreqRange [MHz] | RefLevel [dBm] | Result [dBm] | Limit [dBm] | Verdict |
|---|---|---|---|---|---|---|---|
| | | | 30~1000 | 0.73 | -58.83 | $\leq -19.27$ | PASS |

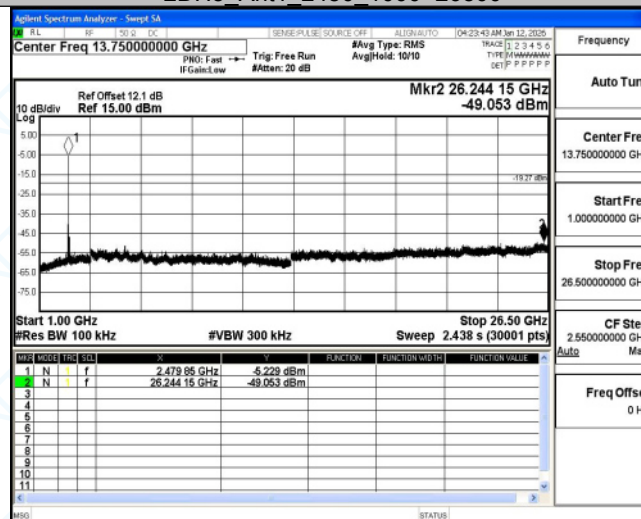
## 2DH5\_Ant1\_2480\_1000~26500

| TestMode | Antenna | Freq(MHz) | FreqRange [MHz] | RefLevel [dBm] | Result [dBm] | Limit [dBm] | Verdict |
|---|---|---|---|---|---|---|---|
| | | | 1000~26500 | 0.73 | -49.05 | $\leq -19.27$ | PASS |

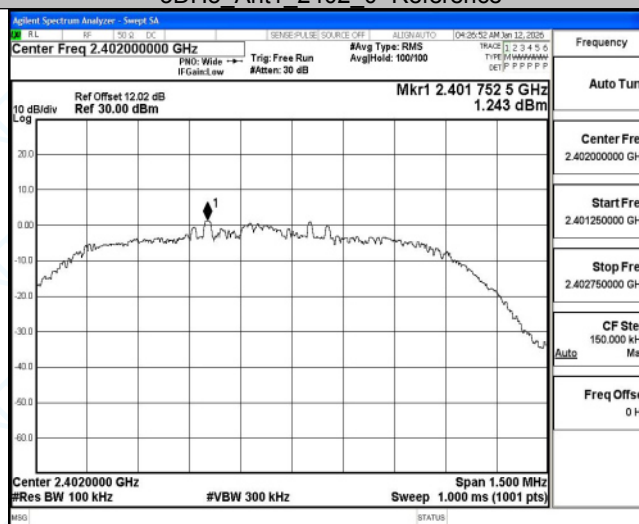
## 3DH5\_Ant1\_2402\_0~Reference

| TestMode | Antenna | Freq(MHz) | FreqRange [MHz] | RefLevel [dBm] | Result [dBm] | Limit [dBm] | Verdict |
|---|---|---|---|---|---|---|---|
| 3DH5 | Ant1 | 2402 | Reference | 1.24 | 1.24 | --- | PASS |

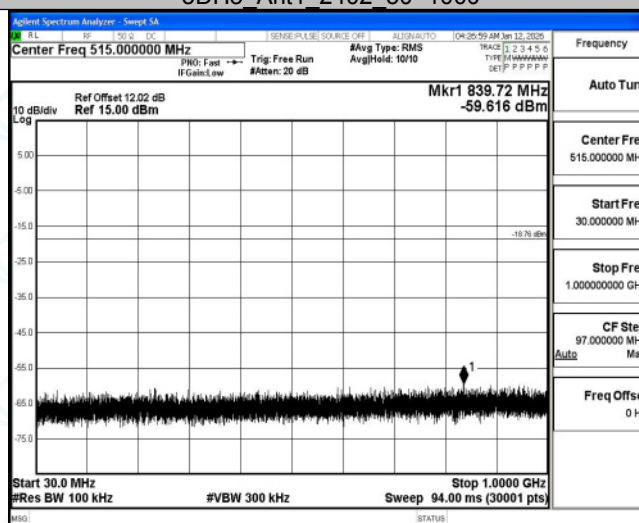
## 3DH5\_Ant1\_2402\_30~1000

| TestMode | Antenna | Freq(MHz) | FreqRange [MHz] | RefLevel [dBm] | Result [dBm] | Limit [dBm] | Verdict |
|---|---|---|---|---|---|---|---|
| | | | 30~1000 | 1.24 | -59.62 | $\leq -18.76$ | PASS |

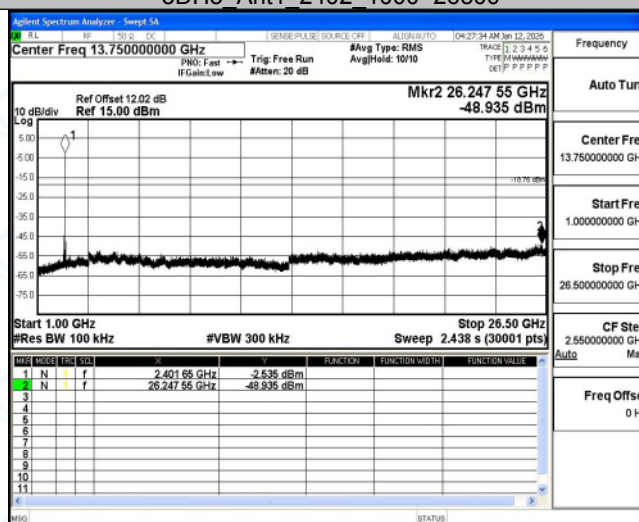
## 3DH5\_Ant1\_2402\_1000~26500

| TestMode | Antenna | Freq(MHz) | FreqRange [MHz] | RefLevel [dBm] | Result [dBm] | Limit [dBm] | Verdict |
|---|---|---|---|---|---|---|---|
| | | | 1000~26500 | 1.24 | -48.94 | $\leq -18.76$ | PASS |

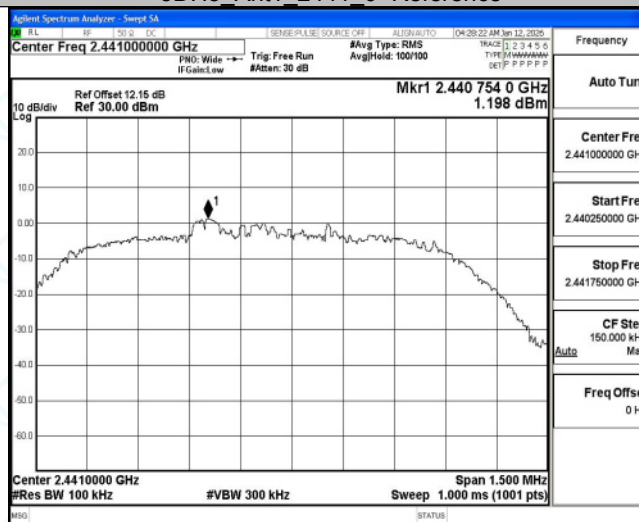
## 3DH5\_Ant1\_2441\_0~Reference

| TestMode | Antenna | Freq(MHz) | FreqRange [MHz] | RefLevel [dBm] | Result [dBm] | Limit [dBm] | Verdict |
|---|---|---|---|---|---|---|---|
| | | 2441 | Reference | 1.20 | 1.20 | --- | PASS |

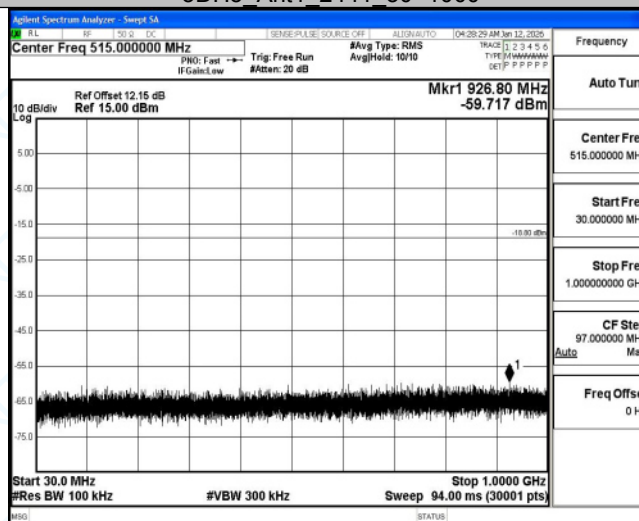
## 3DH5\_Ant1\_2441\_30~1000

| TestMode | Antenna | Freq(MHz) | FreqRange [MHz] | RefLevel [dBm] | Result [dBm] | Limit [dBm] | Verdict |
|---|---|---|---|---|---|---|---|
| | | | 30~1000 | 1.20 | -59.72 | $\leq -18.8$ | PASS |

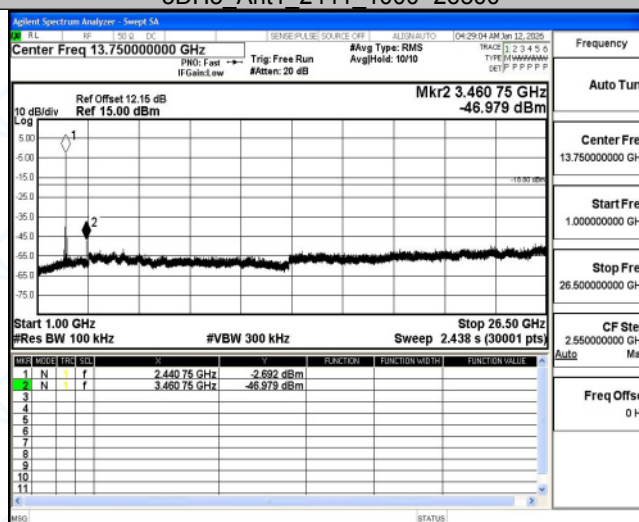
## 3DH5\_Ant1\_2441\_1000~26500

| TestMode | Antenna | Freq(MHz) | FreqRange [MHz] | RefLevel [dBm] | Result [dBm] | Limit [dBm] | Verdict |
|---|---|---|---|---|---|---|---|
| | | | 1000~26500 | 1.20 | -46.98 | $\leq -18.8$ | PASS |

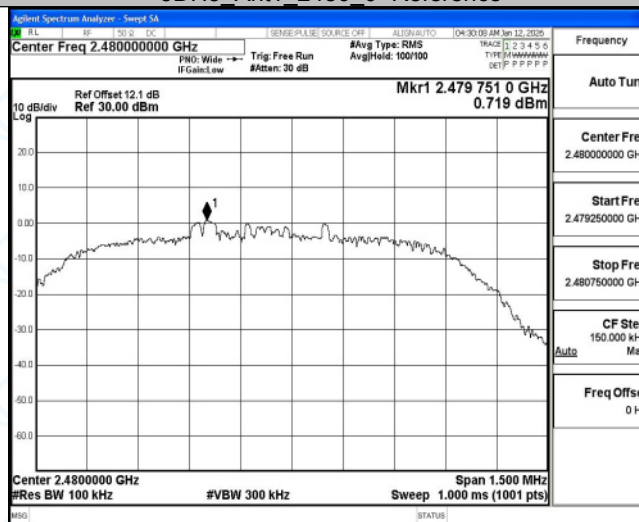
## 3DH5\_Ant1\_2480\_0~Reference

| TestMode | Antenna | Freq(MHz) | FreqRange [MHz] | RefLevel [dBm] | Result [dBm] | Limit [dBm] | Verdict |
|---|---|---|---|---|---|---|---|
| | | 2480 | Reference | 0.72 | 0.72 | --- | PASS |

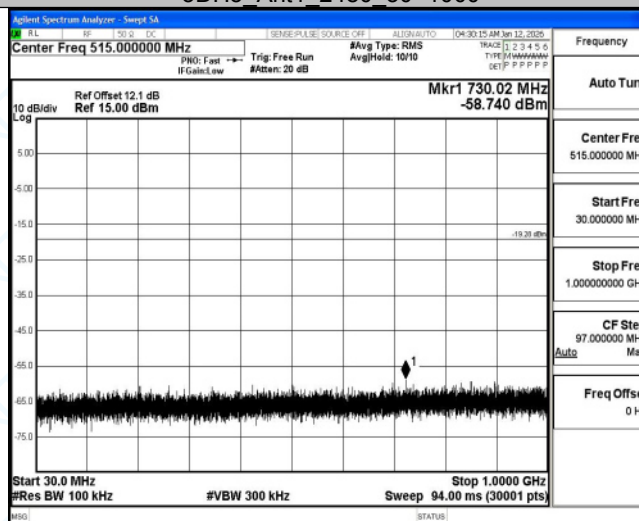
## 3DH5\_Ant1\_2480\_30~1000

| TestMode | Antenna | Freq(MHz) | FreqRange [MHz] | RefLevel [dBm] | Result [dBm] | Limit [dBm] | Verdict |
|---|---|---|---|---|---|---|---|
| | | | 30~1000 | 0.72 | -58.74 | $\leq -19.28$ | PASS |

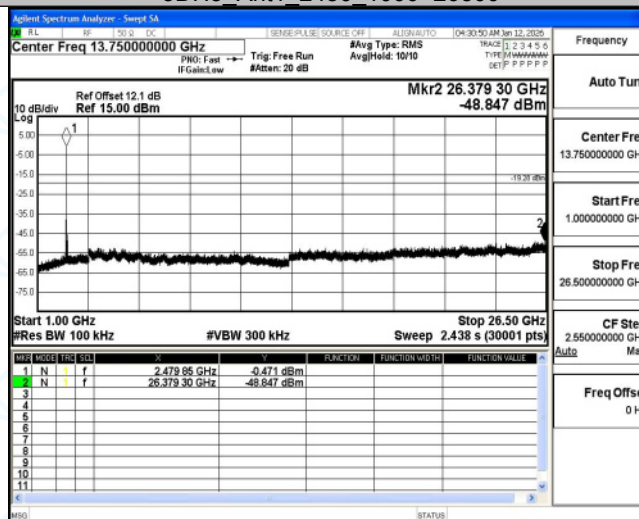
## 3DH5\_Ant1\_2480\_1000~26500

| TestMode | Antenna | Freq(MHz) | FreqRange [MHz] | RefLevel [dBm] | Result [dBm] | Limit [dBm] | Verdict |
|---|---|---|---|---|---|---|---|
| | | | 1000~26500 | 0.72 | -48.85 | $\leq -19.28$ | PASS |
