Appendix D: Dwell Time

## Appendix G: Conducted Spurious Emission

Dongguan DN Testing Co., Ltd.

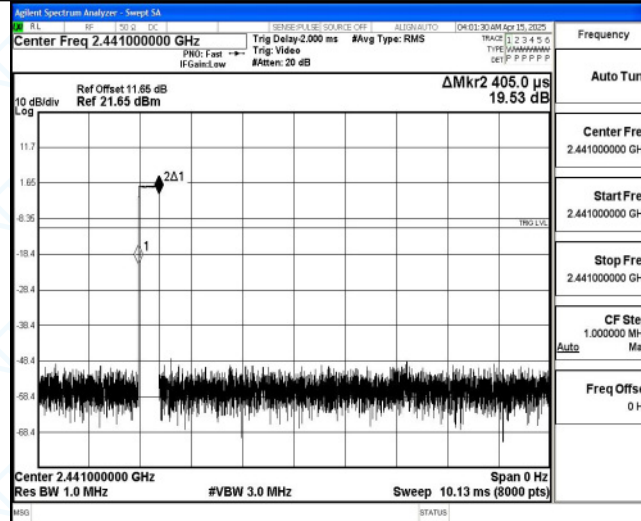
DH1\_Ant1\_Hop

| TestMode | Antenna | Freq(MHz) | BurstWidth<br>[ms] | TotalHops<br>[Num] | Result[s] | Limit[s] | Verdict |
|---|---|---|---|---|---|---|---|
| DH1 | Ant1 | Hop | 0.405 | 320 | 0.13 | ≤0.4 | PASS |

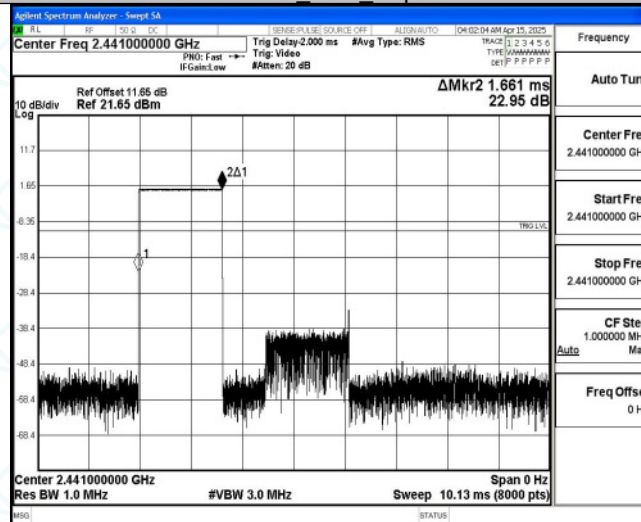
DH3\_Ant1\_Hop

| TestMode | Antenna | Freq(MHz) | BurstWidth<br>[ms] | TotalHops<br>[Num] | Result[s] | Limit[s] | Verdict |
|---|---|---|---|---|---|---|---|
| DH3 | Ant1 | Hop | 1.661 | 160 | 0.266 | ≤0.4 | PASS |

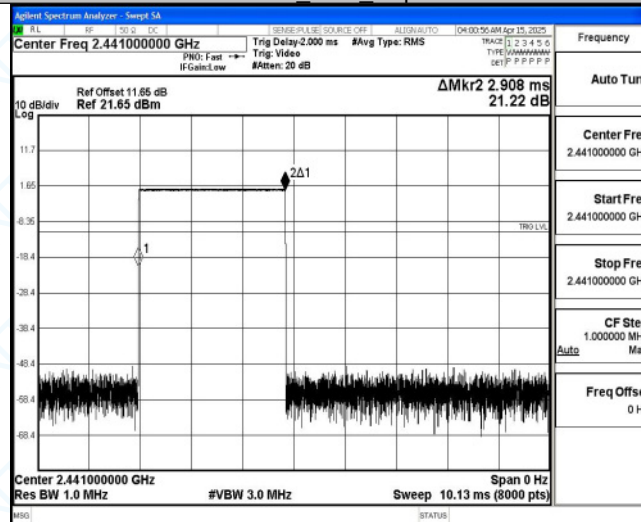
DH5\_Ant1\_Hop

| TestMode | Antenna | Freq(MHz) | BurstWidth<br>[ms] | TotalHops<br>[Num] | Result[s] | Limit[s] | Verdict |
|---|---|---|---|---|---|---|---|
| DH5 | Ant1 | Hop | 2.908 | 106.67 | 0.31 | ≤0.4 | PASS |
