Test Report No.: EFGX26010180-IE-03-E04

## Appendix H: Conducted Spurious Emission

## Appendix J: Emissions in Restricted Bands

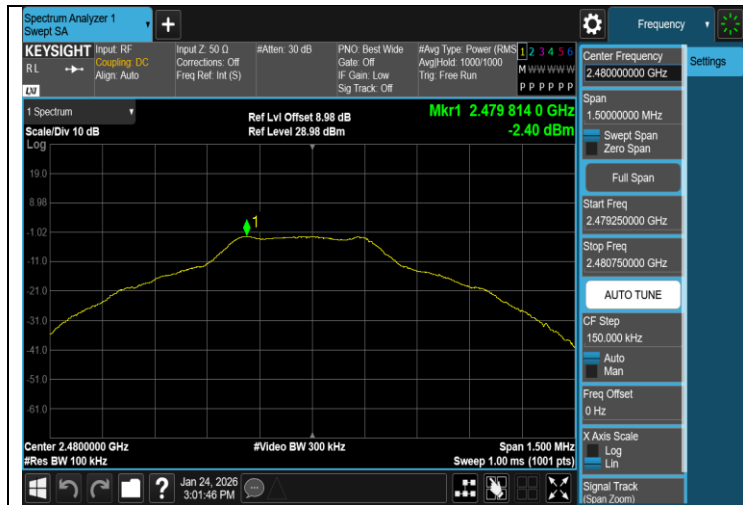
DH5-Ant1-2480-0~Reference-PASS

| TestMode | Antenna | Channel [MHz] | FreqRange [MHz] | RefLevel [dBm] | Result [dBm] | Limit [dBm] | Verdict |
|---|---|---|---|---|---|---|---|
| DH5 | Ant1 | 2480 | 0~Reference | -2.41 | -2.41 | --- | PASS |

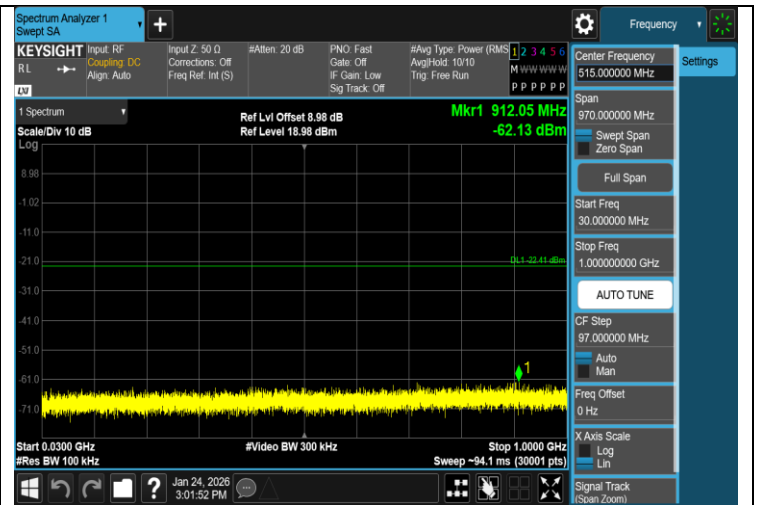
DH5-Ant1-2480-30~1000-PASS

| TestMode | Antenna | Channel [MHz] | FreqRange [MHz] | RefLevel [dBm] | Result [dBm] | Limit [dBm] | Verdict |
|---|---|---|---|---|---|---|---|
| DH5 | Ant1 | 2480 | 30~1000 | -2.41 | -62.13 | ≤-22.41 | PASS |

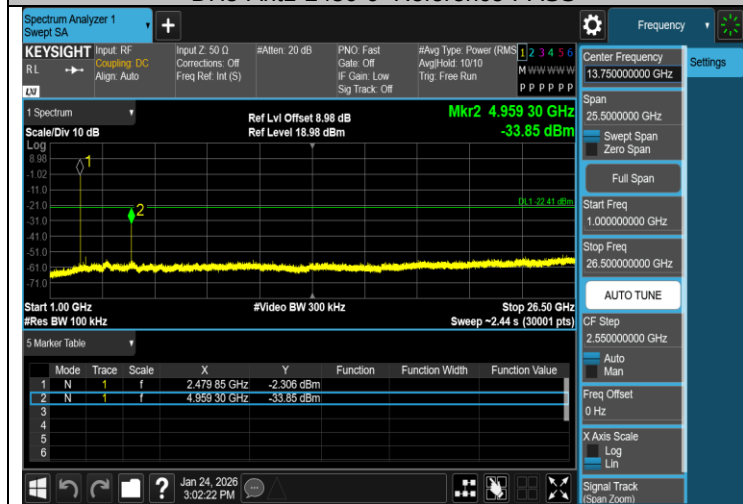
DH5-Ant1-2480-1000~26500-PASS

| TestMode | Antenna | Channel [MHz] | FreqRange [MHz] | RefLevel [dBm] | Result [dBm] | Limit [dBm] | Verdict |
|---|---|---|---|---|---|---|---|
| DH5 | Ant1 | 2480 | 1000~26500 | -2.41 | -33.86 | ≤-22.41 | PASS |

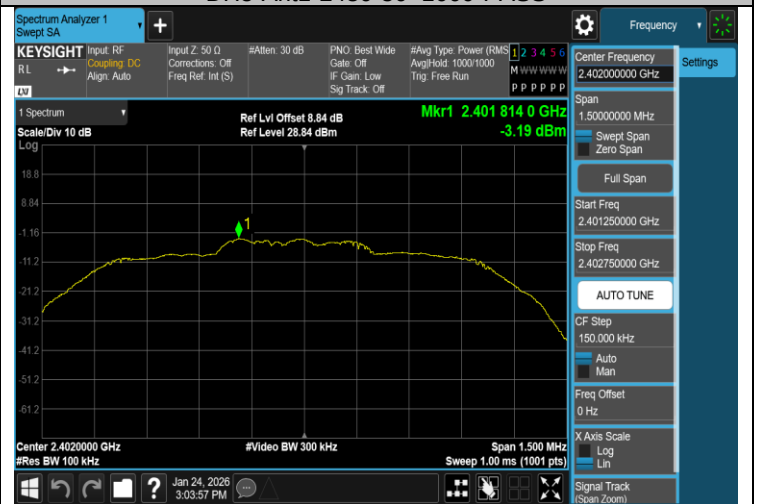
2DH5-Ant1-2402-0~Reference-PASS

| TestMode | Antenna | Channel [MHz] | FreqRange [MHz] | RefLevel [dBm] | Result [dBm] | Limit [dBm] | Verdict |
|---|---|---|---|---|---|---|---|
| 2DH5 | Ant1 | 2402 | 0~Reference | -3.19 | -3.19 | --- | PASS |

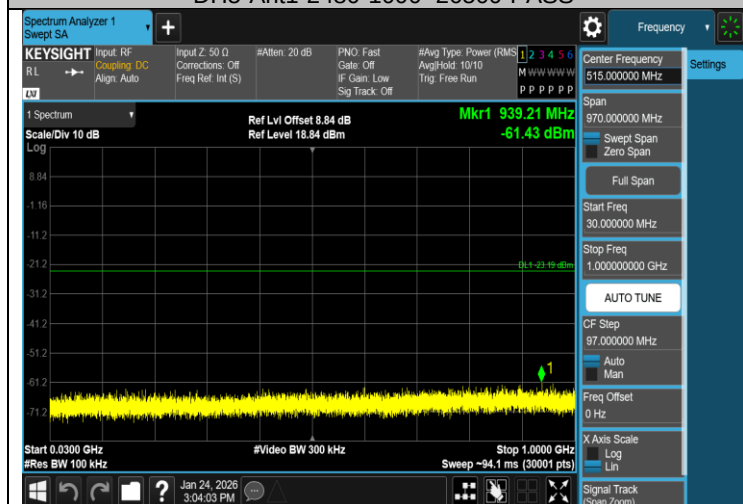
2DH5-Ant1-2402-30~1000-PASS

| TestMode | Antenna | Channel [MHz] | FreqRange [MHz] | RefLevel [dBm] | Result [dBm] | Limit [dBm] | Verdict |
|---|---|---|---|---|---|---|---|
| 2DH5 | Ant1 | 2402 | 30~1000 | -3.19 | -61.43 | ≤-23.19 | PASS |

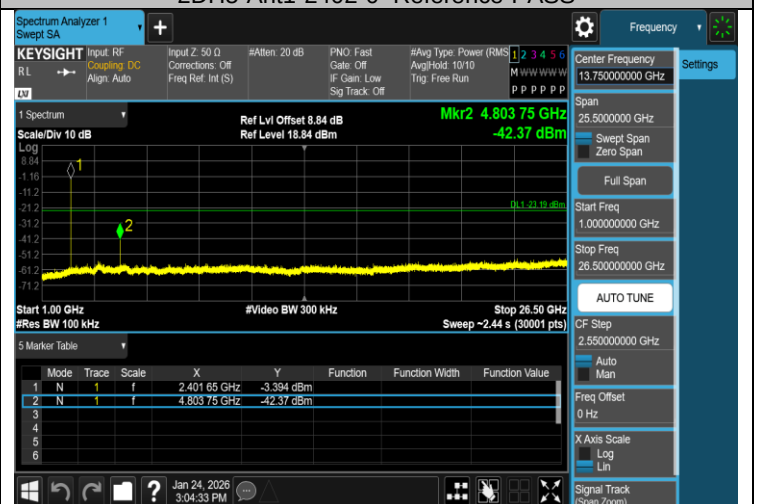
2DH5-Ant1-2402-1000~26500-PASS

| TestMode | Antenna | Channel [MHz] | FreqRange [MHz] | RefLevel [dBm] | Result [dBm] | Limit [dBm] | Verdict |
|---|---|---|---|---|---|---|---|
| 2DH5 | Ant1 | 2402 | 1000~26500 | -3.19 | -42.37 | ≤-23.19 | PASS |

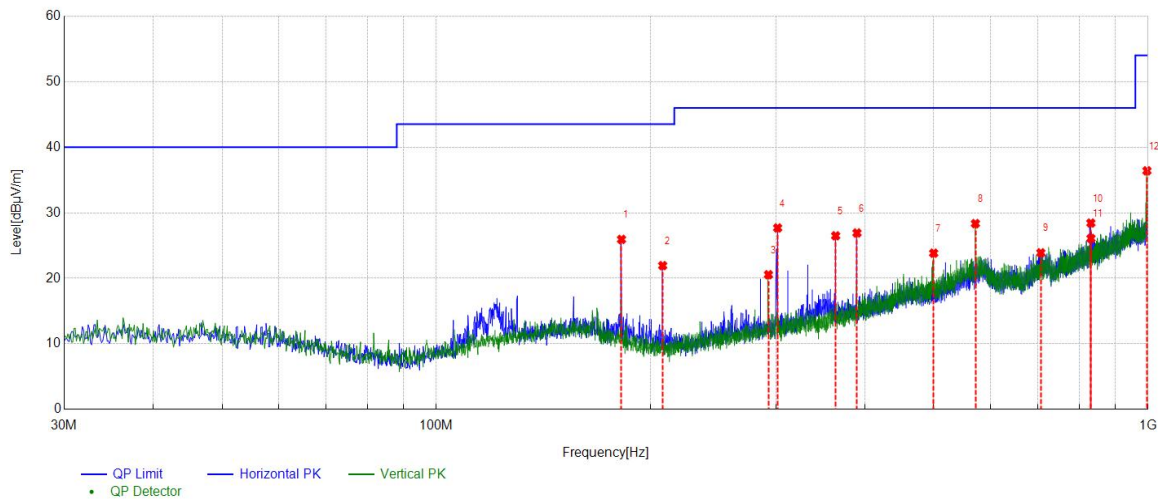
Below 1GHz

| PK Suspected Data List | | | | | | | | | | |
| NO. | Freq. [MHz] | Reading [dBµV/m] | Factor [dB/m] | Level [dBµV/m] | Limit [dBµV/m] | Margin [dB] | Height [cm] | Angle [°] | Polarity | Verdict |
| 1 | 182.0475 | 43.62 | -17.68 | 25.94 | 43.50 | 17.56 | 100 | 232 | Horizontal | PASS |
| 12 | 996.4838 | 37.65 | -1.25 | 36.40 | 54.00 | 17.60 | 100 | 216 | Vertical | PASS |

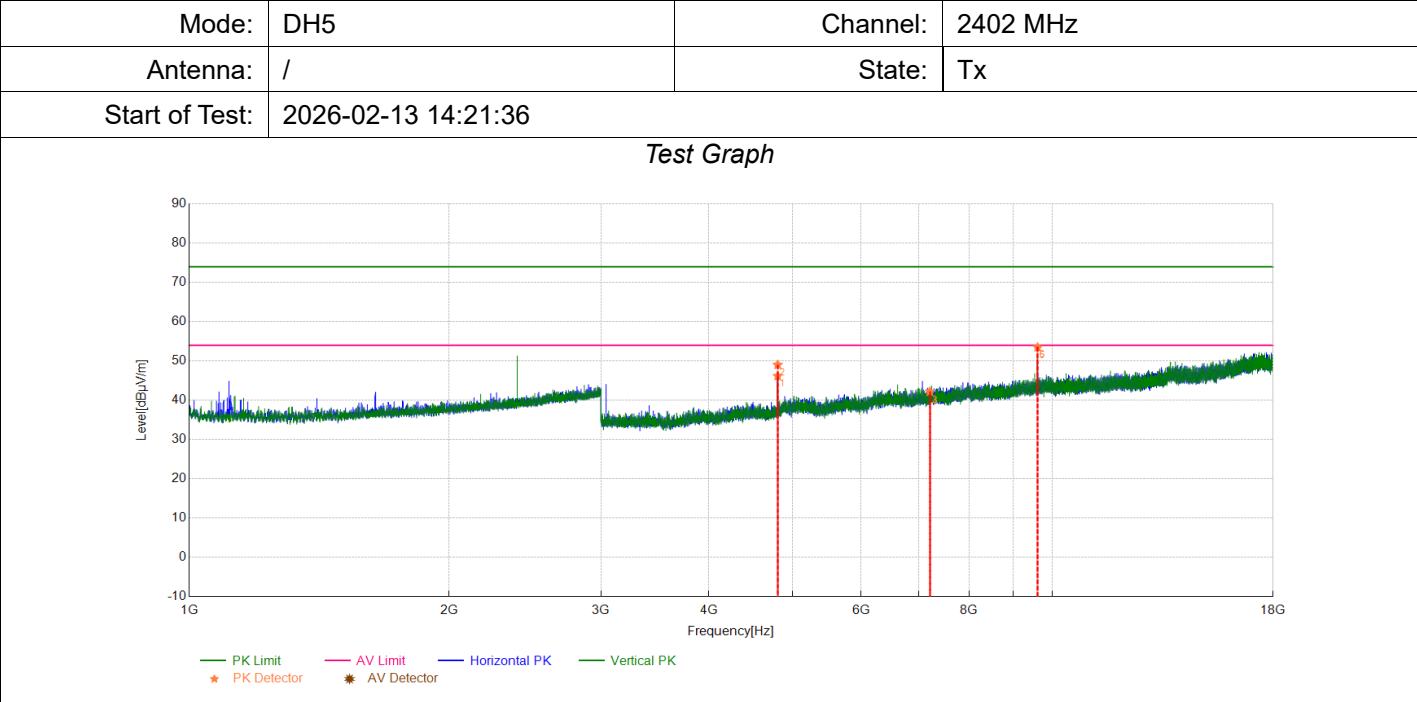
Above 1GHz

| Final Data List | | | | | | | | | | | |
| NO. | Frequency [MHz] | Factor [dB] | PK Reading [dBμV/m] | PK Value [dBμV/m] | PK Limit [dBμV/m] | PK Margin [dB] | AV Limit [dBμV/m] | Height [cm] | Angle [°] | Polarity | Verdict |
| 1 | 4804.0000 | -14.53 | 60.72 | 46.19 | 74.00 | 27.81 | 54.00 | 150 | 268 | Horizontal | PASS |
| 5 | 9608.0000 | -5.07 | 58.556 | 53.49 | 74.00 | 20.51 | 54.00 | 110.8 | 90 | Vertical | PASS |
| 6 | 9608.0000 | -5.07 | 58.742 | 53.67 | 74.00 | 20.33 | 54.00 | 111.7 | 344.3 | Horizontal | PASS |

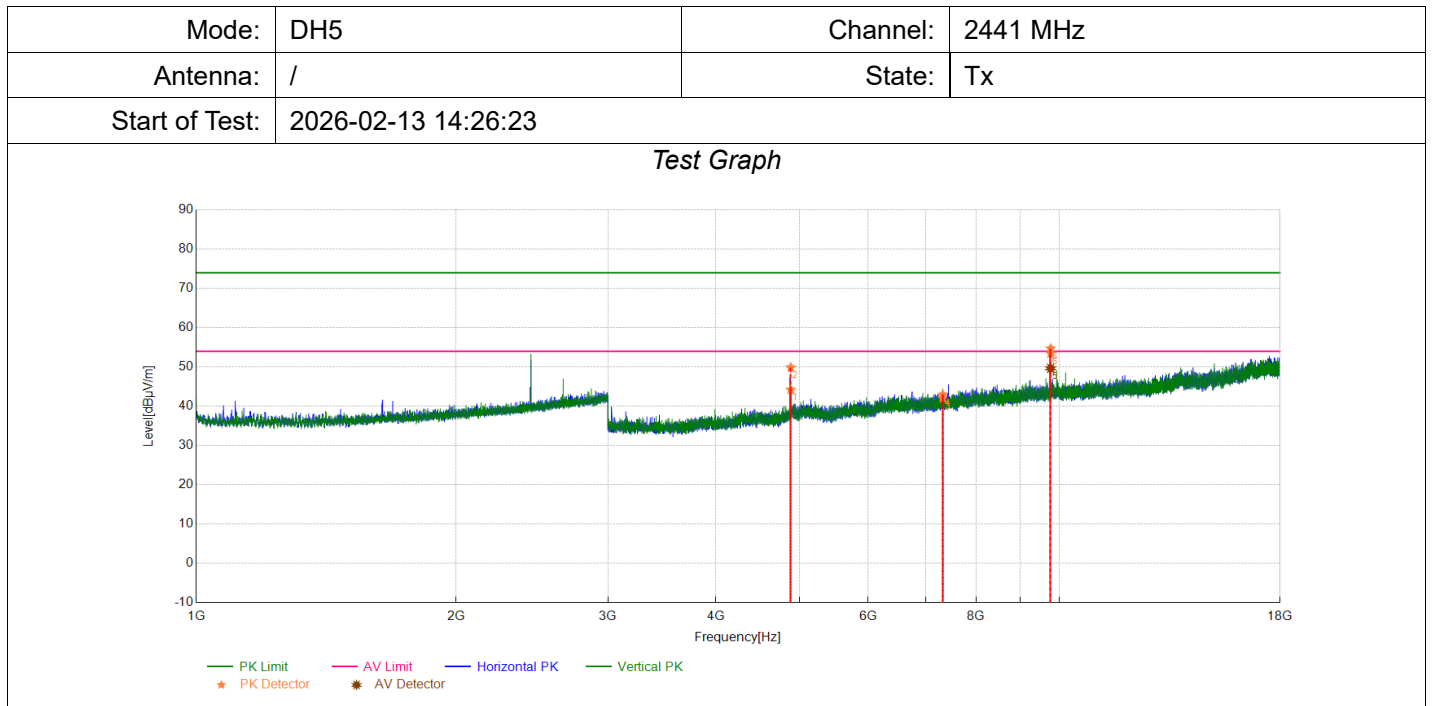
| Final Data List | | | | | | | | | | | | | | |
| NO. | Frequency [MHz] | Factor [dB] | PK Reading [dBμV/m] | PK Value [dBμV/m] | PK Limit [dBμV/m] | PK Margin [dB] | AV Reading [dBμV/m] | AV Value [dBμV/m] | AV Limit [dBμV/m] | AV Margin [dB] | Height [cm] | Angle [°] | Polarity | Verdict |
| 5 | 9764.0000 | -4.62 | 59.353 | 54.73 | 74.00 | 19.27 | 54.302 | 49.68 | 54.00 | 4.32 | 110.8 | 90 | Vertical | PASS |

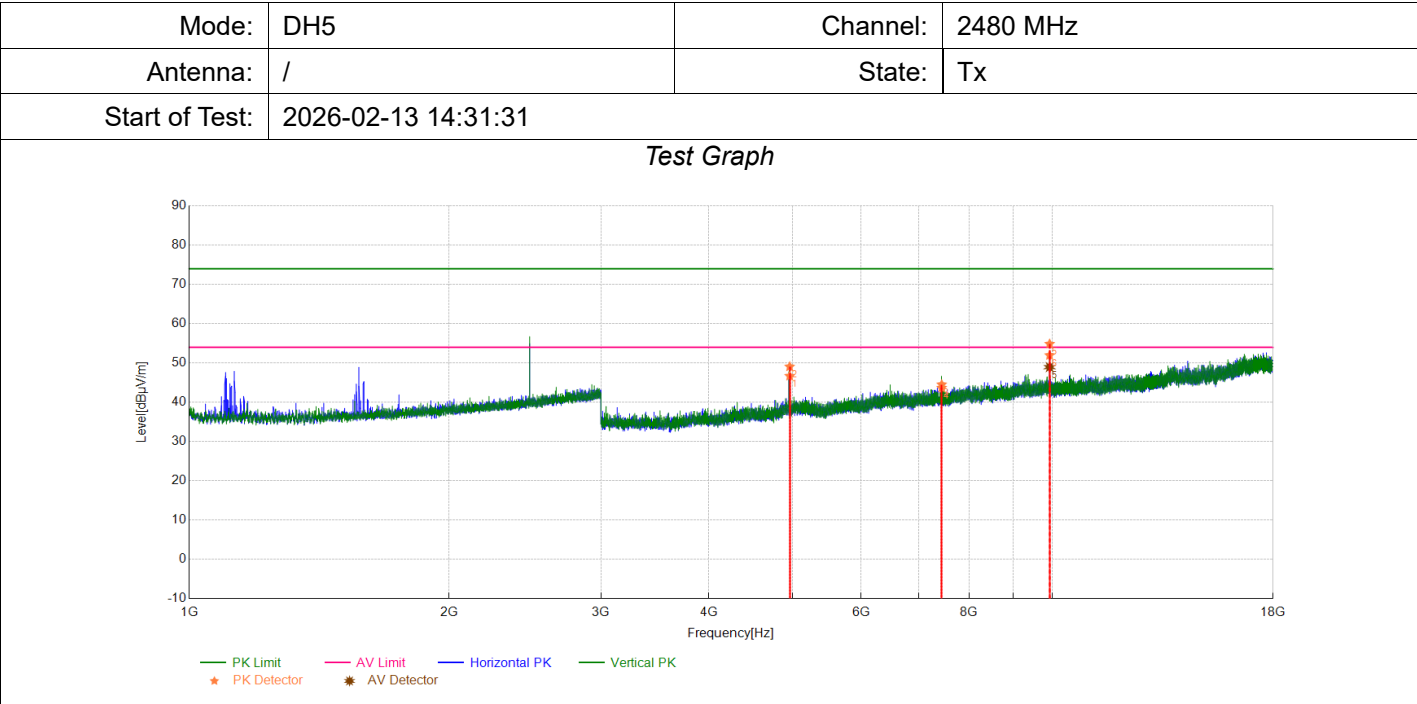
| Final Data List | | | | | | | | | | | | | | |
| NO. | Frequency [MHz] | Factor [dB] | PK Reading [dBµV/m] | PK Value [dBµV/m] | PK Limit [dBµV/m] | PK Margin [dB] | AV Reading [dBµV/m] | AV Value [dBµV/m] | AV Limit [dBµV/m] | AV Margin [dB] | Height [cm] | Angle [°] | Polarity | Verdict |
| 5 | 9920.0000 | -4.28 | 59.145 | 54.87 | 74.00 | 19.13 | 53.239 | 48.96 | 54.00 | 5.04 | 110.8 | 90 | Vertical | PASS |

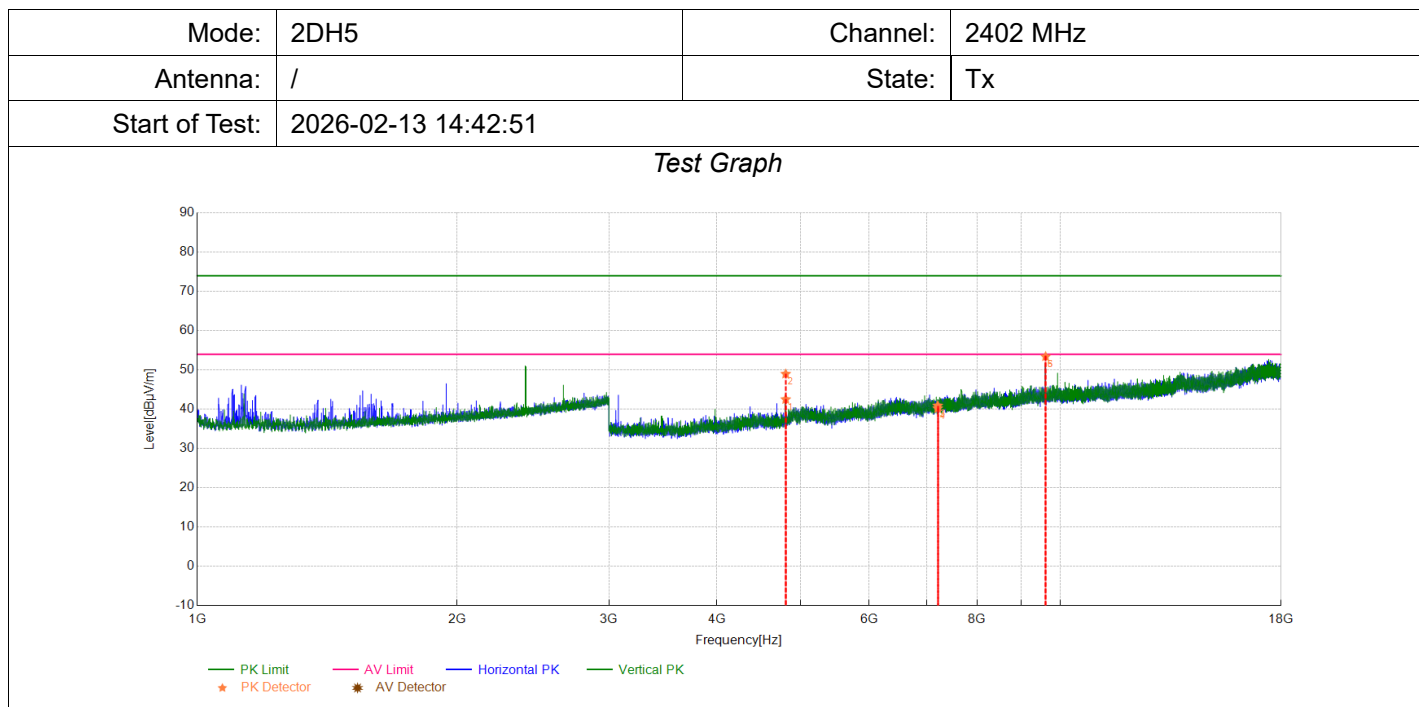
| Final Data List | | | | | | | | | | | |
| NO. | Frequency [MHz] | Factor [dB] | PK Reading [dBμV/m] | PK Value [dBμV/m] | PK Limit [dBμV/m] | PK Margin [dB] | AV Limit [dBμV/m] | Height [cm] | Angle [°] | Polarity | Verdict |
| 5 | 9608.0000 | -5.07 | 58.495 | 53.43 | 74.00 | 20.57 | 54.00 | 110.8 | 90 | Vertical | PASS |
