Test Report No.: EFGX26010180-IE-03-E04

Eurofins Electrical Testing Service (Shenzhen) Co., Ltd.

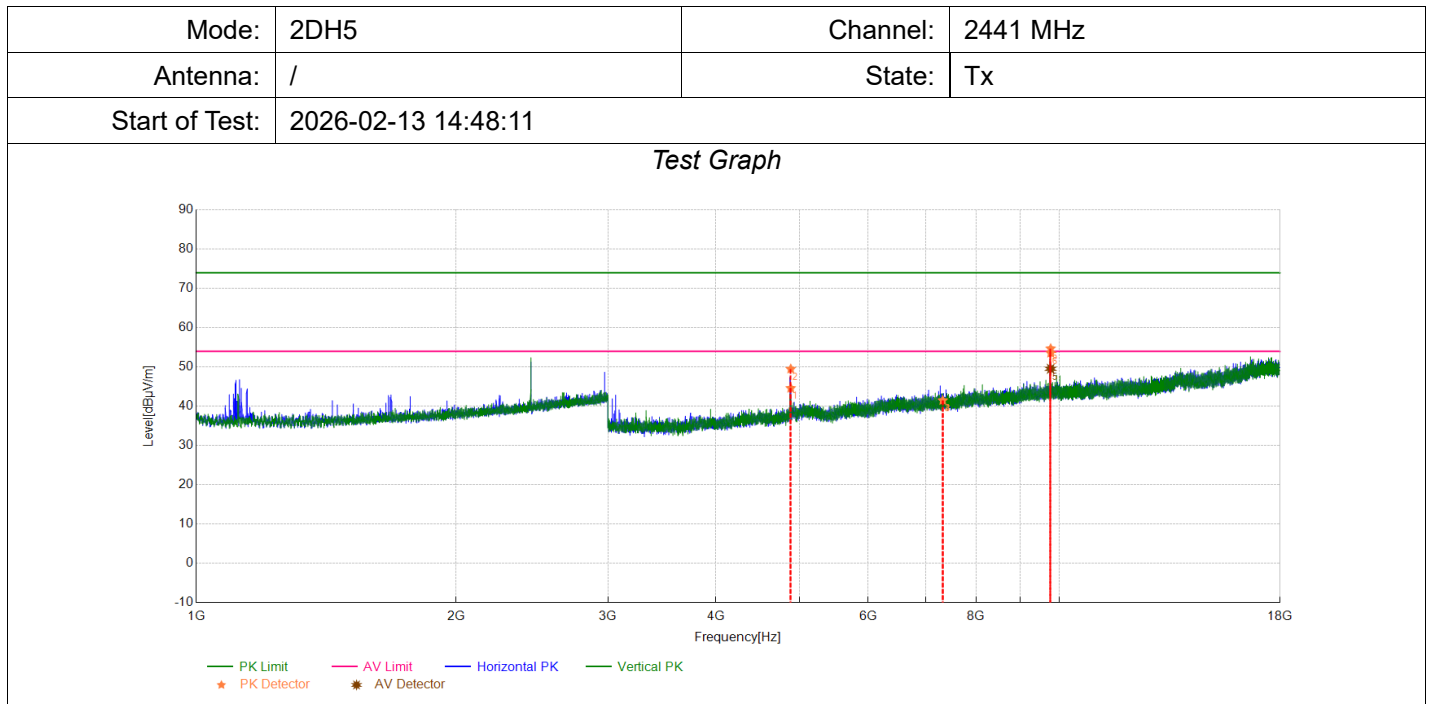
| Final Data List | | | | | | | | | | | | | | |
| NO. | Frequency [MHz] | Factor [dB] | PK Reading [dBμV/m] | PK Value [dBμV/m] | PK Limit [dBμV/m] | PK Margin [dB] | AV Reading [dBμV/m] | AV Value [dBμV/m] | AV Limit [dBμV/m] | AV Margin [dB] | Height [cm] | Angle [°] | Polarity | Verdict |
| 1 | 4882.0000 | -14.00 | 58.62 | 44.62 | 74.00 | 29.38 | | | 54.00 | | 150 | 262 | Horizontal | PASS |
| 2 | 4882.0000 | -14.00 | 63.508 | 49.51 | 74.00 | 24.49 | | | 54.00 | | 153.1 | 228 | Vertical | PASS |
| 3 | 7323.0000 | -9.17 | 50.68 | 41.51 | 74.00 | 32.49 | | | 54.00 | | 150 | 53 | Horizontal | PASS |
| 4 | 7323.0000 | -9.17 | 50.7 | 41.53 | 74.00 | 32.47 | | | 54.00 | | 150 | 326 | Vertical | PASS |
| 5 | 9764.0000 | -4.62 | 59.338 | 54.72 | 74.00 | 19.28 | 54.173 | 49.55 | 54.00 | 4.45 | 110.8 | 90 | Vertical | PASS |
| 6 | 9764.0000 | -4.62 | 58.193 | 53.57 | 74.00 | 20.43 | | | 54.00 | | 111.7 | 344.3 | Horizontal | PASS |

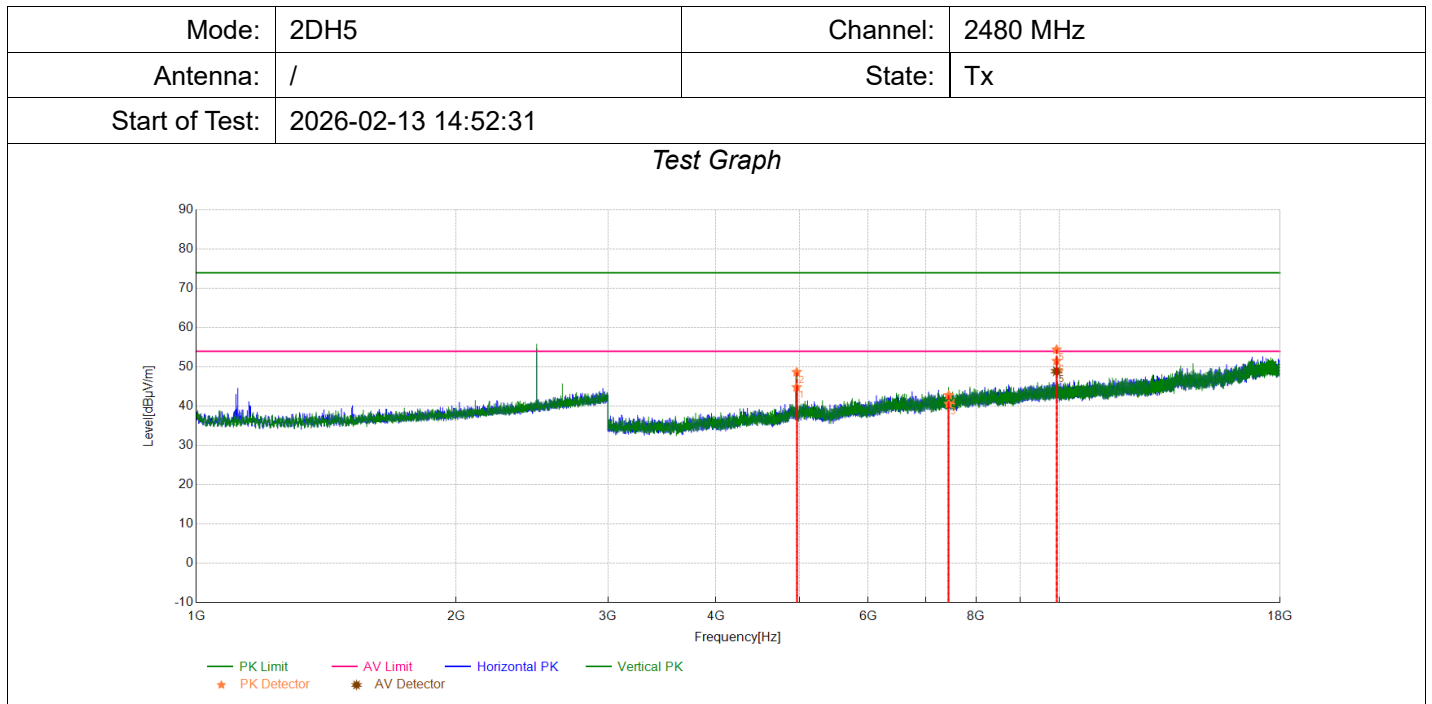
| Final Data List | | | | | | | | | | | | | | |
| NO. | Frequency [MHz] | Factor [dB] | PK Reading [dBμV/m] | PK Value [dBμV/m] | PK Limit [dBμV/m] | PK Margin [dB] | AV Reading [dBμV/m] | AV Value [dBμV/m] | AV Limit [dBμV/m] | AV Margin [dB] | Height [cm] | Angle [°] | Polarity | Verdict |
| 1 | 4960.0000 | -14.84 | 59.69 | 44.85 | 74.00 | 29.15 | | | 54.00 | | 150 | 256 | Horizontal | PASS |
| 2 | 4960.0000 | -14.84 | 63.557 | 48.72 | 74.00 | 25.28 | | | 54.00 | | 153.1 | 228 | Vertical | PASS |
| 3 | 7440.0000 | -8.89 | 49.52 | 40.63 | 74.00 | 33.37 | | | 54.00 | | 150 | 337 | Horizontal | PASS |
| 4 | 7440.0000 | -8.89 | 51.72 | 42.83 | 74.00 | 31.17 | | | 54.00 | | 150 | 211 | Vertical | PASS |
| 5 | 9920.0000 | -4.28 | 58.731 | 54.45 | 74.00 | 19.55 | 53.217 | 48.94 | 54.00 | 5.06 | 110.8 | 90 | Vertical | PASS |
| 6 | 9920.0000 | -4.28 | 55.815 | 51.54 | 74.00 | 22.46 | | | 54.00 | | 111.7 | 344.3 | Horizontal | PASS |

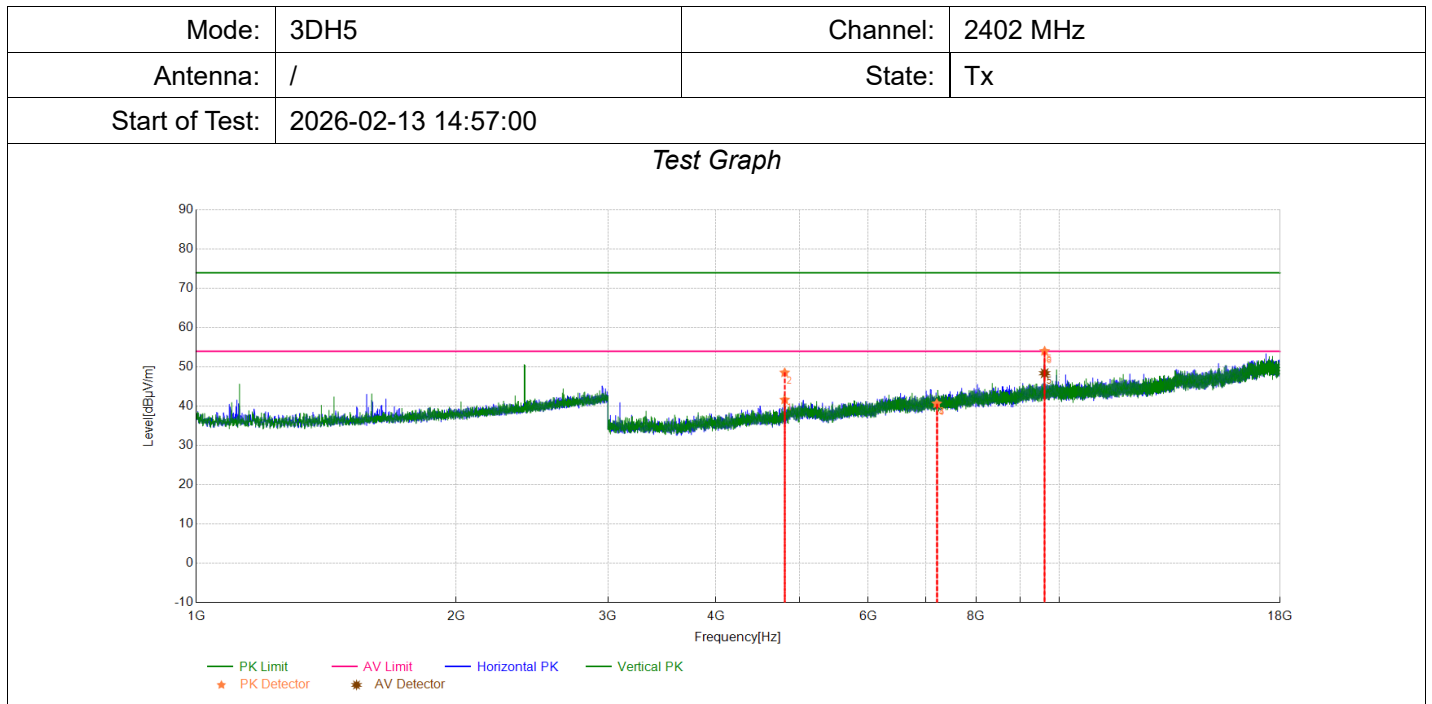
| Final Data List | | | | | | | | | | | | | | |
| NO. | Frequency [MHz] | Factor [dB] | PK Reading [dBμV/m] | PK Value [dBμV/m] | PK Limit [dBμV/m] | PK Margin [dB] | AV Reading [dBμV/m] | AV Value [dBμV/m] | AV Limit [dBμV/m] | AV Margin [dB] | Height [cm] | Angle [°] | Polarity | Verdict |
| 1 | 4804.0000 | -14.53 | 56.19 | 41.66 | 74.00 | 32.34 | | | 54.00 | | 150 | 263 | Horizontal | PASS |
| 2 | 4804.0000 | -14.53 | 63.101 | 48.57 | 74.00 | 25.43 | | | 54.00 | | 153.1 | 228 | Vertical | PASS |
| 3 | 7206.0000 | -9.40 | 50.1 | 40.70 | 74.00 | 33.30 | | | 54.00 | | 150 | 336 | Vertical | PASS |
| 4 | 7206.0000 | -9.40 | 49.89 | 40.49 | 74.00 | 33.51 | | | 54.00 | | 150 | 124 | Horizontal | PASS |
| 5 | 9608.0000 | -5.07 | 59.104 | 54.03 | 74.00 | 19.97 | 53.492 | 48.42 | 54.00 | 5.58 | 110.8 | 90 | Vertical | PASS |
| 6 | 9608.0000 | -5.07 | 58.667 | 53.60 | 74.00 | 20.40 | | | 54.00 | | 111.7 | 344.3 | Horizontal | PASS |

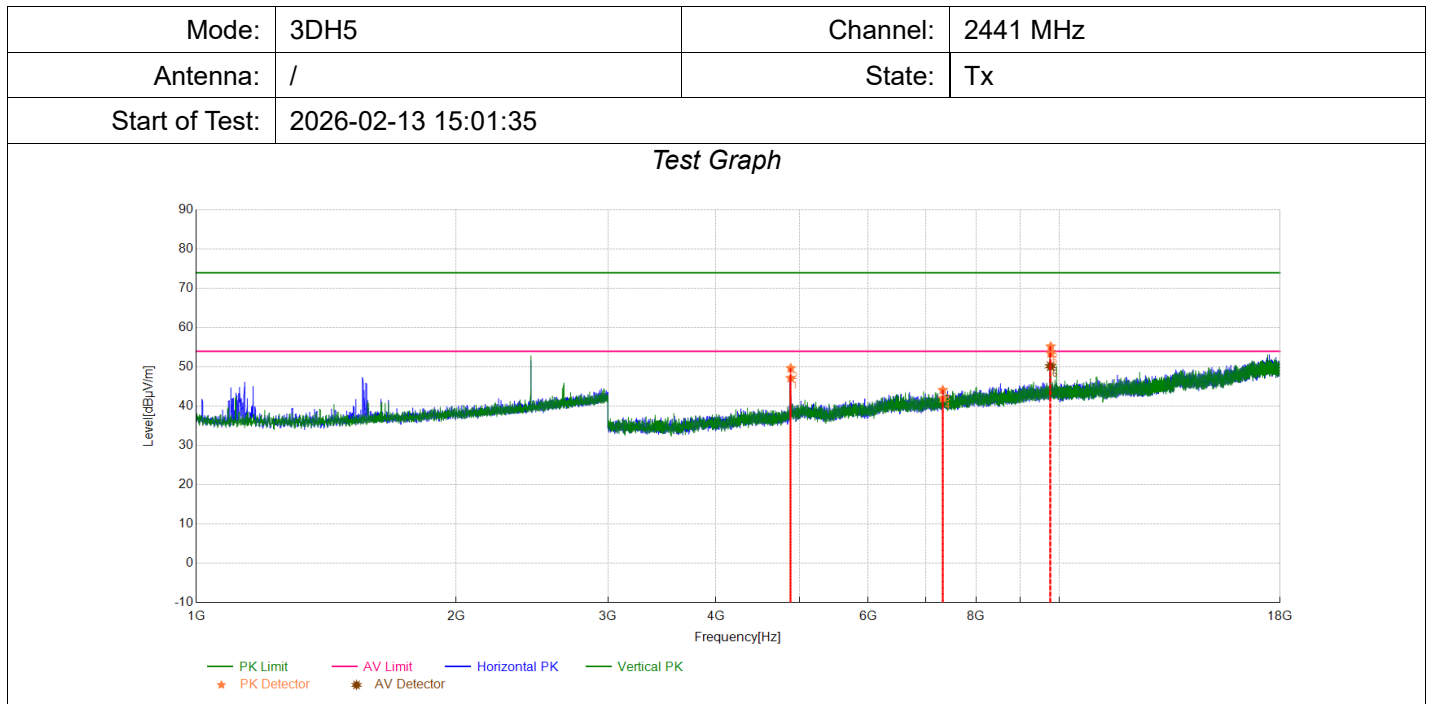
| Final Data List | | | | | | | | | | | | | | |
| NO. | Frequency [MHz] | Factor [dB] | PK Reading [dBμV/m] | PK Value [dBμV/m] | PK Limit [dBμV/m] | PK Margin [dB] | AV Reading [dBμV/m] | AV Value [dBμV/m] | AV Limit [dBμV/m] | AV Margin [dB] | Height [cm] | Angle [°] | Polarity | Verdict |
| 1 | 4882.0000 | -14.00 | 61.2 | 47.20 | 74.00 | 26.80 | | | 54.00 | | 150 | 262 | Horizontal | PASS |
| 2 | 4882.0000 | -14.00 | 63.701 | 49.70 | 74.00 | 24.30 | | | 54.00 | | 153.1 | 228 | Vertical | PASS |
| 3 | 7323.0000 | -9.17 | 53.32 | 44.15 | 74.00 | 29.85 | | | 54.00 | | 150 | 345 | Vertical | PASS |
| 4 | 7323.0000 | -9.17 | 51.2 | 42.03 | 74.00 | 31.97 | | | 54.00 | | 150 | 134 | Horizontal | PASS |
| 5 | 9764.0000 | -4.62 | 58.104 | 53.48 | 74.00 | 20.52 | | | 54.00 | | 111.7 | 344.3 | Horizontal | PASS |
| 6 | 9764.0000 | -4.62 | 59.864 | 55.24 | 74.00 | 18.76 | 54.834 | 50.21 | 54.00 | 3.79 | 110.8 | 90 | Vertical | PASS |

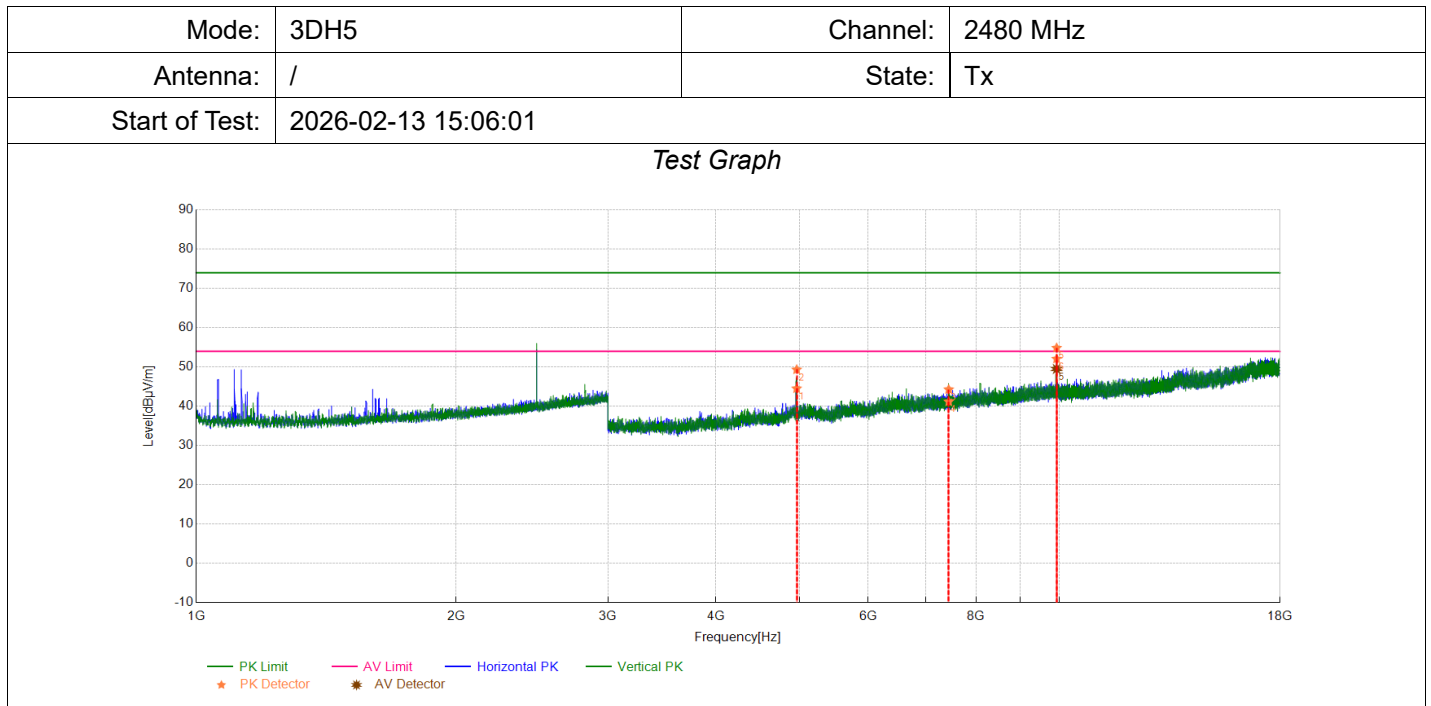
| Final Data List | | | | | | | | | | | | | | |
| NO. | Frequency [MHz] | Factor [dB] | PK Reading [dBμV/m] | PK Value [dBμV/m] | PK Limit [dBμV/m] | PK Margin [dB] | AV Reading [dBμV/m] | AV Value [dBμV/m] | AV Limit [dBμV/m] | AV Margin [dB] | Height [cm] | Angle [°] | Polarity | Verdict |
| 1 | 4960.0000 | -14.84 | 59.37 | 44.53 | 74.00 | 29.47 | | | 54.00 | | 150 | 57 | Horizontal | PASS |
| 2 | 4960.0000 | -14.84 | 64.190 | 49.35 | 74.00 | 24.65 | | | 54.00 | | 153.1 | 228 | Vertical | PASS |
| 3 | 7440.0000 | -8.89 | 53.19 | 44.30 | 74.00 | 29.70 | | | 54.00 | | 150 | 356 | Vertical | PASS |
| 4 | 7440.0000 | -8.89 | 50.08 | 41.19 | 74.00 | 32.81 | | | 54.00 | | 150 | 17 | Horizontal | PASS |
| 5 | 9920.0000 | -4.28 | 59.145 | 54.87 | 74.00 | 19.13 | 53.779 | 49.50 | 54.00 | 4.50 | 110.8 | 90 | Vertical | PASS |
| 6 | 9920.0000 | -4.28 | 56.373 | 52.09 | 74.00 | 21.91 | | | 54.00 | | 111.7 | 344.3 | Horizontal | PASS |

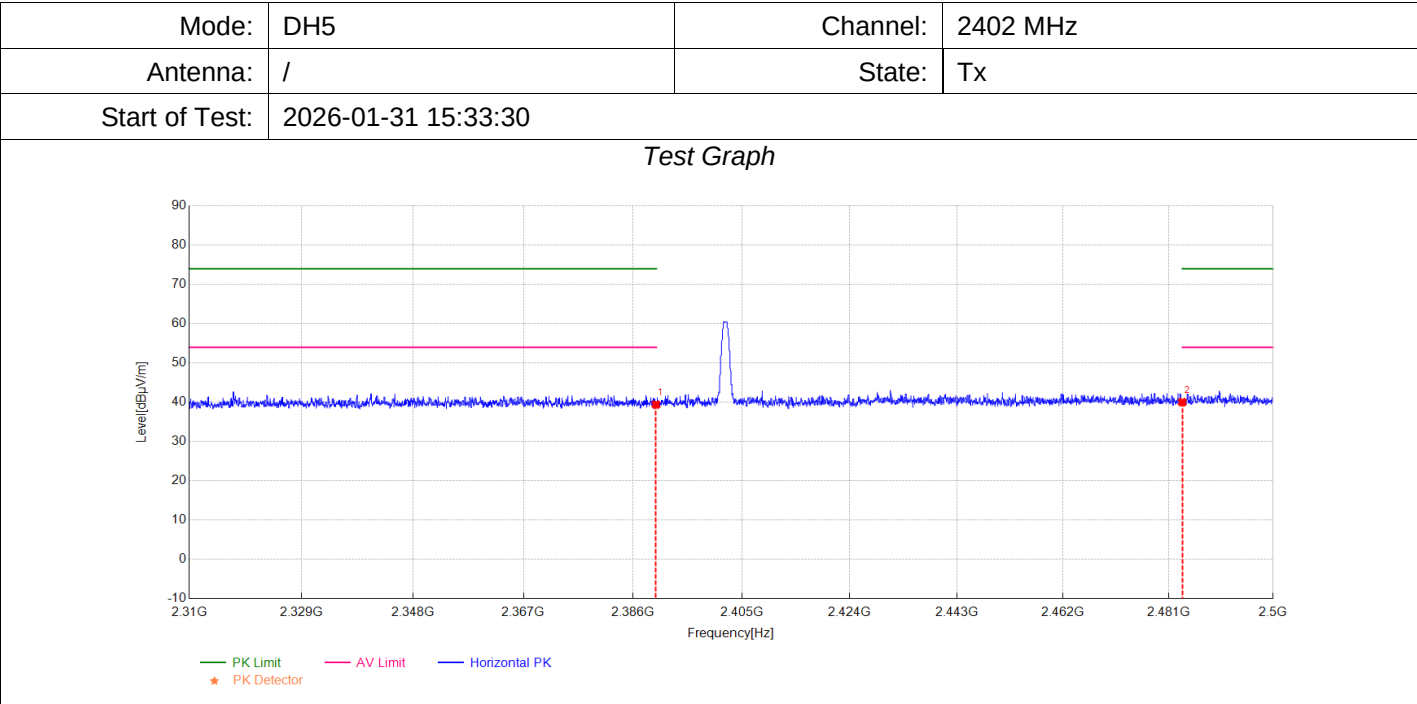
| Suspected Data List | | | | | | | | | | | |
| NO. | Frequency [MHz] | Reading [dBµV/m] | Level [dBµV/m] | Factor [dB] | Limit [dBµV/m] | Margin [dB] | Height [cm] | Angle [°] | Det | Polarity | Verdict |
| 1 | 2390.0000 | 36.46 | 39.41 | 2.95 | 74.00 | 34.59 | 150 | 100 | PK | Horizontal | PASS |
| 2 | 2483.5000 | 36.59 | 40.05 | 3.46 | 74.00 | 33.95 | 150 | 130 | PK | Horizontal | PASS |

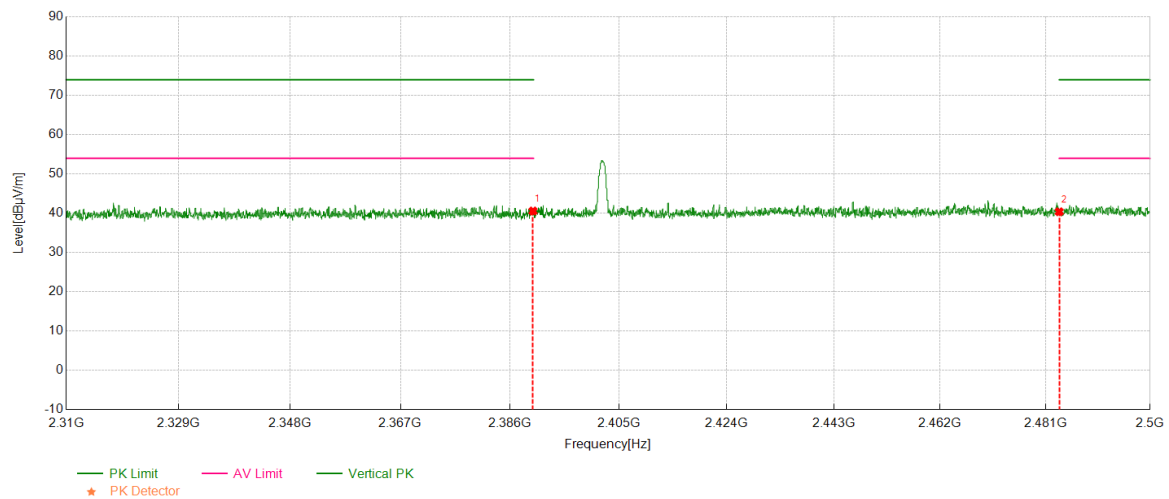
*Test Graph*

| Mode: | DH5 | Channel: | 2402 MHz |
| Antenna: | / | State: | Tx |
| Start of Test: | 2026-01-31 15:57:40 | | |

#### Suspected Data List

| NO. | Frequency [MHz] | Reading [dBμV/m] | Level [dBμV/m] | Factor [dB] | Limit [dBμV/m] | Margin [dB] | Height [cm] | Angle [°] | Det | Polarity | Verdict |
| 1 | 2390.0000 | 37.64 | 40.59 | 2.95 | 74.00 | 33.41 | 137.8 | 350 | PK | Vertical | PASS |
| 2 | 2483.5000 | 36.94 | 40.40 | 3.46 | 74.00 | 33.60 | 137.8 | 260 | PK | Vertical | PASS |

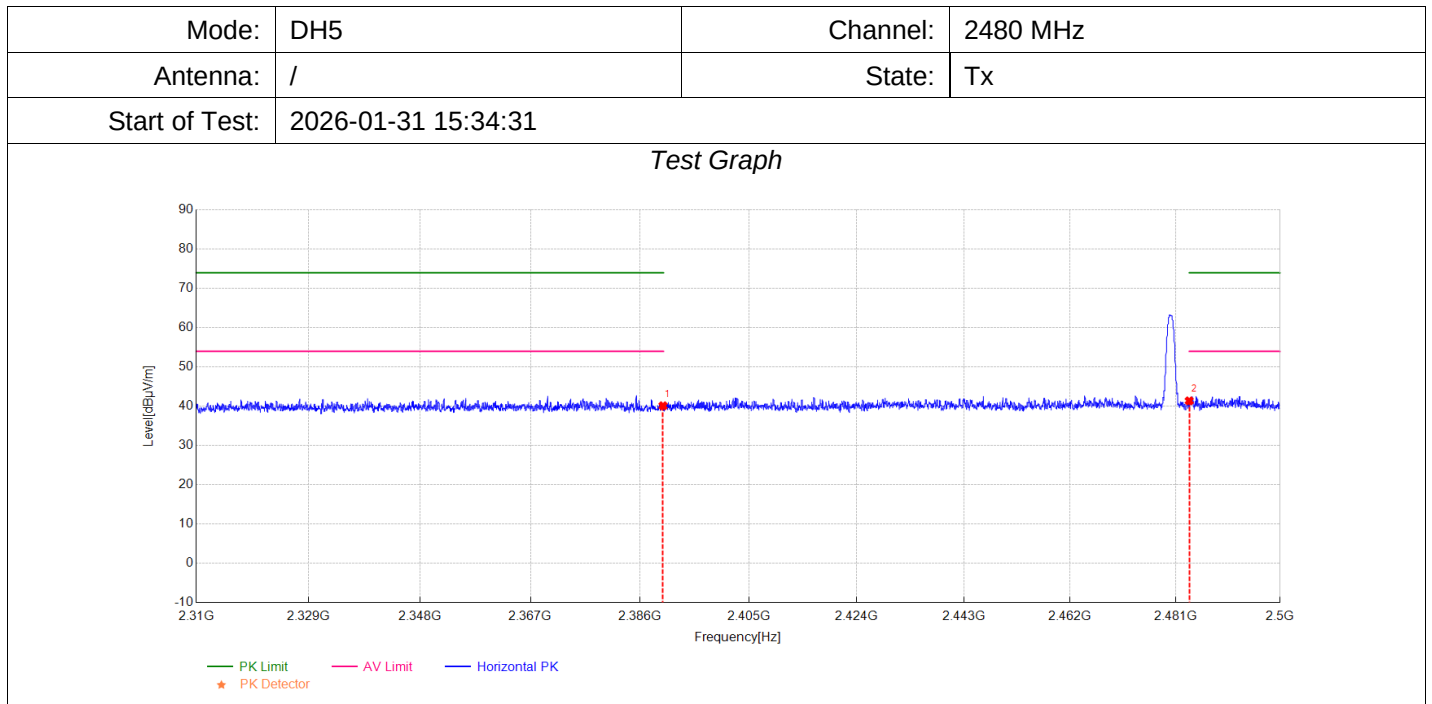
**Suspected Data List**

| NO. | Frequency [MHz] | Reading [dBμV/m] | Level [dBμV/m] | Factor [dB] | Limit [dBμV/m] | Margin [dB] | Height [cm] | Angle [°] | Det | Polarity | Verdict |
| 1 | 2390.0000 | 37.19 | 40.14 | 2.95 | 74.00 | 33.86 | 150 | 190 | PK | Horizontal | PASS |
| 2 | 2483.5000 | 37.94 | 41.40 | 3.46 | 74.00 | 32.60 | 150 | 30 | PK | Horizontal | PASS |

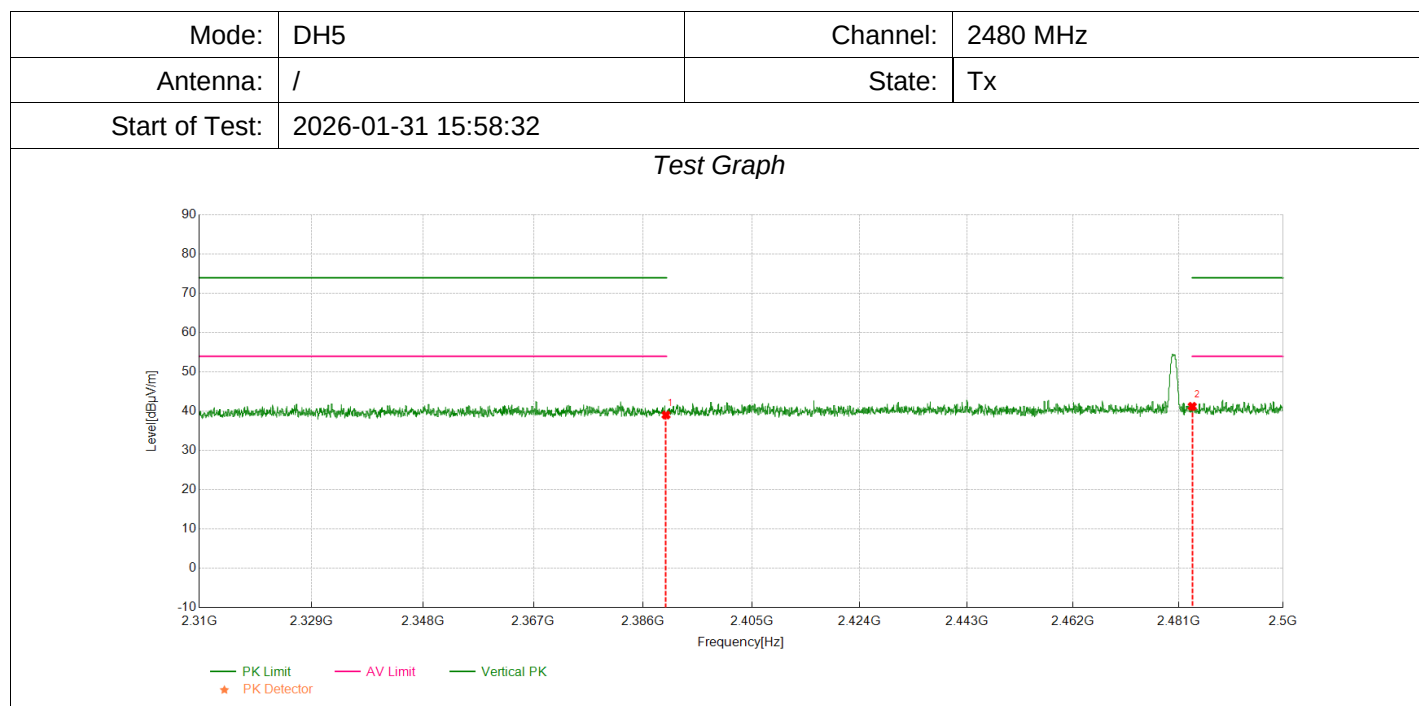
**Suspected Data List**

| NO. | Frequency [MHz] | Reading [dBμV/m] | Level [dBμV/m] | Factor [dB] | Limit [dBμV/m] | Margin [dB] | Height [cm] | Angle [°] | Det | Polarity | Verdict |
| 1 | 2390.0000 | 36.11 | 39.06 | 2.95 | 74.00 | 34.94 | 137.8 | 80 | PK | Vertical | PASS |
| 2 | 2483.5000 | 37.80 | 41.26 | 3.46 | 74.00 | 32.74 | 137.8 | 70 | PK | Vertical | PASS |

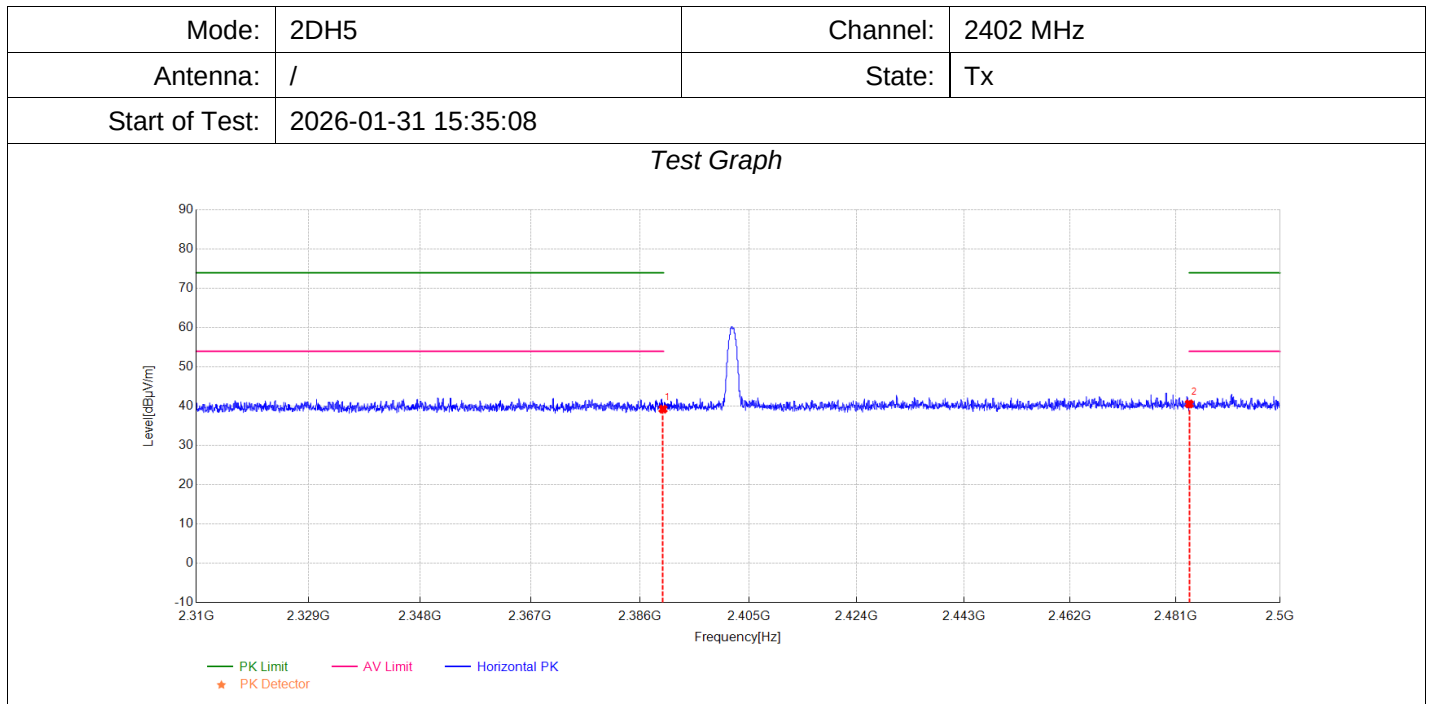
**Suspected Data List**

| NO. | Frequency [MHz] | Reading [dBµV/m] | Level [dBµV/m] | Factor [dB] | Limit [dBµV/m] | Margin [dB] | Height [cm] | Angle [°] | Det | Polarity | Verdict |
| 1 | 2390.0000 | 36.34 | 39.29 | 2.95 | 74.00 | 34.71 | 150 | 130 | PK | Horizontal | PASS |
| 2 | 2483.5000 | 37.16 | 40.62 | 3.46 | 74.00 | 33.38 | 150 | 250 | PK | Horizontal | PASS |

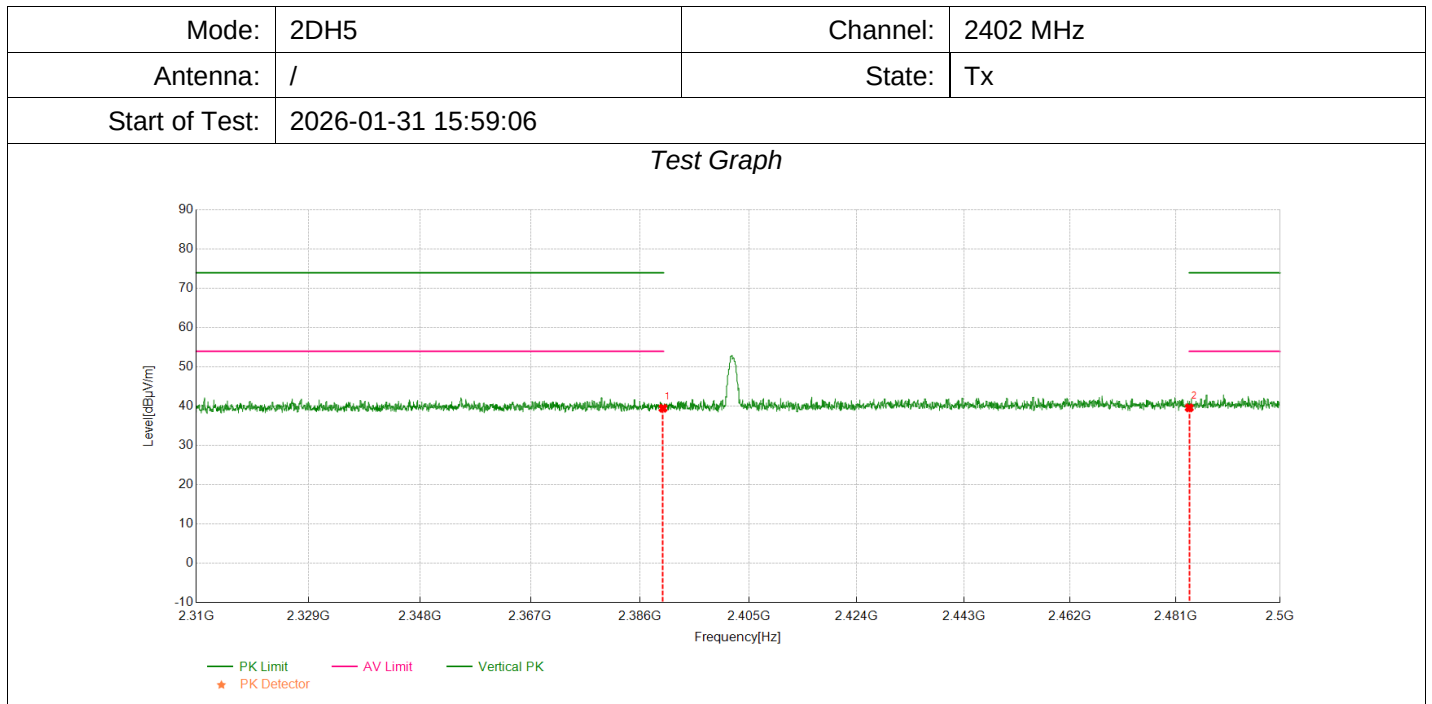
**Suspected Data List**

| NO. | Frequency [MHz] | Reading [dBμV/m] | Level [dBμV/m] | Factor [dB] | Limit [dBμV/m] | Margin [dB] | Height [cm] | Angle [°] | Det | Polarity | Verdict |
| 1 | 2390.0000 | 36.56 | 39.51 | 2.95 | 74.00 | 34.49 | 137.8 | 260 | PK | Vertical | PASS |
| 2 | 2483.5000 | 36.16 | 39.62 | 3.46 | 74.00 | 34.38 | 137.8 | 70 | PK | Vertical | PASS |

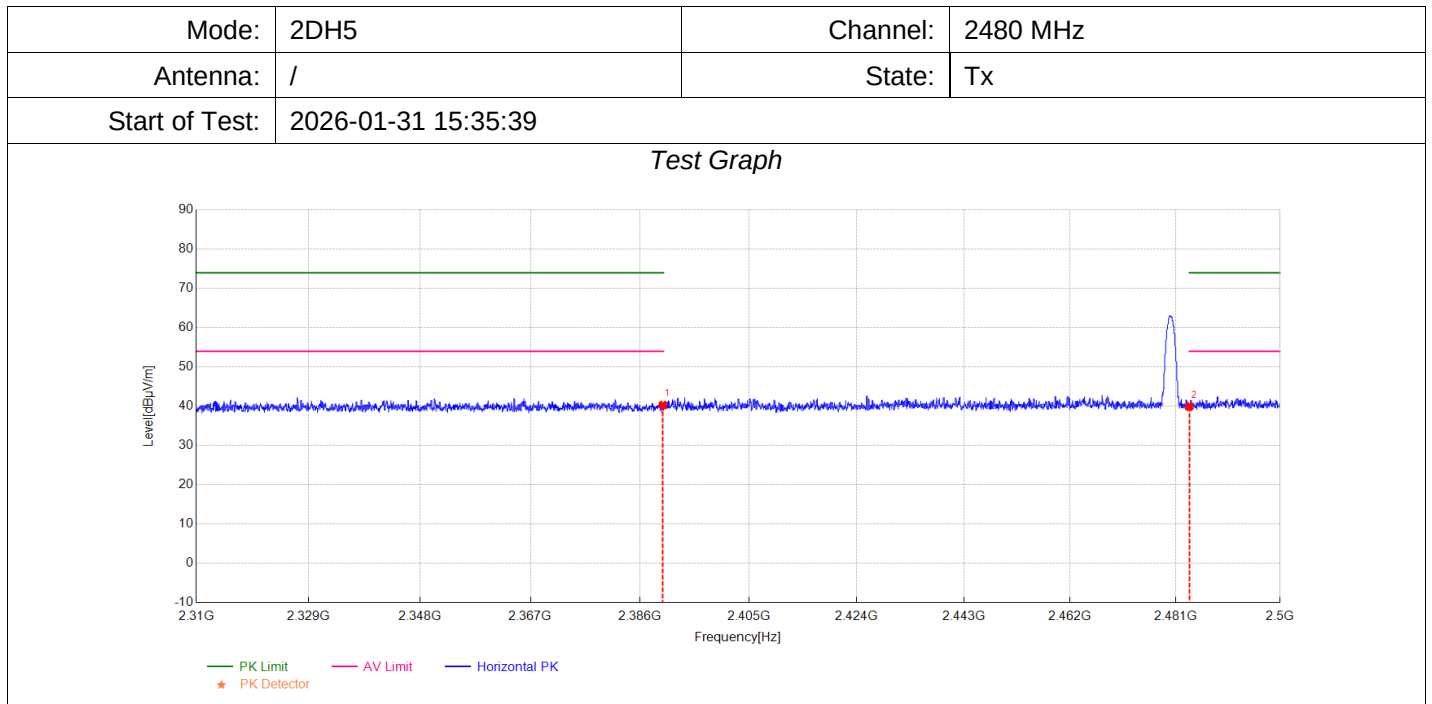
**Suspected Data List**

| NO. | Frequency [MHz] | Reading [dBμV/m] | Level [dBμV/m] | Factor [dB] | Limit [dBμV/m] | Margin [dB] | Height [cm] | Angle [°] | Det | Polarity | Verdict |
| 1 | 2390.0000 | 37.36 | 40.31 | 2.95 | 74.00 | 33.69 | 150 | 10 | PK | Horizontal | PASS |
| 2 | 2483.5000 | 36.47 | 39.93 | 3.46 | 74.00 | 34.07 | 150 | 40 | PK | Horizontal | PASS |

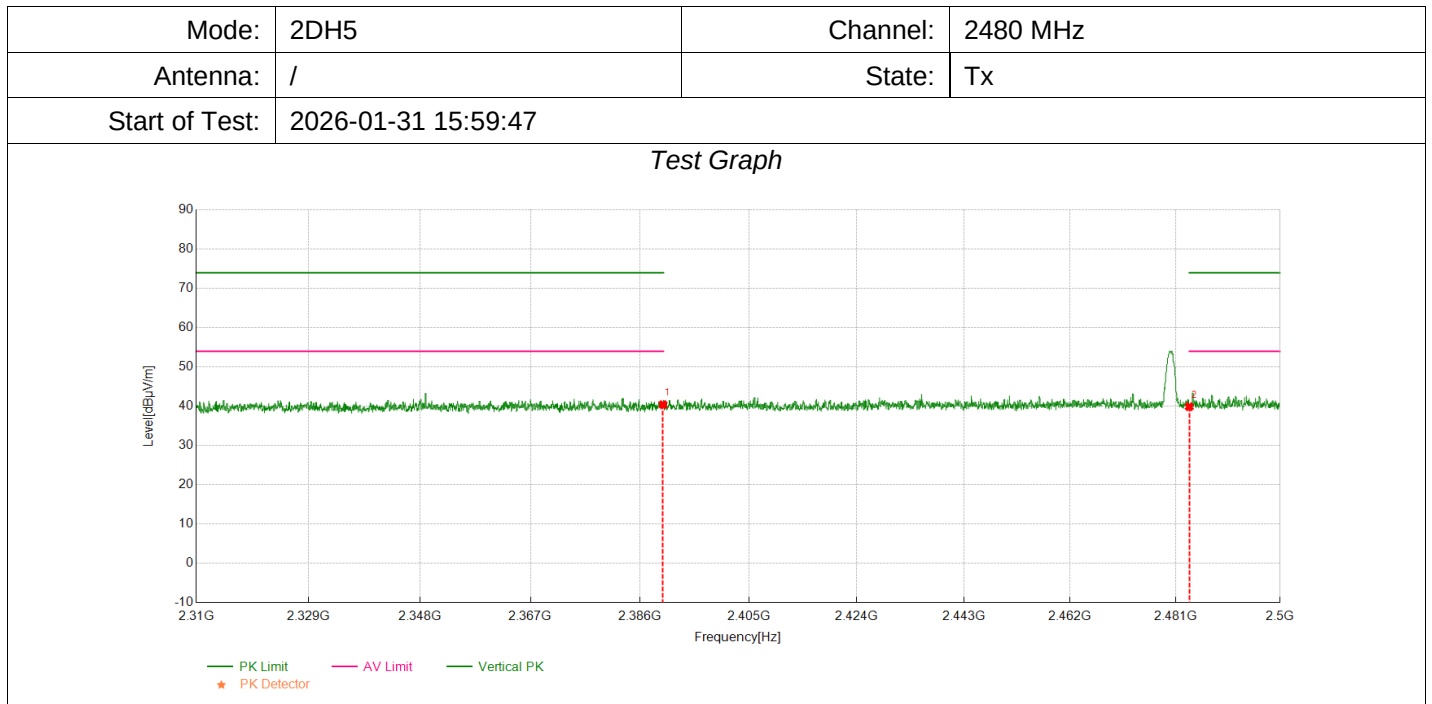
**Suspected Data List**

| NO. | Frequency [MHz] | Reading [dBμV/m] | Level [dBμV/m] | Factor [dB] | Limit [dBμV/m] | Margin [dB] | Height [cm] | Angle [°] | Det | Polarity | Verdict |
| 1 | 2390.0000 | 37.48 | 40.43 | 2.95 | 74.00 | 33.57 | 137.8 | 340 | PK | Vertical | PASS |
| 2 | 2483.5000 | 36.45 | 39.91 | 3.46 | 74.00 | 34.09 | 137.8 | 270 | PK | Vertical | PASS |

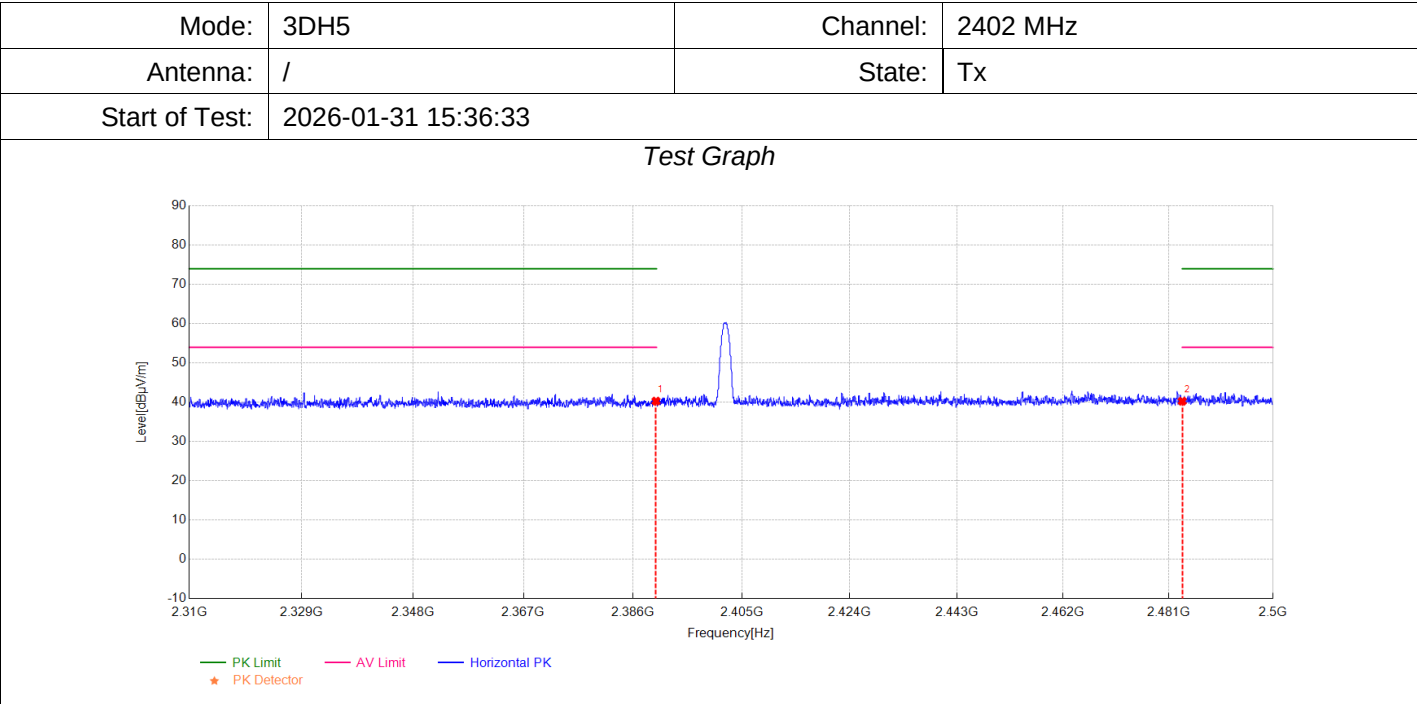
| Suspected Data List | | | | | | | | | | | |
| NO. | Frequency [MHz] | Reading [dBµV/m] | Level [dBµV/m] | Factor [dB] | Limit [dBµV/m] | Margin [dB] | Height [cm] | Angle [°] | Det | Polarity | Verdict |
| 1 | 2390.0000 | 37.36 | 40.31 | 2.95 | 74.00 | 33.69 | 150 | 180 | PK | Horizontal | PASS |
| 2 | 2483.5000 | 36.82 | 40.28 | 3.46 | 74.00 | 33.72 | 150 | 260 | PK | Horizontal | PASS |

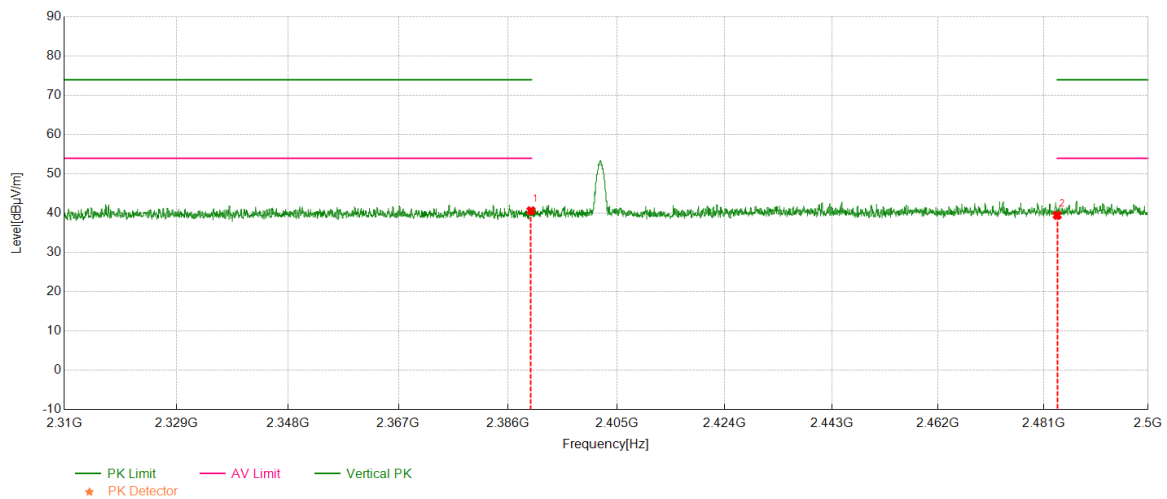
*Test Graph*

| Mode: | 3DH5 | Channel: | 2402 MHz |
| Antenna: | / | State: | Tx |
| Start of Test: | 2026-01-31 16:00:23 | | |

#### Suspected Data List

| NO. | Frequency [MHz] | Reading [dBμV/m] | Level [dBμV/m] | Factor [dB] | Limit [dBμV/m] | Margin [dB] | Height [cm] | Angle [°] | Det | Polarity | Verdict |
| 1 | 2390.0000 | 37.73 | 40.68 | 2.95 | 74.00 | 33.32 | 137.8 | 140 | PK | Vertical | PASS |
| 2 | 2483.5000 | 36.03 | 39.49 | 3.46 | 74.00 | 34.51 | 137.8 | 310 | PK | Vertical | PASS |

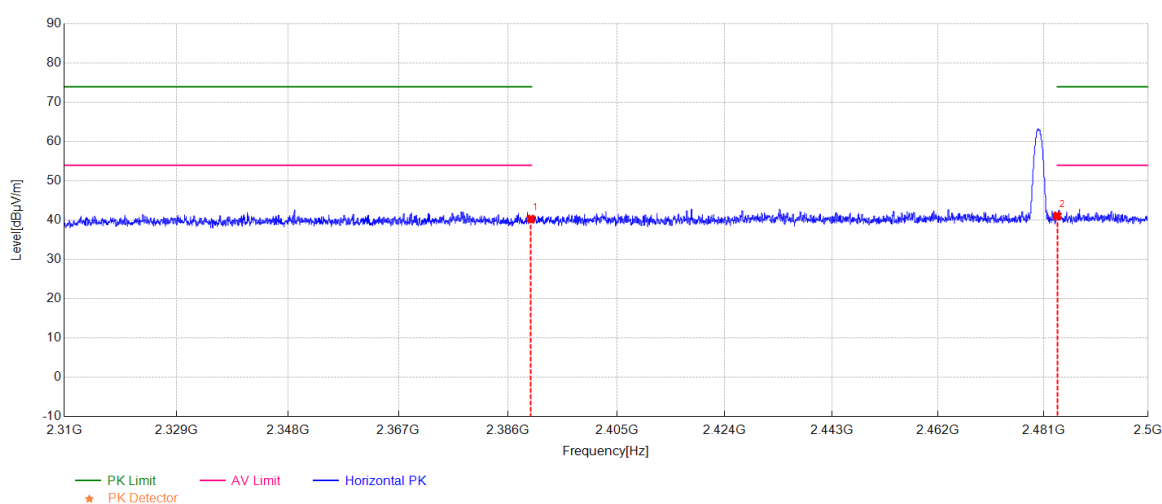
*Test Graph*

| Mode: | 3DH5 | Channel: | 2480 MHz |
| Antenna: | / | State: | Tx |
| Start of Test: | 2026-01-31 15:37:18 | | |

#### Suspected Data List

| NO. | Frequency [MHz] | Reading [dBμV/m] | Level [dBμV/m] | Factor [dB] | Limit [dBμV/m] | Margin [dB] | Height [cm] | Angle [°] | Det | Polarity | Verdict |
| 1 | 2390.0000 | 37.40 | 40.35 | 2.95 | 74.00 | 33.65 | 150 | 290 | PK | Horizontal | PASS |
| 2 | 2483.5000 | 37.68 | 41.14 | 3.46 | 74.00 | 32.86 | 150 | 130 | PK | Horizontal | PASS |

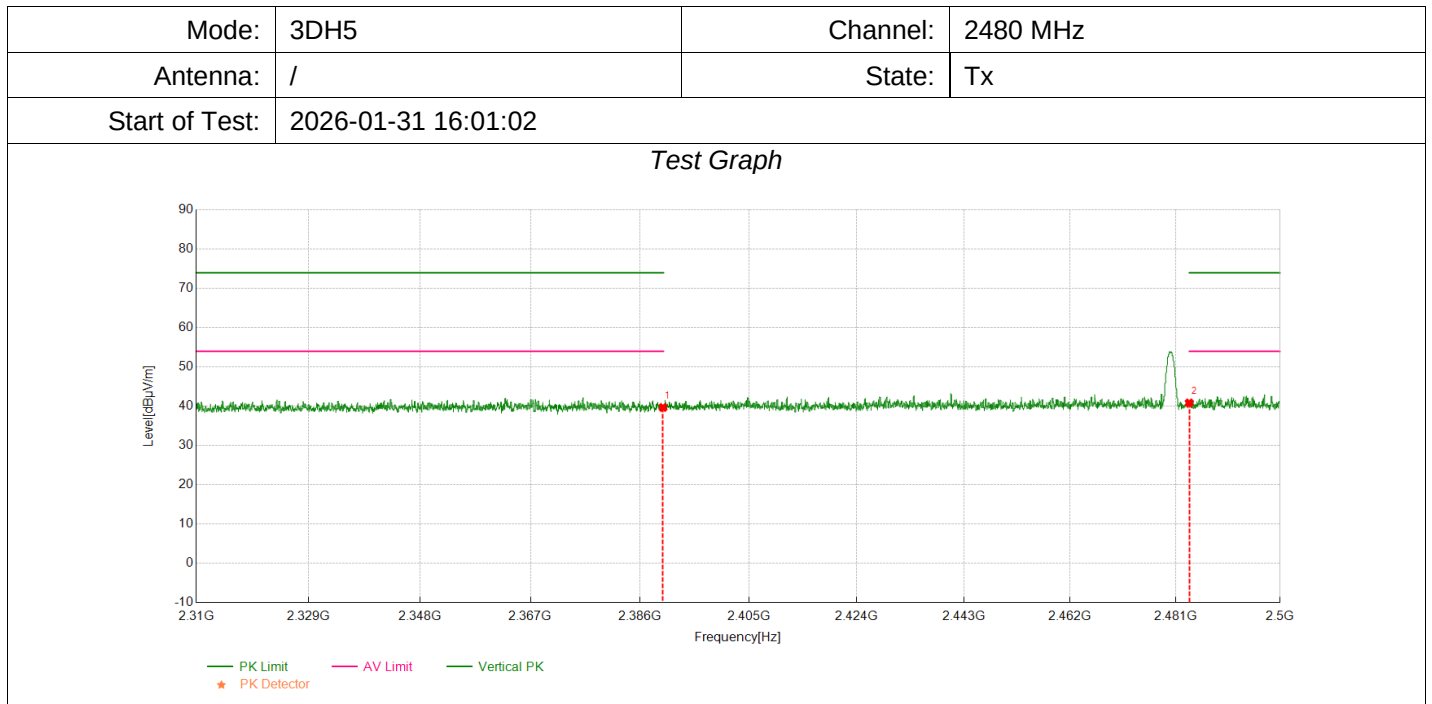
**Suspected Data List**

| NO. | Frequency [MHz] | Reading [dBμV/m] | Level [dBμV/m] | Factor [dB] | Limit [dBμV/m] | Margin [dB] | Height [cm] | Angle [°] | Det | Polarity | Verdict |
| 1 | 2390.0000 | 36.76 | 39.71 | 2.95 | 74.00 | 34.29 | 137.8 | 90 | PK | Vertical | PASS |
| 2 | 2483.5000 | 37.41 | 40.87 | 3.46 | 74.00 | 33.13 | 137.8 | 280 | PK | Vertical | PASS |

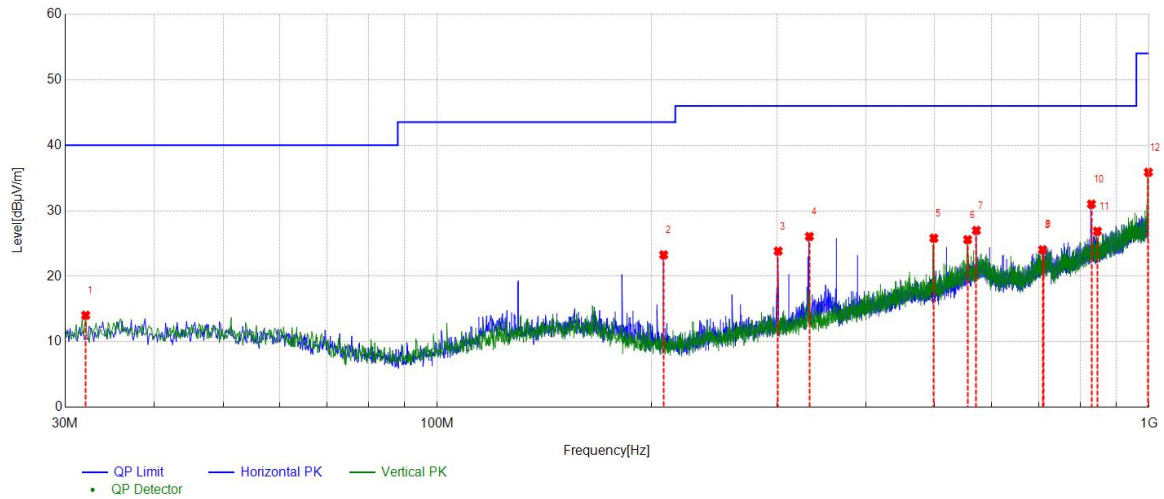
### Test Graph

## P15 measurement

Below 1GHz

| Mode: | Normal operation | Channel: | / |

Start of Test: 2026-02-06 10:29:57

### PK Suspected Data List

| NO. | Freq. [MHz] | Reading [dBμV/m] | Factor [dB/m] | Level [dBμV/m] | Limit [dBμV/m] | Margin [dB] | Height [cm] | Angle [°] | Polarity | Verdict |
| 1 | 32.0612 | 30.31 | -16.25 | 14.06 | 40.00 | 25.94 | 100 | 192 | Vertical | PASS |
| 10 | 829.8862 | 35.40 | -4.39 | 31.01 | 46.00 | 14.99 | 100 | 311 | Horizontal | PASS |
| 12 | 997.8175 | 37.10 | -1.23 | 35.87 | 54.00 | 18.13 | 100 | 208 | Vertical | PASS |

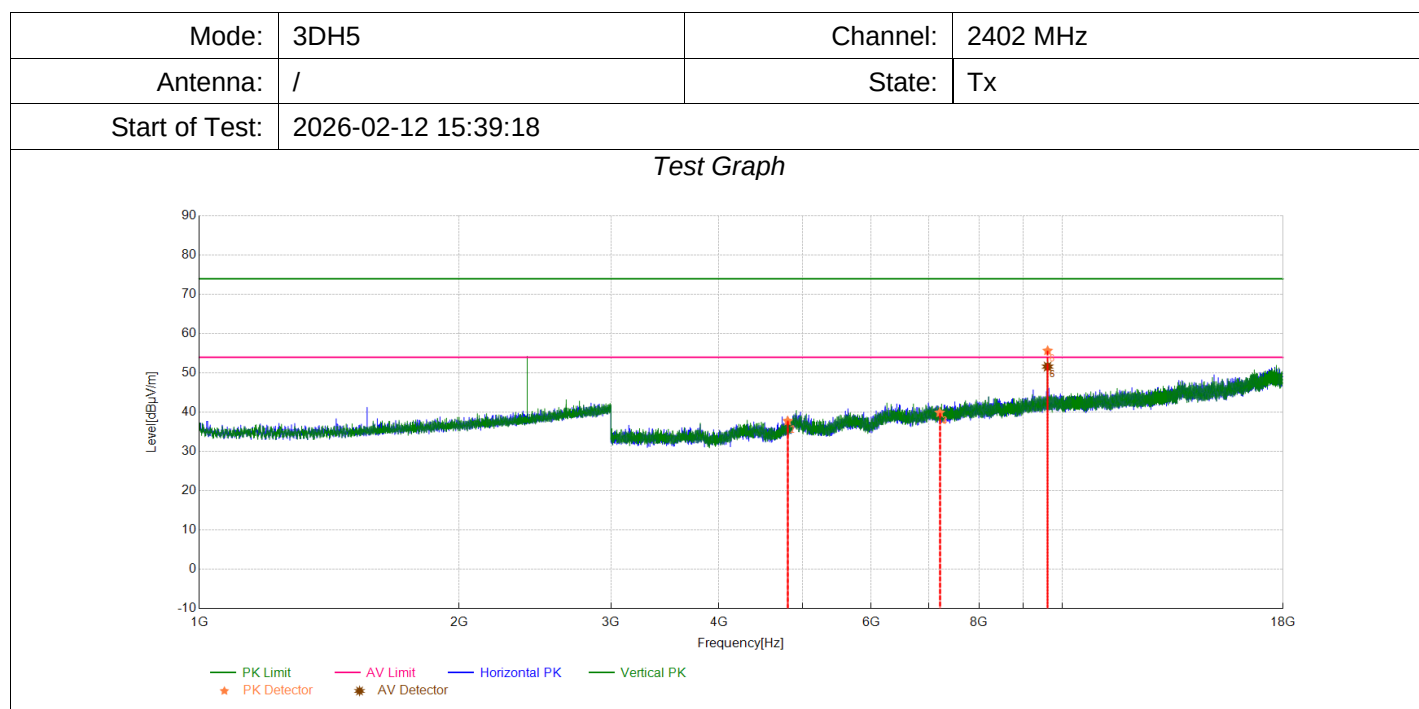
Above 1GHz

| Final Data List | | | | | | | | | | | | | | |
| NO. | Frequency [MHz] | Factor [dB] | PK Reading [dBμV/m] | PK Value [dBμV/m] | PK Limit [dBμV/m] | PK Margin [dB] | AV Reading [dBμV/m] | AV Value [dBμV/m] | AV Limit [dBμV/m] | AV Margin [dB] | Height [cm] | Angle [°] | Polarity | Verdict |
| 5 | 9608.0000 | -5.07 | 56.718 | 51.65 | 74.00 | 22.35 | | | 54.00 | | 110.9 | 43.3 | Horizontal | PASS |
| 6 | 9608.0000 | -5.07 | 60.755 | 55.69 | 74.00 | 18.31 | 56.705 | 51.64 | 54.00 | 2.36 | 120 | 0 | Vertical | PASS |

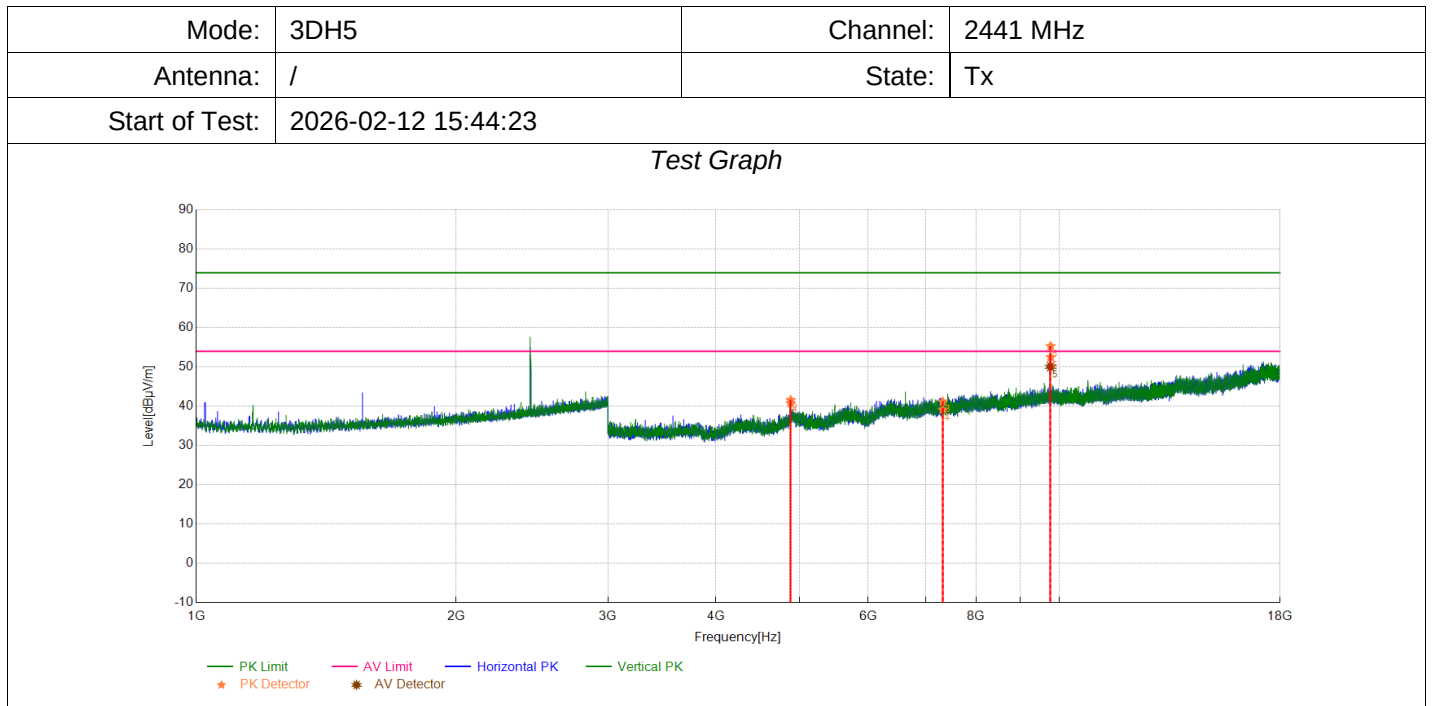
| Final Data List | | | | | | | | | | | | | | |
| NO. | Frequency [MHz] | Factor [dB] | PK Reading [dBµV/m] | PK Value [dBµV/m] | PK Limit [dBµV/m] | PK Margin [dB] | AV Reading [dBµV/m] | AV Value [dBµV/m] | AV Limit [dBµV/m] | AV Margin [dB] | Height [cm] | Angle [°] | Polarity | Verdict |
| 5 | 9764.0000 | -4.62 | 59.936 | 55.32 | 74.00 | 18.68 | 54.721 | 50.10 | 54.00 | 3.90 | 120 | 0 | Vertical | PASS |
| 6 | 9764.0000 | -4.62 | 57.136 | 52.52 | 74.00 | 21.48 | | | 54.00 | | 110.9 | 43.3 | Horizontal | PASS |

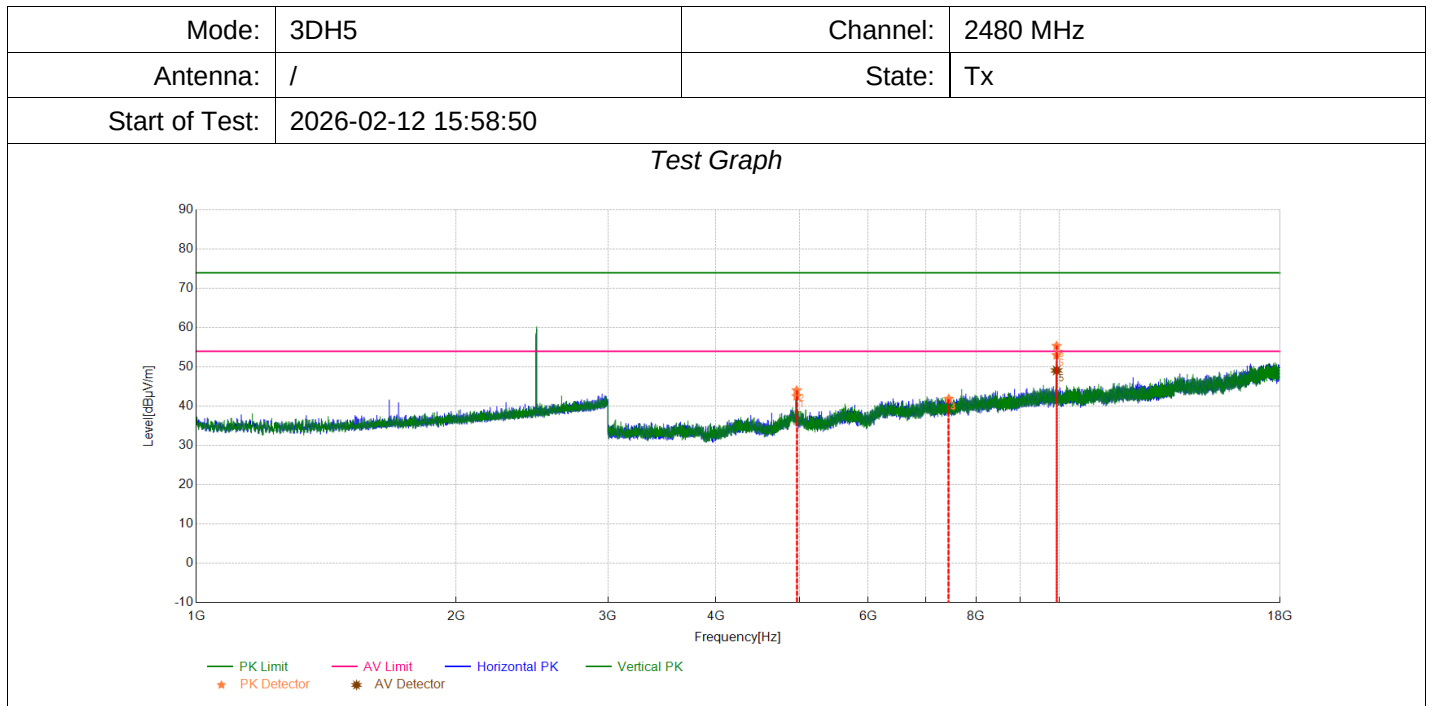
| Final Data List | | | | | | | | | | | | | | |
| NO. | Frequency [MHz] | Factor [dB] | PK Reading [dBμV/m] | PK Value [dBμV/m] | PK Limit [dBμV/m] | PK Margin [dB] | AV Reading [dBμV/m] | AV Value [dBμV/m] | AV Limit [dBμV/m] | AV Margin [dB] | Height [cm] | Angle [°] | Polarity | Verdict |
| 5 | 9920.0000 | -4.28 | 59.650 | 55.37 | 74.00 | 18.63 | 53.423 | 49.14 | 54.00 | 4.86 | 120 | 0 | Vertical | PASS |
| 6 | 9920.0000 | -4.28 | 57.286 | 53.01 | 74.00 | 20.99 | | | 54.00 | | 110.9 | 43.3 | Horizontal | PASS |
