Test Report No.: EFGX26010180-IE-03-E04

Eurofins Electrical Testing Service (Shenzhen) Co., Ltd.

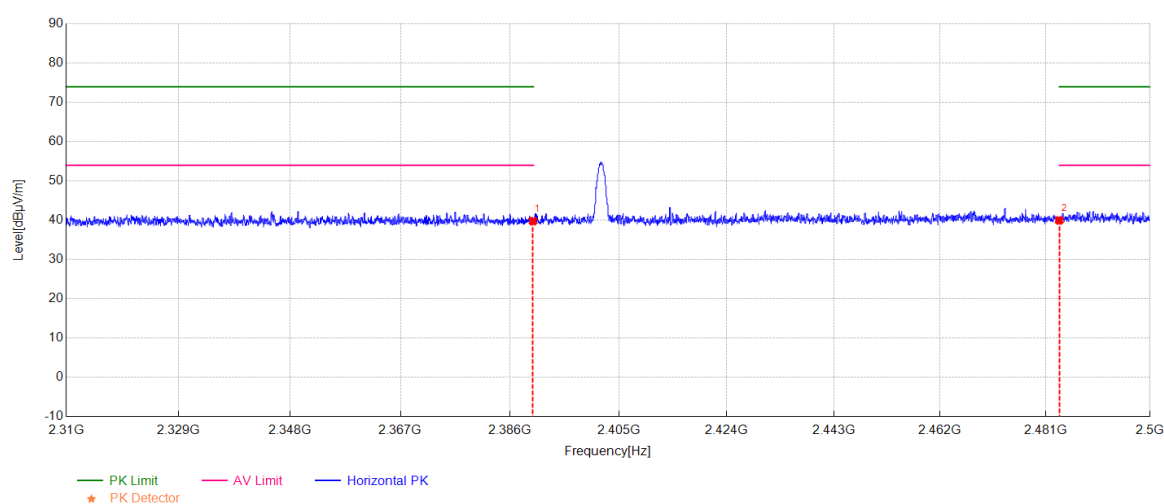
*Test Graph*

| Mode: | 3DH5 | Channel: | 2402 MHz |
| Antenna: | / | State: | Tx |
| Start of Test: | 2026-02-12 17:18:59 | | |

#### Suspected Data List

| NO. | Frequency [MHz] | Reading [dBµV/m] | Level [dBµV/m] | Factor [dB] | Limit [dBµV/m] | Margin [dB] | Height [cm] | Angle [°] | Det | Polarity | Verdict |
| 1 | 2390.0000 | 36.86 | 39.81 | 2.95 | 74.00 | 34.19 | 101.8 | 10 | PK | Horizontal | PASS |
| 2 | 2483.5000 | 36.54 | 40.00 | 3.46 | 74.00 | 34.00 | 101.8 | 240 | PK | Horizontal | PASS |

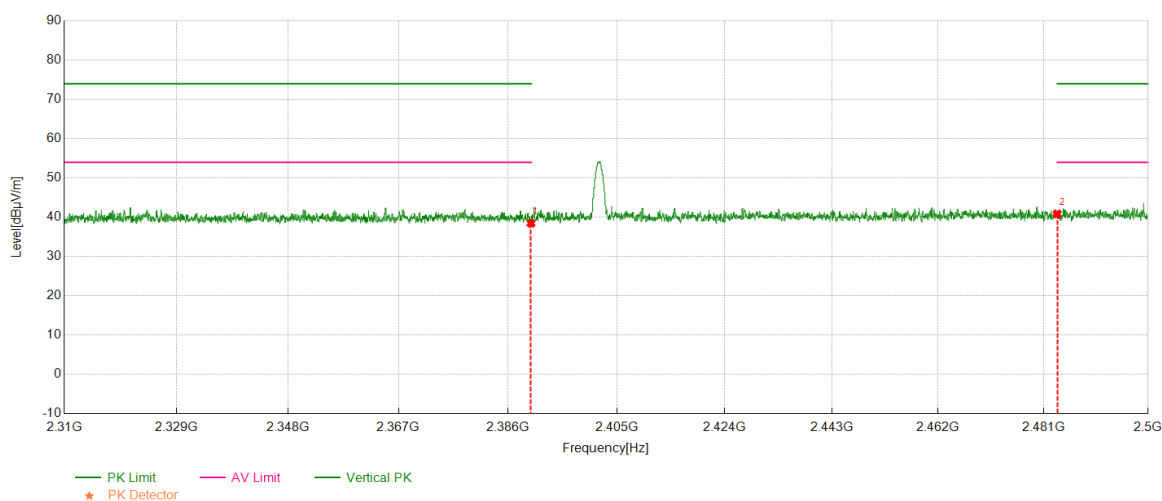
*Test Graph*

| Start of Test: | 2026-02-12 17:33:22 | | |

#### Suspected Data List

| NO. | Frequency [MHz] | Reading [dBμV/m] | Level [dBμV/m] | Factor [dB] | Limit [dBμV/m] | Margin [dB] | Height [cm] | Angle [°] | Det | Polarity | Verdict |

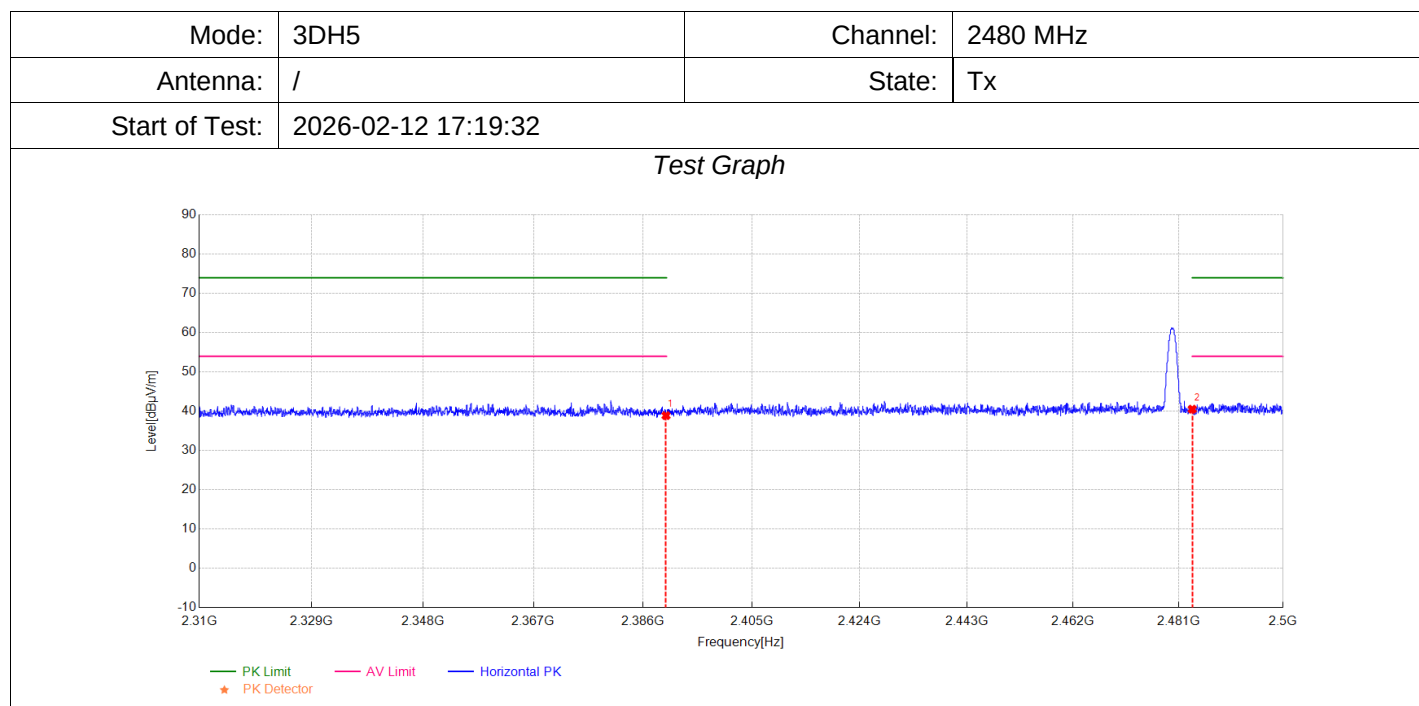
**Suspected Data List**

| NO. | Frequency [MHz] | Reading [dBμV/m] | Level [dBμV/m] | Factor [dB] | Limit [dBμV/m] | Margin [dB] | Height [cm] | Angle [°] | Det | Polarity | Verdict |

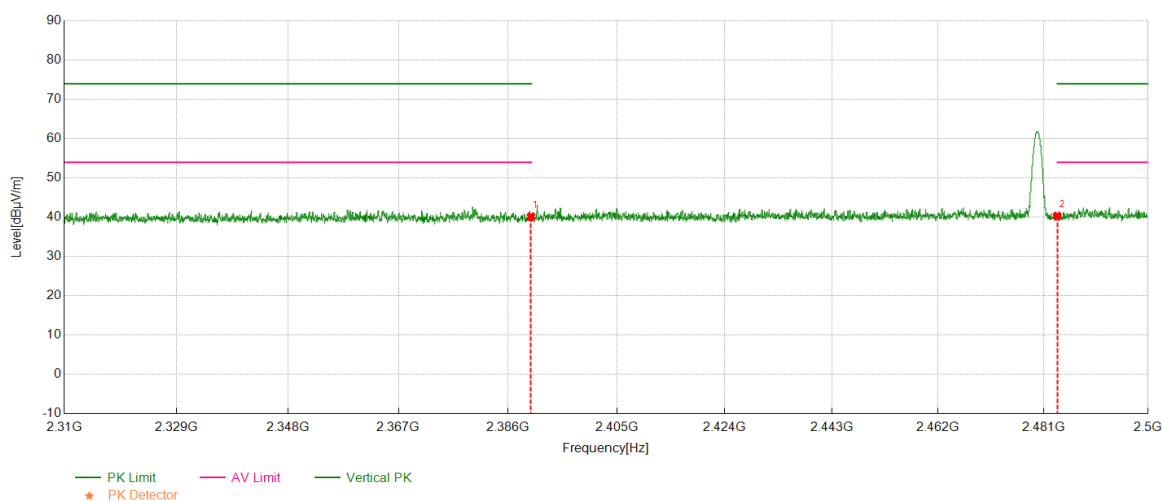
*Test Graph*

| Start of Test: | 2026-02-12 17:33:56 | | |

#### Suspected Data List

| NO. | Frequency [MHz] | Reading [dBμV/m] | Level [dBμV/m] | Factor [dB] | Limit [dBμV/m] | Margin [dB] | Height [cm] | Angle [°] | Det | Polarity | Verdict |
