## Appendix G: Conducted Spurious Emission

### Test Result

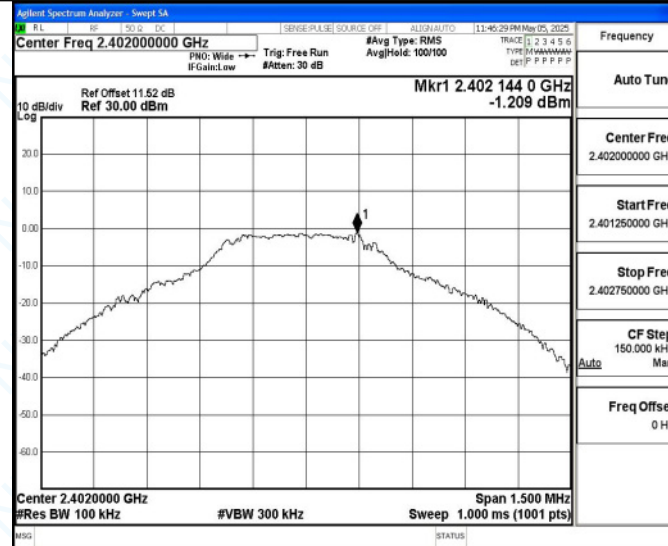
DH5\_Ant1\_2402\_0~Reference

| TestMode | Antenna | Freq(MHz) | FreqRange [MHz] | RefLevel [dBm] | Result [dBm] | Limit [dBm] | Verdict |
|---|---|---|---|---|---|---|---|
| DH5 | Ant1 | 2402 | Reference | -1.21 | -1.21 | --- | PASS |

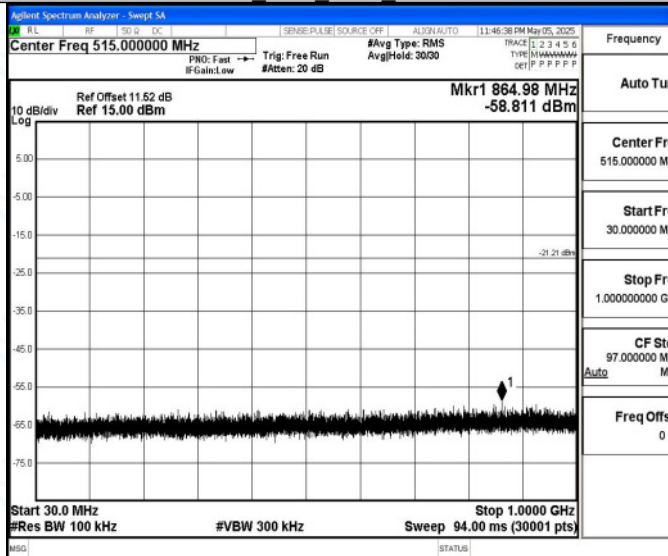
DH5\_Ant1\_2402\_30~1000

| TestMode | Antenna | Freq(MHz) | FreqRange [MHz] | RefLevel [dBm] | Result [dBm] | Limit [dBm] | Verdict |
|---|---|---|---|---|---|---|---|
| | | | 30~1000 | -1.21 | -58.81 | $\leq -21.21$ | PASS |

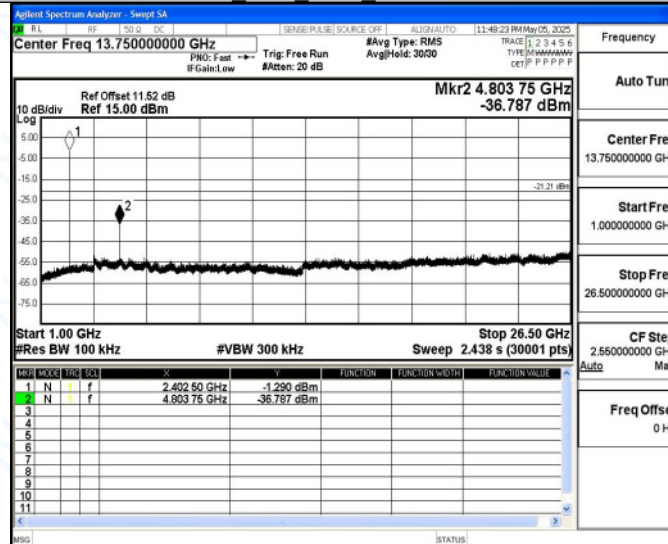
DH5\_Ant1\_2402\_1000~26500

| TestMode | Antenna | Freq(MHz) | FreqRange [MHz] | RefLevel [dBm] | Result [dBm] | Limit [dBm] | Verdict |
|---|---|---|---|---|---|---|---|
| | | | 1000~26500 | -1.21 | -36.79 | $\leq -21.21$ | PASS |

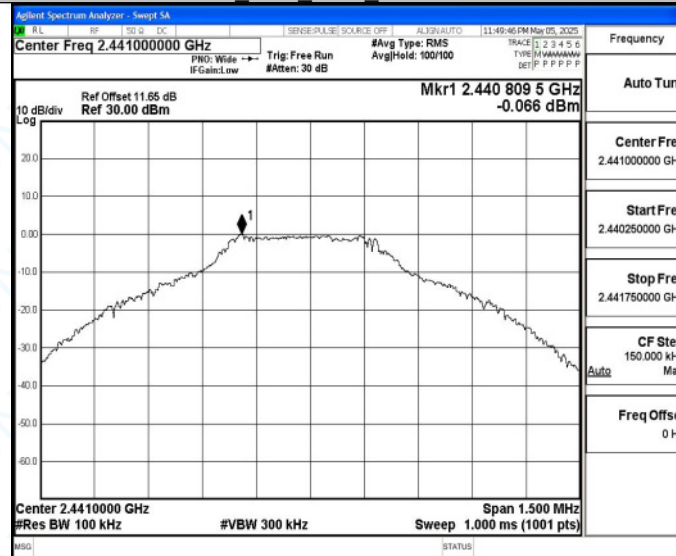
## DH5\_Ant1\_2441\_0~Reference

| TestMode | Antenna | Freq(MHz) | FreqRange [MHz] | RefLevel [dBm] | Result [dBm] | Limit [dBm] | Verdict |
|---|---|---|---|---|---|---|---|
| | | 2441 | Reference | -0.07 | -0.07 | --- | PASS |

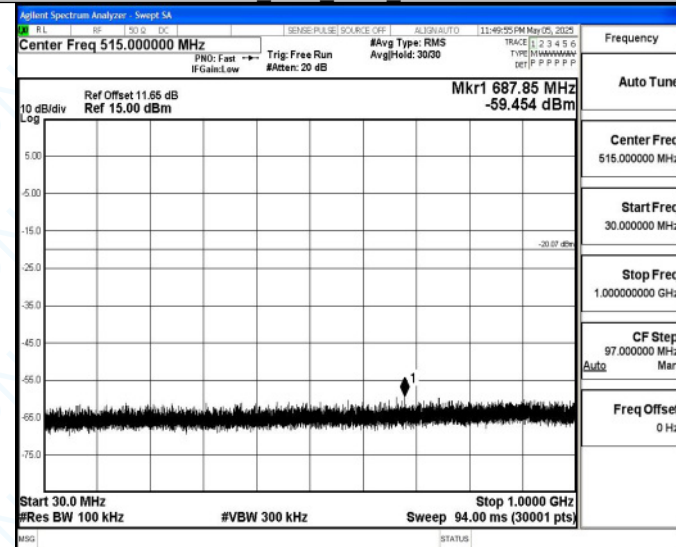
## DH5\_Ant1\_2441\_30~1000

| TestMode | Antenna | Freq(MHz) | FreqRange [MHz] | RefLevel [dBm] | Result [dBm] | Limit [dBm] | Verdict |
|---|---|---|---|---|---|---|---|
| | | | 30~1000 | -0.07 | -59.45 | $\leq -20.07$ | PASS |

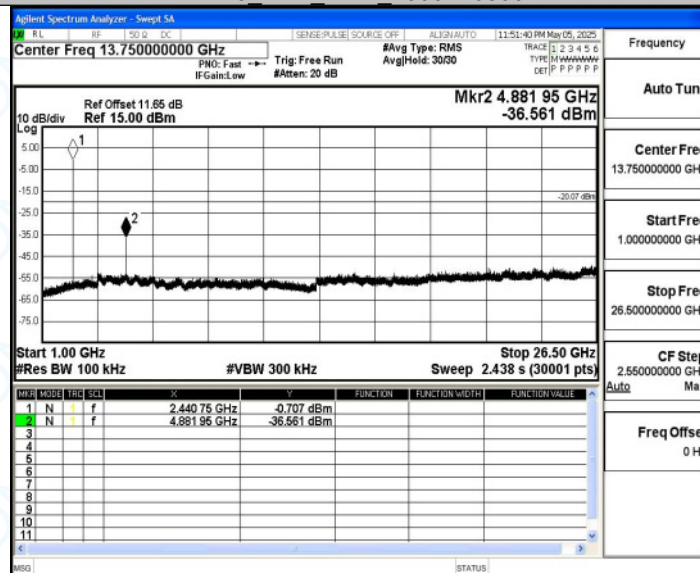
## DH5\_Ant1\_2441\_1000~26500

| TestMode | Antenna | Freq(MHz) | FreqRange [MHz] | RefLevel [dBm] | Result [dBm] | Limit [dBm] | Verdict |
|---|---|---|---|---|---|---|---|
| | | | 1000~26500 | -0.07 | -36.56 | $\leq -20.07$ | PASS |

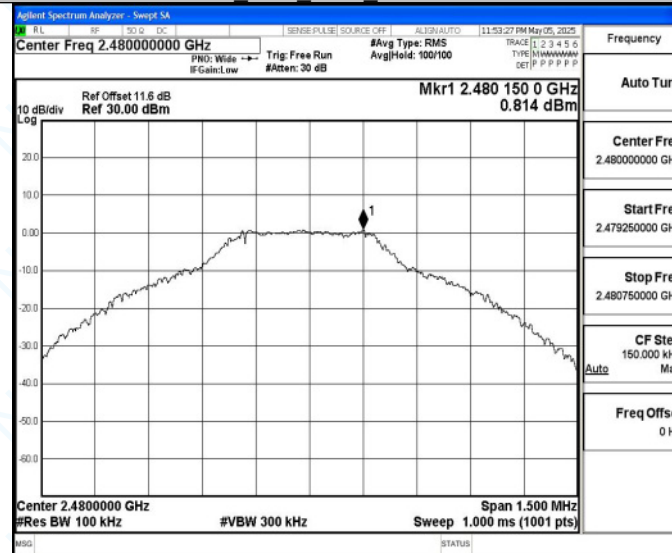
## DH5\_Ant1\_2480\_0~Reference

| TestMode | Antenna | Freq(MHz) | FreqRange [MHz] | RefLevel [dBm] | Result [dBm] | Limit [dBm] | Verdict |
|---|---|---|---|---|---|---|---|
| | | 2480 | Reference | 0.81 | 0.81 | --- | PASS |

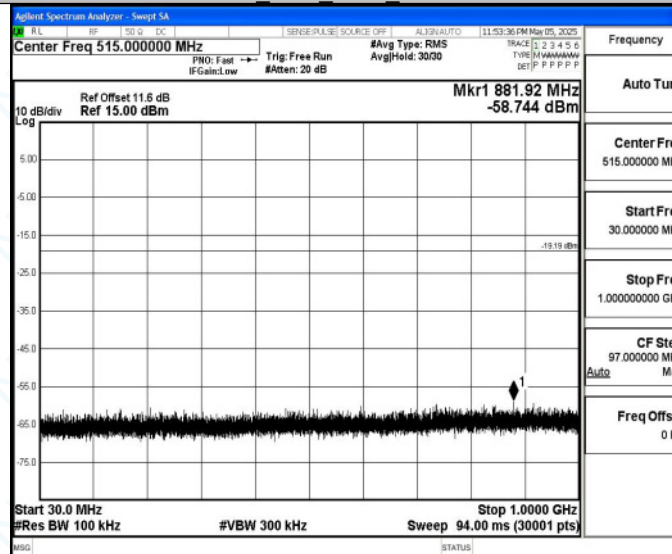
## DH5\_Ant1\_2480\_30~1000

| TestMode | Antenna | Freq(MHz) | FreqRange [MHz] | RefLevel [dBm] | Result [dBm] | Limit [dBm] | Verdict |
|---|---|---|---|---|---|---|---|
| | | | 30~1000 | 0.81 | -58.74 | $\leq -19.19$ | PASS |

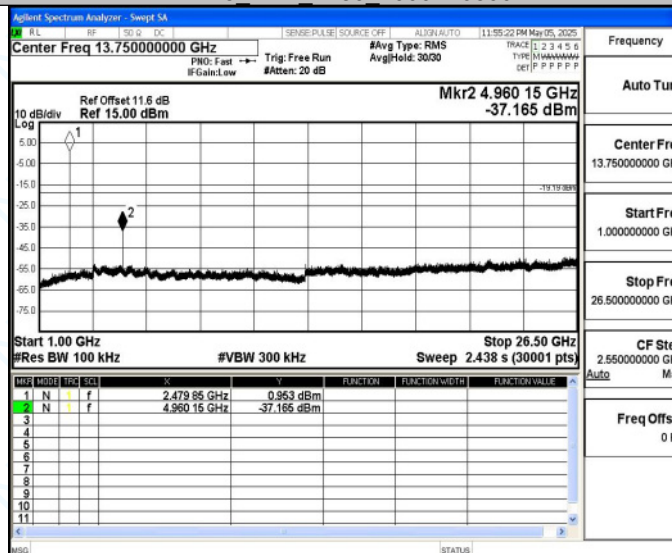
## DH5\_Ant1\_2480\_1000~26500

| TestMode | Antenna | Freq(MHz) | FreqRange [MHz] | RefLevel [dBm] | Result [dBm] | Limit [dBm] | Verdict |
|---|---|---|---|---|---|---|---|
| | | | 1000~26500 | 0.81 | -37.17 | $\leq -19.19$ | PASS |

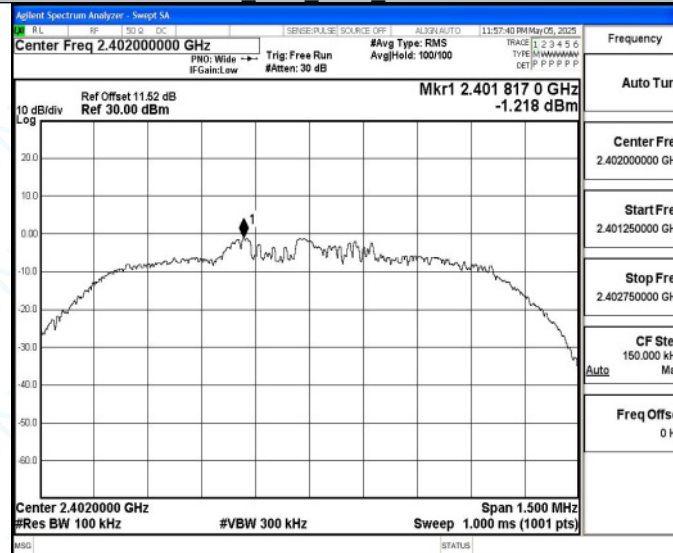
## 2DH5\_Ant1\_2402\_0~Reference

| TestMode | Antenna | Freq(MHz) | FreqRange [MHz] | RefLevel [dBm] | Result [dBm] | Limit [dBm] | Verdict |
|---|---|---|---|---|---|---|---|
| 2DH5 | Ant1 | 2402 | Reference | -1.22 | -1.22 | --- | PASS |

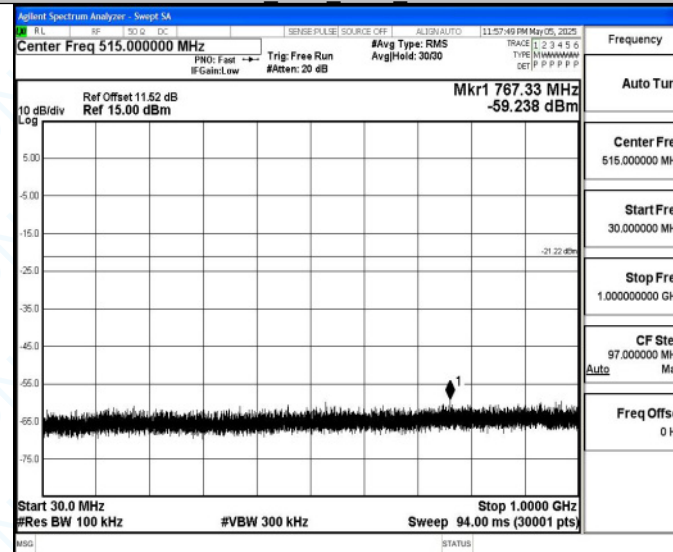
## 2DH5\_Ant1\_2402\_30~1000

| TestMode | Antenna | Freq(MHz) | FreqRange [MHz] | RefLevel [dBm] | Result [dBm] | Limit [dBm] | Verdict |
|---|---|---|---|---|---|---|---|
| | | | 30~1000 | -1.22 | -59.24 | $\leq -21.22$ | PASS |

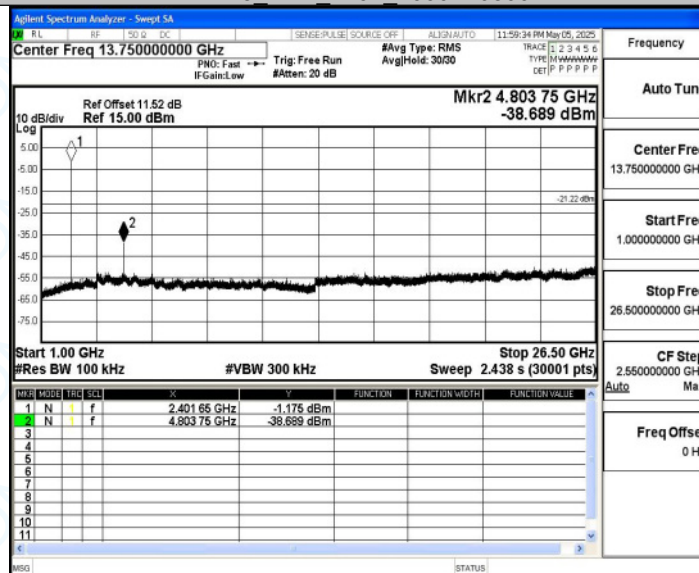
## 2DH5\_Ant1\_2402\_1000~26500

| TestMode | Antenna | Freq(MHz) | FreqRange [MHz] | RefLevel [dBm] | Result [dBm] | Limit [dBm] | Verdict |
|---|---|---|---|---|---|---|---|
| | | | 1000~26500 | -1.22 | -38.69 | $\leq -21.22$ | PASS |

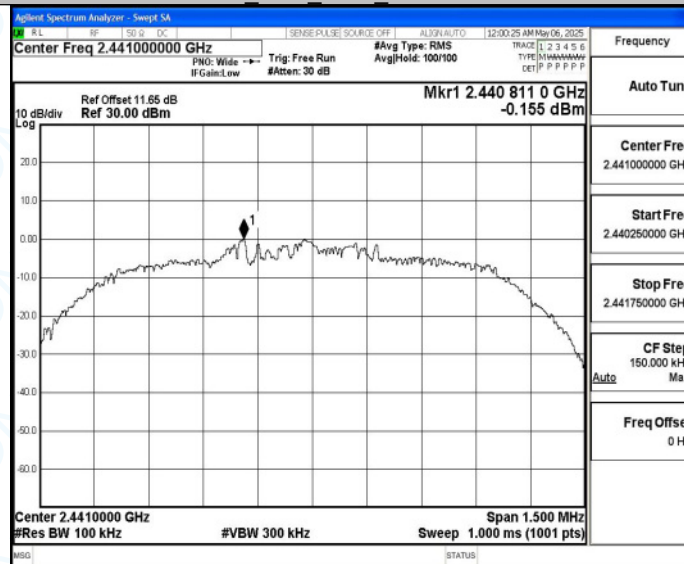
## 2DH5 Ant1 2441 0~Reference

| TestMode | Antenna | Freq(MHz) | FreqRange [MHz] | RefLevel [dBm] | Result [dBm] | Limit [dBm] | Verdict |
|---|---|---|---|---|---|---|---|
| | | 2441 | Reference | -0.16 | -0.16 | --- | PASS |

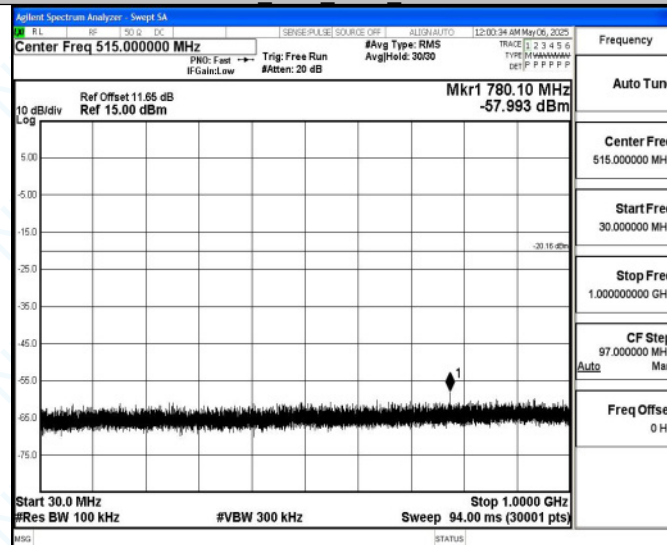
## 2DH5 Ant1 2441 30~1000

| TestMode | Antenna | Freq(MHz) | FreqRange [MHz] | RefLevel [dBm] | Result [dBm] | Limit [dBm] | Verdict |
|---|---|---|---|---|---|---|---|
| | | | 30~1000 | -0.16 | -57.99 | $\leq -20.16$ | PASS |

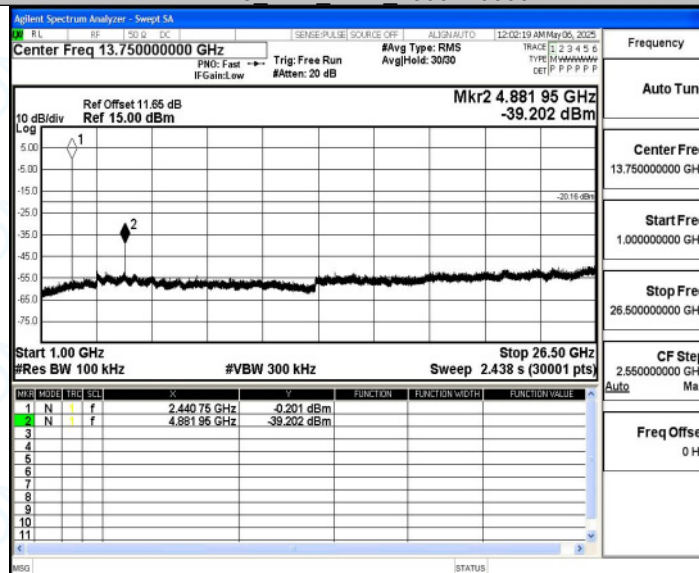
## 2DH5 Ant1 2441 1000~26500

| TestMode | Antenna | Freq(MHz) | FreqRange [MHz] | RefLevel [dBm] | Result [dBm] | Limit [dBm] | Verdict |
|---|---|---|---|---|---|---|---|
| | | | 1000~26500 | -0.16 | -39.2 | $\leq -20.16$ | PASS |

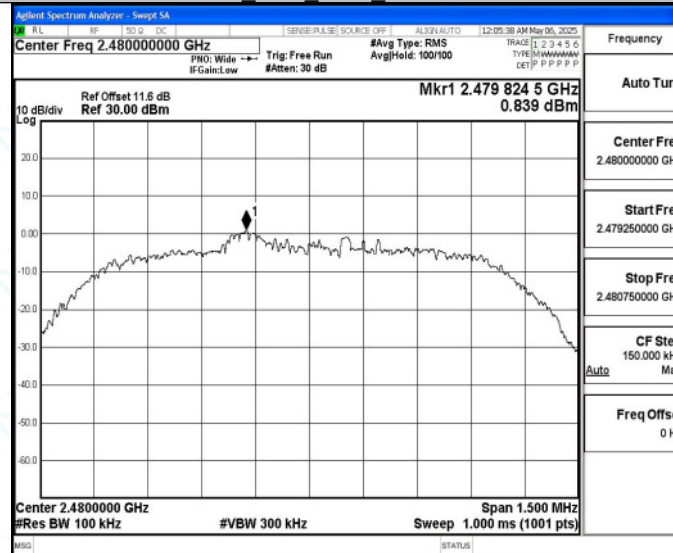
## 2DH5 Ant1 2480 0~Reference

| TestMode | Antenna | Freq(MHz) | FreqRange [MHz] | RefLevel [dBm] | Result [dBm] | Limit [dBm] | Verdict |
|---|---|---|---|---|---|---|---|
| | | 2480 | Reference | 0.84 | 0.84 | --- | PASS |

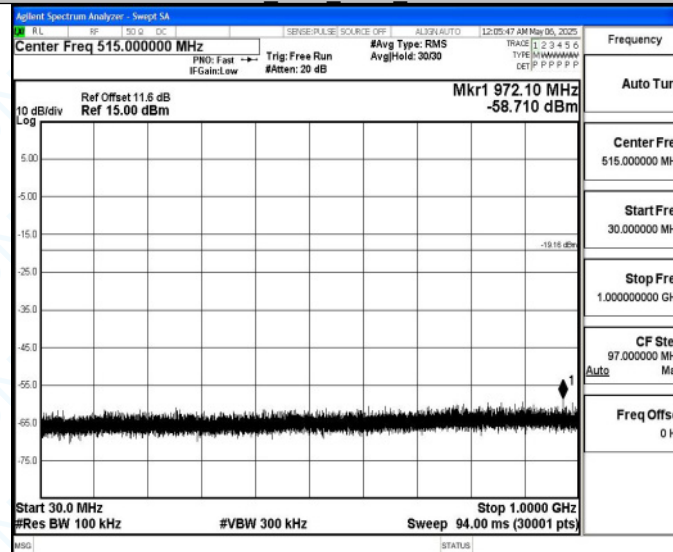
## 2DH5 Ant1 2480 30~1000

| TestMode | Antenna | Freq(MHz) | FreqRange [MHz] | RefLevel [dBm] | Result [dBm] | Limit [dBm] | Verdict |
|---|---|---|---|---|---|---|---|
| | | | 30~1000 | 0.84 | -58.71 | $\leq -19.16$ | PASS |

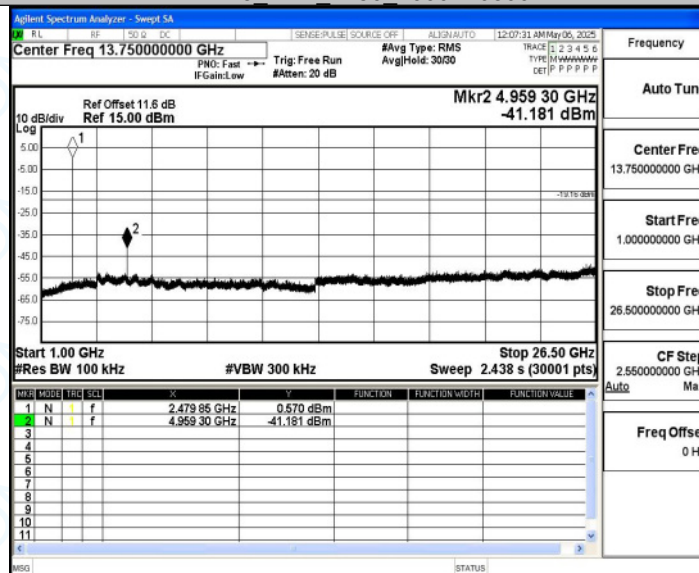
## 2DH5 Ant1 2480 1000~26500

| TestMode | Antenna | Freq(MHz) | FreqRange [MHz] | RefLevel [dBm] | Result [dBm] | Limit [dBm] | Verdict |
|---|---|---|---|---|---|---|---|
| | | | 1000~26500 | 0.84 | -41.18 | $\leq -19.16$ | PASS |

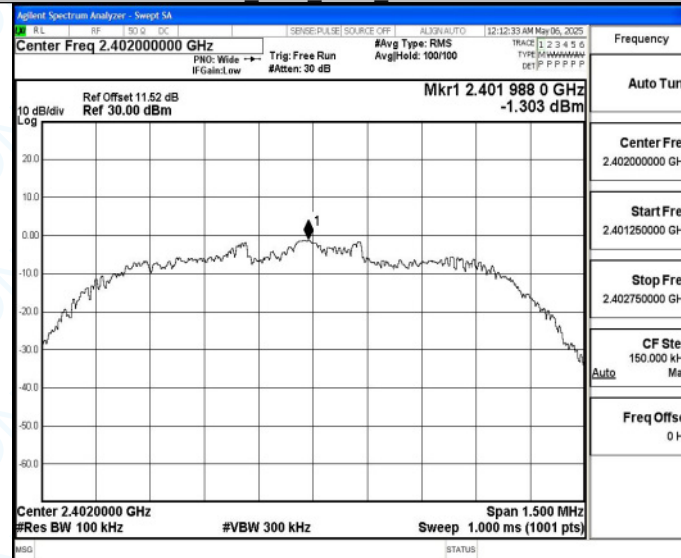
## 3DH5 Ant1 2402 0~Reference

| TestMode | Antenna | Freq(MHz) | FreqRange [MHz] | RefLevel [dBm] | Result [dBm] | Limit [dBm] | Verdict |
|---|---|---|---|---|---|---|---|
| 3DH5 | Ant1 | 2402 | Reference | -1.30 | -1.30 | --- | PASS |

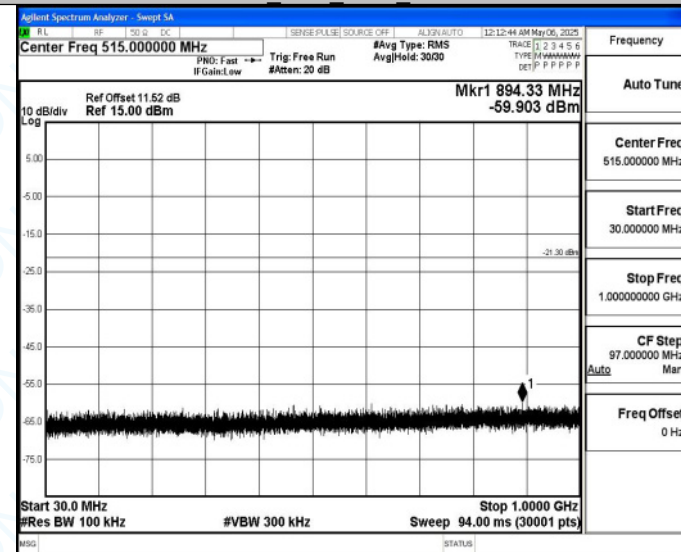
## 3DH5 Ant1 2402 30~1000

| TestMode | Antenna | Freq(MHz) | FreqRange [MHz] | RefLevel [dBm] | Result [dBm] | Limit [dBm] | Verdict |
|---|---|---|---|---|---|---|---|
| | | | 30~1000 | -1.30 | -59.9 | $\leq -21.3$ | PASS |

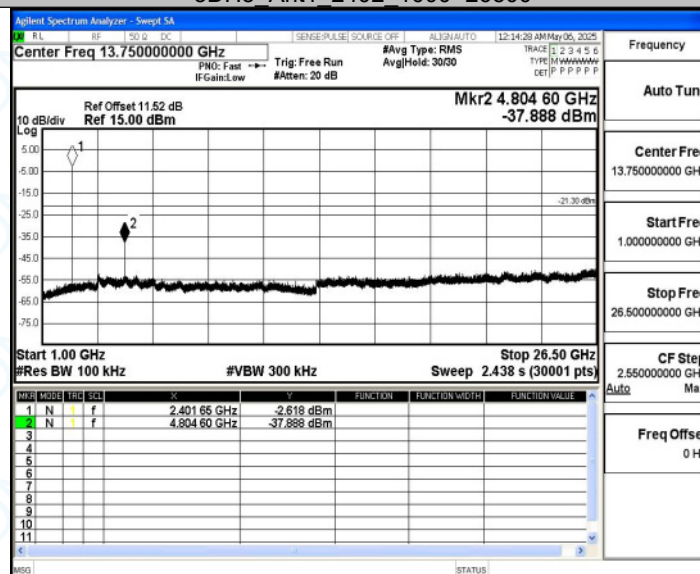
## 3DH5 Ant1 2402 1000~26500

| TestMode | Antenna | Freq(MHz) | FreqRange [MHz] | RefLevel [dBm] | Result [dBm] | Limit [dBm] | Verdict |
|---|---|---|---|---|---|---|---|
| | | | 1000~26500 | -1.30 | -37.89 | $\leq -21.3$ | PASS |

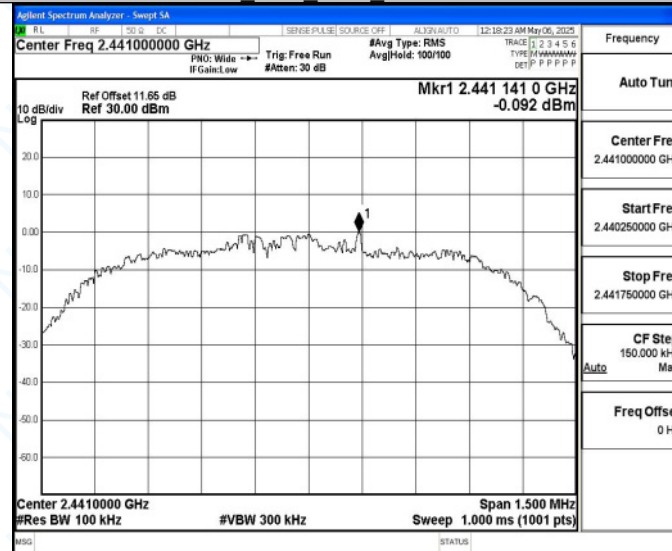
## 3DH5\_Ant1\_2441\_0~Reference

| TestMode | Antenna | Freq(MHz) | FreqRange [MHz] | RefLevel [dBm] | Result [dBm] | Limit [dBm] | Verdict |
|---|---|---|---|---|---|---|---|
| | | 2441 | Reference | -0.09 | -0.09 | --- | PASS |

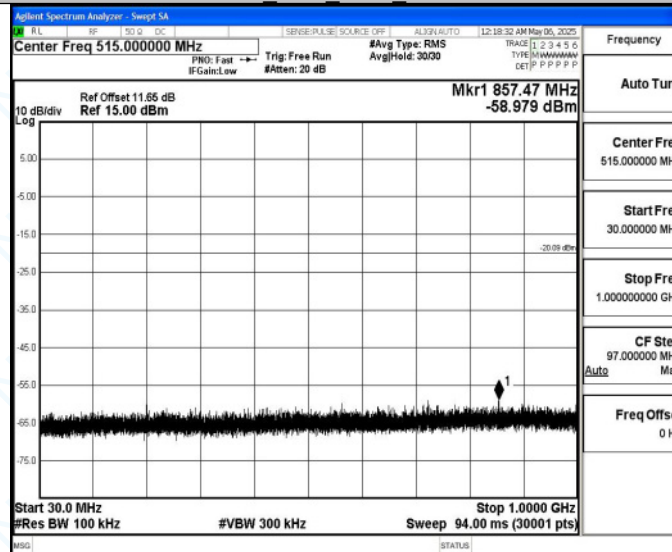
## 3DH5\_Ant1\_2441\_30~1000

| TestMode | Antenna | Freq(MHz) | FreqRange [MHz] | RefLevel [dBm] | Result [dBm] | Limit [dBm] | Verdict |
|---|---|---|---|---|---|---|---|
| | | | 30~1000 | -0.09 | -58.98 | $\leq -20.09$ | PASS |

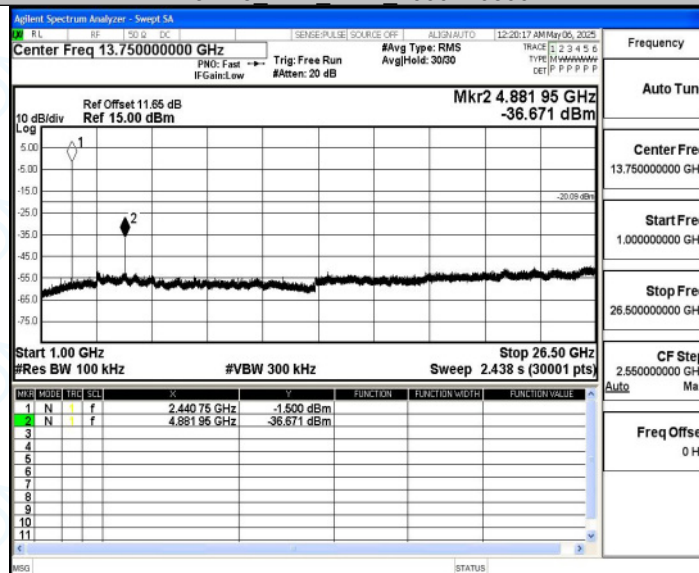
## 3DH5\_Ant1\_2441\_1000~26500

| TestMode | Antenna | Freq(MHz) | FreqRange [MHz] | RefLevel [dBm] | Result [dBm] | Limit [dBm] | Verdict |
|---|---|---|---|---|---|---|---|
| | | | 1000~26500 | -0.09 | -36.67 | $\leq -20.09$ | PASS |

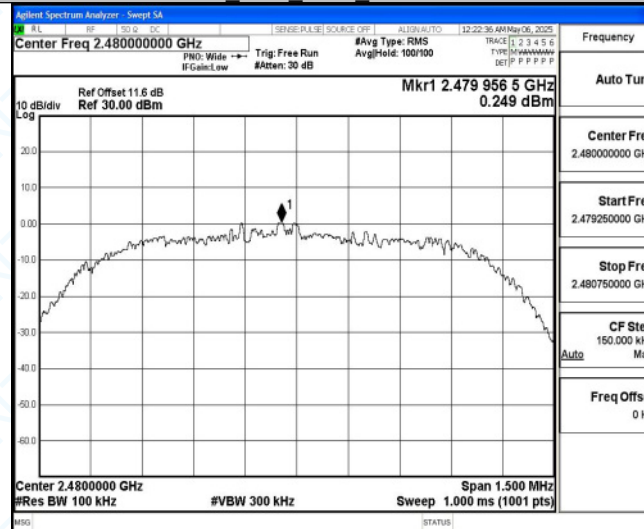
## 3DH5 Ant1 2480 0~Reference

| TestMode | Antenna | Freq(MHz) | FreqRange [MHz] | RefLevel [dBm] | Result [dBm] | Limit [dBm] | Verdict |
|---|---|---|---|---|---|---|---|
| | | 2480 | Reference | 0.25 | 0.25 | --- | PASS |

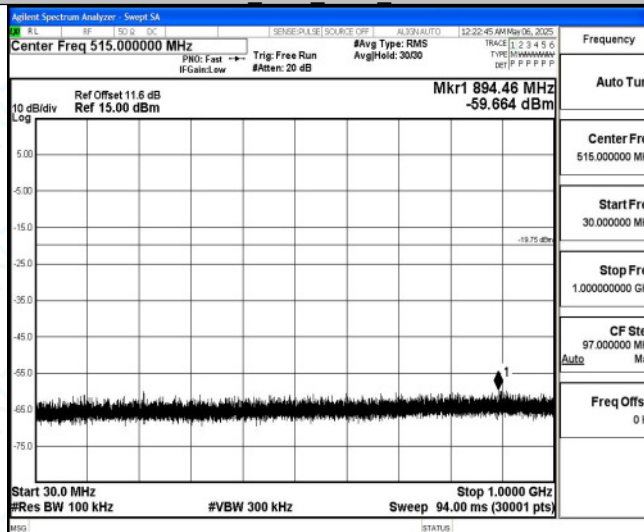
## 3DH5 Ant1 2480 30~1000

| TestMode | Antenna | Freq(MHz) | FreqRange [MHz] | RefLevel [dBm] | Result [dBm] | Limit [dBm] | Verdict |
|---|---|---|---|---|---|---|---|
| | | | 30~1000 | 0.25 | -59.66 | $\leq -19.75$ | PASS |

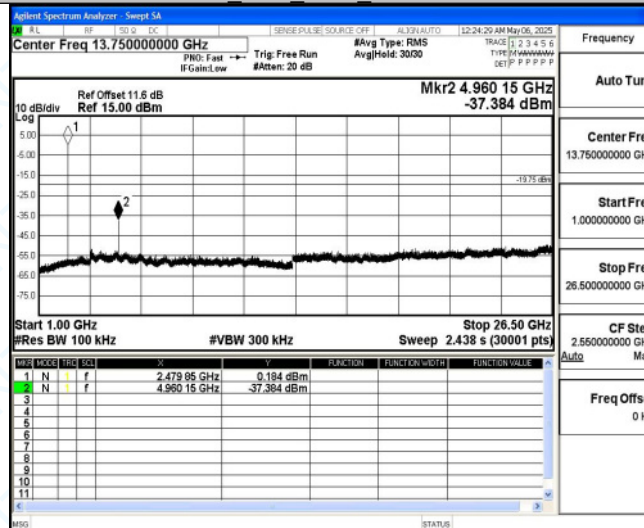
## 3DH5 Ant1 2480 1000~26500

| TestMode | Antenna | Freq(MHz) | FreqRange [MHz] | RefLevel [dBm] | Result [dBm] | Limit [dBm] | Verdict |
|---|---|---|---|---|---|---|---|
| | | | 1000~26500 | 0.25 | -37.38 | $\leq -19.75$ | PASS |
