## Appendix G: Conducted Spurious Emission

### Test Result

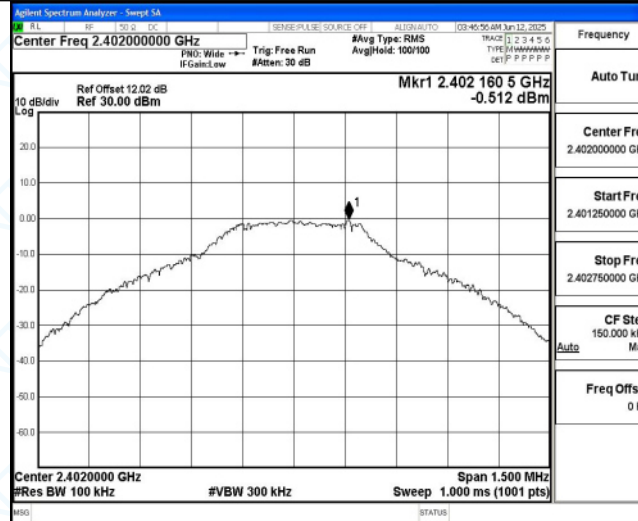
DH5\_Ant1\_2402\_0~Reference

| TestMode | Antenna | Freq(MHz) | FreqRange [MHz] | RefLevel [dBm] | Result [dBm] | Limit [dBm] | Verdict |
|---|---|---|---|---|---|---|---|
| DH5 | Ant1 | 2402 | Reference | -0.51 | -0.51 | --- | PASS |

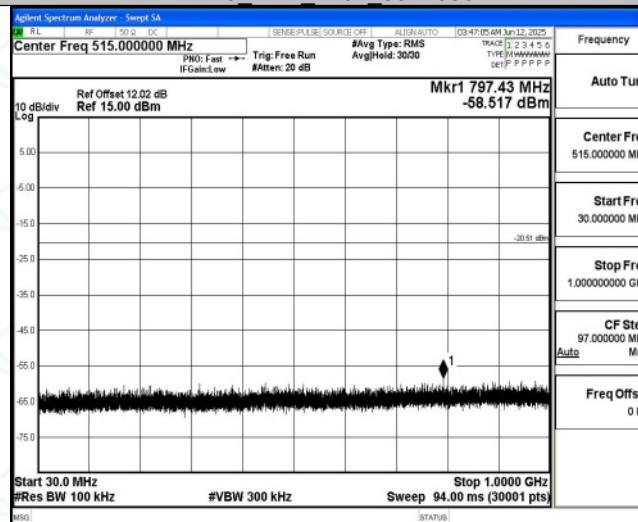
DH5\_Ant1\_2402\_30~1000

| TestMode | Antenna | Freq(MHz) | FreqRange [MHz] | RefLevel [dBm] | Result [dBm] | Limit [dBm] | Verdict |
|---|---|---|---|---|---|---|---|
| | | | 30~1000 | -0.51 | -58.52 | $\leq -20.51$ | PASS |

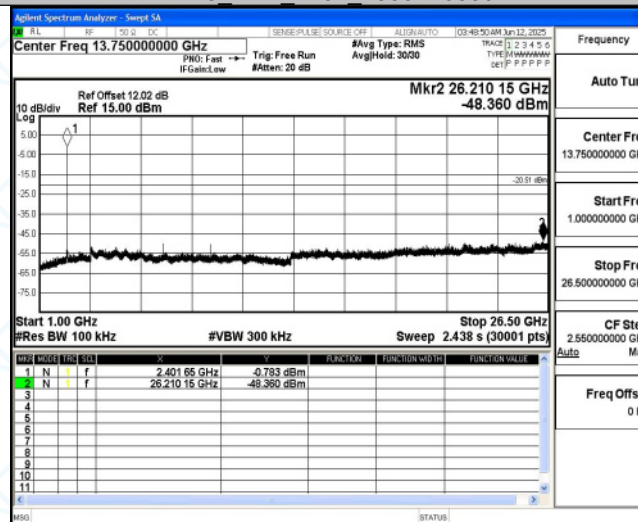
DH5\_Ant1\_2402\_1000~26500

| TestMode | Antenna | Freq(MHz) | FreqRange [MHz] | RefLevel [dBm] | Result [dBm] | Limit [dBm] | Verdict |
|---|---|---|---|---|---|---|---|
| | | | 1000~26500 | -0.51 | -48.36 | $\leq -20.51$ | PASS |

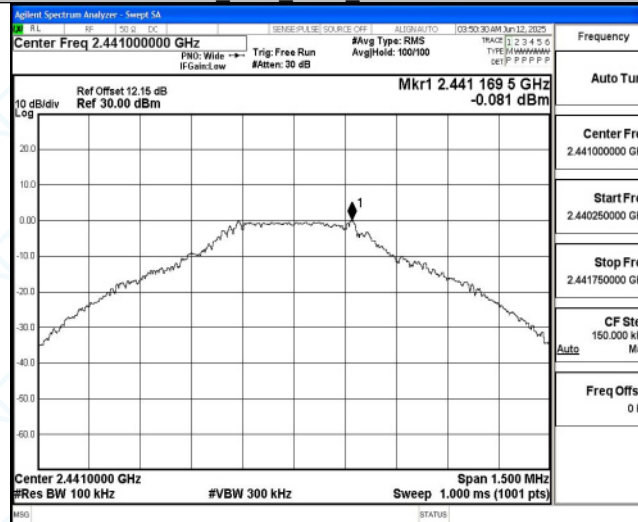
## DH5\_Ant1\_2441\_0~Reference

| TestMode | Antenna | Freq(MHz) | FreqRange [MHz] | RefLevel [dBm] | Result [dBm] | Limit [dBm] | Verdict |
|---|---|---|---|---|---|---|---|
| | | 2441 | Reference | -0.08 | -0.08 | --- | PASS |

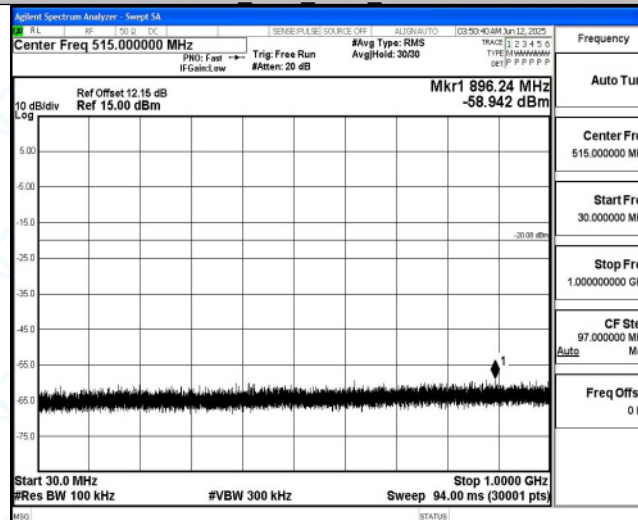
## DH5\_Ant1\_2441\_30~1000

| TestMode | Antenna | Freq(MHz) | FreqRange [MHz] | RefLevel [dBm] | Result [dBm] | Limit [dBm] | Verdict |
|---|---|---|---|---|---|---|---|
| | | | 30~1000 | -0.08 | -58.94 | $\leq -20.08$ | PASS |

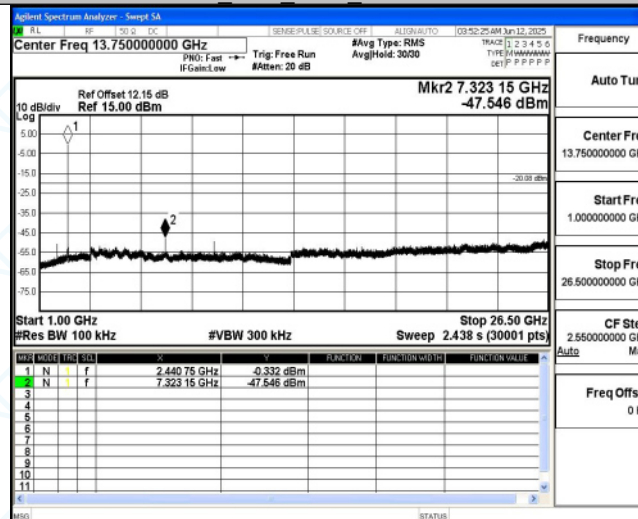
## DH5\_Ant1\_2441\_1000~26500

| TestMode | Antenna | Freq(MHz) | FreqRange [MHz] | RefLevel [dBm] | Result [dBm] | Limit [dBm] | Verdict |
|---|---|---|---|---|---|---|---|
| | | | 1000~26500 | -0.08 | -47.55 | $\leq -20.08$ | PASS |

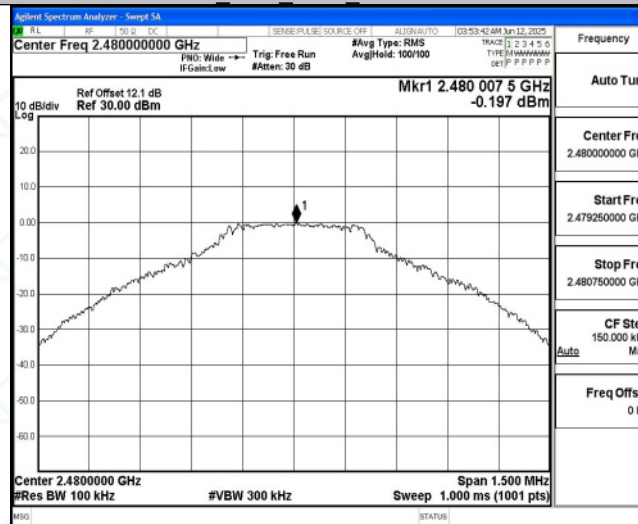
## DH5\_Ant1\_2480\_0~Reference

| TestMode | Antenna | Freq(MHz) | FreqRange [MHz] | RefLevel [dBm] | Result [dBm] | Limit [dBm] | Verdict |
|---|---|---|---|---|---|---|---|
| | | 2480 | Reference | -0.20 | -0.20 | --- | PASS |

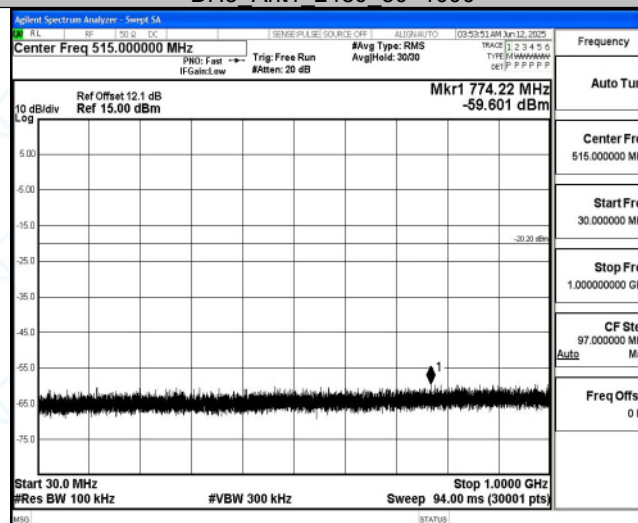
## DH5\_Ant1\_2480\_30~1000

| TestMode | Antenna | Freq(MHz) | FreqRange [MHz] | RefLevel [dBm] | Result [dBm] | Limit [dBm] | Verdict |
|---|---|---|---|---|---|---|---|
| | | | 30~1000 | -0.20 | -59.6 | $\leq -20.2$ | PASS |

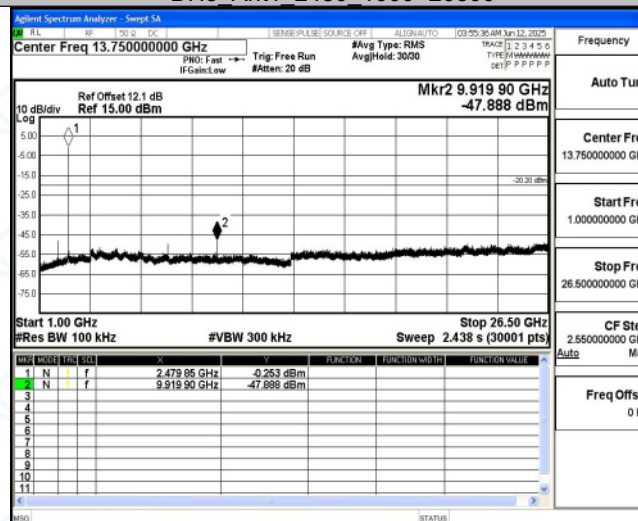
## DH5\_Ant1\_2480\_1000~26500

| TestMode | Antenna | Freq(MHz) | FreqRange [MHz] | RefLevel [dBm] | Result [dBm] | Limit [dBm] | Verdict |
|---|---|---|---|---|---|---|---|
| | | | 1000~26500 | -0.20 | -47.89 | $\leq -20.2$ | PASS |

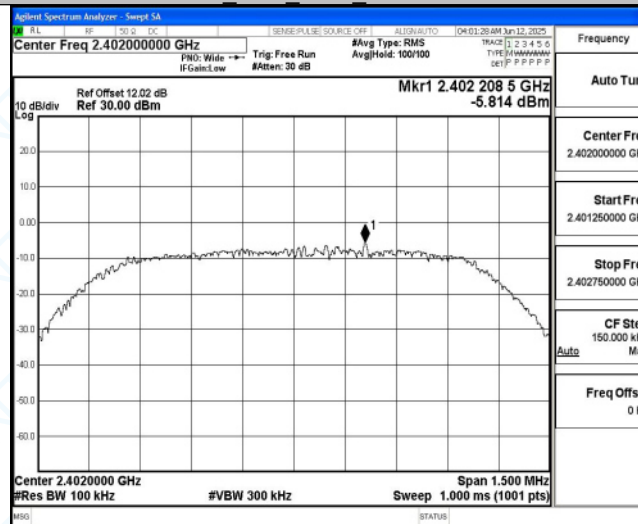
## 2DH5\_Ant1\_2402\_0~Reference

| TestMode | Antenna | Freq(MHz) | FreqRange [MHz] | RefLevel [dBm] | Result [dBm] | Limit [dBm] | Verdict |
|---|---|---|---|---|---|---|---|
| 2DH5 | Ant1 | 2402 | Reference | -5.81 | -5.81 | --- | PASS |

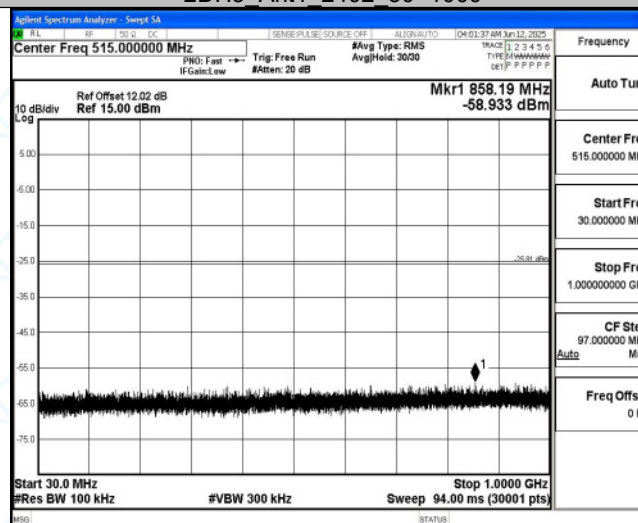
## 2DH5\_Ant1\_2402\_30~1000

| TestMode | Antenna | Freq(MHz) | FreqRange [MHz] | RefLevel [dBm] | Result [dBm] | Limit [dBm] | Verdict |
|---|---|---|---|---|---|---|---|
| | | | 30~1000 | -5.81 | -58.93 | $\leq -25.81$ | PASS |

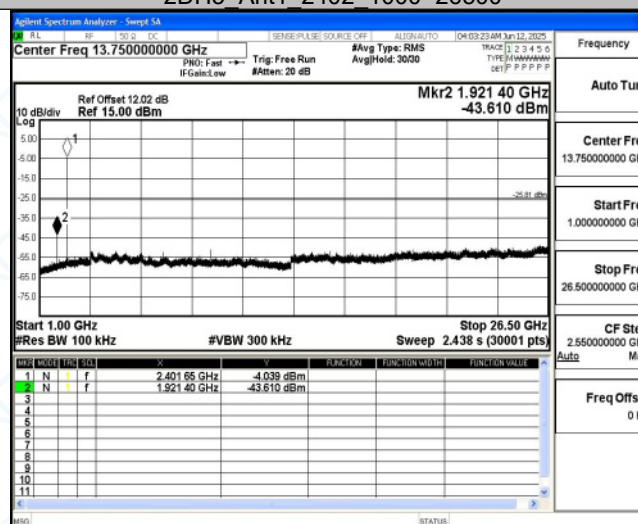
## 2DH5\_Ant1\_2402\_1000~26500

| TestMode | Antenna | Freq(MHz) | FreqRange [MHz] | RefLevel [dBm] | Result [dBm] | Limit [dBm] | Verdict |
|---|---|---|---|---|---|---|---|
| | | | 1000~26500 | -5.81 | -43.61 | $\leq -25.81$ | PASS |

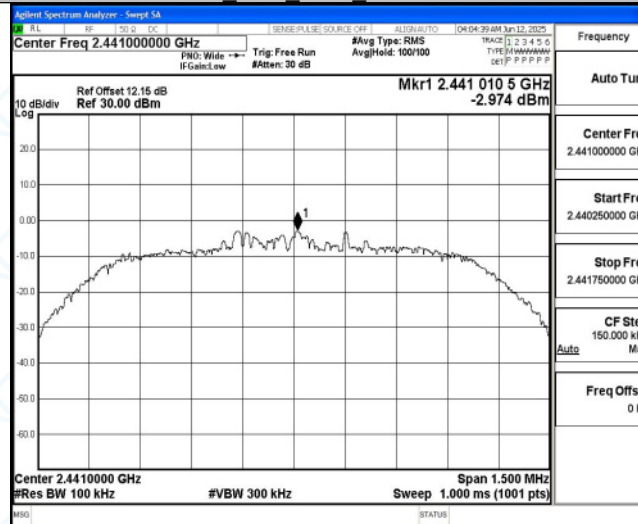
## 2DH5\_Ant1\_2441\_0~Reference

| TestMode | Antenna | Freq(MHz) | FreqRange [MHz] | RefLevel [dBm] | Result [dBm] | Limit [dBm] | Verdict |
|---|---|---|---|---|---|---|---|
| | | 2441 | Reference | -2.97 | -2.97 | --- | PASS |

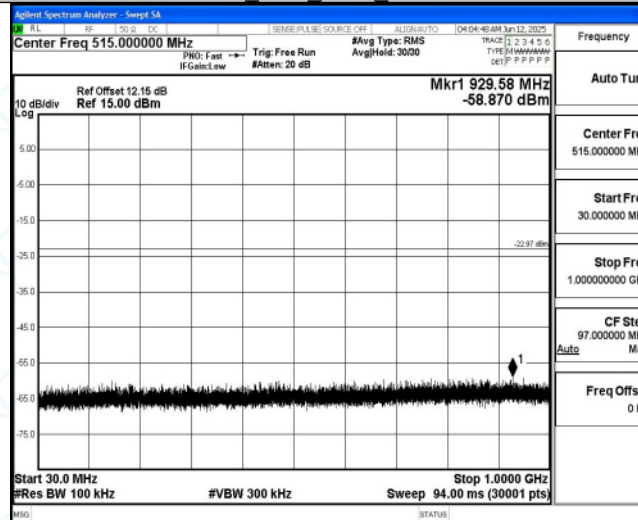
## 2DH5\_Ant1\_2441\_30~1000

| TestMode | Antenna | Freq(MHz) | FreqRange [MHz] | RefLevel [dBm] | Result [dBm] | Limit [dBm] | Verdict |
|---|---|---|---|---|---|---|---|
| | | | 30~1000 | -2.97 | -58.87 | $\leq -22.97$ | PASS |

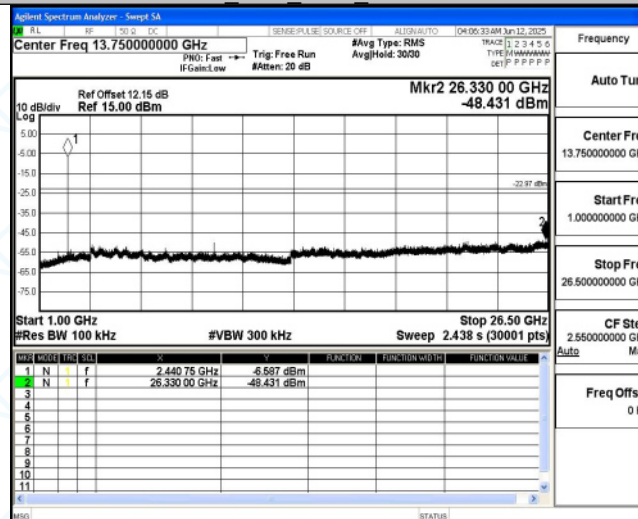
## 2DH5\_Ant1\_2441\_1000~26500

| TestMode | Antenna | Freq(MHz) | FreqRange [MHz] | RefLevel [dBm] | Result [dBm] | Limit [dBm] | Verdict |
|---|---|---|---|---|---|---|---|
| | | | 1000~26500 | -2.97 | -48.43 | $\leq -22.97$ | PASS |

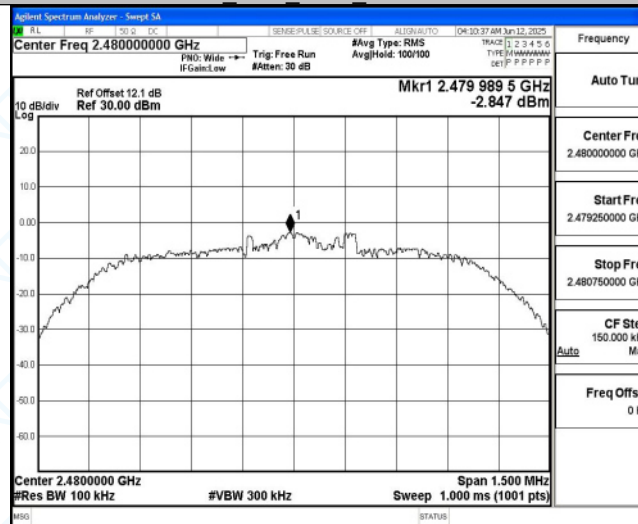
## 2DH5\_Ant1\_2480\_0~Reference

| TestMode | Antenna | Freq(MHz) | FreqRange [MHz] | RefLevel [dBm] | Result [dBm] | Limit [dBm] | Verdict |
|---|---|---|---|---|---|---|---|
| | | 2480 | Reference | -2.85 | -2.85 | --- | PASS |

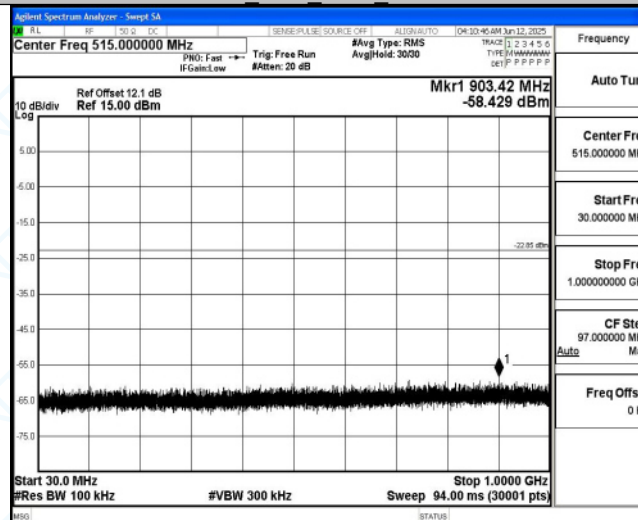
## 2DH5\_Ant1\_2480\_30~1000

| TestMode | Antenna | Freq(MHz) | FreqRange [MHz] | RefLevel [dBm] | Result [dBm] | Limit [dBm] | Verdict |
|---|---|---|---|---|---|---|---|
| | | | 30~1000 | -2.85 | -58.43 | $\leq -22.85$ | PASS |

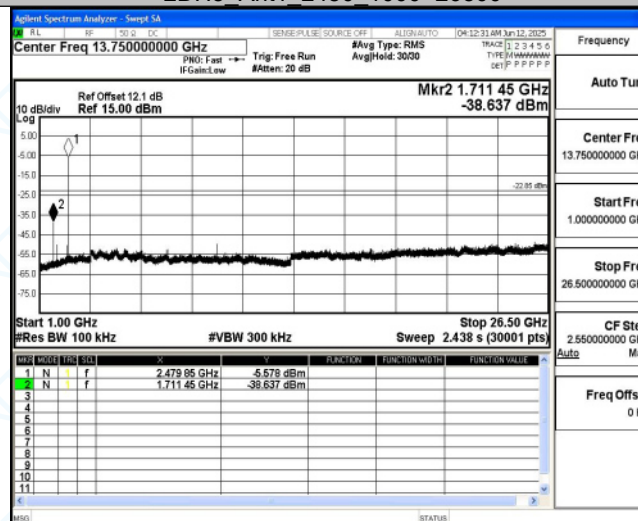
## 2DH5\_Ant1\_2480\_1000~26500

| TestMode | Antenna | Freq(MHz) | FreqRange [MHz] | RefLevel [dBm] | Result [dBm] | Limit [dBm] | Verdict |
|---|---|---|---|---|---|---|---|
| | | | 1000~26500 | -2.85 | -38.64 | $\leq -22.85$ | PASS |
