## 7.6 Conducted RF Spurious Emission

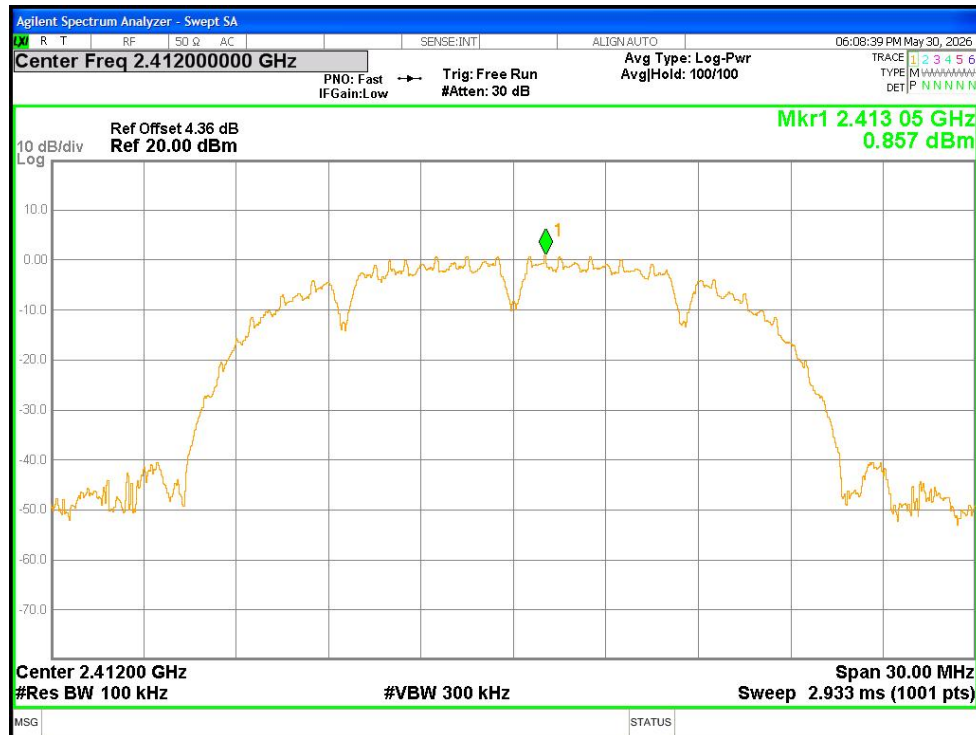
## Tx. Spurious NVNT b 2412MHz Ant1 Ref

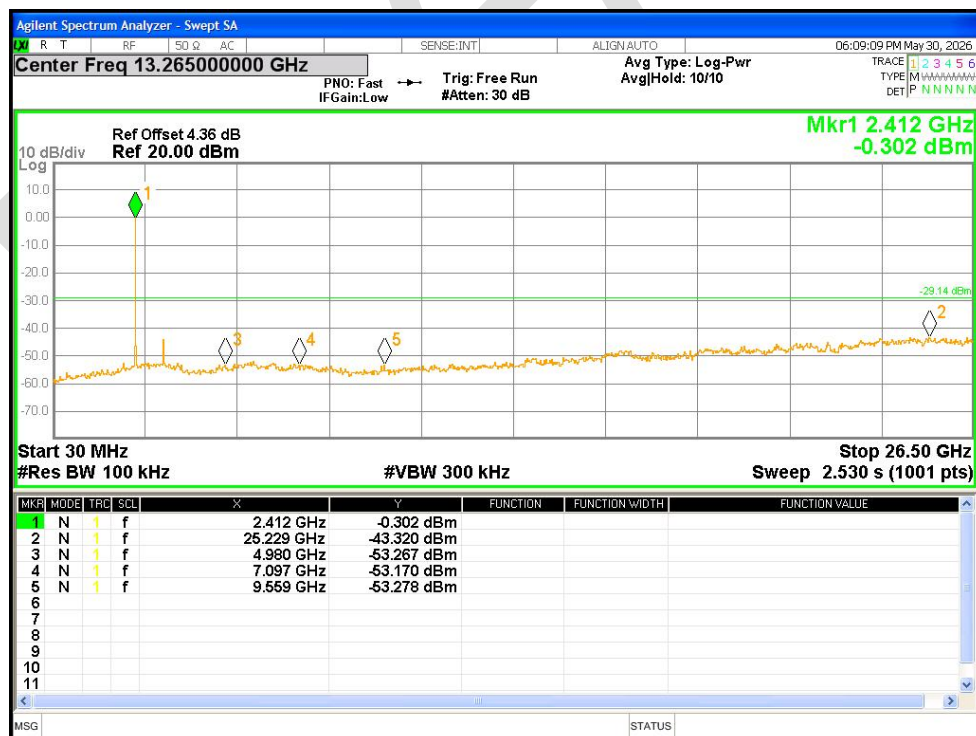
## Tx. Spurious NVNT b 2412MHz Ant1 Emission

| Condition | Mode | Frequency (MHz) | Antenna | Max Value (dBc) | Limit (dBc) | Verdict |
|---|---|---|---|---|---|---|
| NVNT | b | 2412 | Ant1 | -44.17 | -30 | Pass |

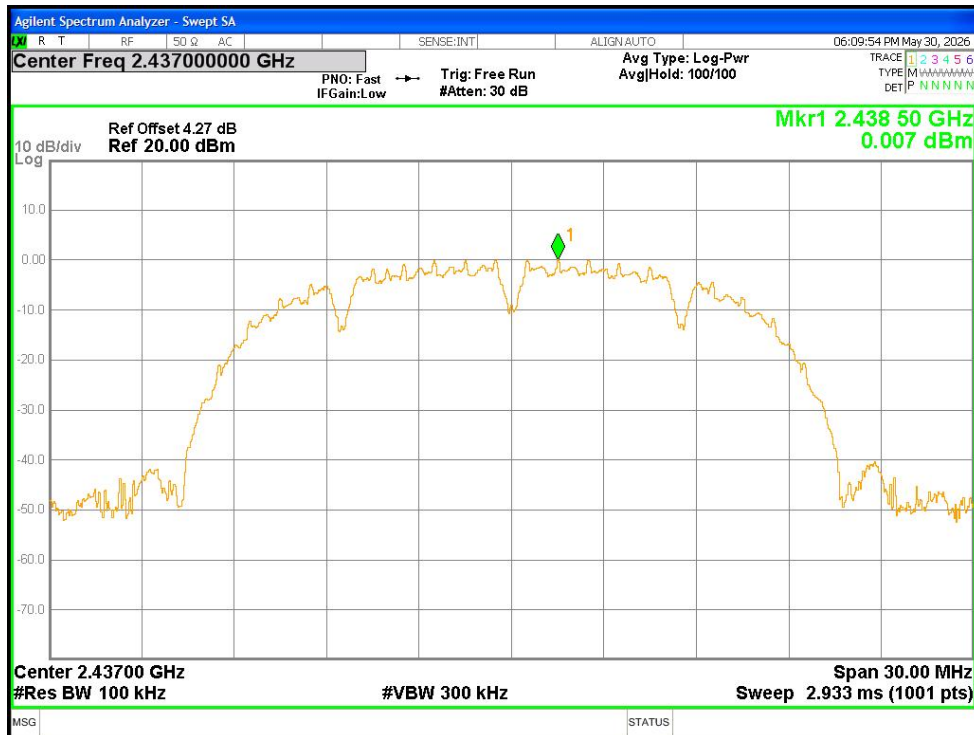
## Tx. Spurious NVNT b 2437MHz Ant1 Ref

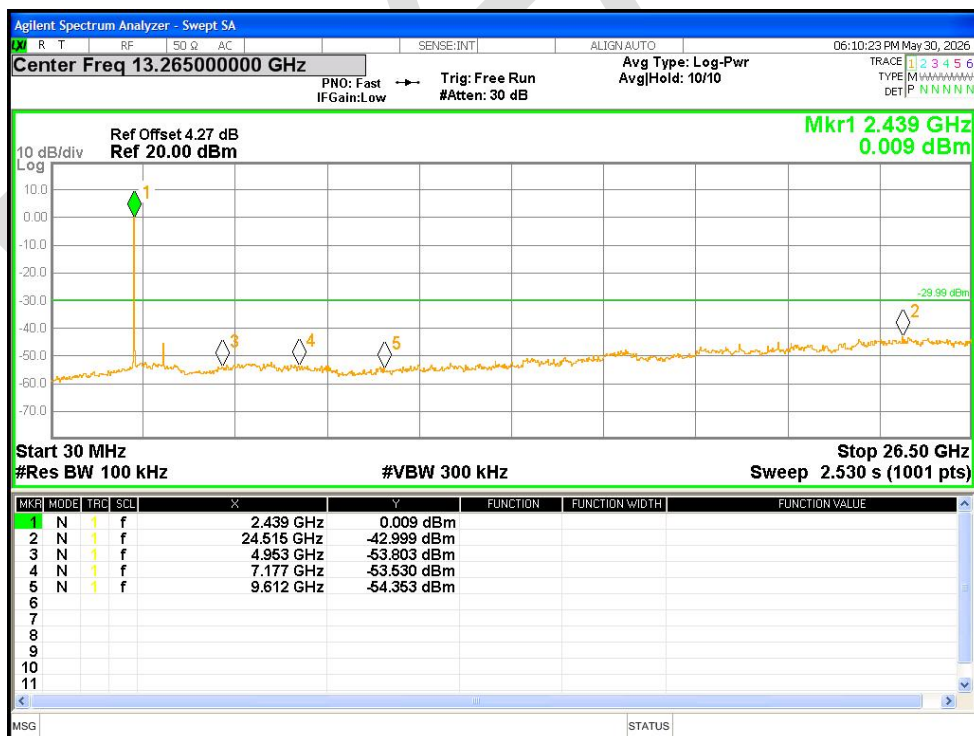
## Tx. Spurious NVNT b 2437MHz Ant1 Emission

| Condition | Mode | Frequency (MHz) | Antenna | Max Value (dBc) | Limit (dBc) | Verdict |
|---|---|---|---|---|---|---|
| NVNT | b | 2437 | Ant1 | -43 | -30 | Pass |

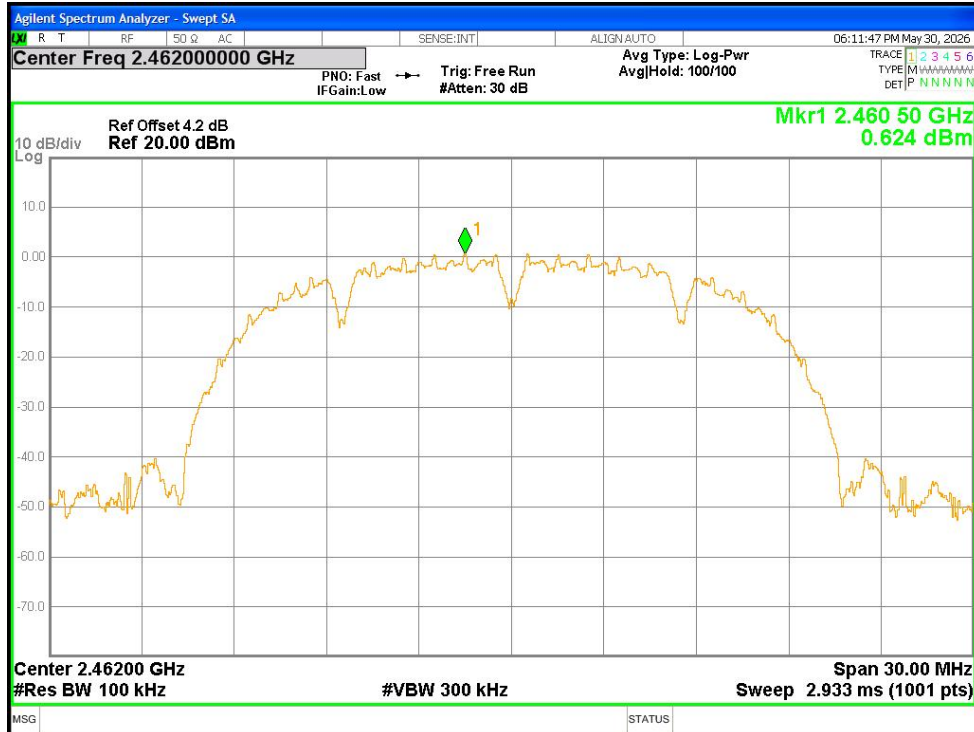
## Tx. Spurious NVNT b 2462MHz Ant1 Ref

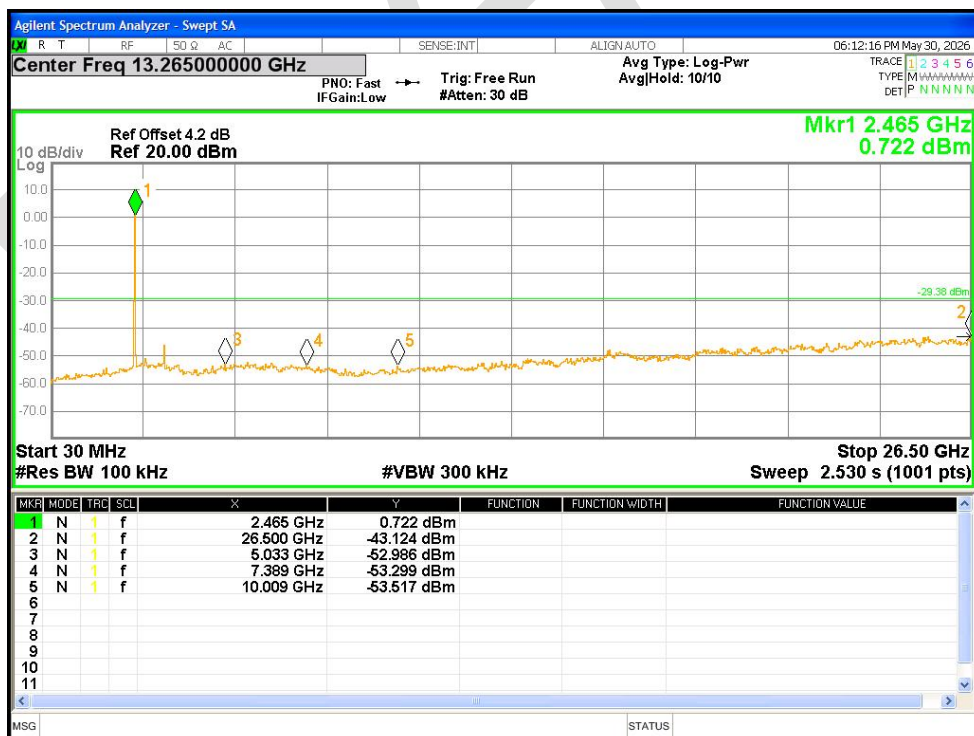
## Tx. Spurious NVNT b 2462MHz Ant1 Emission

| Condition | Mode | Frequency (MHz) | Antenna | Max Value (dBc) | Limit (dBc) | Verdict |
|---|---|---|---|---|---|---|
| NVNT | b | 2462 | Ant1 | -43.74 | -30 | Pass |

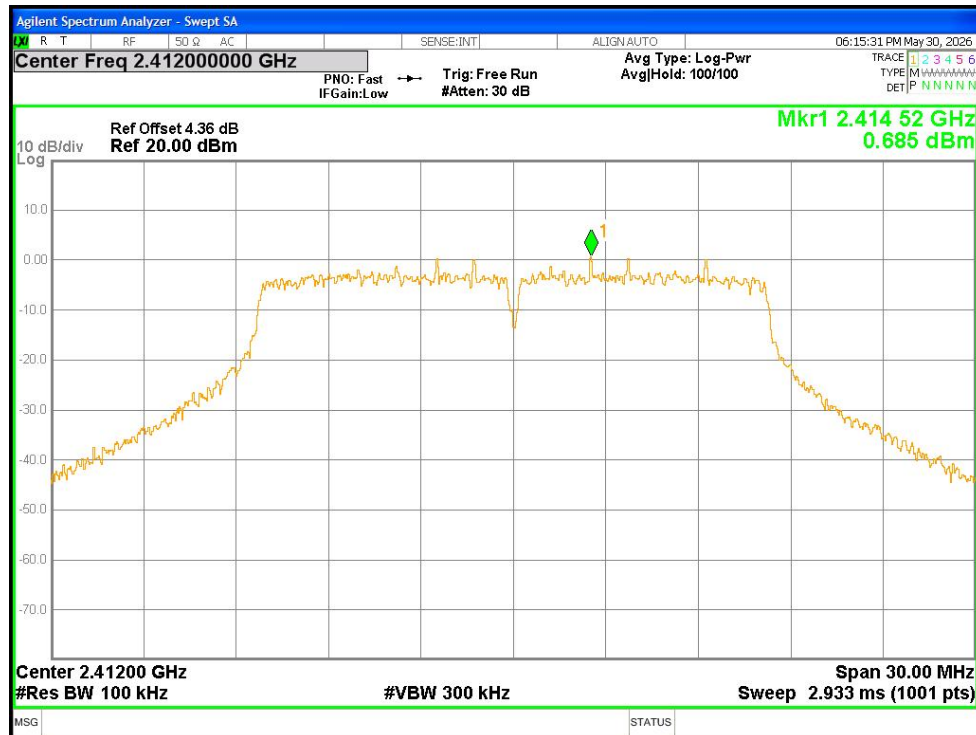
## Tx. Spurious NVNT g 2412MHz Ant1 Ref

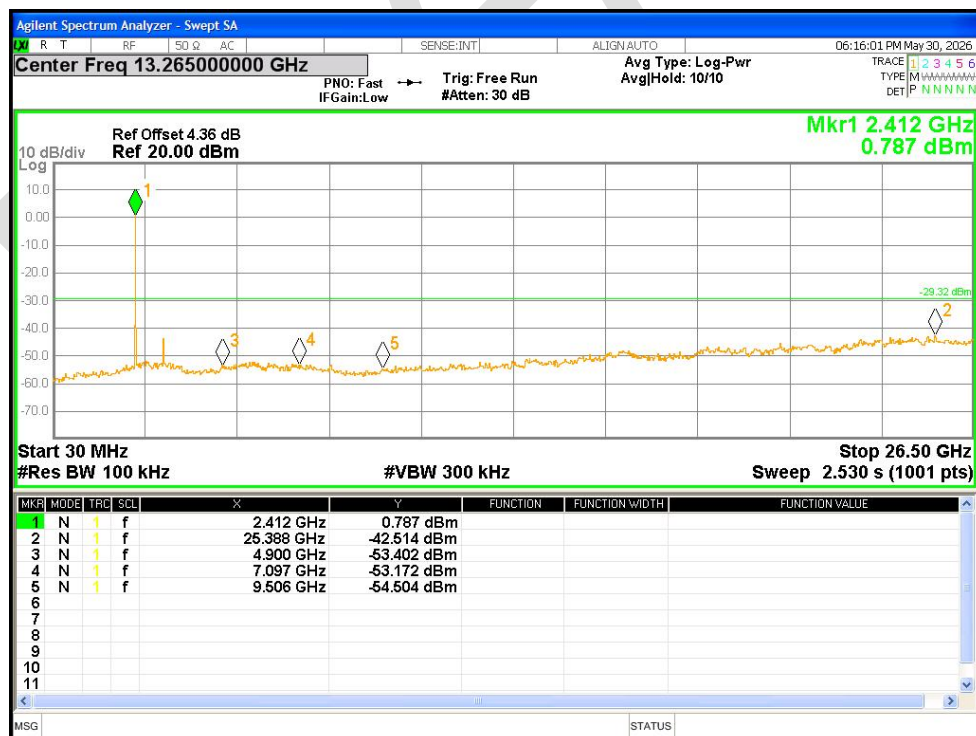
## Tx. Spurious NVNT g 2412MHz Ant1 Emission

| Condition | Mode | Frequency (MHz) | Antenna | Max Value (dBc) | Limit (dBc) | Verdict |
|---|---|---|---|---|---|---|
| NVNT | g | 2412 | Ant1 | -43.2 | -30 | Pass |

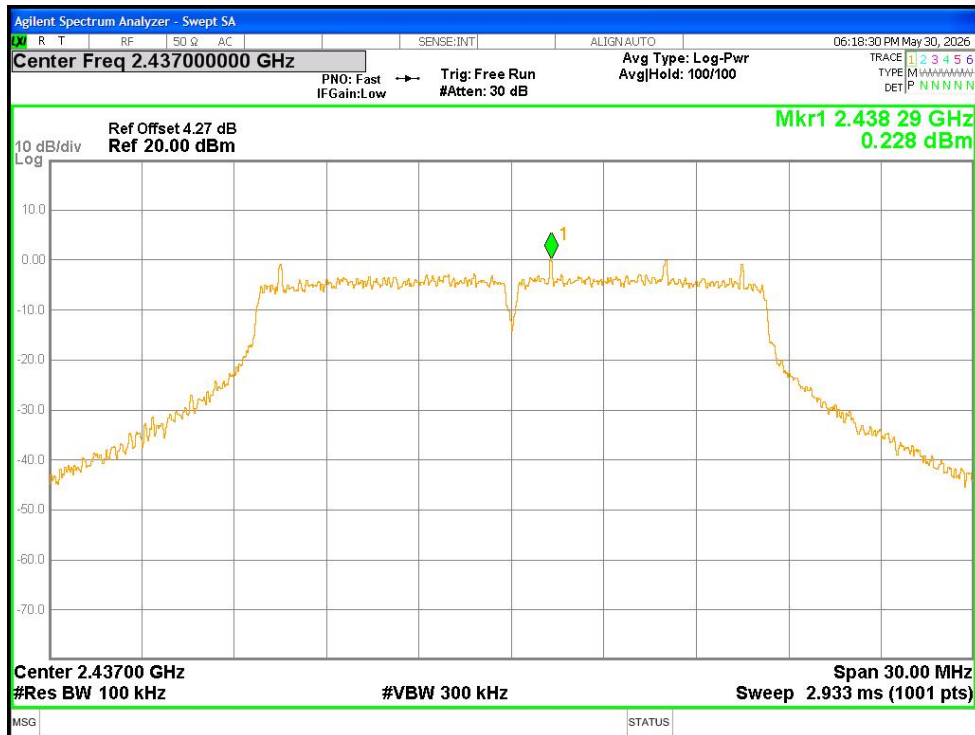
## Tx. Spurious NVNT g 2437MHz Ant1 Ref

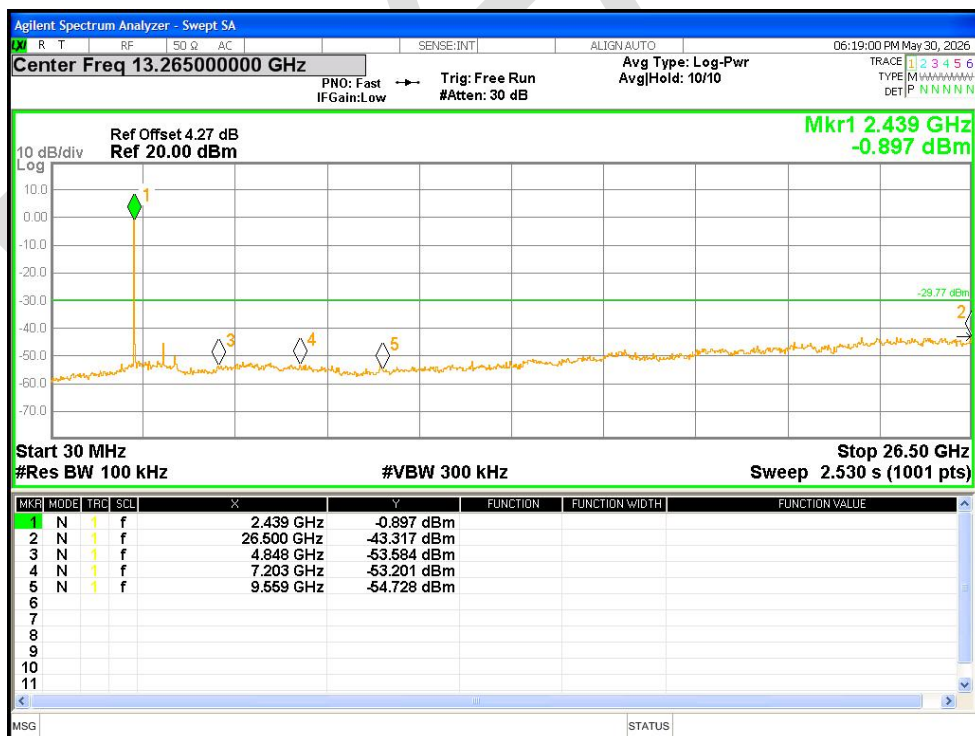
## Tx. Spurious NVNT g 2437MHz Ant1 Emission

| Condition | Mode | Frequency (MHz) | Antenna | Max Value (dBc) | Limit (dBc) | Verdict |
|---|---|---|---|---|---|---|
| NVNT | g | 2437 | Ant1 | -43.54 | -30 | Pass |

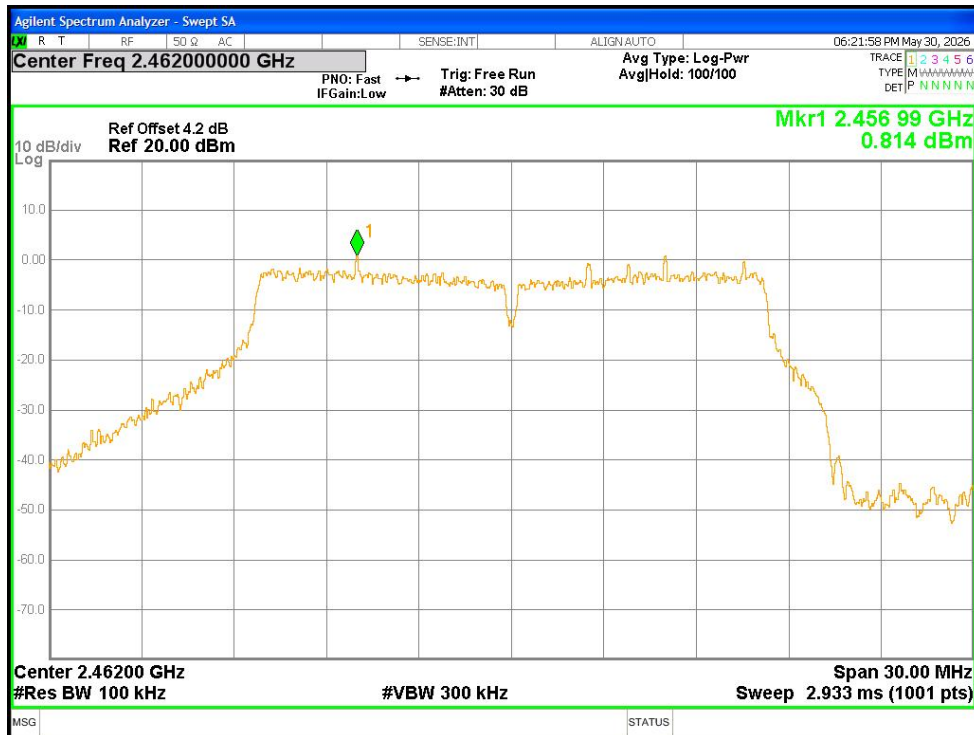
## Tx. Spurious NVNT g 2462MHz Ant1 Ref

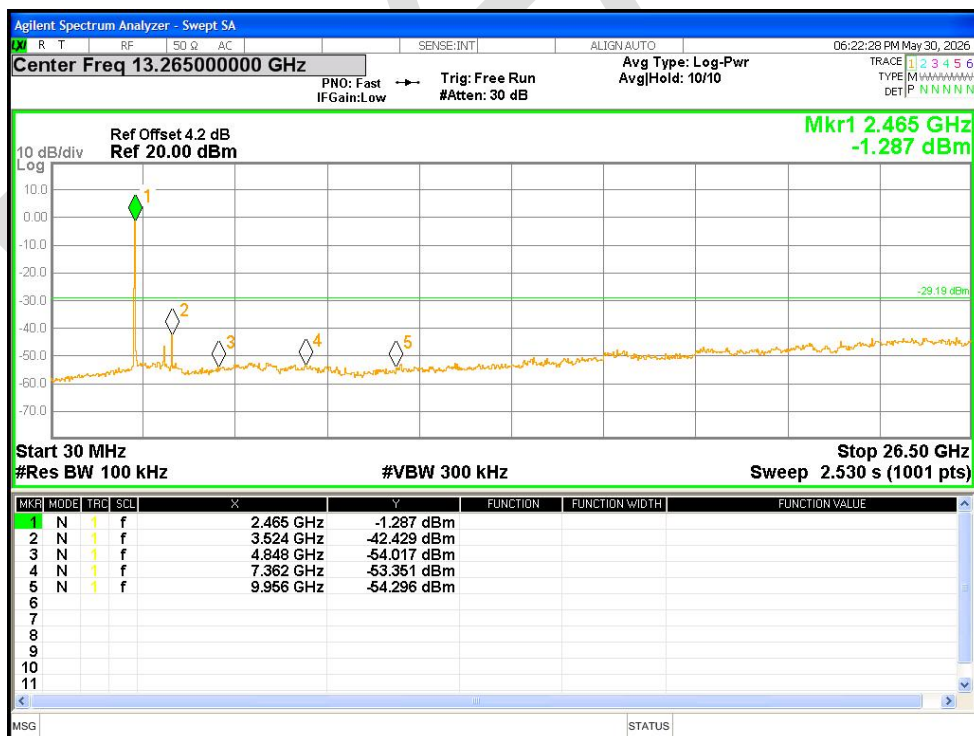
## Tx. Spurious NVNT g 2462MHz Ant1 Emission

| Condition | Mode | Frequency (MHz) | Antenna | Max Value (dBc) | Limit (dBc) | Verdict |
|---|---|---|---|---|---|---|
| NVNT | g | 2462 | Ant1 | -43.23 | -30 | Pass |

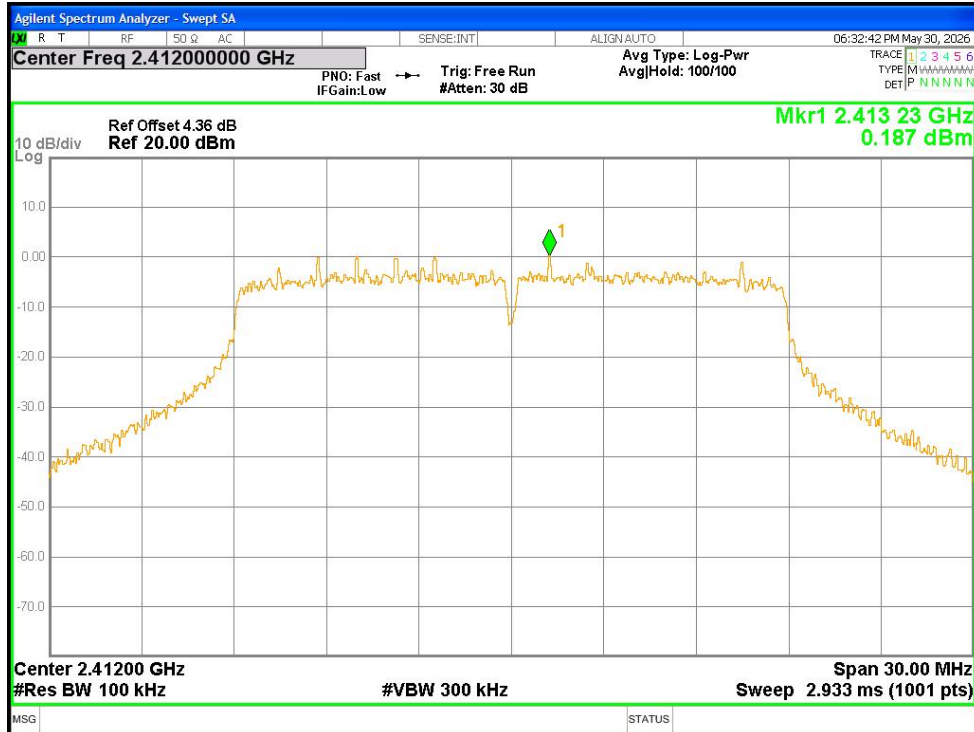
## Tx. Spurious NVNT n20 2412MHz Ant1 Ref

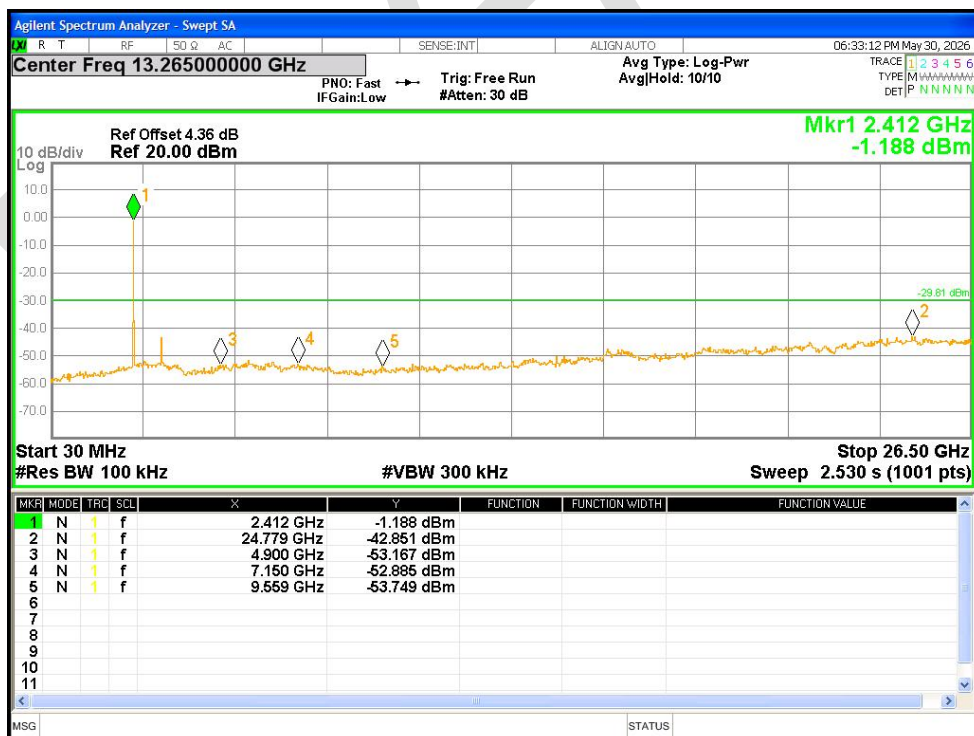
## Tx. Spurious NVNT n20 2412MHz Ant1 Emission

| Condition | Mode | Frequency (MHz) | Antenna | Max Value (dBc) | Limit (dBc) | Verdict |
|---|---|---|---|---|---|---|
| NVNT | n20 | 2412 | Ant1 | -43.04 | -30 | Pass |

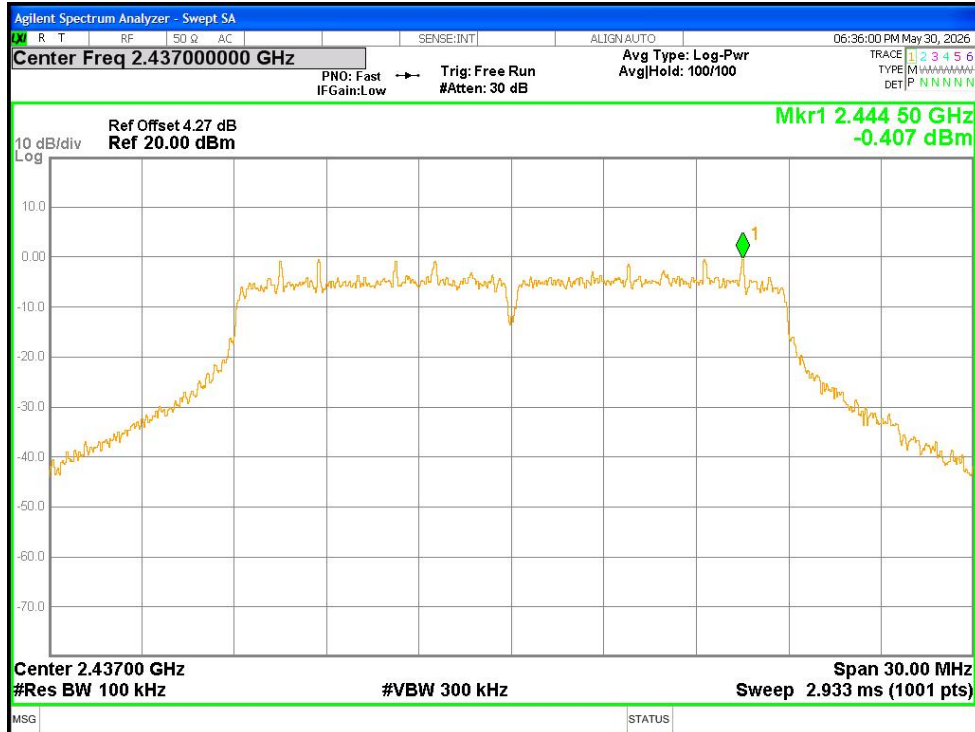
## Tx. Spurious NVNT n20 2437MHz Ant1 Ref

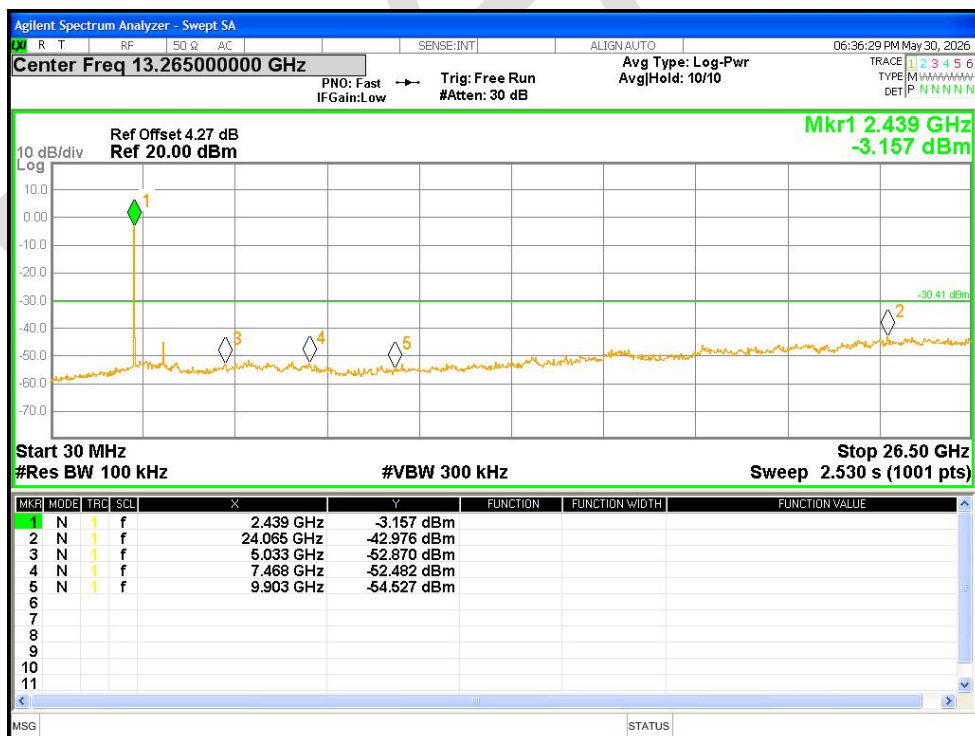
## Tx. Spurious NVNT n20 2437MHz Ant1 Emission

| Condition | Mode | Frequency (MHz) | Antenna | Max Value (dBc) | Limit (dBc) | Verdict |
|---|---|---|---|---|---|---|
| NVNT | n20 | 2437 | Ant1 | -42.56 | -30 | Pass |

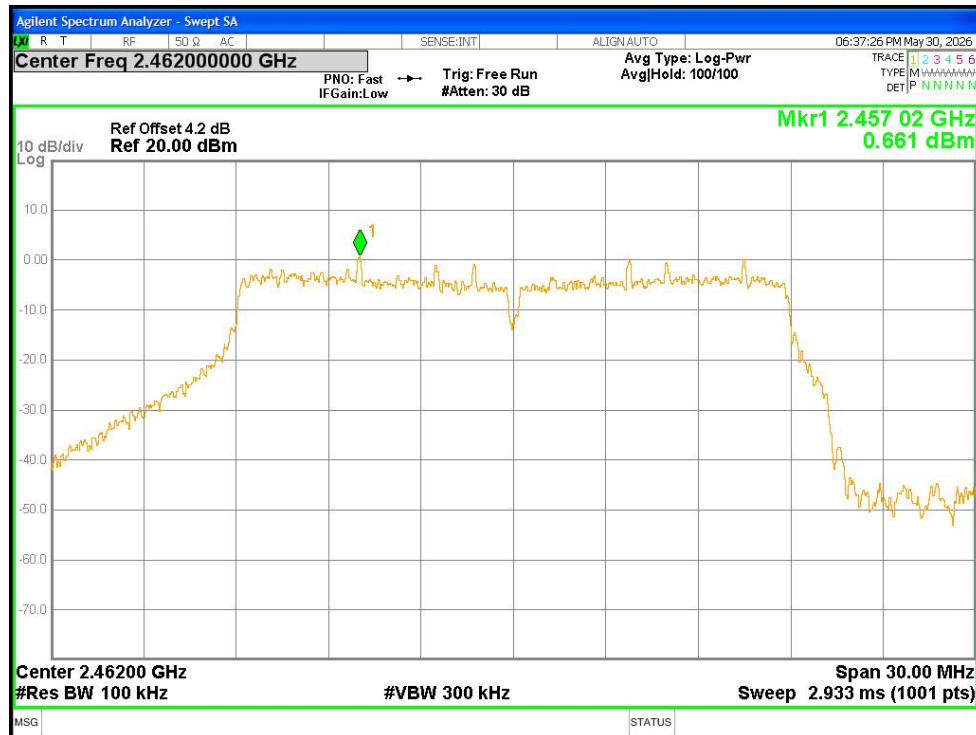
## Tx. Spurious NVNT n20 2462MHz Ant1 Ref

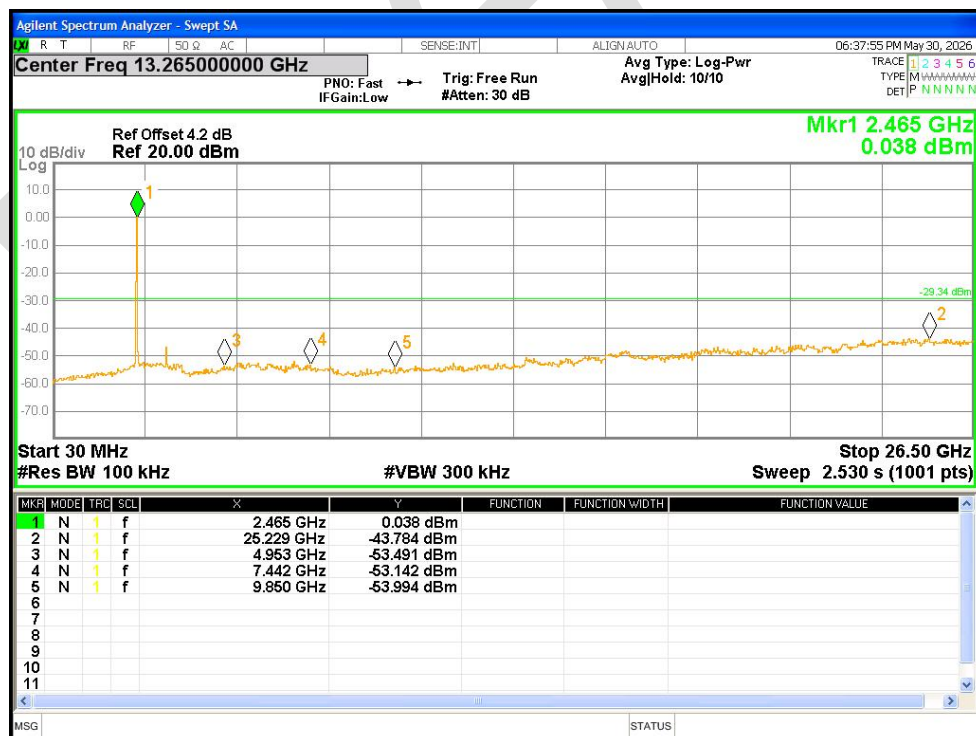
## Tx. Spurious NVNT n20 2462MHz Ant1 Emission

| Condition | Mode | Frequency (MHz) | Antenna | Max Value (dBc) | Limit (dBc) | Verdict |
|---|---|---|---|---|---|---|
| NVNT | n20 | 2462 | Ant1 | -44.44 | -30 | Pass |

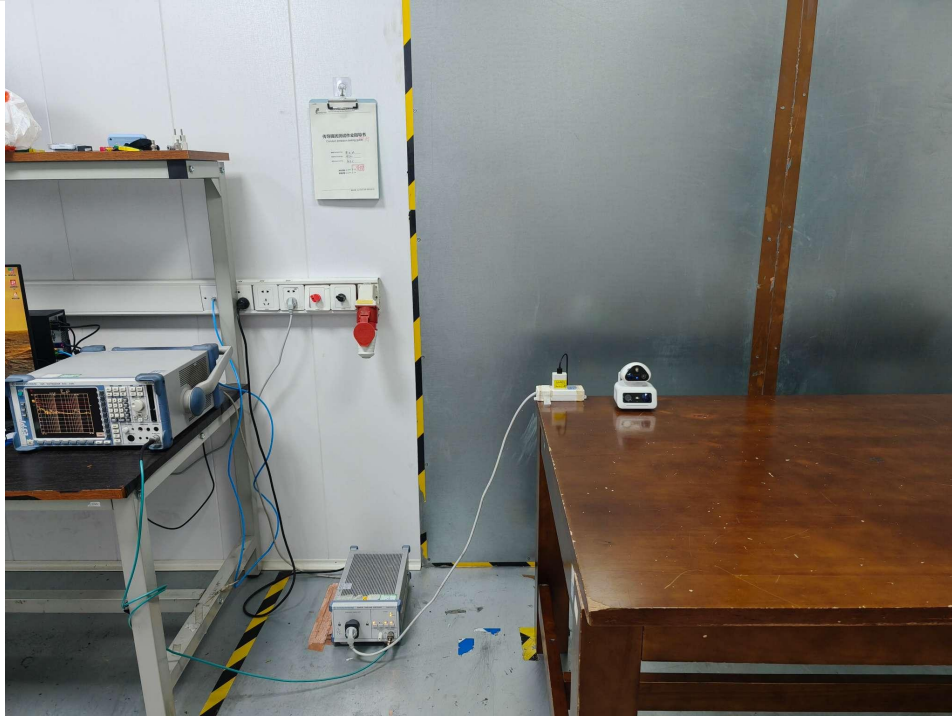
Conducted emissions at AC power line (150kHz-30MHz)

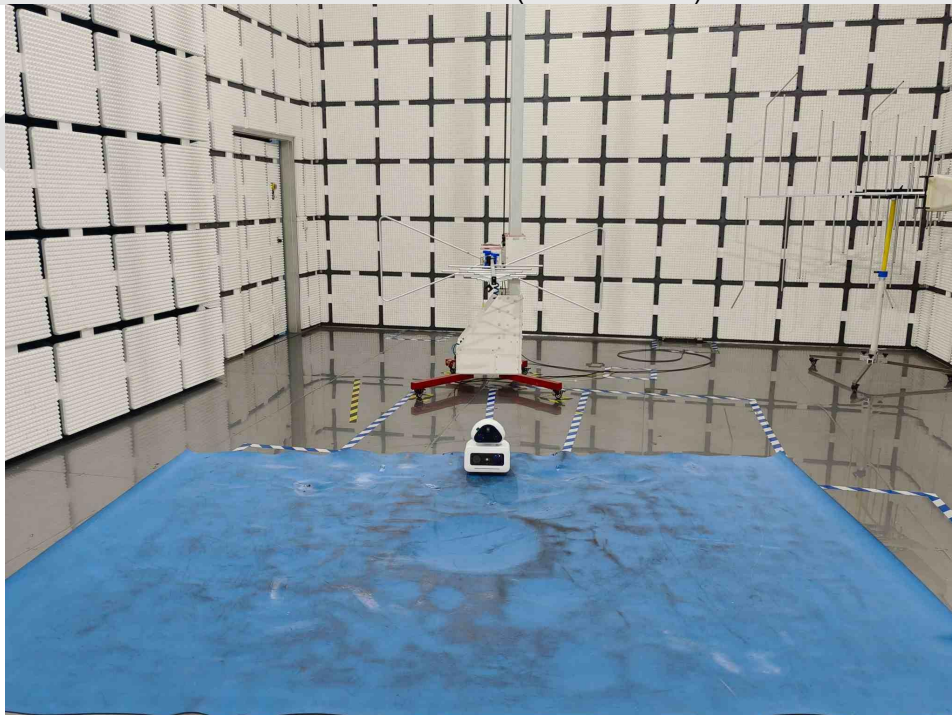
Radiated Emissions (30MHz-1GHz)

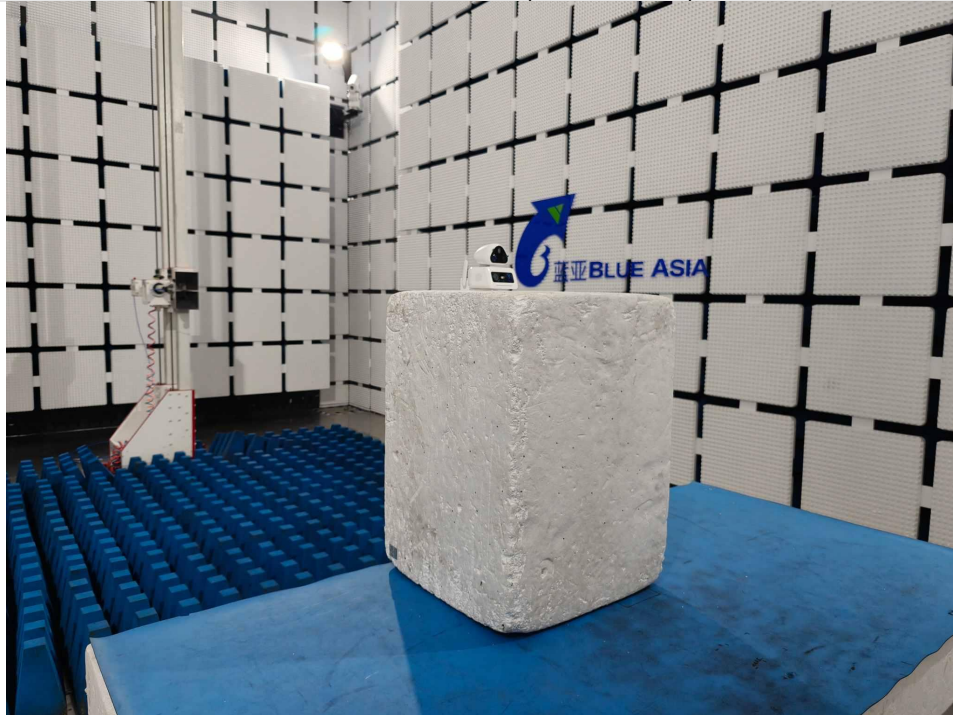
Radiated Emissions (above 1GHz)
