## Appendix F: Conducted Spurious Emission

### Test Result

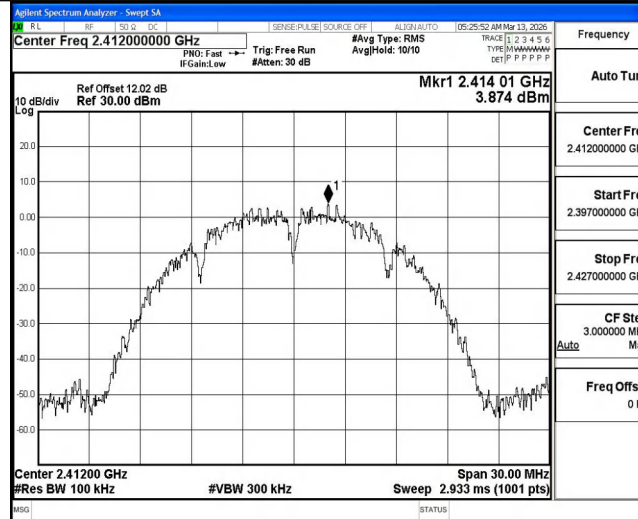
11B\_Ant1\_2412\_0~Reference

| TestMode | Antenna | Frequency[MHz] | FreqRange [Mhz] | RefLevel [dBm] | Result [dBm] | Limit [dBm] | Verdict |
|---|---|---|---|---|---|---|---|
| 11B | Ant1 | 2412 | Reference | 3.87 | 3.87 | --- | PASS |

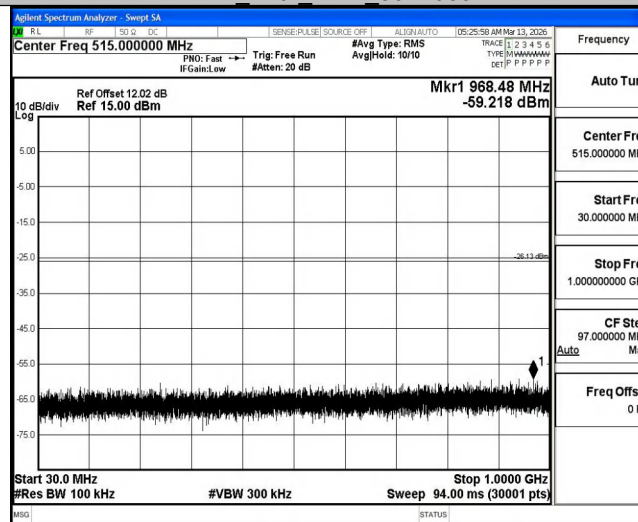
11B\_Ant1\_2412\_30~1000

| TestMode | Antenna | Frequency[MHz] | FreqRange [Mhz] | RefLevel [dBm] | Result [dBm] | Limit [dBm] | Verdict |
|---|---|---|---|---|---|---|---|
| | | | 30~1000 | 3.87 | -59.22 | $\leq -26.13$ | PASS |

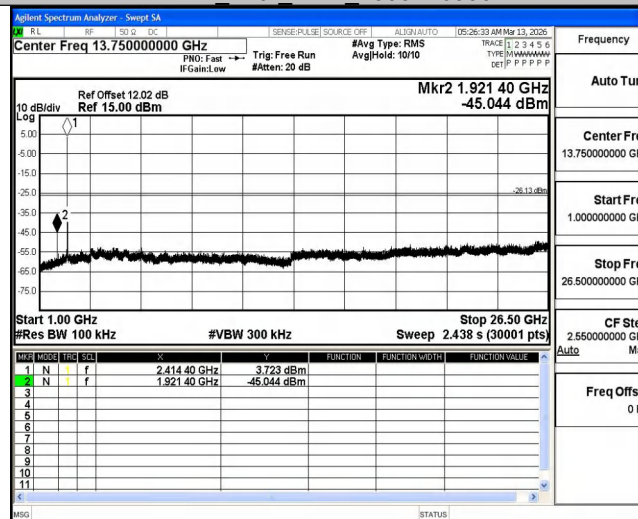
11B\_Ant1\_2412\_1000~26500

| TestMode | Antenna | Frequency[MHz] | FreqRange [Mhz] | RefLevel [dBm] | Result [dBm] | Limit [dBm] | Verdict |
|---|---|---|---|---|---|---|---|
| | | | 1000~26500 | 3.87 | -45.04 | $\leq -26.13$ | PASS |

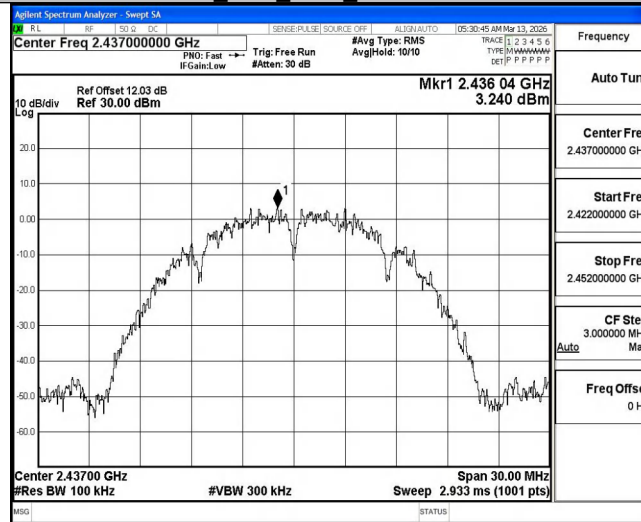
## 11B\_Ant1\_2437\_0~Reference

| TestMode | Antenna | Frequency[MHz] | FreqRange [Mhz] | RefLevel [dBm] | Result [dBm] | Limit [dBm] | Verdict |
|---|---|---|---|---|---|---|---|
| | | 2437 | Reference | 3.24 | 3.24 | --- | PASS |

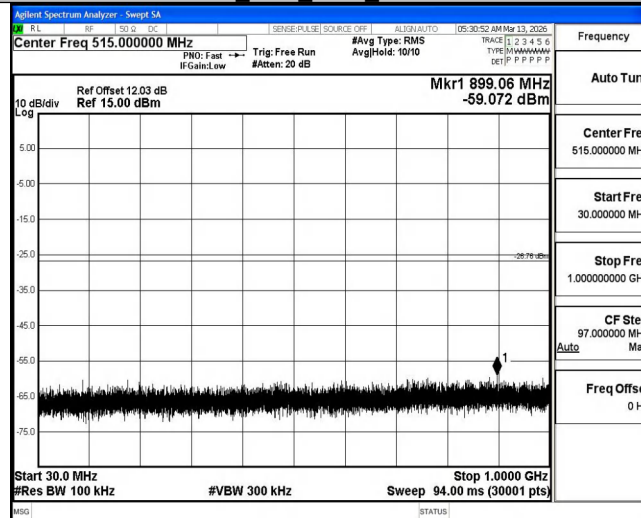
## 11B\_Ant1\_2437\_30~1000

| TestMode | Antenna | Frequency[MHz] | FreqRange [Mhz] | RefLevel [dBm] | Result [dBm] | Limit [dBm] | Verdict |
|---|---|---|---|---|---|---|---|
| | | | 30~1000 | 3.24 | -59.07 | $\leq -26.76$ | PASS |

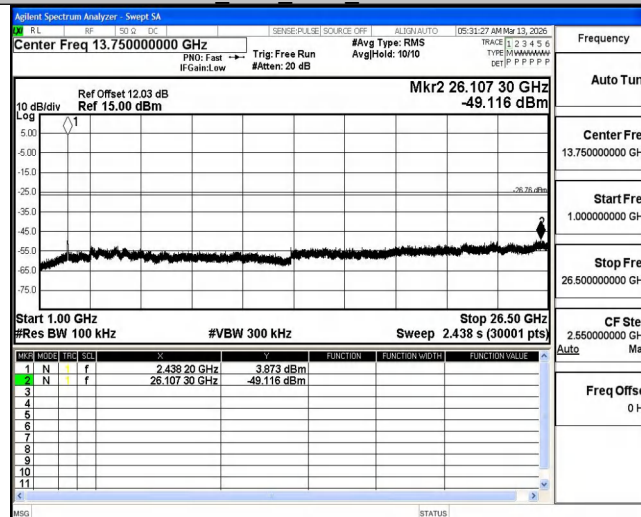
## 11B\_Ant1\_2437\_1000~26500

| TestMode | Antenna | Frequency[MHz] | FreqRange [Mhz] | RefLevel [dBm] | Result [dBm] | Limit [dBm] | Verdict |
|---|---|---|---|---|---|---|---|
| | | | 1000~26500 | 3.24 | -49.12 | $\leq -26.76$ | PASS |

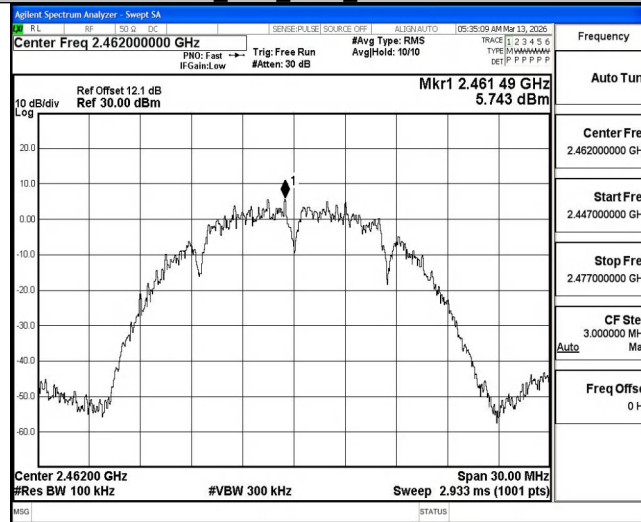
## 11B\_Ant1\_2462\_0~Reference

| TestMode | Antenna | Frequency[MHz] | FreqRange [Mhz] | RefLevel [dBm] | Result [dBm] | Limit [dBm] | Verdict |
|---|---|---|---|---|---|---|---|
| | | 2462 | Reference | 5.74 | 5.74 | --- | PASS |

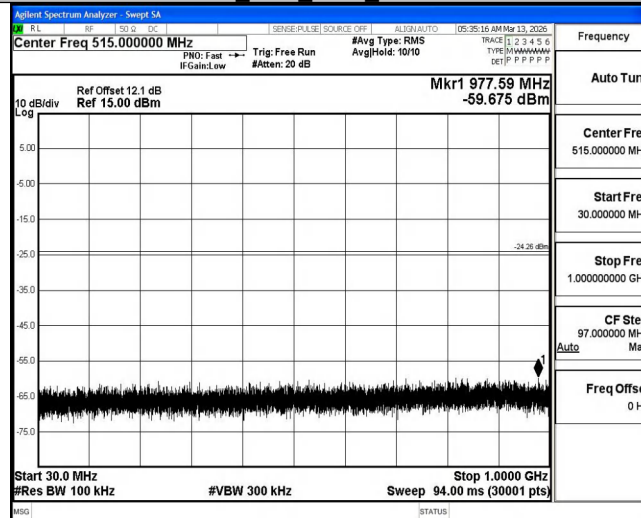
## 11B\_Ant1\_2462\_30~1000

| TestMode | Antenna | Frequency[MHz] | FreqRange [Mhz] | RefLevel [dBm] | Result [dBm] | Limit [dBm] | Verdict |
|---|---|---|---|---|---|---|---|
| | | | 30~1000 | 5.74 | -59.68 | $\leq -24.26$ | PASS |

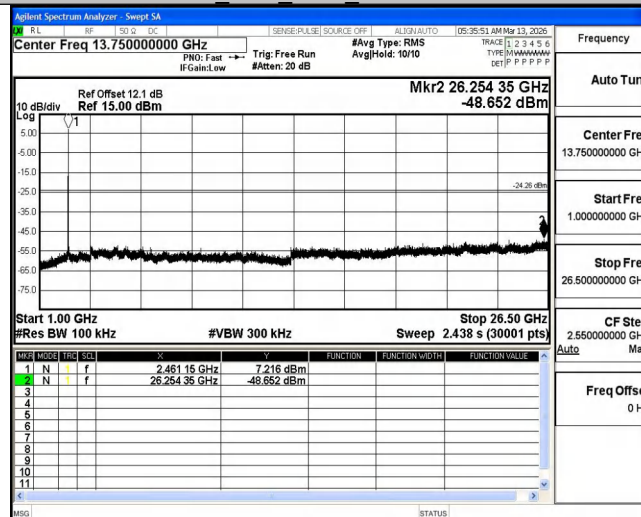
## 11B\_Ant1\_2462\_1000~26500

| TestMode | Antenna | Frequency[MHz] | FreqRange [Mhz] | RefLevel [dBm] | Result [dBm] | Limit [dBm] | Verdict |
|---|---|---|---|---|---|---|---|
| | | | 1000~26500 | 5.74 | -48.65 | $\leq -24.26$ | PASS |

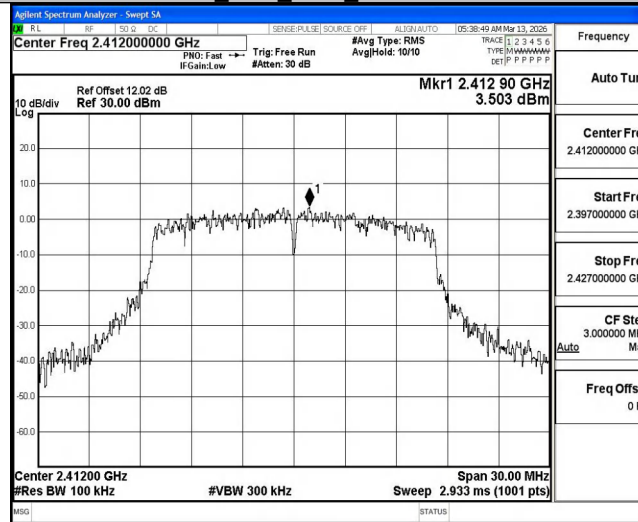
## 11G\_Ant1\_2412\_0~Reference

| TestMode | Antenna | Frequency[MHz] | FreqRange [Mhz] | RefLevel [dBm] | Result [dBm] | Limit [dBm] | Verdict |
|---|---|---|---|---|---|---|---|
| 11G | Ant1 | 2412 | Reference | 3.50 | 3.50 | --- | PASS |

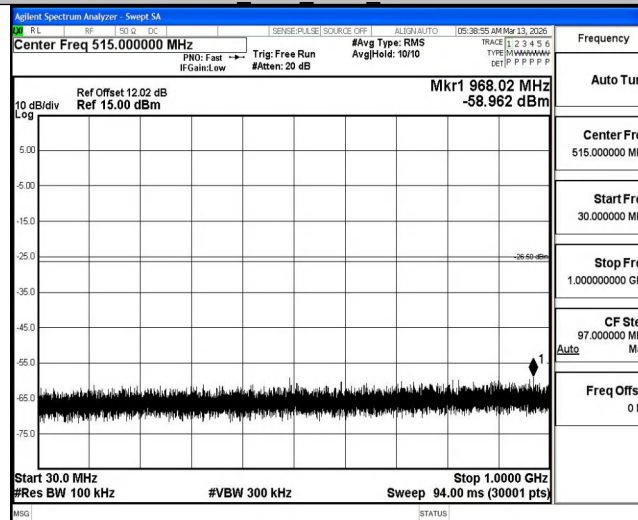
## 11G\_Ant1\_2412\_30~1000

| TestMode | Antenna | Frequency[MHz] | FreqRange [Mhz] | RefLevel [dBm] | Result [dBm] | Limit [dBm] | Verdict |
|---|---|---|---|---|---|---|---|
| | | | 30~1000 | 3.50 | -58.96 | $\leq -26.5$ | PASS |

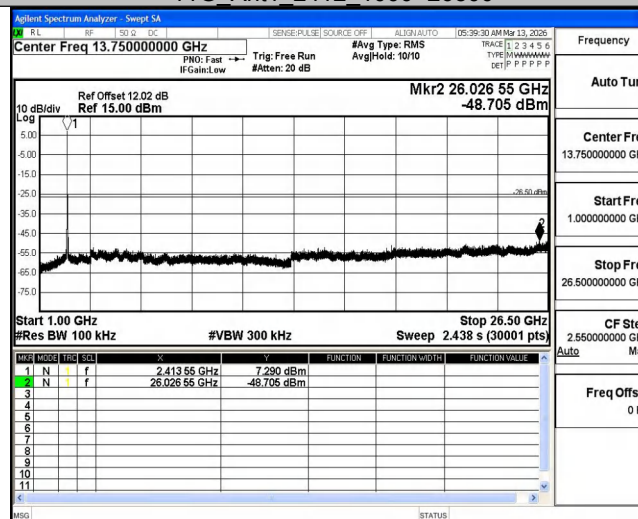
## 11G\_Ant1\_2412\_1000~26500

| TestMode | Antenna | Frequency[MHz] | FreqRange [Mhz] | RefLevel [dBm] | Result [dBm] | Limit [dBm] | Verdict |
|---|---|---|---|---|---|---|---|
| | | | 1000~26500 | 3.50 | -48.71 | $\leq -26.5$ | PASS |

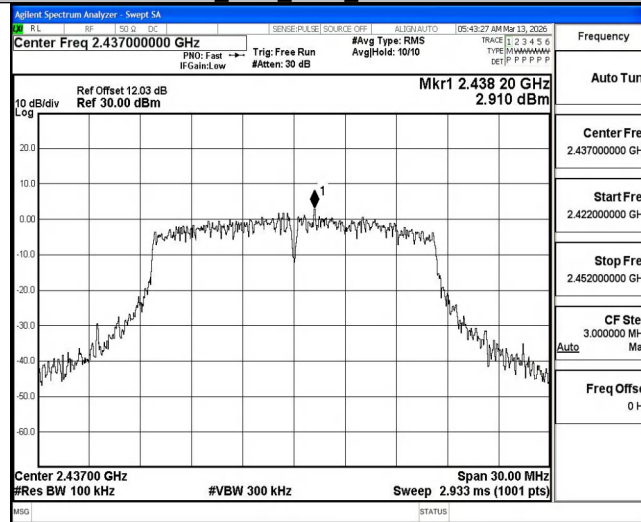
## 11G\_Ant1\_2437\_0~Reference

| TestMode | Antenna | Frequency[MHz] | FreqRange [Mhz] | RefLevel [dBm] | Result [dBm] | Limit [dBm] | Verdict |
|---|---|---|---|---|---|---|---|
| | | 2437 | Reference | 2.91 | 2.91 | --- | PASS |

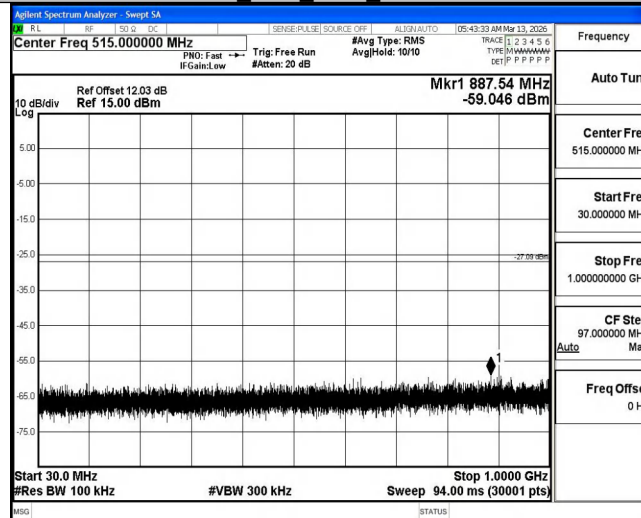
## 11G\_Ant1\_2437\_30~1000

| TestMode | Antenna | Frequency[MHz] | FreqRange [Mhz] | RefLevel [dBm] | Result [dBm] | Limit [dBm] | Verdict |
|---|---|---|---|---|---|---|---|
| | | | 30~1000 | 2.91 | -59.05 | $\leq -27.09$ | PASS |

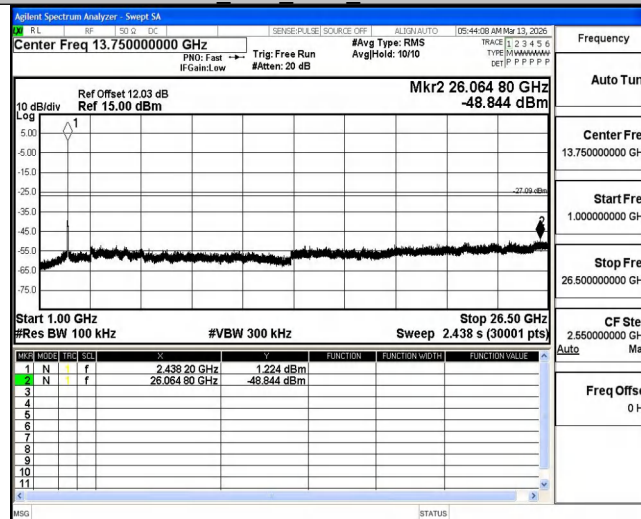
## 11G\_Ant1\_2437\_1000~26500

| TestMode | Antenna | Frequency[MHz] | FreqRange [Mhz] | RefLevel [dBm] | Result [dBm] | Limit [dBm] | Verdict |
|---|---|---|---|---|---|---|---|
| | | | 1000~26500 | 2.91 | -48.84 | $\leq -27.09$ | PASS |

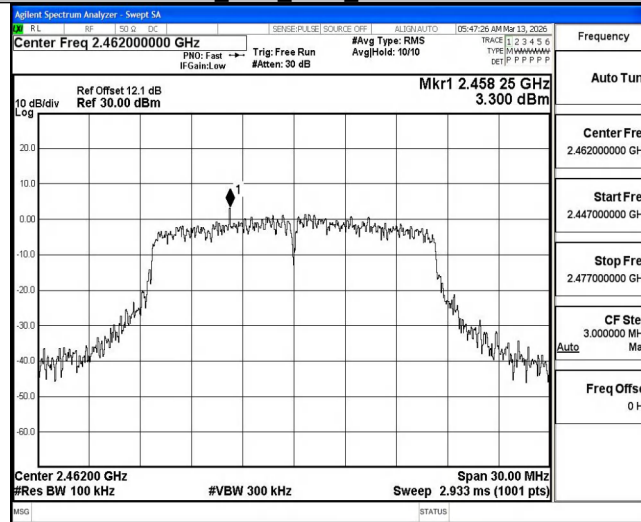
## 11G\_Ant1\_2462\_0~Reference

| TestMode | Antenna | Frequency[MHz] | FreqRange [Mhz] | RefLevel [dBm] | Result [dBm] | Limit [dBm] | Verdict |
|---|---|---|---|---|---|---|---|
| | | 2462 | Reference | 3.30 | 3.30 | --- | PASS |

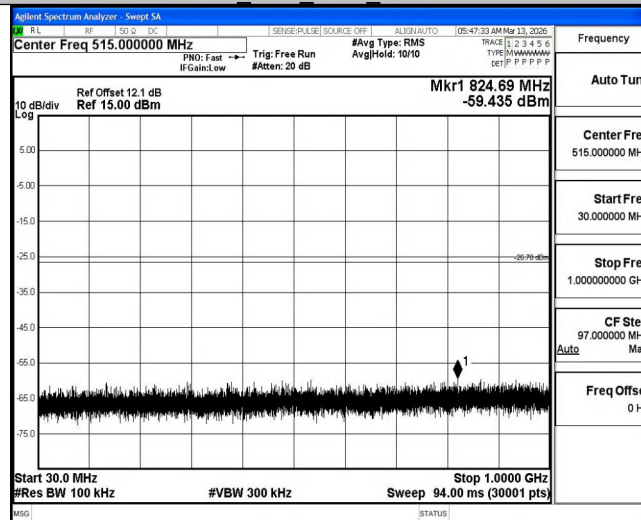
## 11G\_Ant1\_2462\_30~1000

| TestMode | Antenna | Frequency[MHz] | FreqRange [Mhz] | RefLevel [dBm] | Result [dBm] | Limit [dBm] | Verdict |
|---|---|---|---|---|---|---|---|
| | | | 30~1000 | 3.30 | -59.44 | $\leq -26.7$ | PASS |

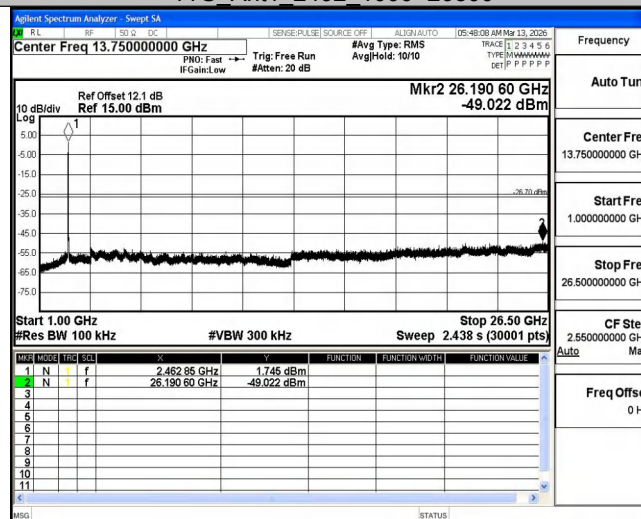
## 11G\_Ant1\_2462\_1000~26500

| TestMode | Antenna | Frequency[MHz] | FreqRange [Mhz] | RefLevel [dBm] | Result [dBm] | Limit [dBm] | Verdict |
|---|---|---|---|---|---|---|---|
| | | | 1000~26500 | 3.30 | -49.02 | $\leq -26.7$ | PASS |

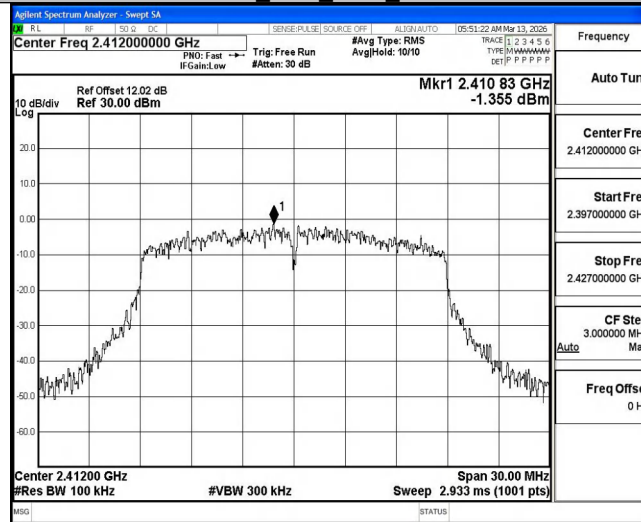
## 11N20SISO Ant1 2412 0~Reference

| TestMode | Antenna | Frequency[MHz] | FreqRange [Mhz] | RefLevel [dBm] | Result [dBm] | Limit [dBm] | Verdict |
|---|---|---|---|---|---|---|---|
| 11N20SISO | Ant1 | 2412 | Reference | -1.36 | -1.36 | --- | PASS |

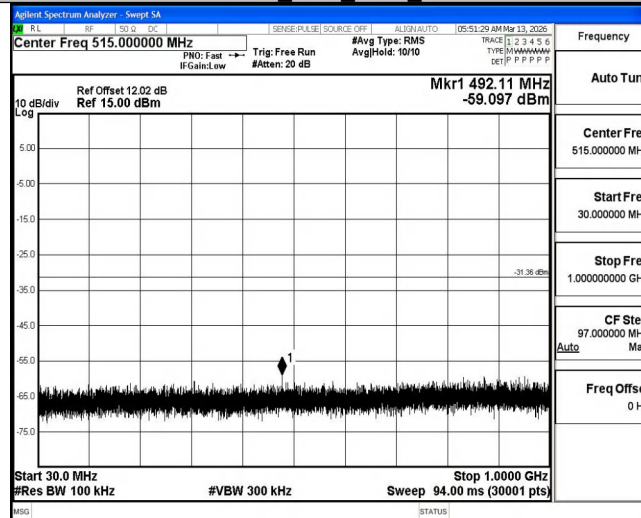
## 11N20SISO Ant1 2412 30~1000

| TestMode | Antenna | Frequency[MHz] | FreqRange [Mhz] | RefLevel [dBm] | Result [dBm] | Limit [dBm] | Verdict |
|---|---|---|---|---|---|---|---|
| | | | 30~1000 | -1.36 | -59.1 | $\leq -31.36$ | PASS |

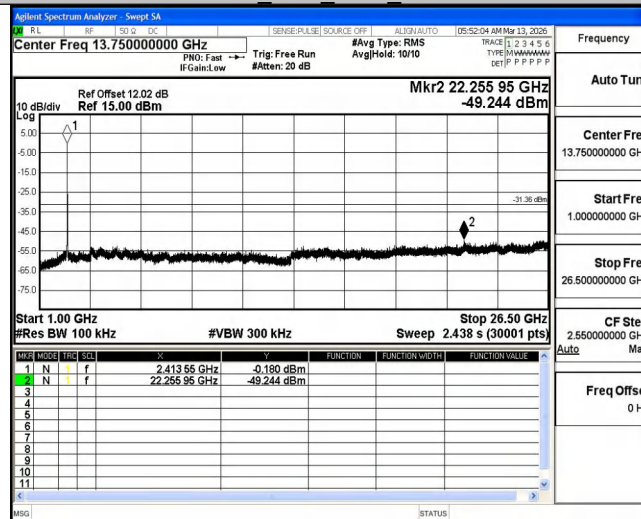
## 11N20SISO Ant1 2412 1000~26500

| TestMode | Antenna | Frequency[MHz] | FreqRange [Mhz] | RefLevel [dBm] | Result [dBm] | Limit [dBm] | Verdict |
|---|---|---|---|---|---|---|---|
| | | | 1000~26500 | -1.36 | -49.24 | $\leq -31.36$ | PASS |

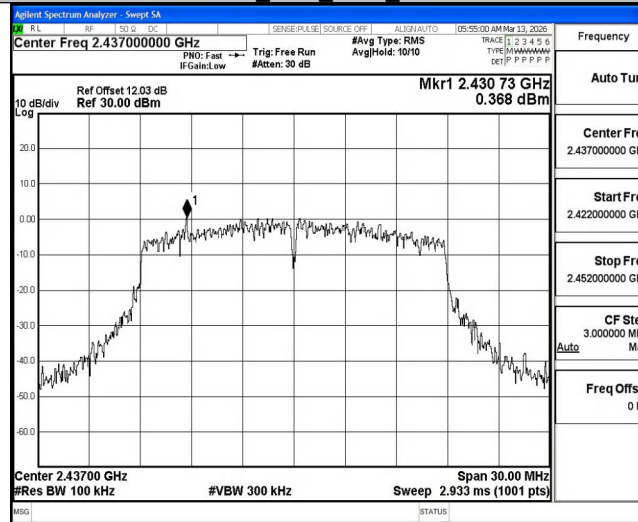
## 11N20SISO Ant1 2437 0~Reference

| TestMode | Antenna | Frequency[MHz] | FreqRange [Mhz] | RefLevel [dBm] | Result [dBm] | Limit [dBm] | Verdict |
|---|---|---|---|---|---|---|---|
| | | 2437 | Reference | 0.37 | 0.37 | --- | PASS |

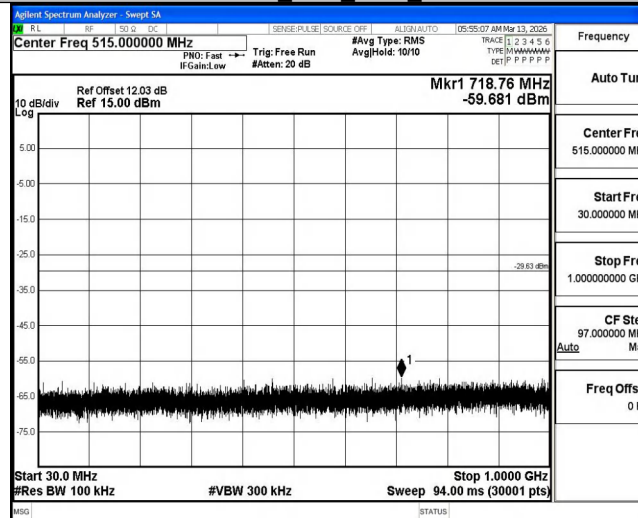
## 11N20SISO Ant1 2437 30~1000

| TestMode | Antenna | Frequency[MHz] | FreqRange [Mhz] | RefLevel [dBm] | Result [dBm] | Limit [dBm] | Verdict |
|---|---|---|---|---|---|---|---|
| | | | 30~1000 | 0.37 | -59.68 | $\leq -29.63$ | PASS |

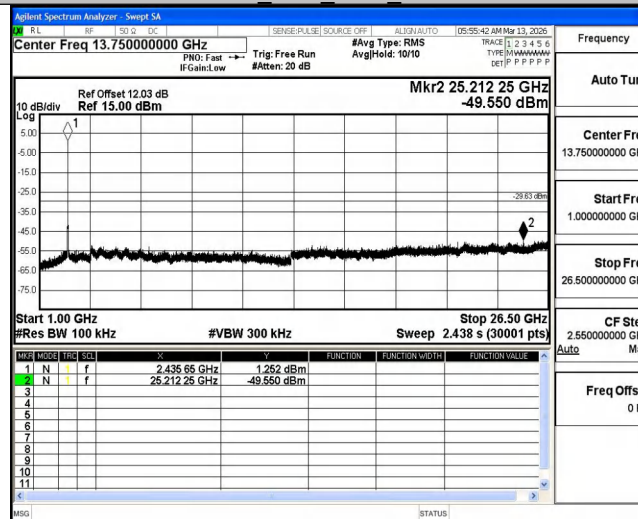
## 11N20SISO Ant1 2437 1000~26500

| TestMode | Antenna | Frequency[MHz] | FreqRange [Mhz] | RefLevel [dBm] | Result [dBm] | Limit [dBm] | Verdict |
|---|---|---|---|---|---|---|---|
| | | | 1000~26500 | 0.37 | -49.55 | $\leq -29.63$ | PASS |

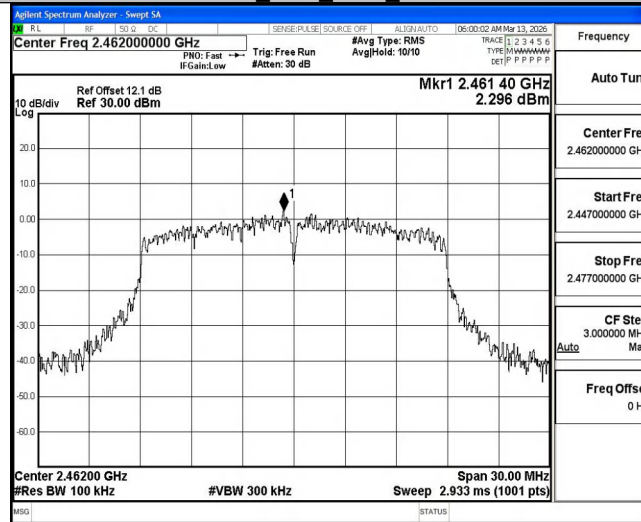
## 11N20SISO Ant1 2462 0~Reference

| TestMode | Antenna | Frequency[MHz] | FreqRange [Mhz] | RefLevel [dBm] | Result [dBm] | Limit [dBm] | Verdict |
|---|---|---|---|---|---|---|---|
| | | 2462 | Reference | 2.30 | 2.30 | --- | PASS |

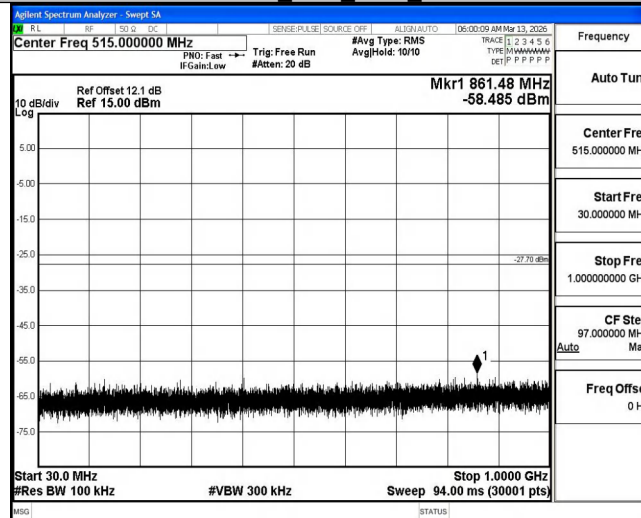
## 11N20SISO Ant1 2462 30~1000

| TestMode | Antenna | Frequency[MHz] | FreqRange [Mhz] | RefLevel [dBm] | Result [dBm] | Limit [dBm] | Verdict |
|---|---|---|---|---|---|---|---|
| | | | 30~1000 | 2.30 | -58.49 | $\leq -27.7$ | PASS |

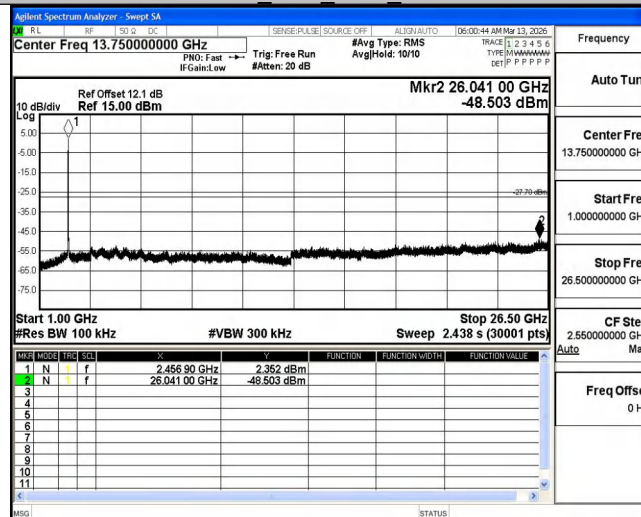
## 11N20SISO Ant1 2462 1000~26500

| TestMode | Antenna | Frequency[MHz] | FreqRange [Mhz] | RefLevel [dBm] | Result [dBm] | Limit [dBm] | Verdict |
|---|---|---|---|---|---|---|---|
| | | | 1000~26500 | 2.30 | -48.5 | $\leq -27.7$ | PASS |

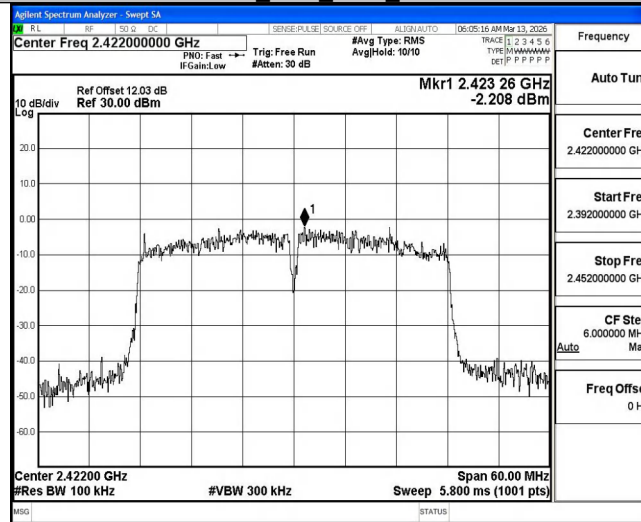
## 11N40SISO Ant1 2422 0~Reference

| TestMode | Antenna | Frequency[MHz] | FreqRange [Mhz] | RefLevel [dBm] | Result [dBm] | Limit [dBm] | Verdict |
|---|---|---|---|---|---|---|---|
| 11N40SISO | Ant1 | 2422 | Reference | -2.21 | -2.21 | --- | PASS |

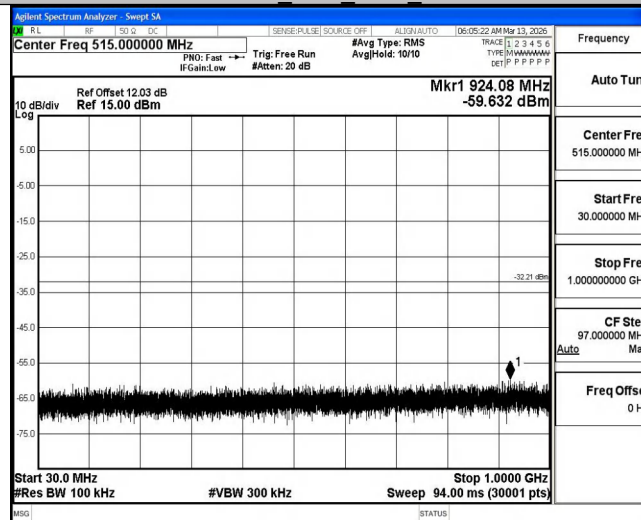
## 11N40SISO Ant1 2422 30~1000

| TestMode | Antenna | Frequency[MHz] | FreqRange [Mhz] | RefLevel [dBm] | Result [dBm] | Limit [dBm] | Verdict |
|---|---|---|---|---|---|---|---|
| | | | 30~1000 | -2.21 | -59.63 | $\leq -32.21$ | PASS |

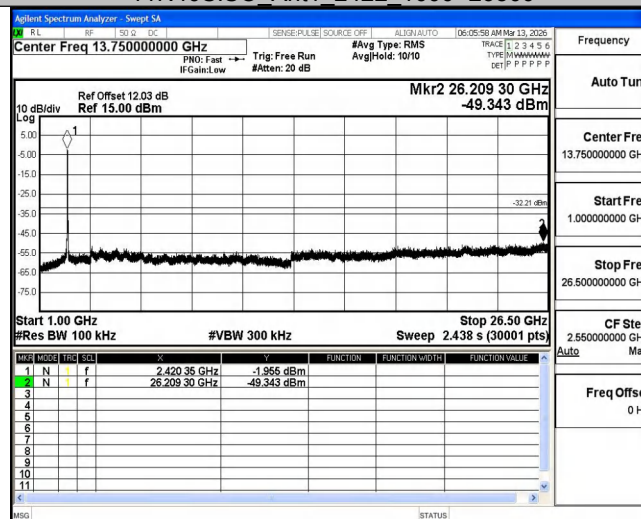
## 11N40SISO Ant1 2422 1000~26500

| TestMode | Antenna | Frequency[MHz] | FreqRange [Mhz] | RefLevel [dBm] | Result [dBm] | Limit [dBm] | Verdict |
|---|---|---|---|---|---|---|---|
| | | | 1000~26500 | -2.21 | -49.34 | $\leq -32.21$ | PASS |

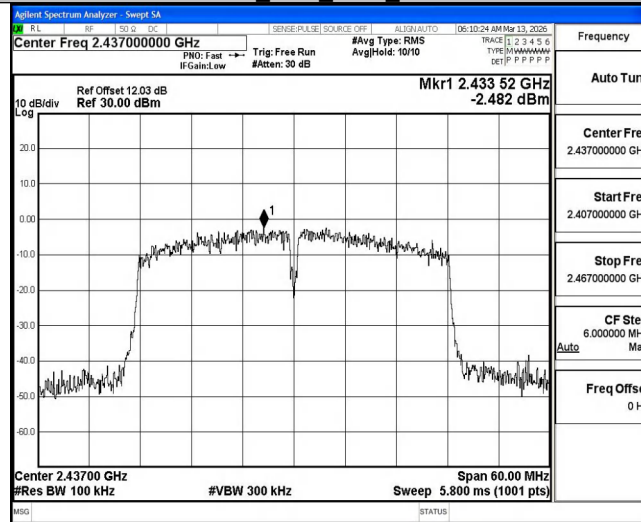
## 11N40SISO Ant1 2437 0~Reference

| TestMode | Antenna | Frequency[MHz] | FreqRange [Mhz] | RefLevel [dBm] | Result [dBm] | Limit [dBm] | Verdict |
|---|---|---|---|---|---|---|---|
| | | 2437 | Reference | -2.48 | -2.48 | --- | PASS |

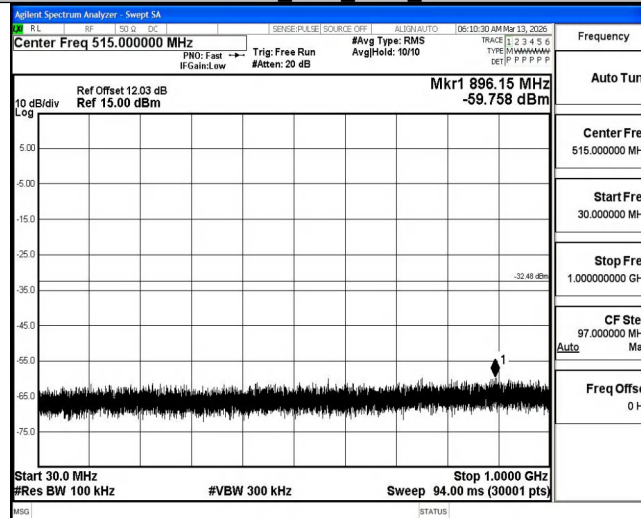
## 11N40SISO Ant1 2437 30~1000

| TestMode | Antenna | Frequency[MHz] | FreqRange [Mhz] | RefLevel [dBm] | Result [dBm] | Limit [dBm] | Verdict |
|---|---|---|---|---|---|---|---|
| | | | 30~1000 | -2.48 | -59.76 | $\leq -32.48$ | PASS |

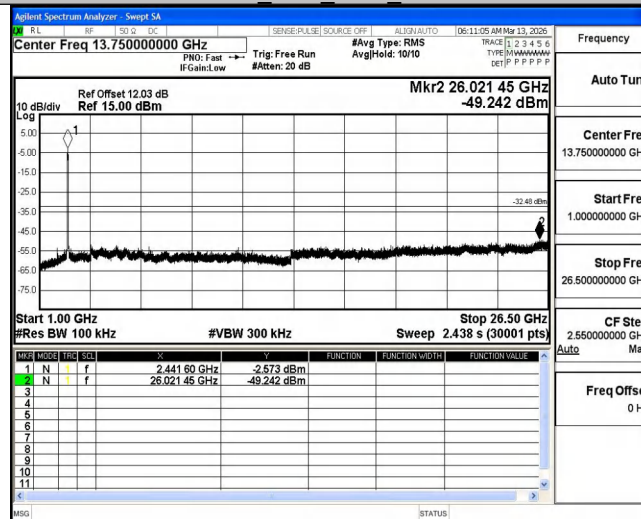
## 11N40SISO Ant1 2437 1000~26500

| TestMode | Antenna | Frequency[MHz] | FreqRange [Mhz] | RefLevel [dBm] | Result [dBm] | Limit [dBm] | Verdict |
|---|---|---|---|---|---|---|---|
| | | | 1000~26500 | -2.48 | -49.24 | $\leq -32.48$ | PASS |

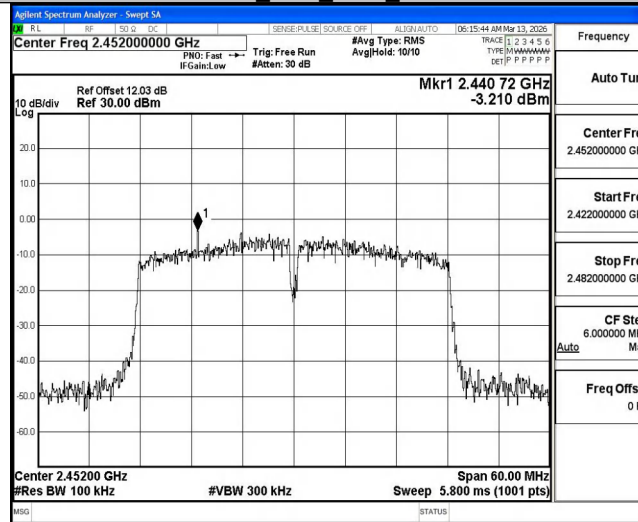
## 11N40SISO Ant1 2452 0~Reference

| TestMode | Antenna | Frequency[MHz] | FreqRange [Mhz] | RefLevel [dBm] | Result [dBm] | Limit [dBm] | Verdict |
|---|---|---|---|---|---|---|---|
| | | 2452 | Reference | -3.21 | -3.21 | --- | PASS |

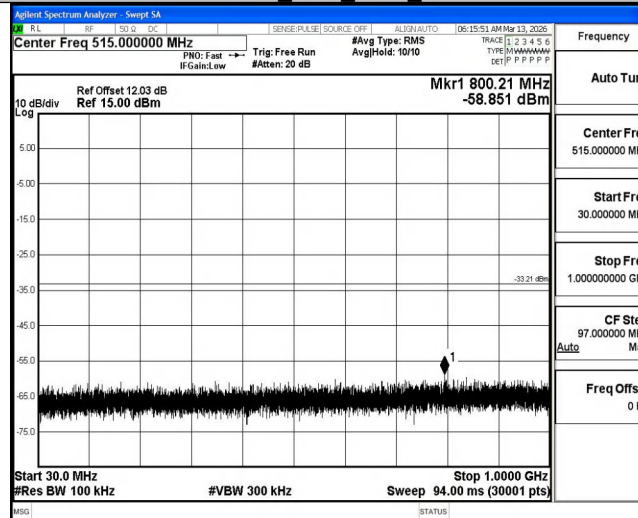
## 11N40SISO Ant1 2452 30~1000

| TestMode | Antenna | Frequency[MHz] | FreqRange [Mhz] | RefLevel [dBm] | Result [dBm] | Limit [dBm] | Verdict |
|---|---|---|---|---|---|---|---|
| | | | 30~1000 | -3.21 | -58.85 | $\leq -33.21$ | PASS |

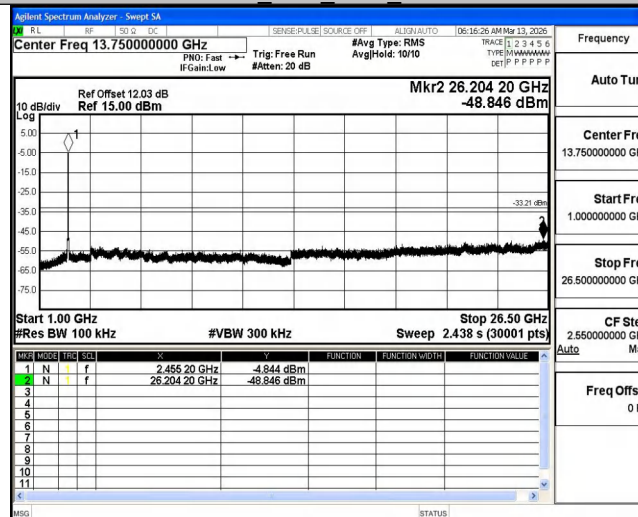
## 11N40SISO Ant1 2452 1000~26500

| TestMode | Antenna | Frequency[MHz] | FreqRange [Mhz] | RefLevel [dBm] | Result [dBm] | Limit [dBm] | Verdict |
|---|---|---|---|---|---|---|---|
| | | | 1000~26500 | -3.21 | -48.85 | $\leq -33.21$ | PASS |
