**Appendix F: Conducted Spurious Emission****Test Result**

GuangDong DN Testing Co., Ltd.

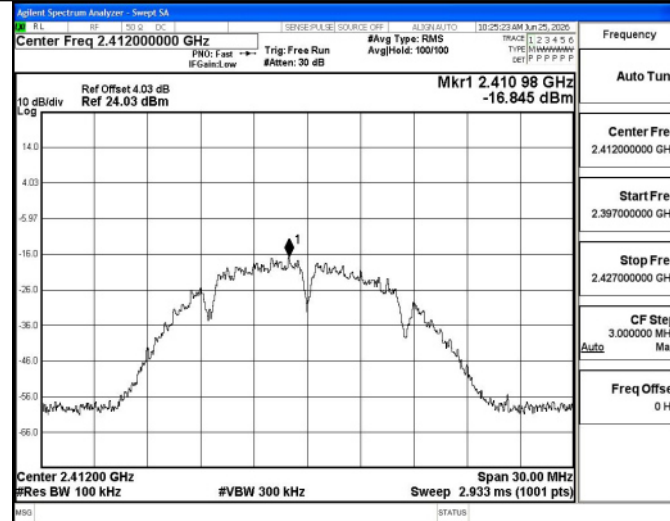
11B\_Ant1\_2412\_0~Reference

| TestMode | Antenna | Frequency[MHz] | FreqRange [Mhz] | RefLevel [dBm] | Result [dBm] | Limit [dBm] | Verdict |
|---|---|---|---|---|---|---|---|
| 11B | Ant1 | 2412 | Reference | -16.85 | -16.85 | --- | PASS |

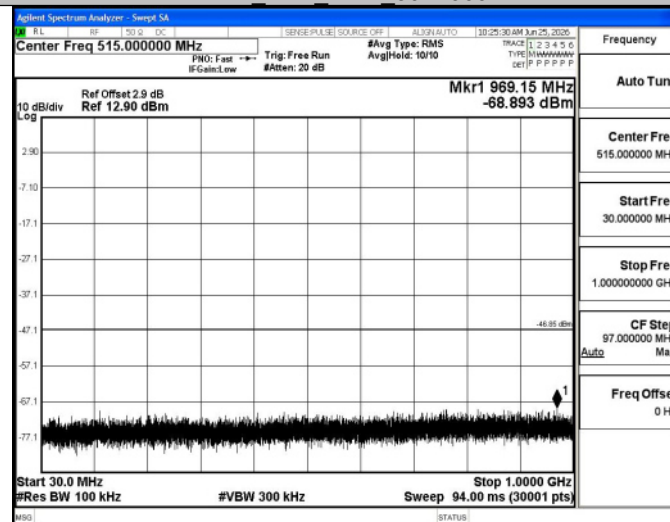
11B\_Ant1\_2412\_30~1000

| TestMode | Antenna | Frequency[MHz] | FreqRange [Mhz] | RefLevel [dBm] | Result [dBm] | Limit [dBm] | Verdict |
|---|---|---|---|---|---|---|---|
| | | | 30~1000 | -16.85 | -68.89 | ≤-46.85 | PASS |

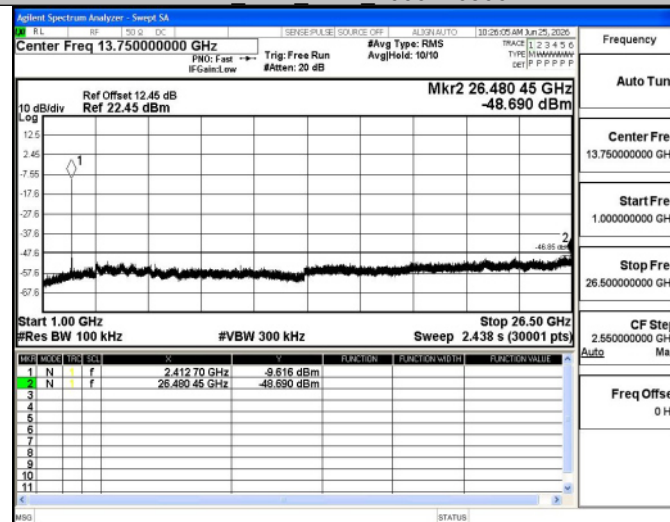
11B\_Ant1\_2412\_1000~26500

| TestMode | Antenna | Frequency[MHz] | FreqRange [Mhz] | RefLevel [dBm] | Result [dBm] | Limit [dBm] | Verdict |
|---|---|---|---|---|---|---|---|
| | | | 1000~26500 | -16.85 | -48.69 | ≤-46.85 | PASS |

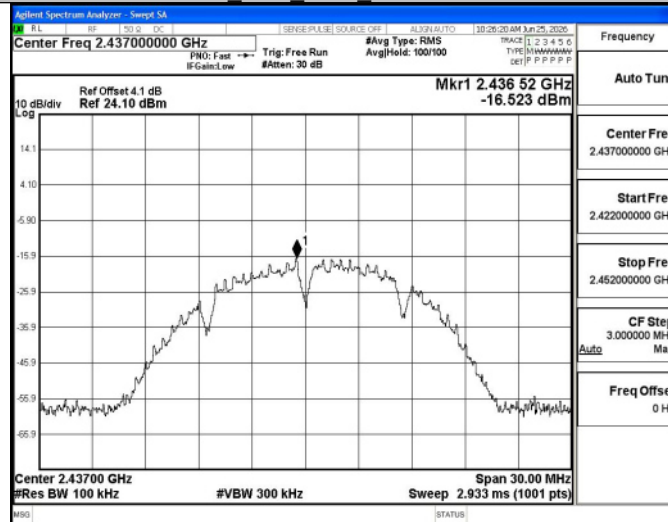
## 11B\_Ant1\_2437\_0~Reference

| TestMode | Antenna | Frequency[MHz] | FreqRange [Mhz] | RefLevel [dBm] | Result [dBm] | Limit [dBm] | Verdict |
|---|---|---|---|---|---|---|---|
| | | 2437 | Reference | -16.52 | -16.52 | --- | PASS |

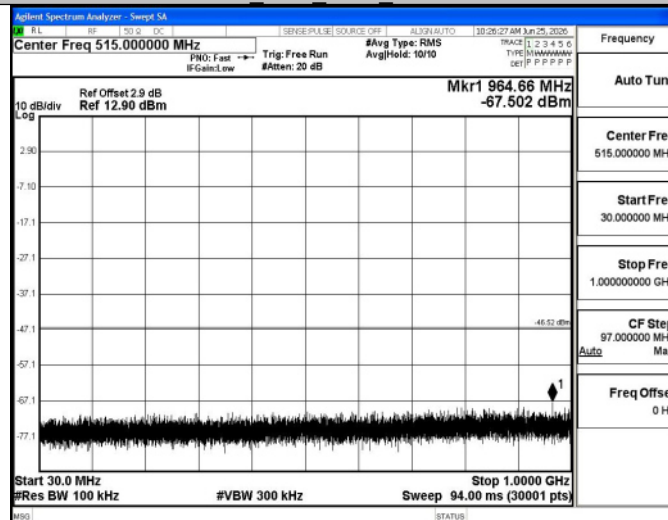
## 11B\_Ant1\_2437\_30~1000

| TestMode | Antenna | Frequency[MHz] | FreqRange [Mhz] | RefLevel [dBm] | Result [dBm] | Limit [dBm] | Verdict |
|---|---|---|---|---|---|---|---|
| | | | 30~1000 | -16.52 | -67.5 | ≤-46.52 | PASS |

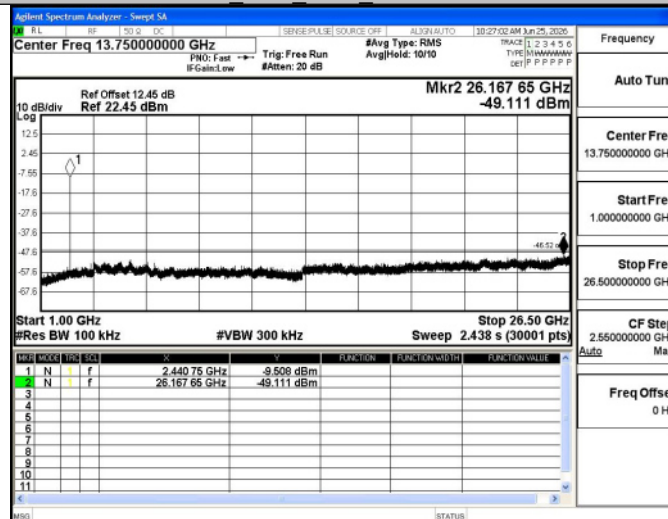
## 11B\_Ant1\_2437\_1000~26500

| TestMode | Antenna | Frequency[MHz] | FreqRange [Mhz] | RefLevel [dBm] | Result [dBm] | Limit [dBm] | Verdict |
|---|---|---|---|---|---|---|---|
| | | | 1000~26500 | -16.52 | -49.11 | ≤-46.52 | PASS |

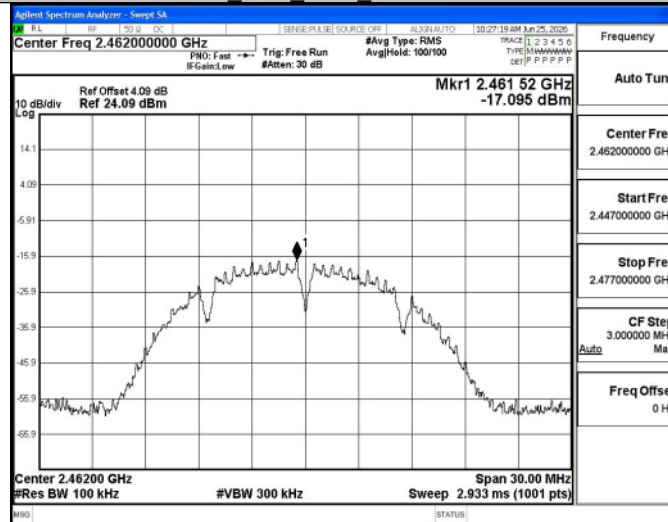
## 11B\_Ant1\_2462\_0~Reference

| TestMode | Antenna | Frequency[MHz] | FreqRange [Mhz] | RefLevel [dBm] | Result [dBm] | Limit [dBm] | Verdict |
|---|---|---|---|---|---|---|---|
| | | 2462 | Reference | -17.10 | -17.10 | --- | PASS |

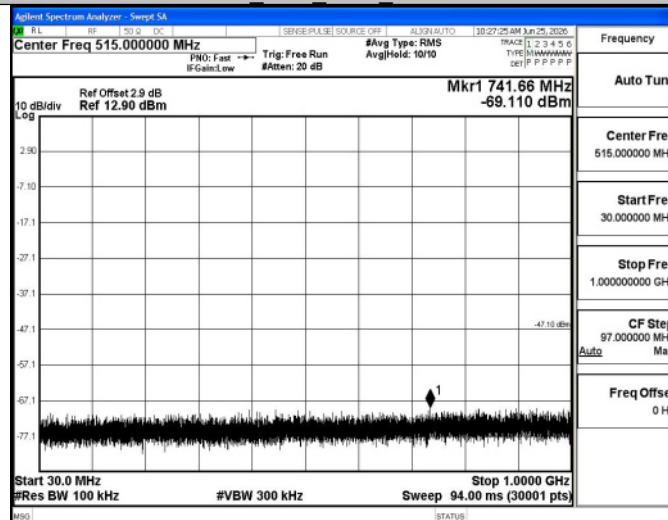
## 11B\_Ant1\_2462\_30~1000

| TestMode | Antenna | Frequency[MHz] | FreqRange [Mhz] | RefLevel [dBm] | Result [dBm] | Limit [dBm] | Verdict |
|---|---|---|---|---|---|---|---|
| | | | 30~1000 | -17.10 | -69.11 | ≤-47.1 | PASS |

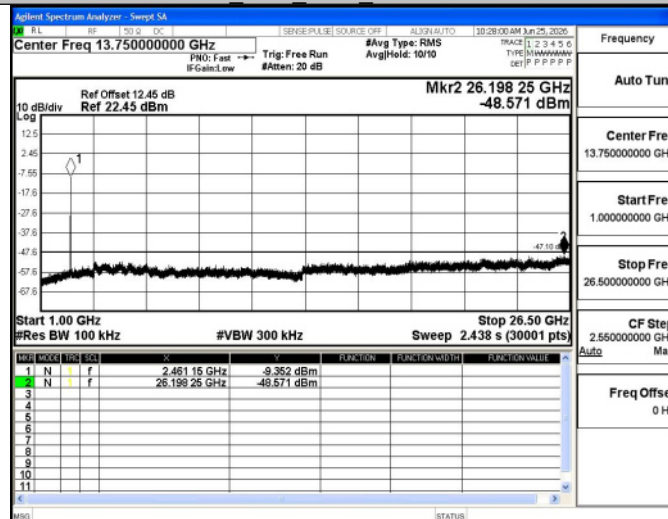
## 11B\_Ant1\_2462\_1000~26500

| TestMode | Antenna | Frequency[MHz] | FreqRange [Mhz] | RefLevel [dBm] | Result [dBm] | Limit [dBm] | Verdict |
|---|---|---|---|---|---|---|---|
| | | | 1000~26500 | -17.10 | -48.57 | ≤-47.1 | PASS |

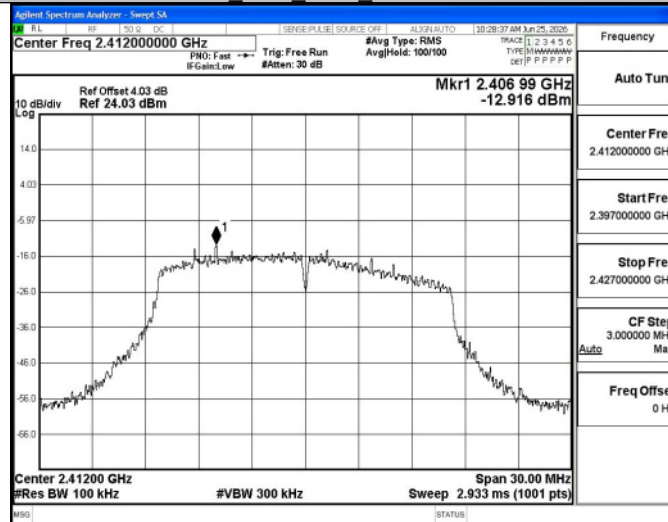
## 11G\_Ant1\_2412\_0~Reference

| TestMode | Antenna | Frequency[MHz] | FreqRange [Mhz] | RefLevel [dBm] | Result [dBm] | Limit [dBm] | Verdict |
|---|---|---|---|---|---|---|---|
| 11G | Ant1 | 2412 | Reference | -12.92 | -12.92 | --- | PASS |

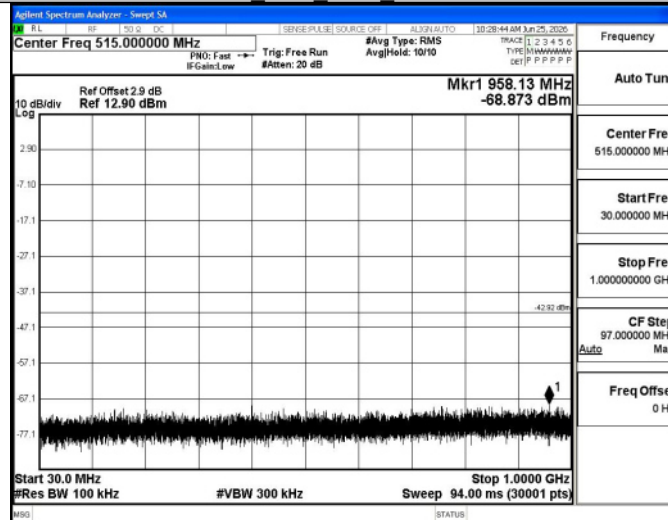
## 11G\_Ant1\_2412\_30~1000

| TestMode | Antenna | Frequency[MHz] | FreqRange [Mhz] | RefLevel [dBm] | Result [dBm] | Limit [dBm] | Verdict |
|---|---|---|---|---|---|---|---|
| | | | 30~1000 | -12.92 | -68.87 | ≤-42.92 | PASS |

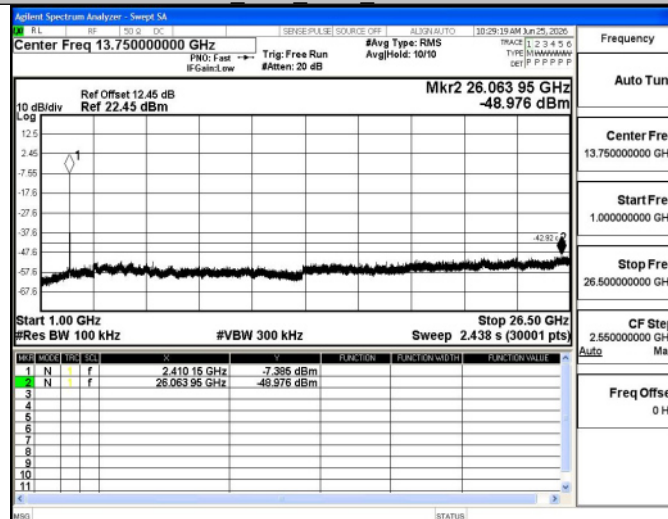
## 11G\_Ant1\_2412\_1000~26500

| TestMode | Antenna | Frequency[MHz] | FreqRange [Mhz] | RefLevel [dBm] | Result [dBm] | Limit [dBm] | Verdict |
|---|---|---|---|---|---|---|---|
| | | | 1000~26500 | -12.92 | -48.98 | ≤-42.92 | PASS |

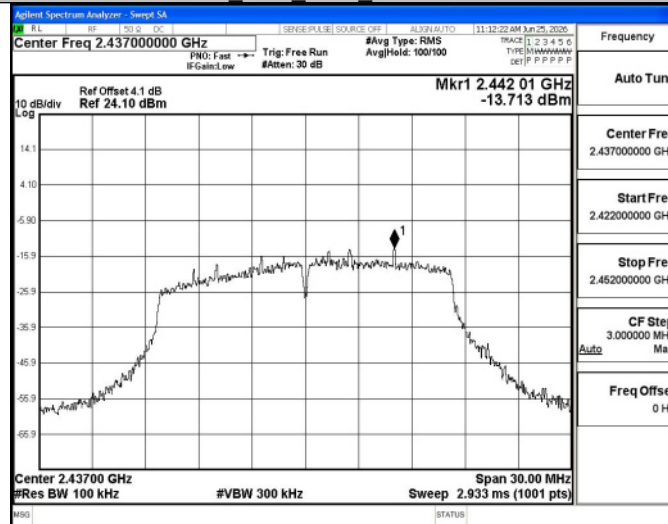
## 11G\_Ant1\_2437\_0~Reference

| TestMode | Antenna | Frequency[MHz] | FreqRange [Mhz] | RefLevel [dBm] | Result [dBm] | Limit [dBm] | Verdict |
|---|---|---|---|---|---|---|---|
| | | 2437 | Reference | -13.71 | -13.71 | --- | PASS |

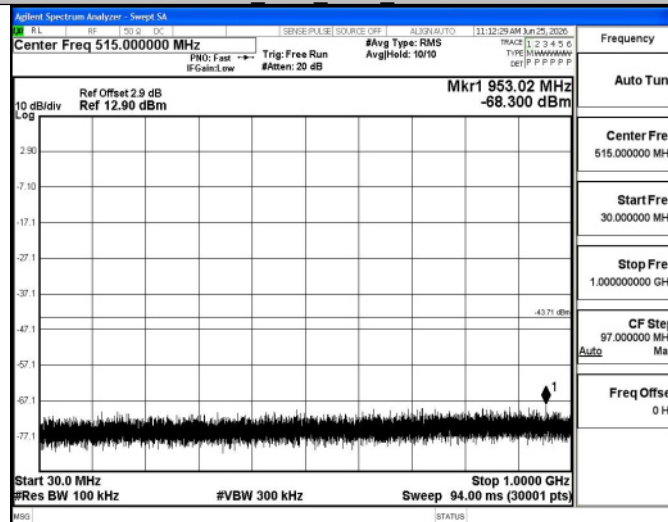
## 11G\_Ant1\_2437\_30~1000

| TestMode | Antenna | Frequency[MHz] | FreqRange [Mhz] | RefLevel [dBm] | Result [dBm] | Limit [dBm] | Verdict |
|---|---|---|---|---|---|---|---|
| | | | 30~1000 | -13.71 | -68.3 | ≤-43.71 | PASS |

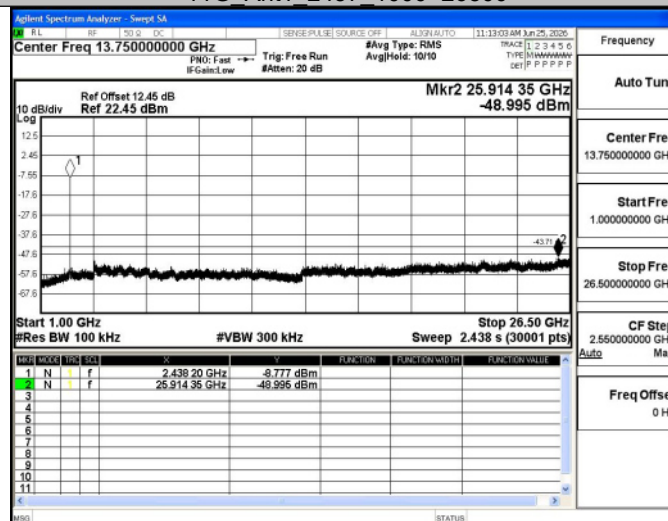
## 11G\_Ant1\_2437\_1000~26500

| TestMode | Antenna | Frequency[MHz] | FreqRange [Mhz] | RefLevel [dBm] | Result [dBm] | Limit [dBm] | Verdict |
|---|---|---|---|---|---|---|---|
| | | | 1000~26500 | -13.71 | -49 | ≤-43.71 | PASS |

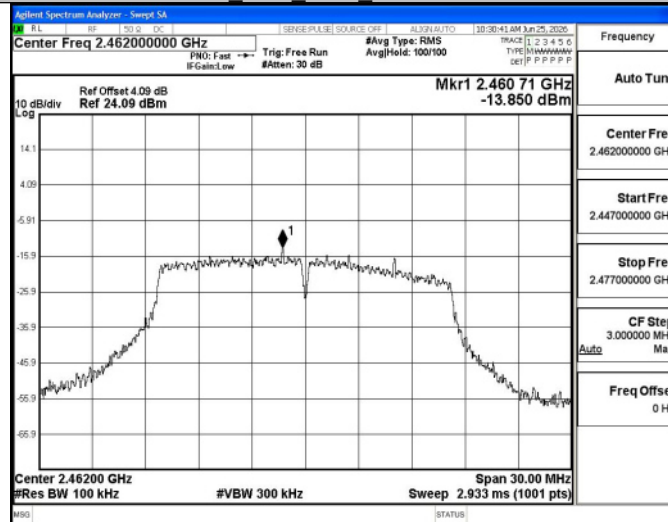
## 11G\_Ant1\_2462\_0~Reference

| TestMode | Antenna | Frequency[MHz] | FreqRange [Mhz] | RefLevel [dBm] | Result [dBm] | Limit [dBm] | Verdict |
|---|---|---|---|---|---|---|---|
| | | 2462 | Reference | -13.85 | -13.85 | --- | PASS |

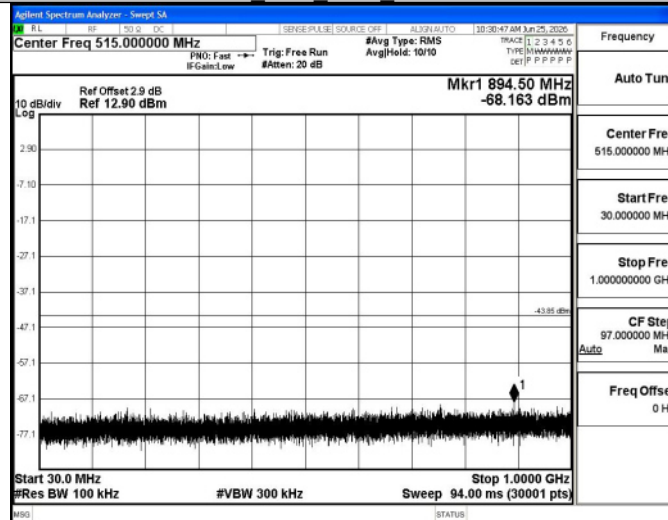
## 11G\_Ant1\_2462\_30~1000

| TestMode | Antenna | Frequency[MHz] | FreqRange [Mhz] | RefLevel [dBm] | Result [dBm] | Limit [dBm] | Verdict |
|---|---|---|---|---|---|---|---|
| | | | 30~1000 | -13.85 | -68.16 | ≤-43.85 | PASS |

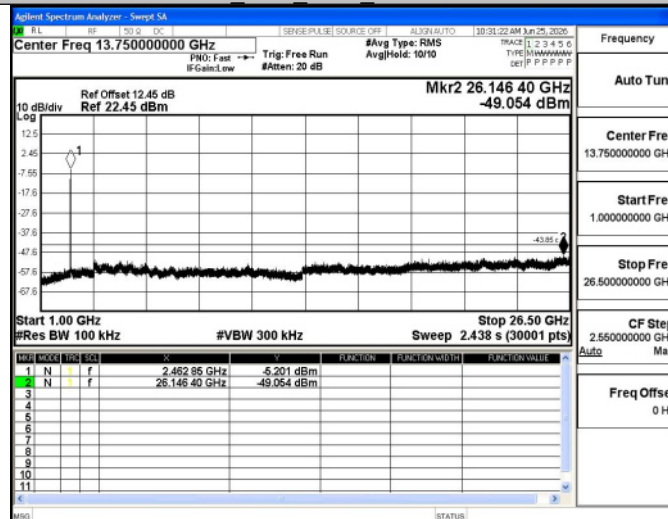
## 11G\_Ant1\_2462\_1000~26500

| TestMode | Antenna | Frequency[MHz] | FreqRange [Mhz] | RefLevel [dBm] | Result [dBm] | Limit [dBm] | Verdict |
|---|---|---|---|---|---|---|---|
| | | | 1000~26500 | -13.85 | -49.05 | ≤-43.85 | PASS |

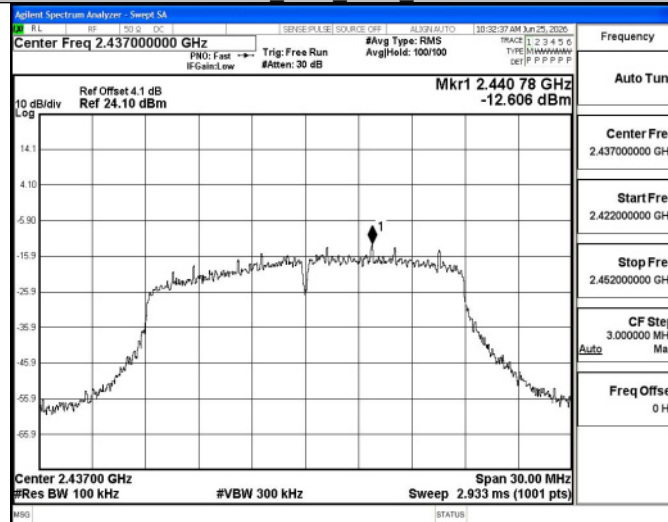
## 11N20SISO Ant1 2437 0~Reference

| TestMode | Antenna | Frequency[MHz] | FreqRange [Mhz] | RefLevel [dBm] | Result [dBm] | Limit [dBm] | Verdict |
|---|---|---|---|---|---|---|---|
| | | 2437 | Reference | -12.61 | -12.61 | --- | PASS |

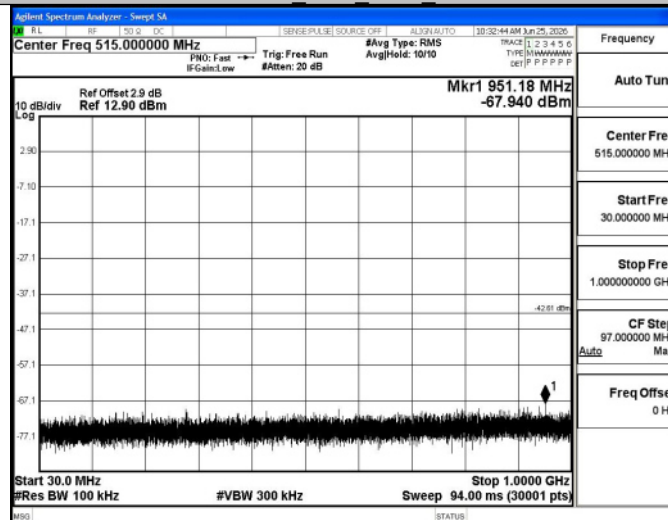
## 11N20SISO Ant1 2437 30~1000

| TestMode | Antenna | Frequency[MHz] | FreqRange [Mhz] | RefLevel [dBm] | Result [dBm] | Limit [dBm] | Verdict |
|---|---|---|---|---|---|---|---|
| | | | 30~1000 | -12.61 | -67.94 | ≤-42.61 | PASS |

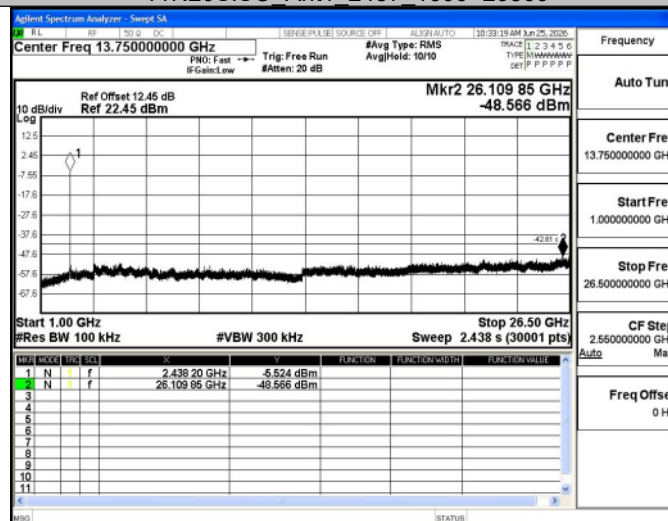
## 11N20SISO Ant1 2437 1000~26500

| TestMode | Antenna | Frequency[MHz] | FreqRange [Mhz] | RefLevel [dBm] | Result [dBm] | Limit [dBm] | Verdict |
|---|---|---|---|---|---|---|---|
| | | | 1000~26500 | -12.61 | -48.57 | ≤-42.61 | PASS |

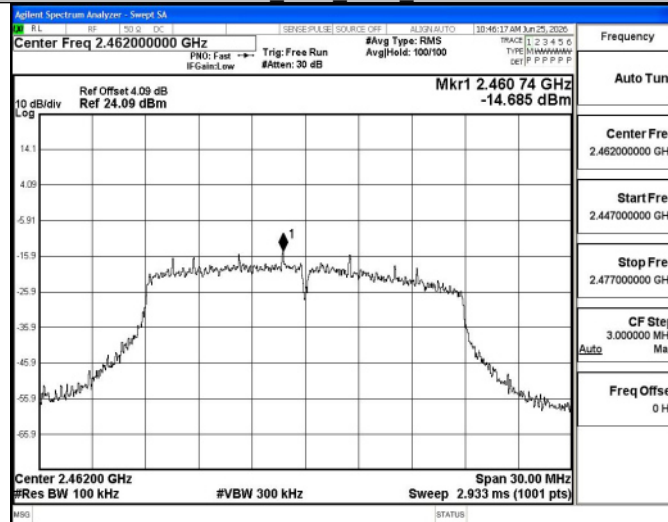
## 11N20SISO Ant1 2462 0~Reference

| TestMode | Antenna | Frequency[MHz] | FreqRange [Mhz] | RefLevel [dBm] | Result [dBm] | Limit [dBm] | Verdict |
|---|---|---|---|---|---|---|---|
| | | 2462 | Reference | -14.69 | -14.69 | --- | PASS |

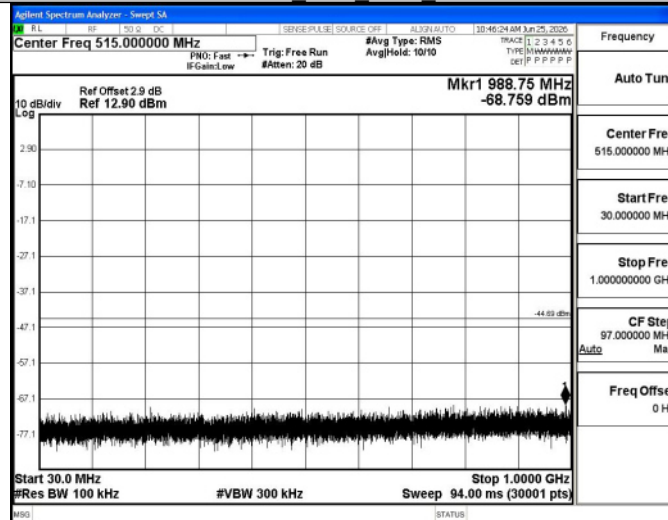
## 11N20SISO Ant1 2462 30~1000

| TestMode | Antenna | Frequency[MHz] | FreqRange [Mhz] | RefLevel [dBm] | Result [dBm] | Limit [dBm] | Verdict |
|---|---|---|---|---|---|---|---|
| | | | 30~1000 | -14.69 | -68.76 | ≤-44.69 | PASS |

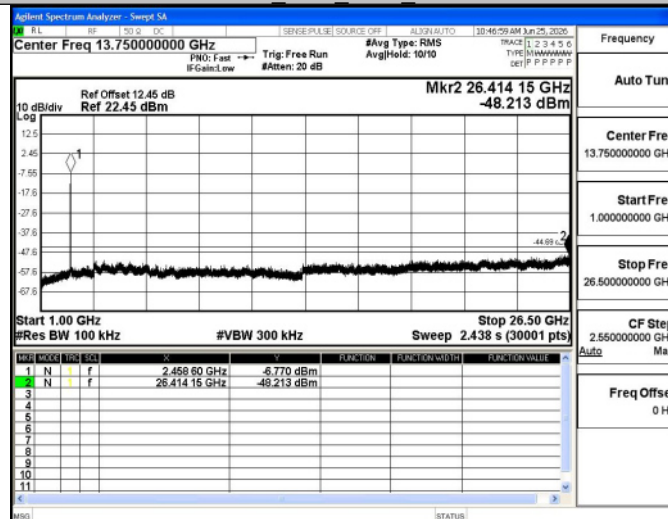
## 11N20SISO Ant1 2462 1000~26500

| TestMode | Antenna | Frequency[MHz] | FreqRange [Mhz] | RefLevel [dBm] | Result [dBm] | Limit [dBm] | Verdict |
|---|---|---|---|---|---|---|---|
| | | | 1000~26500 | -14.69 | -48.21 | ≤-44.69 | PASS |

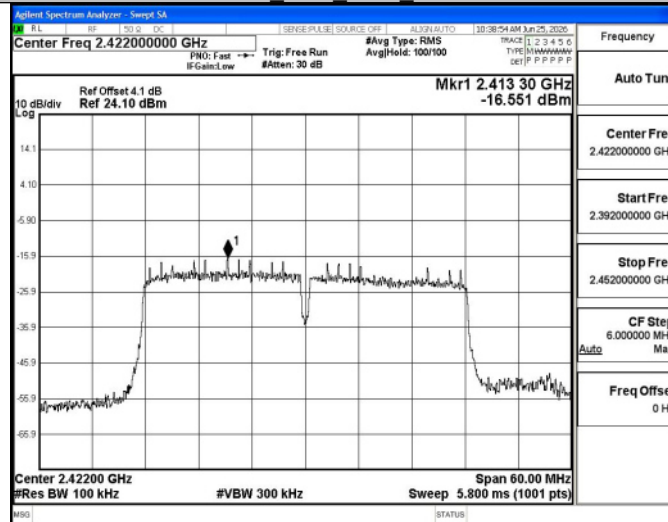
## 11N40SISO Ant1 2422 0~Reference

| TestMode | Antenna | Frequency[MHz] | FreqRange [Mhz] | RefLevel [dBm] | Result [dBm] | Limit [dBm] | Verdict |
|---|---|---|---|---|---|---|---|
| 11N40SISO | Ant1 | 2422 | Reference | -16.55 | -16.55 | --- | PASS |

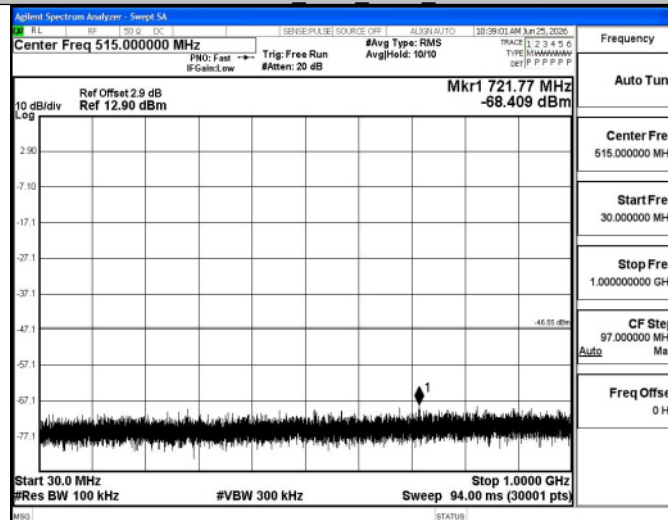
## 11N40SISO Ant1 2422 30~1000

| TestMode | Antenna | Frequency[MHz] | FreqRange [Mhz] | RefLevel [dBm] | Result [dBm] | Limit [dBm] | Verdict |
|---|---|---|---|---|---|---|---|
| | | | 30~1000 | -16.55 | -68.41 | ≤-46.55 | PASS |

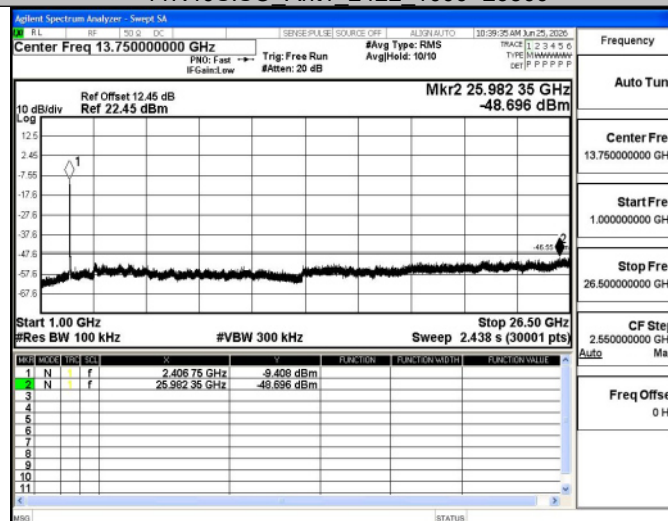
## 11N40SISO Ant1 2422 1000~26500

| TestMode | Antenna | Frequency[MHz] | FreqRange [Mhz] | RefLevel [dBm] | Result [dBm] | Limit [dBm] | Verdict |
|---|---|---|---|---|---|---|---|
| | | | 1000~26500 | -16.55 | -48.7 | ≤-46.55 | PASS |

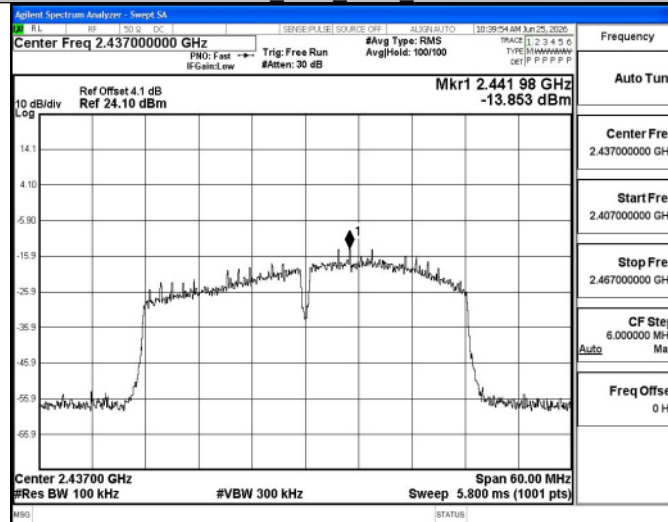
## 11N40SISO Ant1 2437 0~Reference

| TestMode | Antenna | Frequency[MHz] | FreqRange [Mhz] | RefLevel [dBm] | Result [dBm] | Limit [dBm] | Verdict |
|---|---|---|---|---|---|---|---|
| | | 2437 | Reference | -13.85 | -13.85 | --- | PASS |

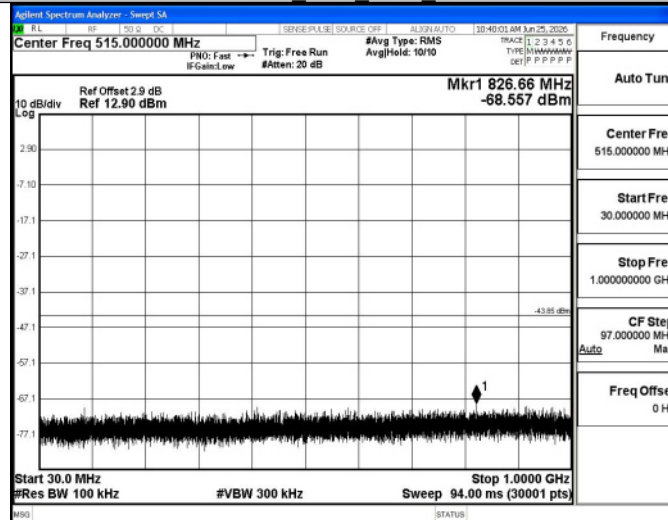
## 11N40SISO Ant1 2437 30~1000

| TestMode | Antenna | Frequency[MHz] | FreqRange [Mhz] | RefLevel [dBm] | Result [dBm] | Limit [dBm] | Verdict |
|---|---|---|---|---|---|---|---|
| | | | 30~1000 | -13.85 | -68.56 | ≤-43.85 | PASS |

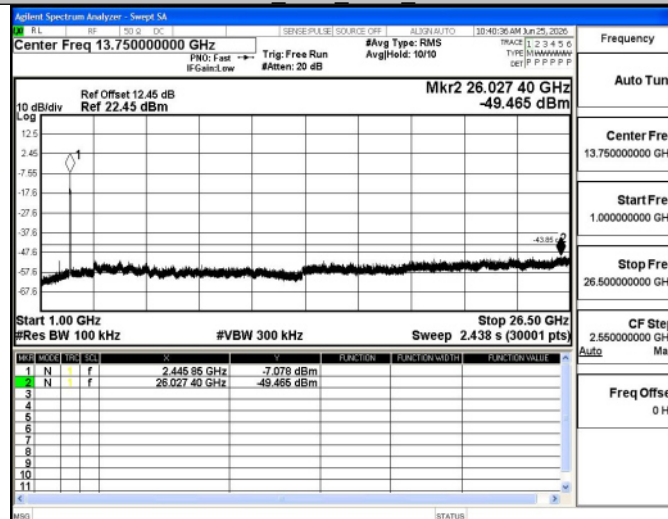
## 11N40SISO Ant1 2437 1000~26500

| TestMode | Antenna | Frequency[MHz] | FreqRange [Mhz] | RefLevel [dBm] | Result [dBm] | Limit [dBm] | Verdict |
|---|---|---|---|---|---|---|---|
| | | | 1000~26500 | -13.85 | -49.47 | ≤-43.85 | PASS |

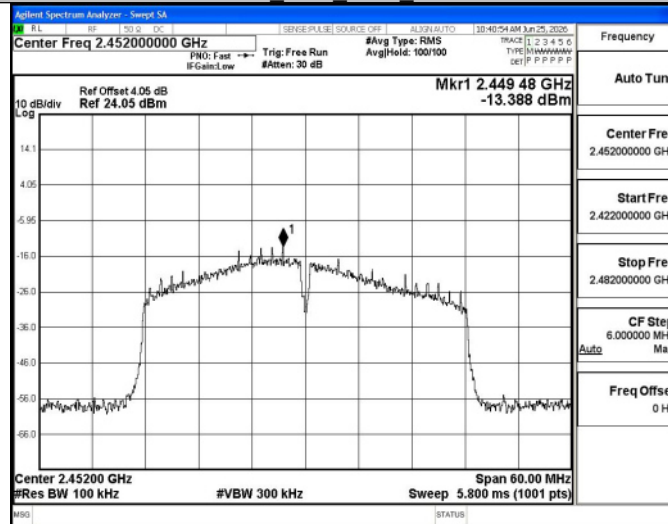
## 11N40SISO Ant1 2452 0~Reference

| TestMode | Antenna | Frequency[MHz] | FreqRange [Mhz] | RefLevel [dBm] | Result [dBm] | Limit [dBm] | Verdict |
|---|---|---|---|---|---|---|---|
| | | 2452 | Reference | -13.39 | -13.39 | --- | PASS |

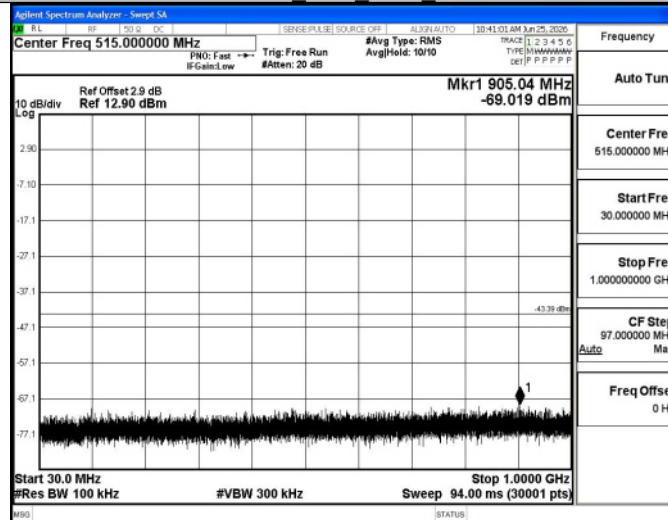
## 11N40SISO Ant1 2452 30~1000

| TestMode | Antenna | Frequency[MHz] | FreqRange [Mhz] | RefLevel [dBm] | Result [dBm] | Limit [dBm] | Verdict |
|---|---|---|---|---|---|---|---|
| | | | 30~1000 | -13.39 | -69.02 | ≤-43.39 | PASS |

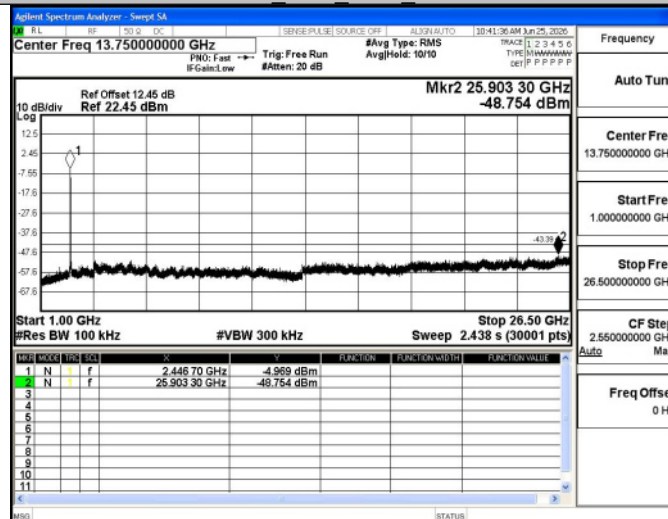
## 11N40SISO Ant1 2452 1000~26500

| TestMode | Antenna | Frequency[MHz] | FreqRange [Mhz] | RefLevel [dBm] | Result [dBm] | Limit [dBm] | Verdict |
|---|---|---|---|---|---|---|---|
| | | | 1000~26500 | -13.39 | -48.75 | ≤-43.39 | PASS |
