The End Report

Dongguan DN Testing Co., Ltd.

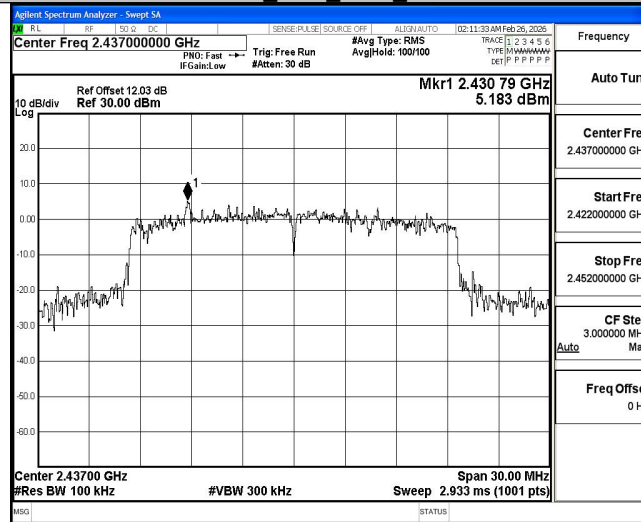
## 11AX20SISO\_Ant1\_2437\_0~Reference

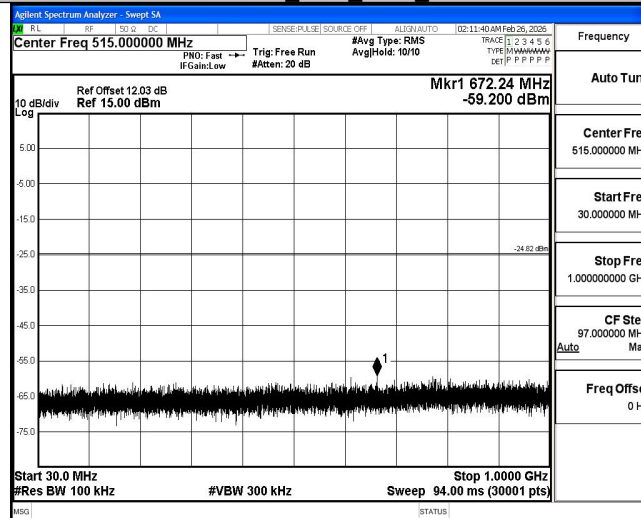
## 11AX20SISO\_Ant1\_2437\_30~1000

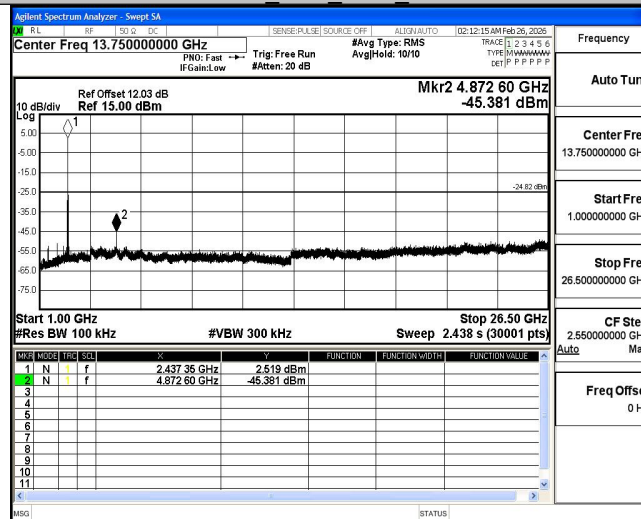
## 11AX20SISO\_Ant1\_2437\_1000~26500

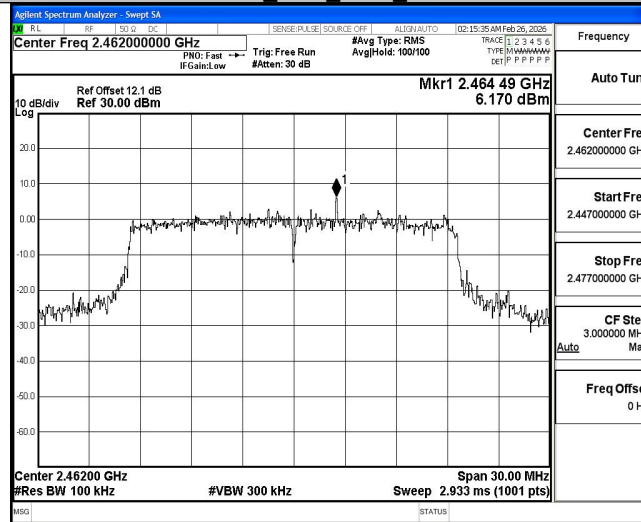
## 11AX20SISO\_Ant1\_2462\_0~Reference

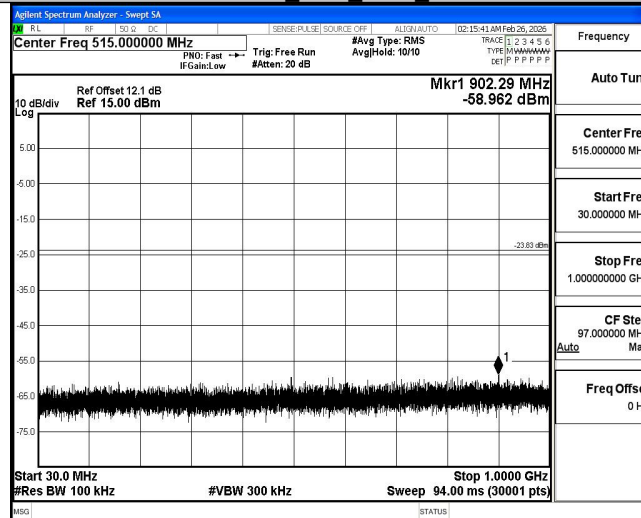
## 11AX20SISO\_Ant1\_2462\_30~1000

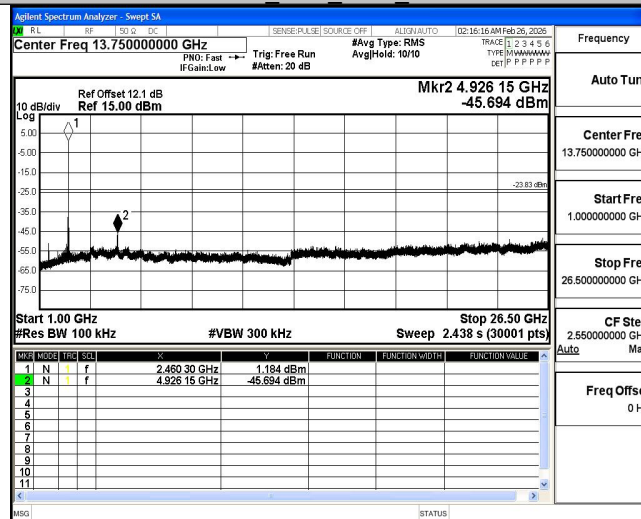
## 11AX20SISO\_Ant1\_2462\_1000~26500

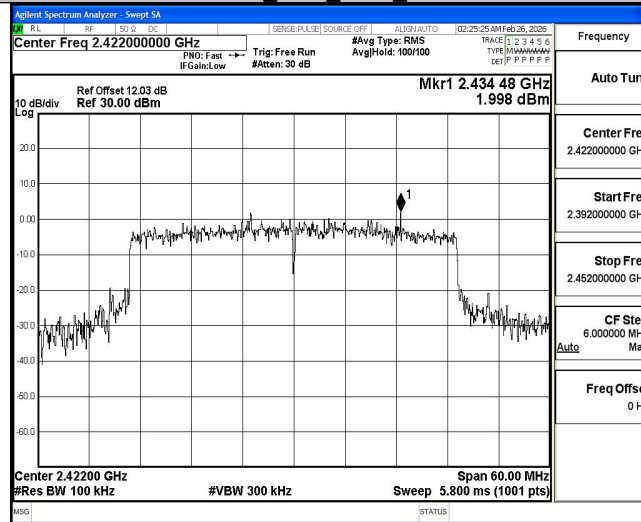
## 11AX40SISO\_Ant1\_2422\_0~Reference

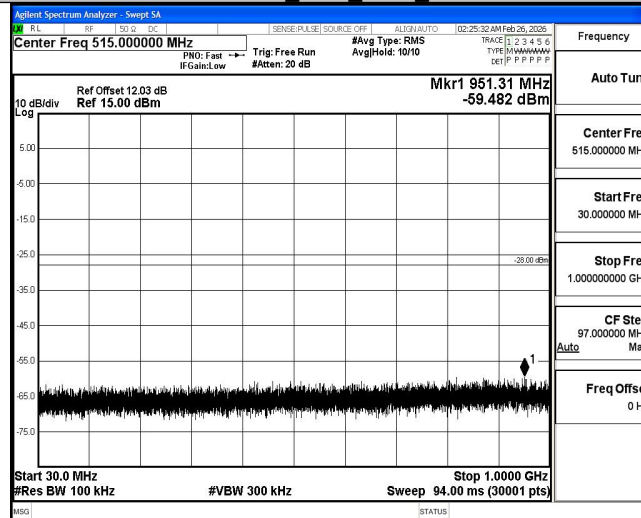
## 11AX40SISO\_Ant1\_2422\_30~1000

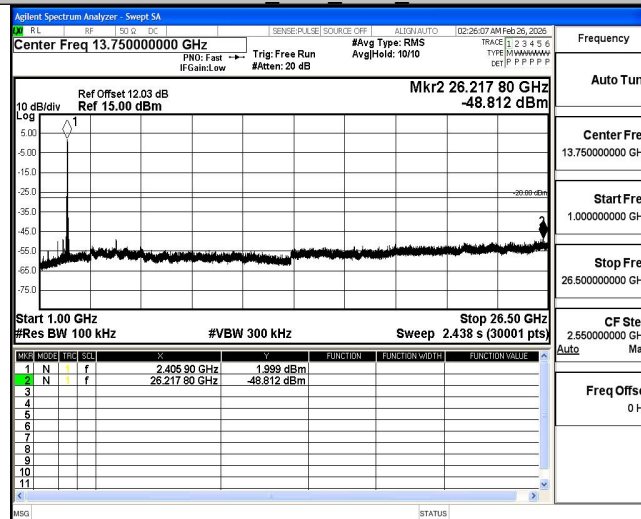
## 11AX40SISO\_Ant1\_2422\_1000~26500

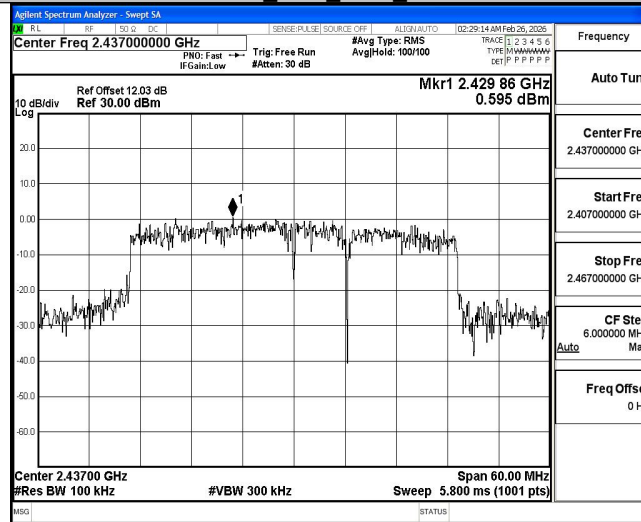
## 11AX40SISO\_Ant1\_2437\_0~Reference

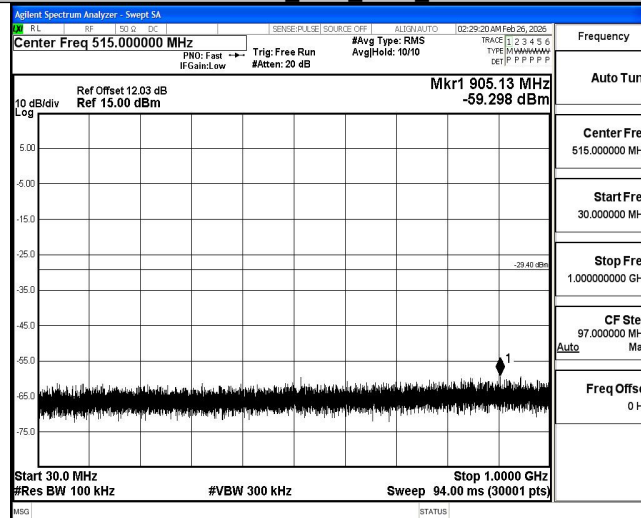
## 11AX40SISO\_Ant1\_2437\_30~1000

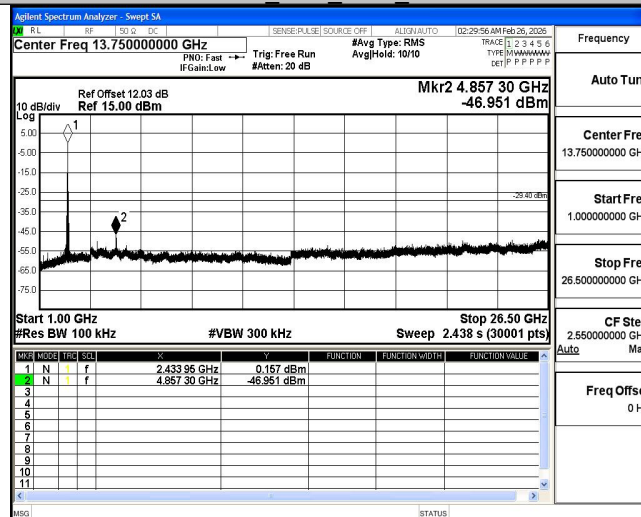
## 11AX40SISO\_Ant1\_2437\_1000~26500

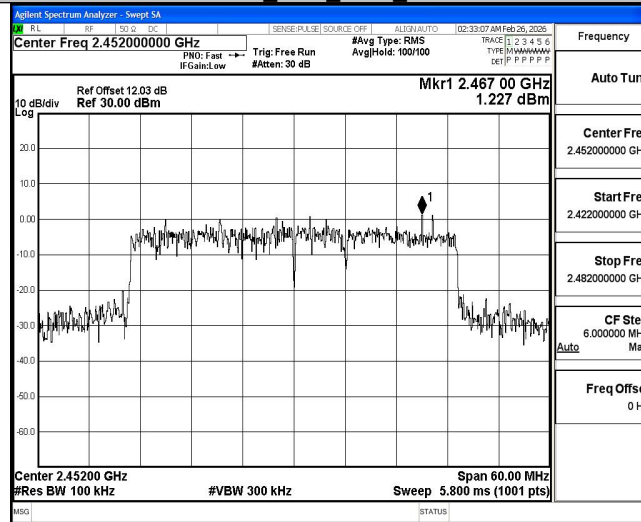
## 11AX40SISO\_Ant1\_2452\_0~Reference

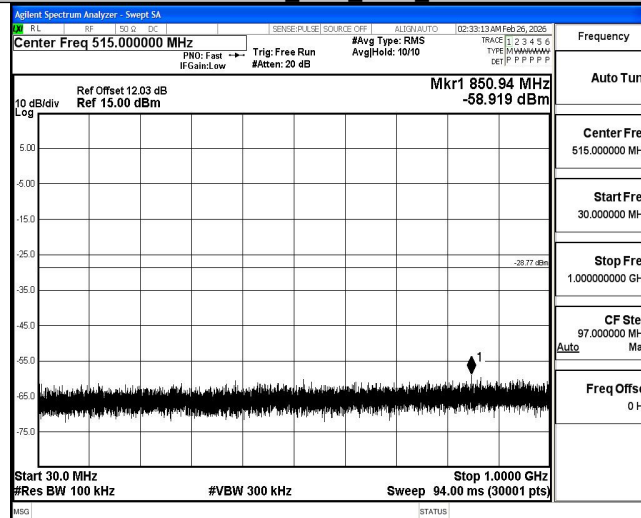
## 11AX40SISO\_Ant1\_2452\_30~1000

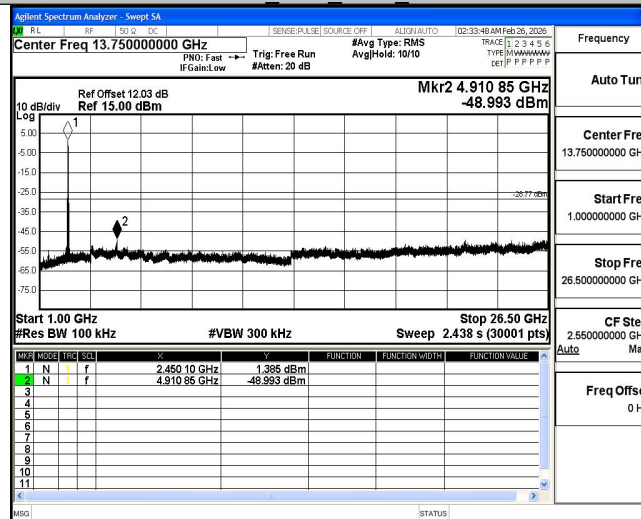
## 11AX40SISO\_Ant1\_2452\_1000~26500
