## Appendix B: photographs of test setup

## Appendix C: photographs of EUT

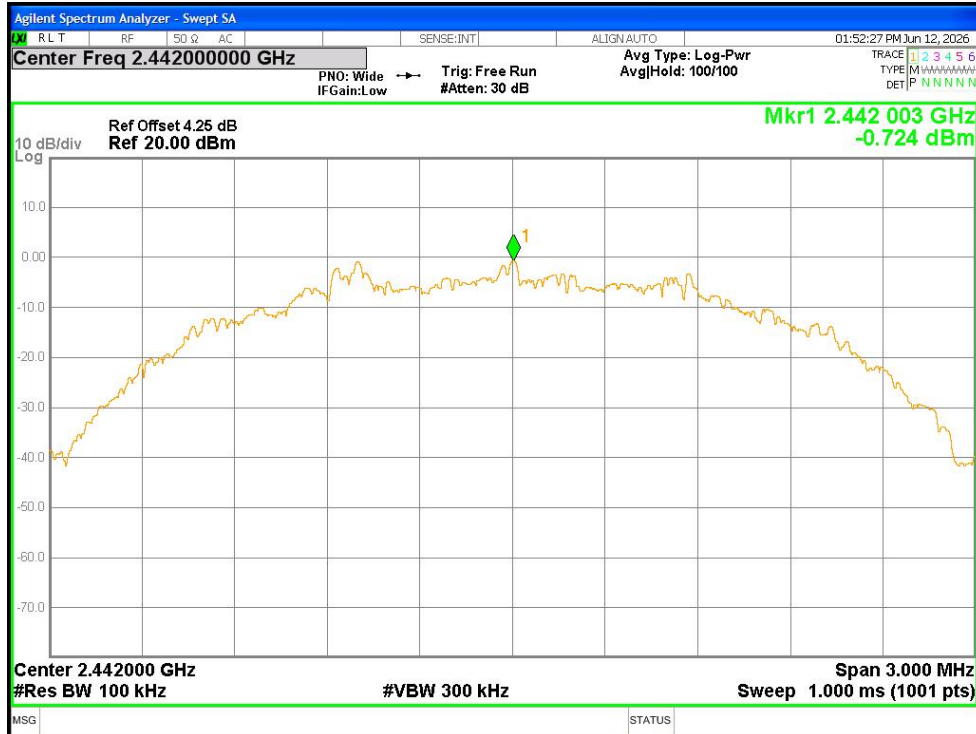
Tx. Spurious NVNT BLE 2M 2442MHz Ant1 Emission

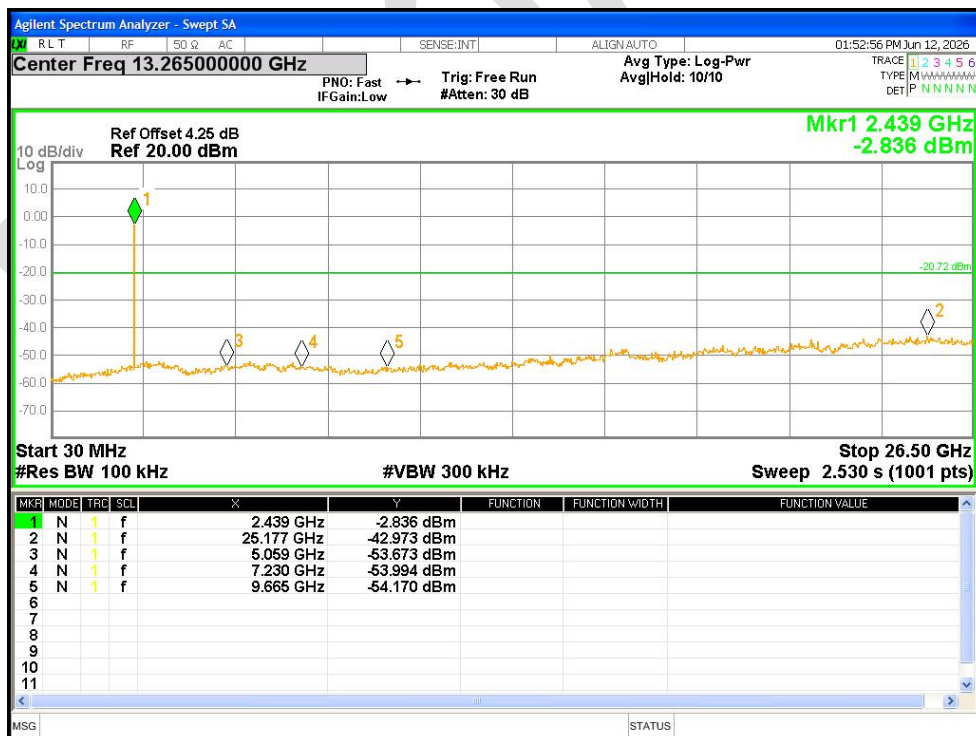
Tx. Spurious NVNT BLE 2M 2480MHz Ant1 Ref

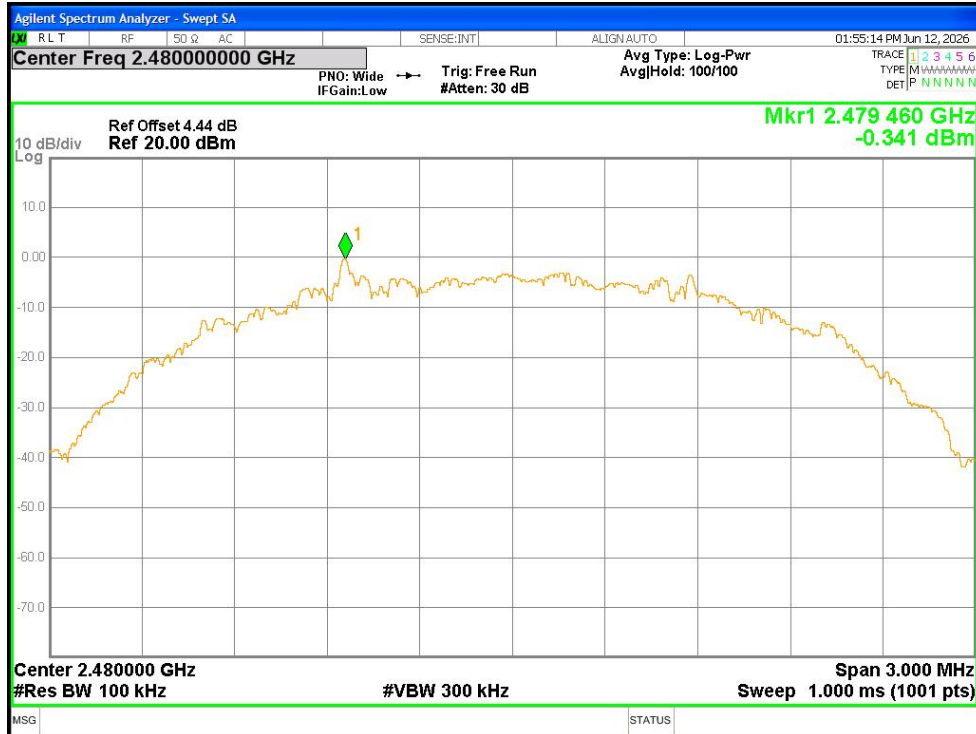
Tx. Spurious NVNT BLE 2M 2480MHz Ant1 Emission

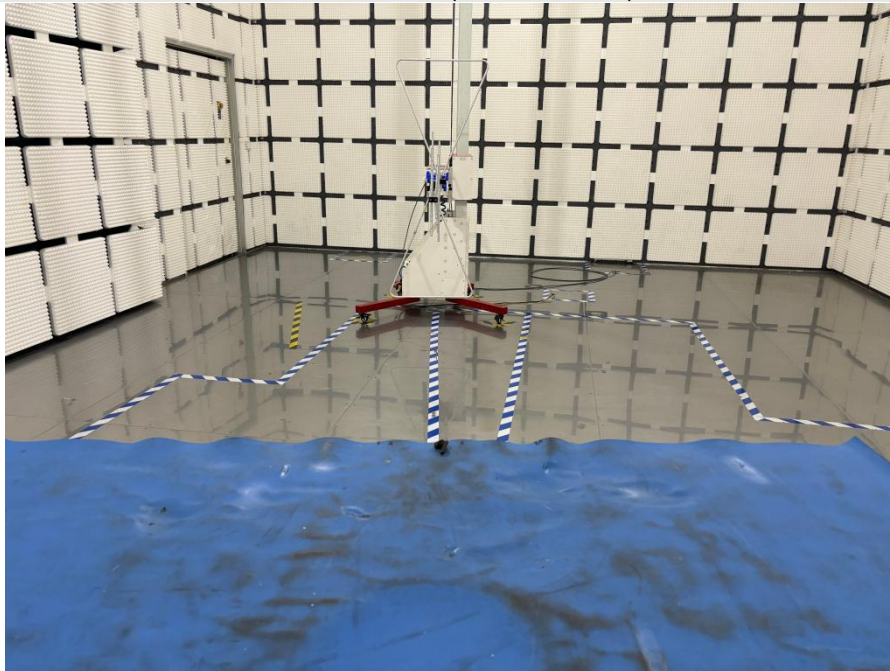
Radiated Emissions (30MHz-1GHz) L ear

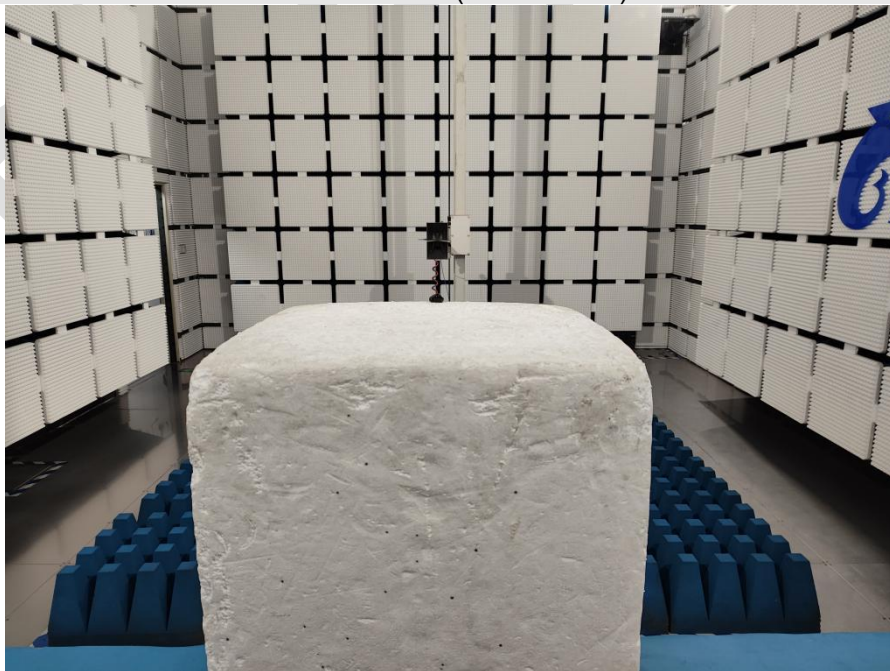
Radiated Emissions (above 1GHz) L ear
