# FCC SAR Test Report

## <Photographs of SAR Setup>

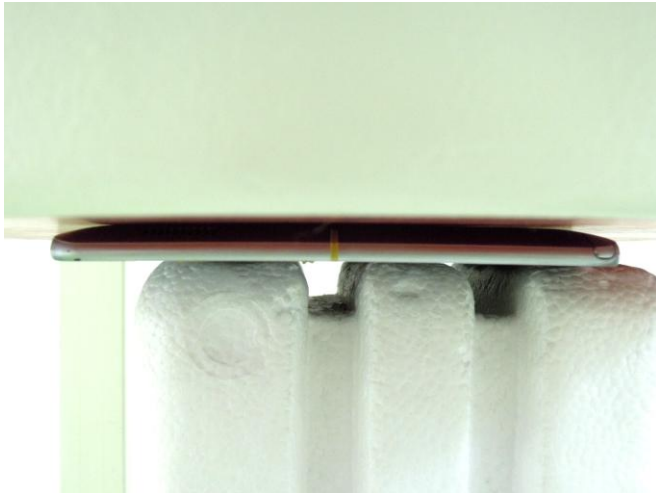
Rear Face of EUT with 0 cm Gap

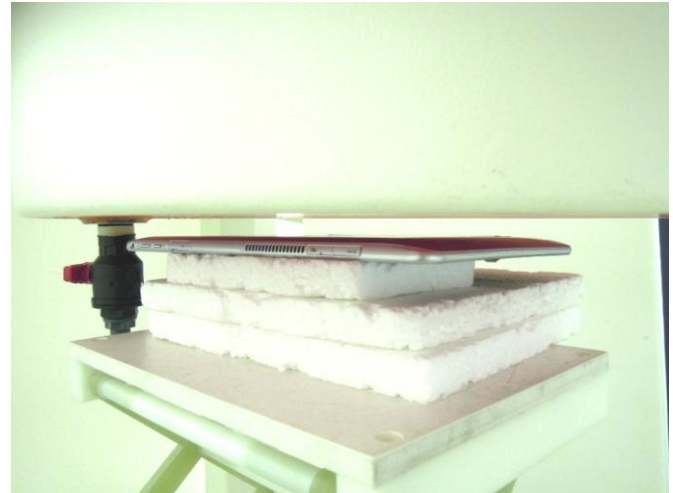
Rear Face of EUT with 1.6 cm Gap

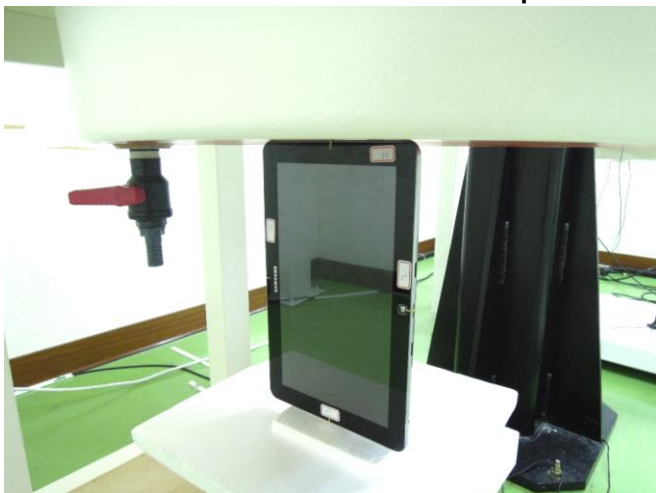
Primary Portrait with 0 cm Gap

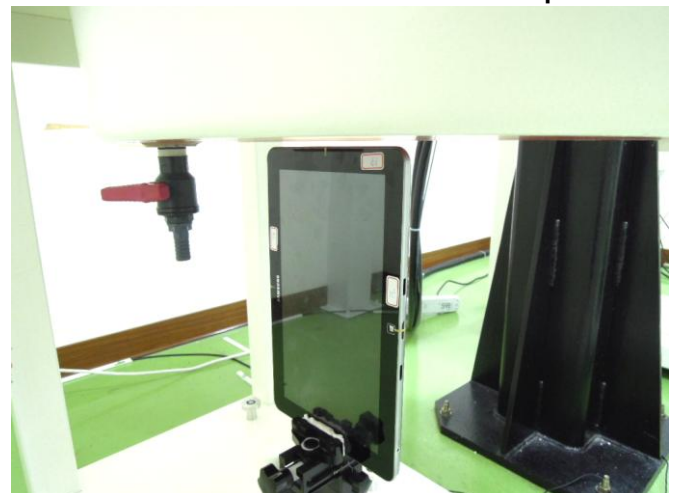
Primary Portrait with 0.9 cm Gap

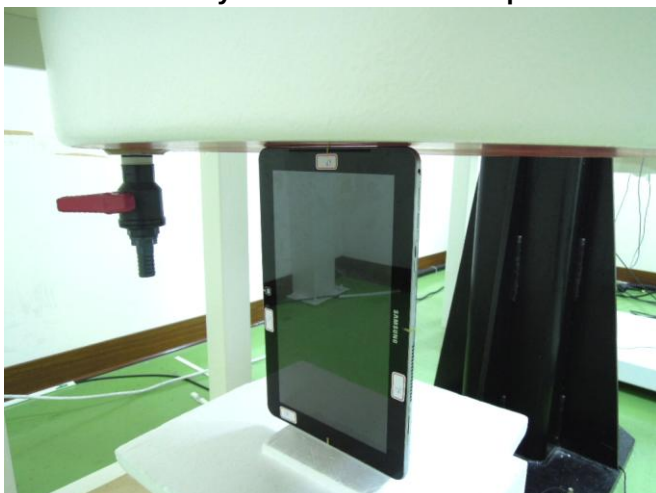
Secondary Portrait with 0 cm Gap

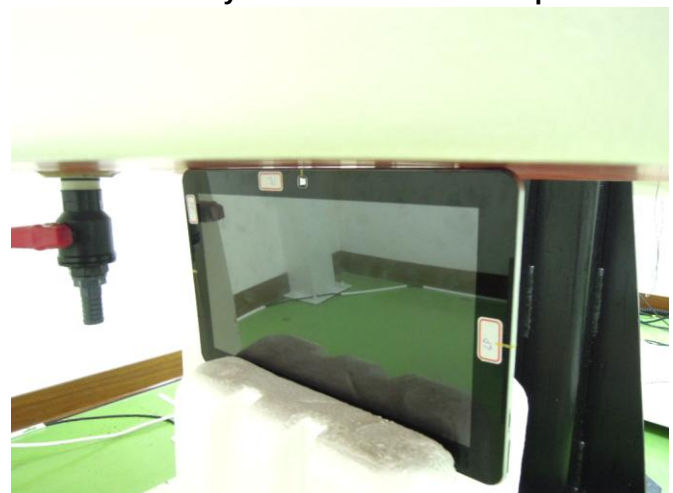
Primary Landscape with 0 cm Gap

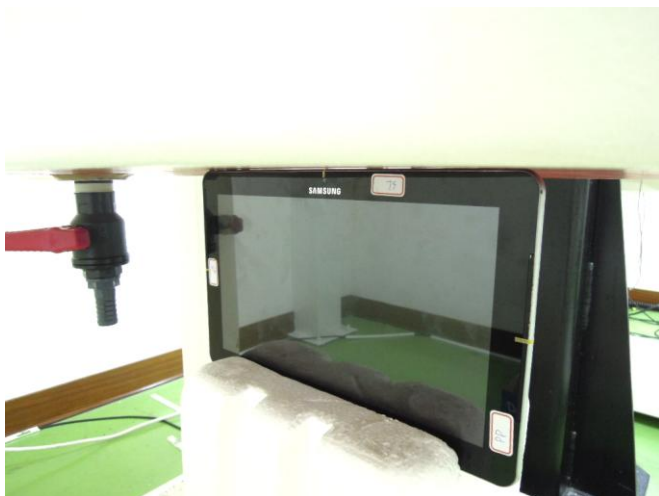
**Secondary Landscape with 0 cm Gap**

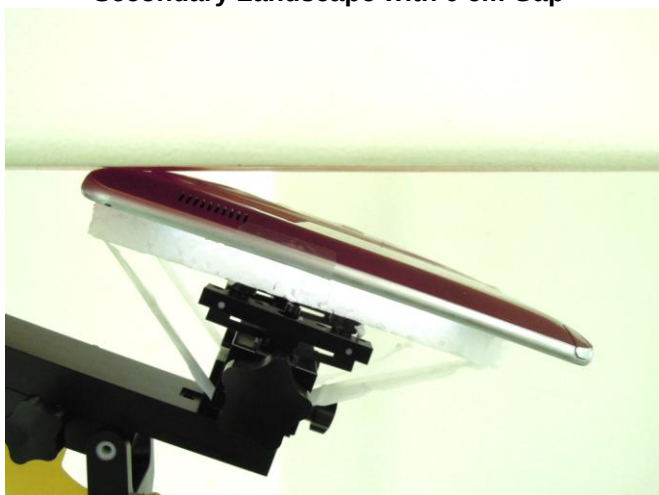
**Rear Face of EUT with 0 cm Gap  
(Top Edge/Left Rear Corner at 20 degree)**

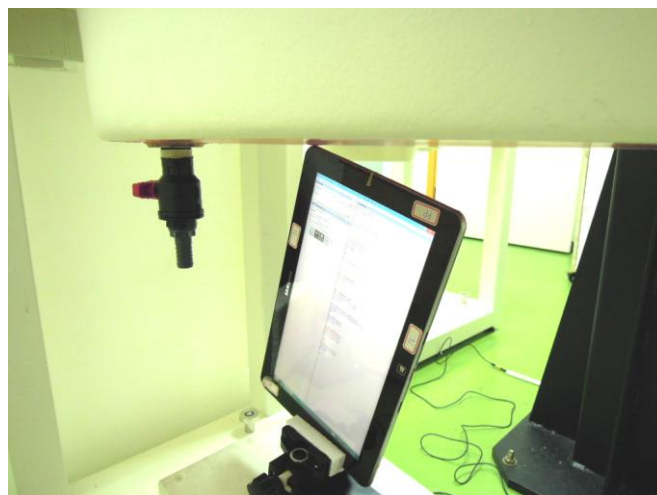
**Primary Portrait with 0 cm Gap  
(Top Edge/Left Corner at 14 degree)**
