## APPENDIX D: SAR TEST SETUP PHOTOGRAPHS

| <b>FCC ID:</b> A3LGT18190 | | <b>SAR EVALUATION REPORT</b> | | <b>Reviewed by:</b><br>Quality Manager |
| <b>Test Dates:</b><br>09/25/12 - 10/02/12 | <b>DUT Type:</b><br>Portable Handset | | | Page D1 of D6 |

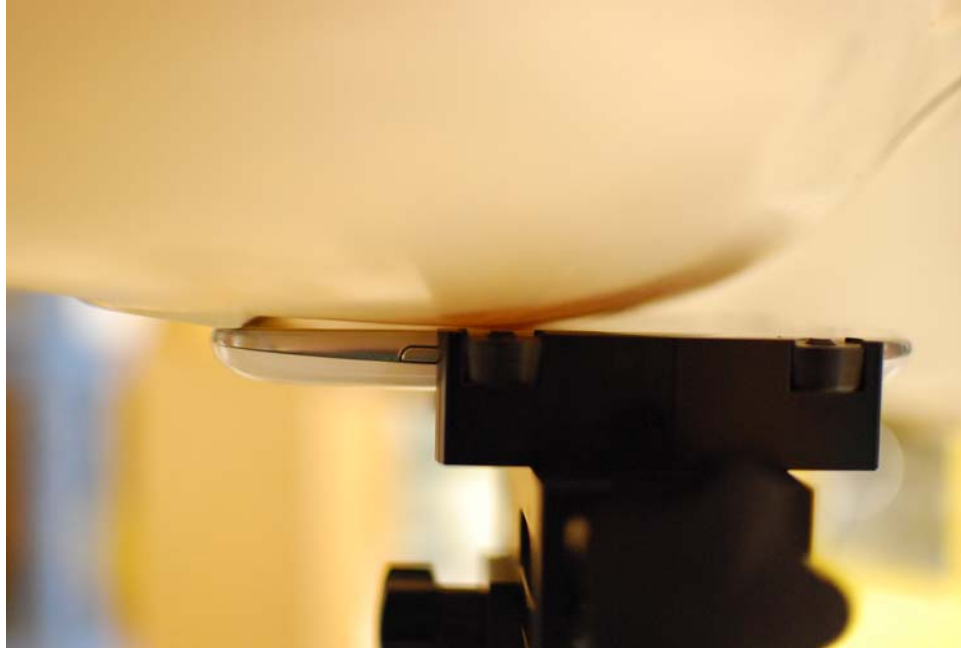
**SAR Test Setup Photo 1 – Right Cheek**

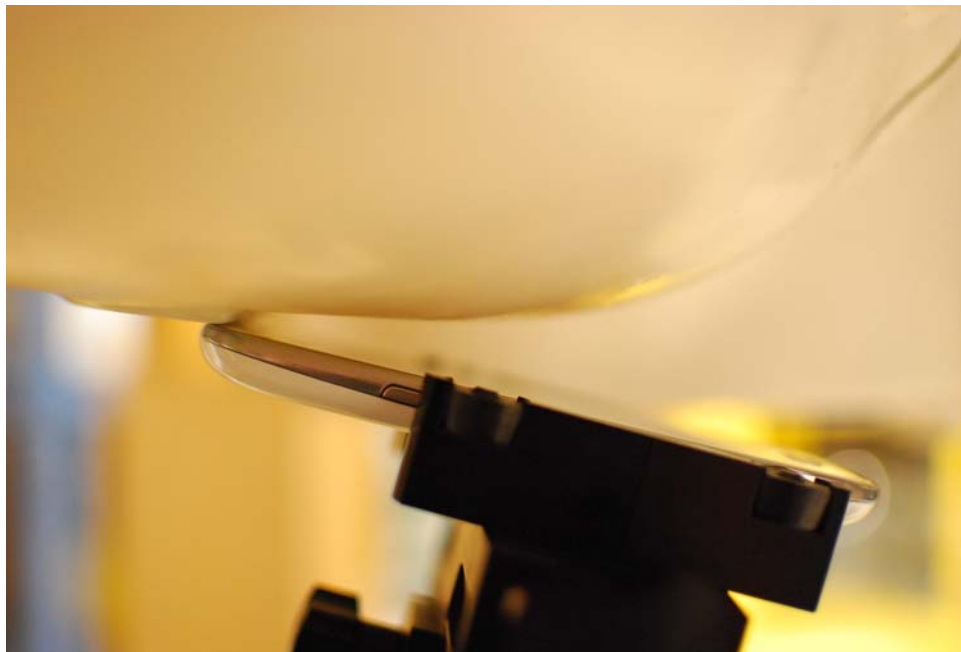
**SAR Test Setup Photo 2 – Right Tilt**

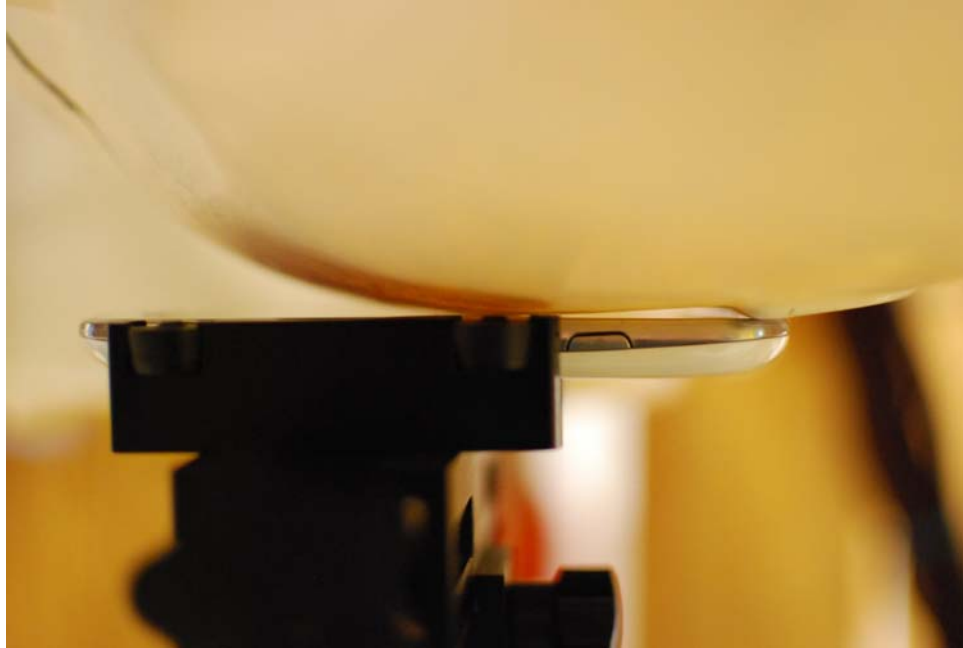
**SAR Test Setup Photo 3 – Left Cheek**

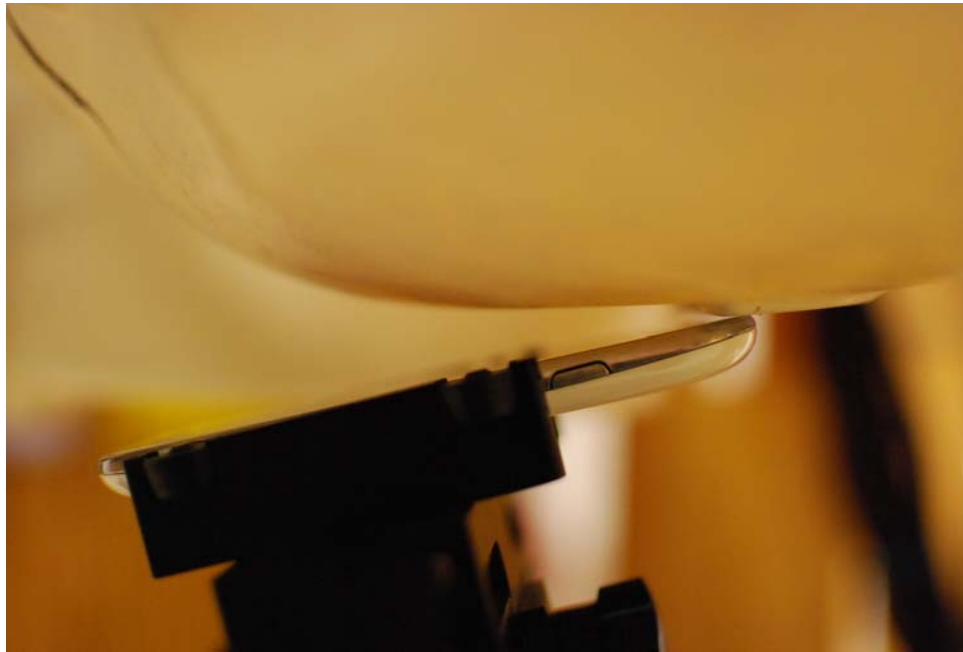
**SAR Test Setup Photo 4 – Left Tilt**

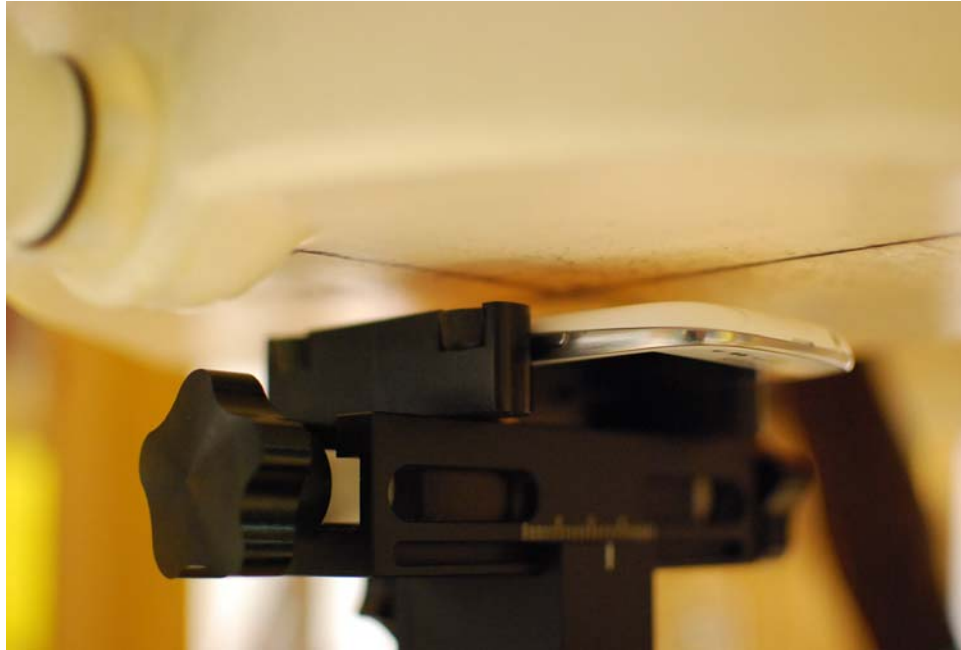
**SAR Test Setup Photo 5 – Back Side at 1.0 cm**

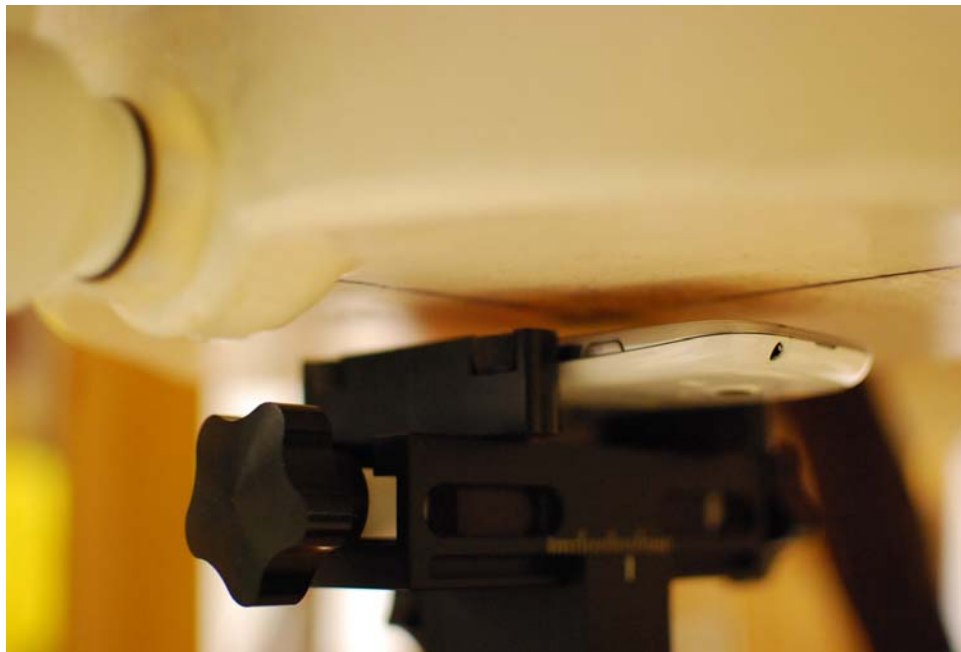
**SAR Test Setup Photo 6 – Front Side at 1.0 cm**

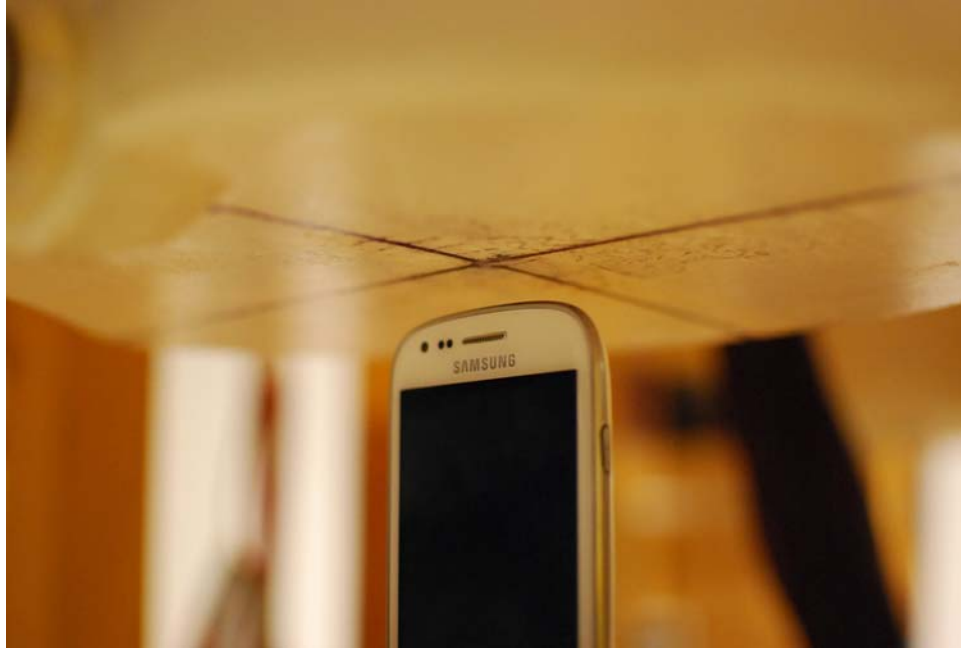
**SAR Test Setup Photo 7 – Top Edge at 1.0 cm**

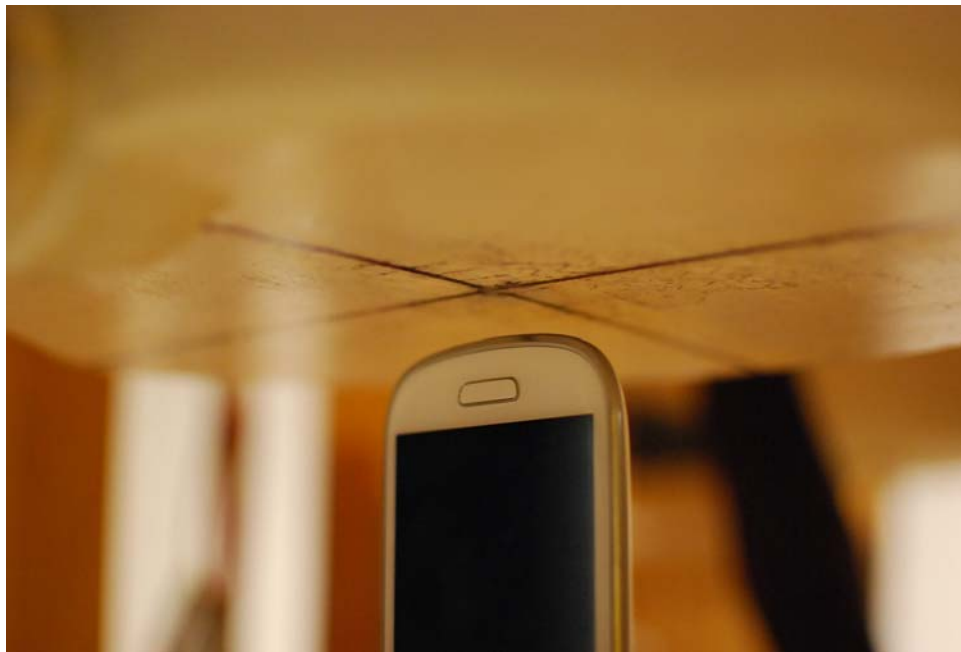
**SAR Test Setup Photo 8 – Bottom Edge at 1.0 cm**

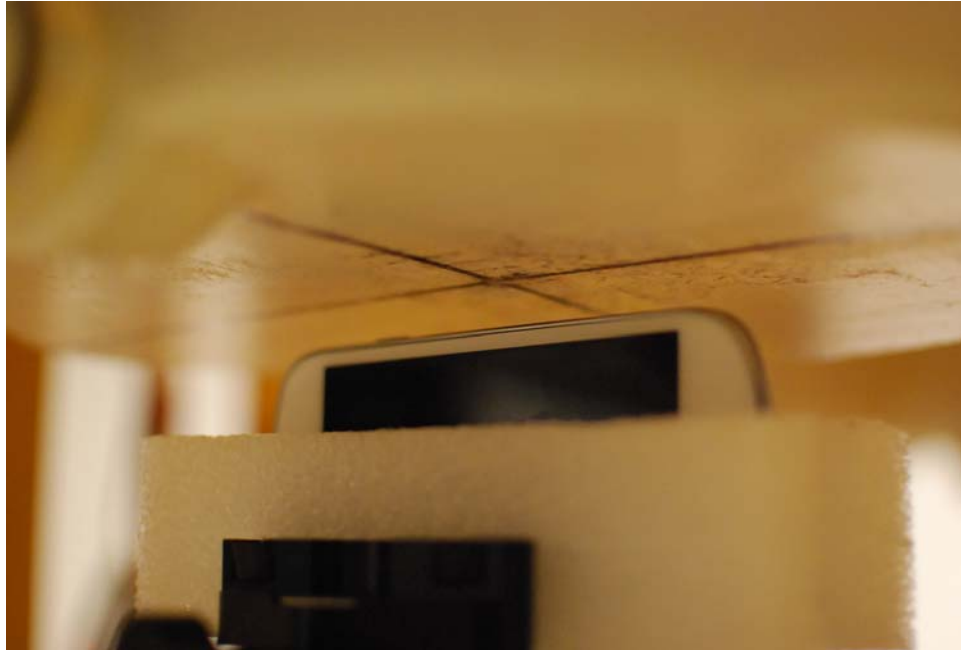
**SAR Test Setup Photo 9 – Right Edge at 1.0 cm**

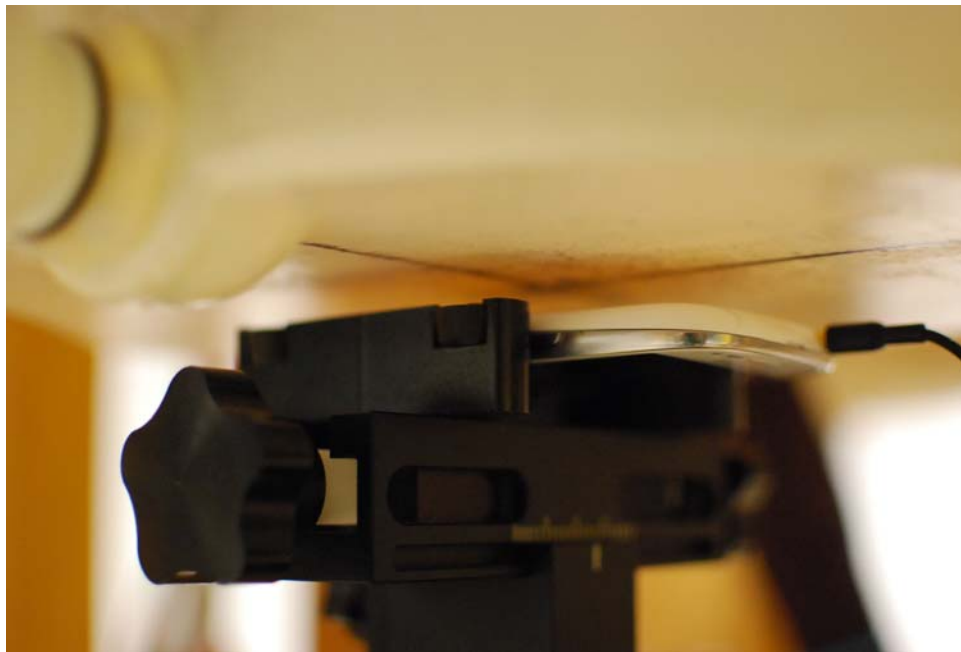
**SAR Test Setup Photo 10 – Body-Worn at 1.0 cm**

**Note:** Headset Cable is connected to the device during some body-worn SAR assessment, as seen above.
