## 19 SAR TEST SETUP PHOTOGRAPHS

| <b>FCC ID:</b> A3LSCHR261 | | <b>SAR COMPLIANCE REPORT</b> | | <b>Reviewed by:</b><br>Quality Manager |
| <b>Filename:</b><br>0Y1103140508-R1.A3L | <b>Test Dates:</b><br>03/14/11 - 03/18/11 | <b>EUT Type:</b><br>Cellular/AWS/PCS CDMA Phone with Bluetooth | | Page 31 of 34 |

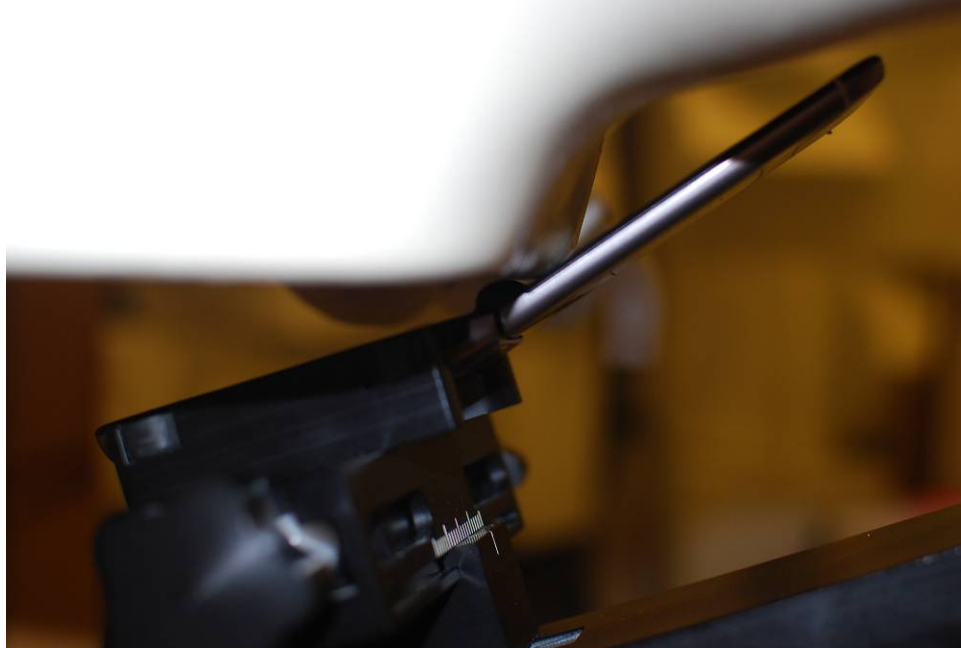
**Figure 19-1**  
**SAR Test Setup Photo 1 – Mouth-Jaw**

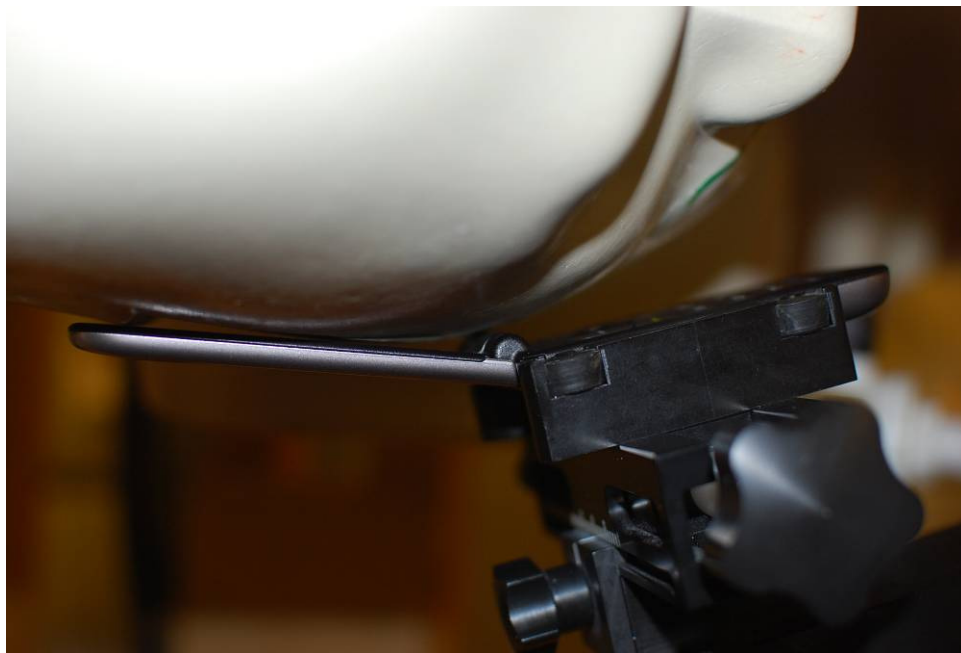
**Figure 19-2**  
**SAR Test Setup Photo 2 – Right Touch**

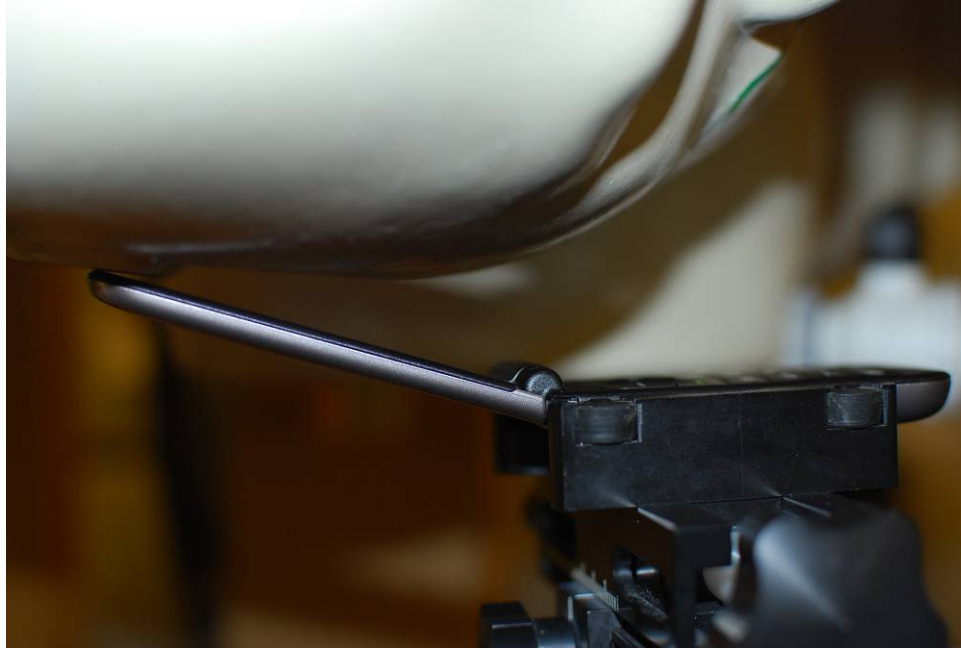
**Figure 19-3**  
**SAR Test Setup Photo 3 – Right Tilt**

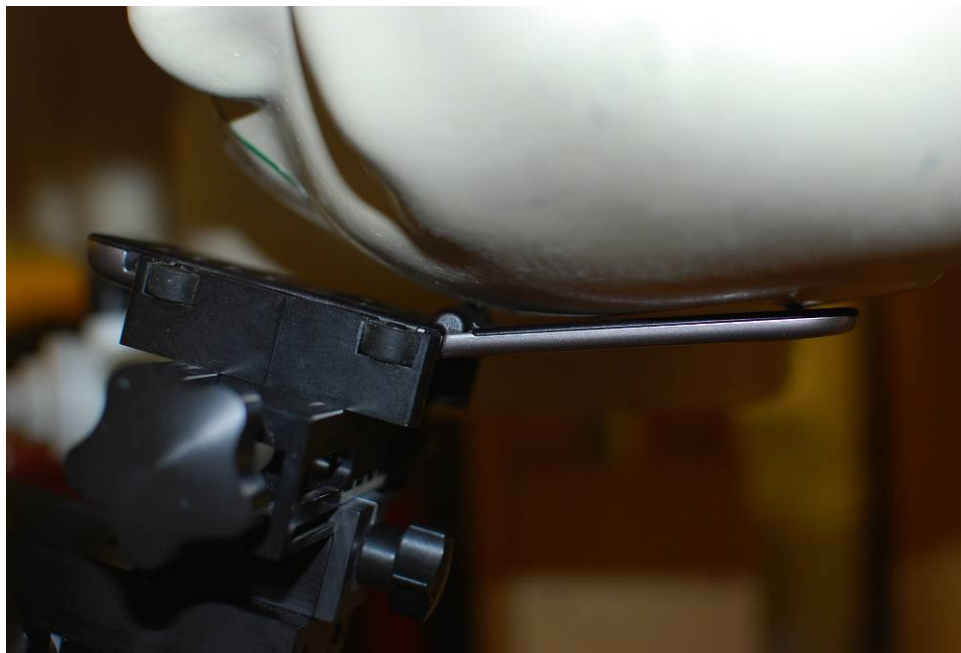
**Figure 19-4**  
**SAR Test Setup Photo 4 – Left Touch**

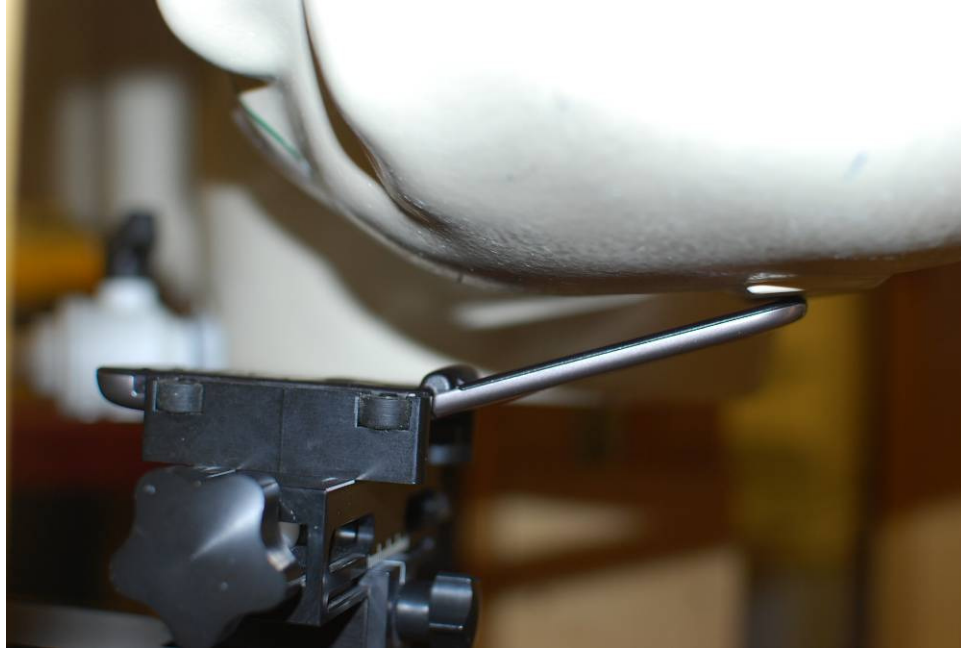
**Figure 19-5**  
**SAR Test Setup Photo 5 – Left Tilt**

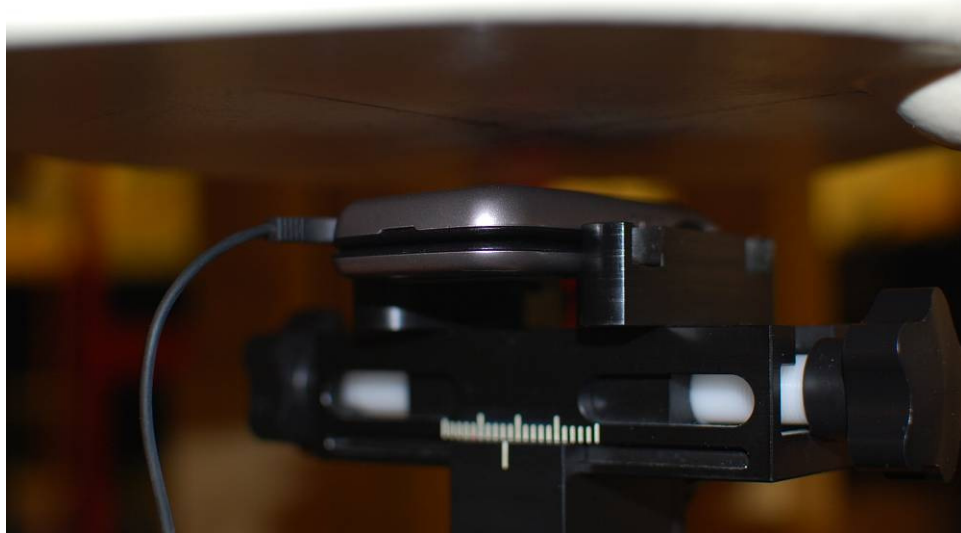
**Figure 19-6**  
**SAR Test Setup Photo 6 – Body Back**

**Note:** Headset Cable is connected to the device during Body SAR assessment, as seen above.
