**Appendix D. Antenna Location & Distance**

Report No.:  
KR19-SPF0032-A  
Page (290) of (308)

### Appendix E. EUT Photo

### Appendix F. Test Setup Photo

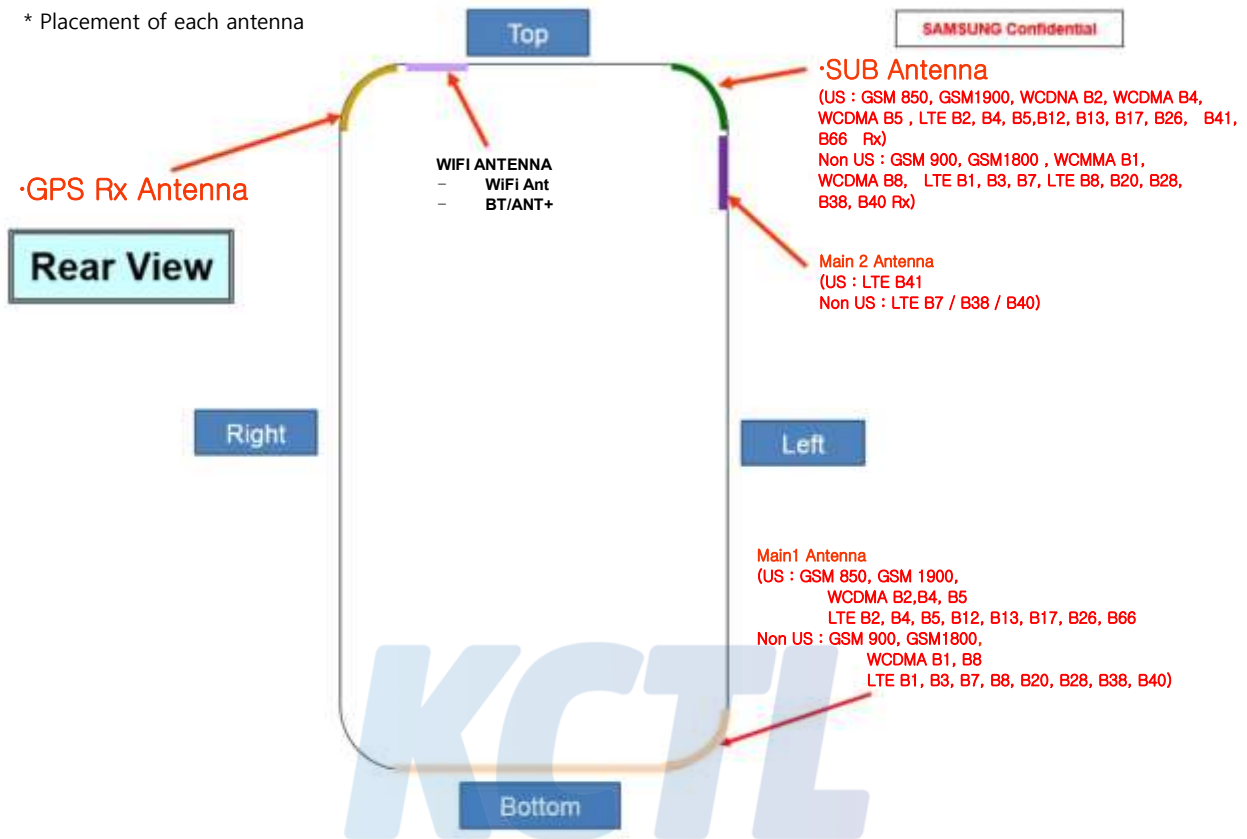
\* Placement of each antenna

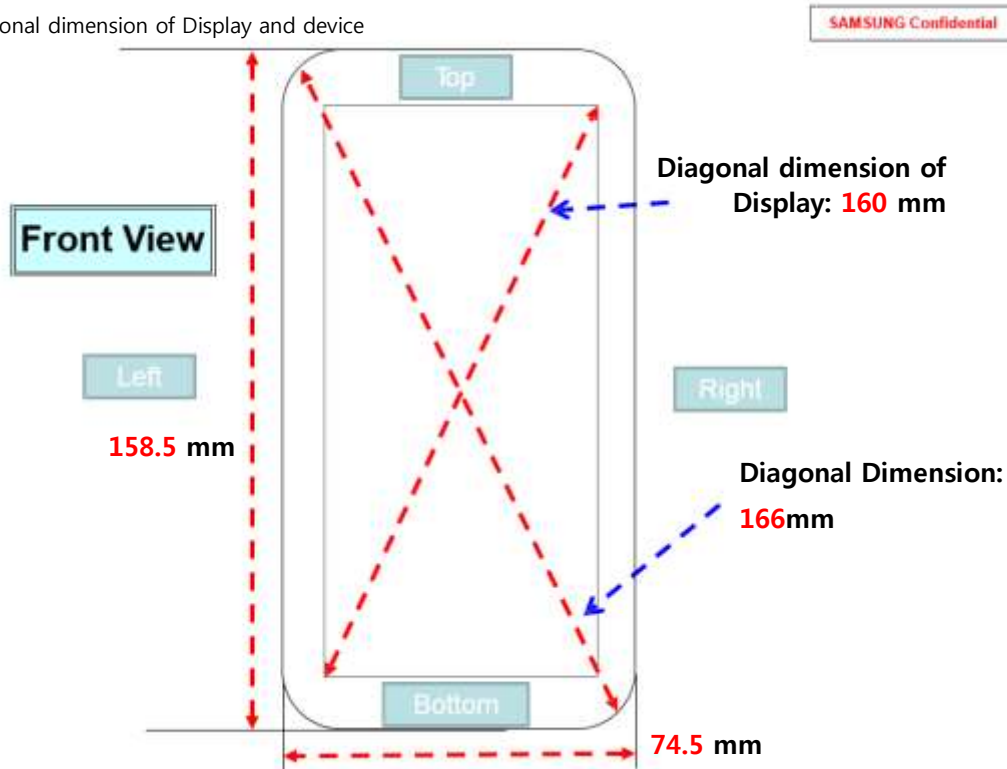
\* Diagonal dimension of Display and device

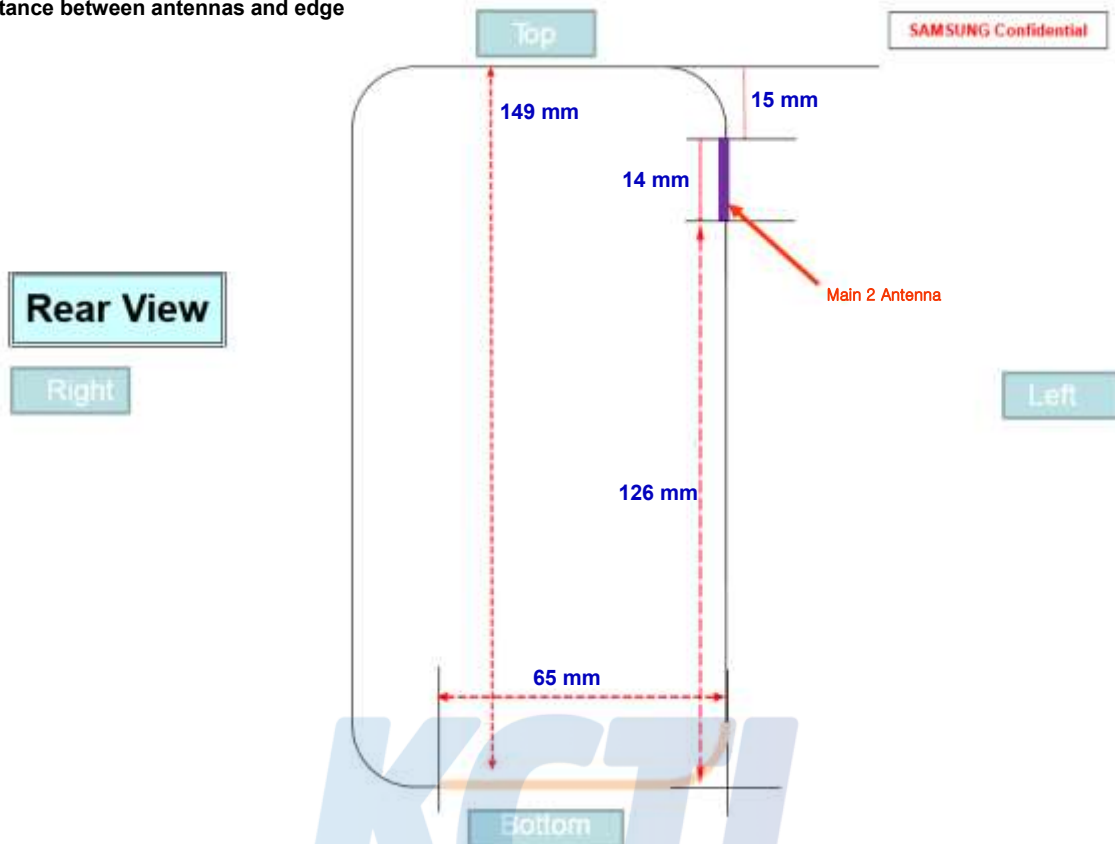
**\* Distance between antennas and edge**

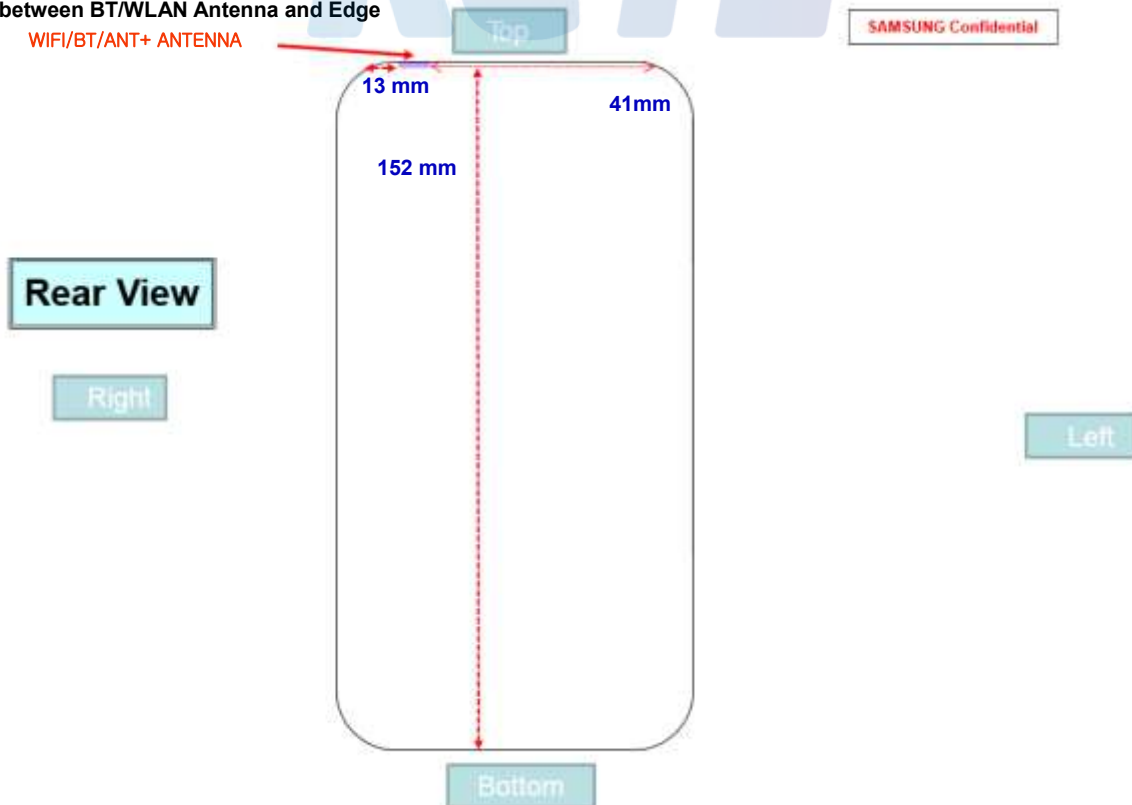
**\* Distance between BT/WLAN Antenna and Edge**

WIFI/BT/ANT+ ANTENNA

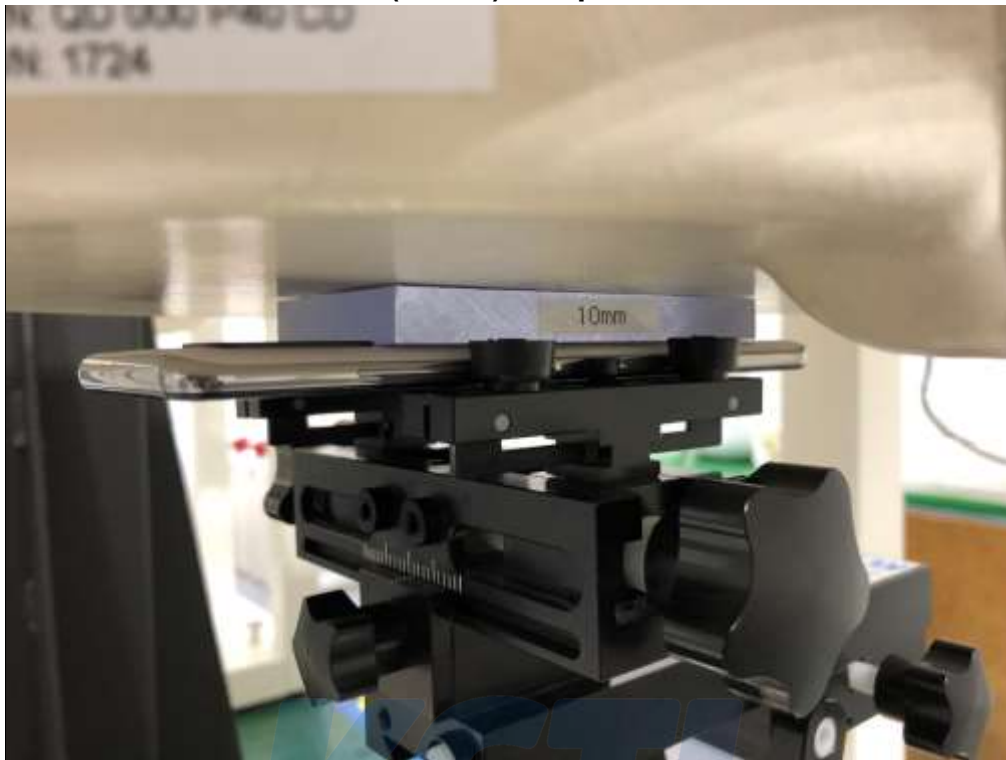
**Rear (10mm) - Grip Sensor**

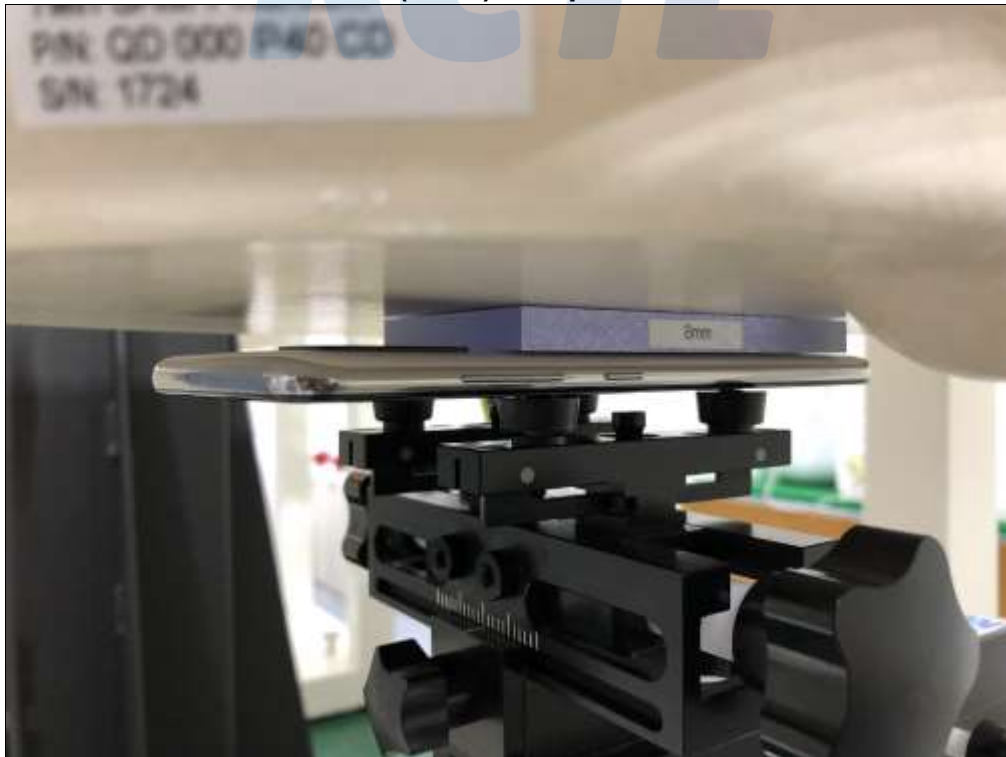
**Rear (8mm) - Grip Sensor**

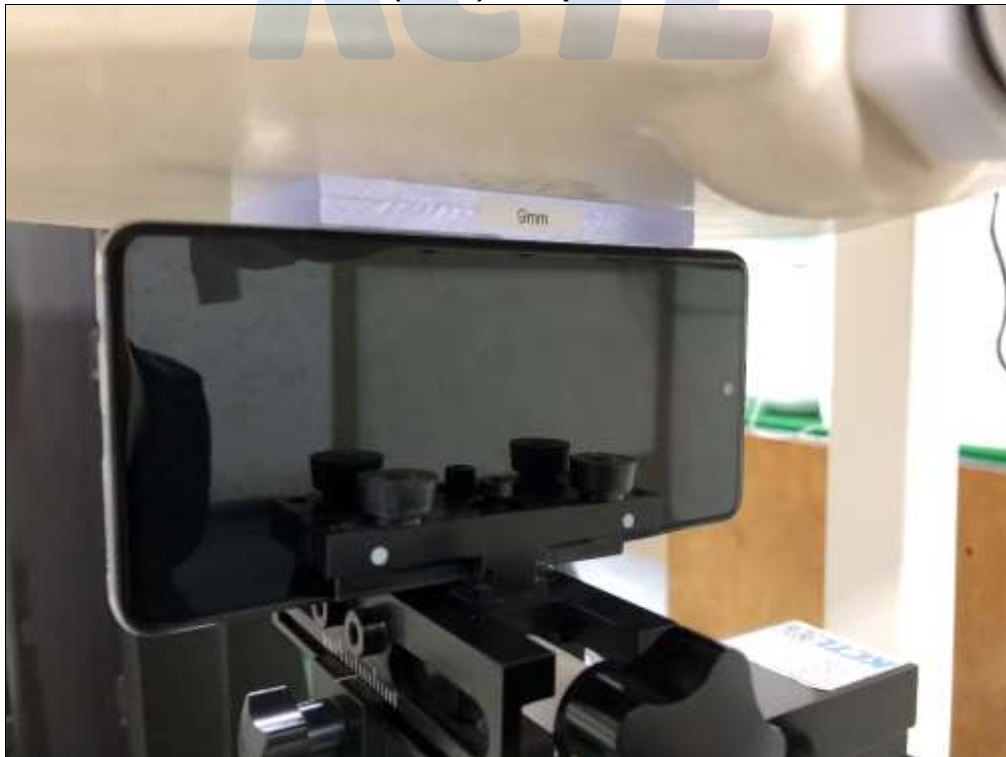
**Left (9mm) - Grip Sensor**

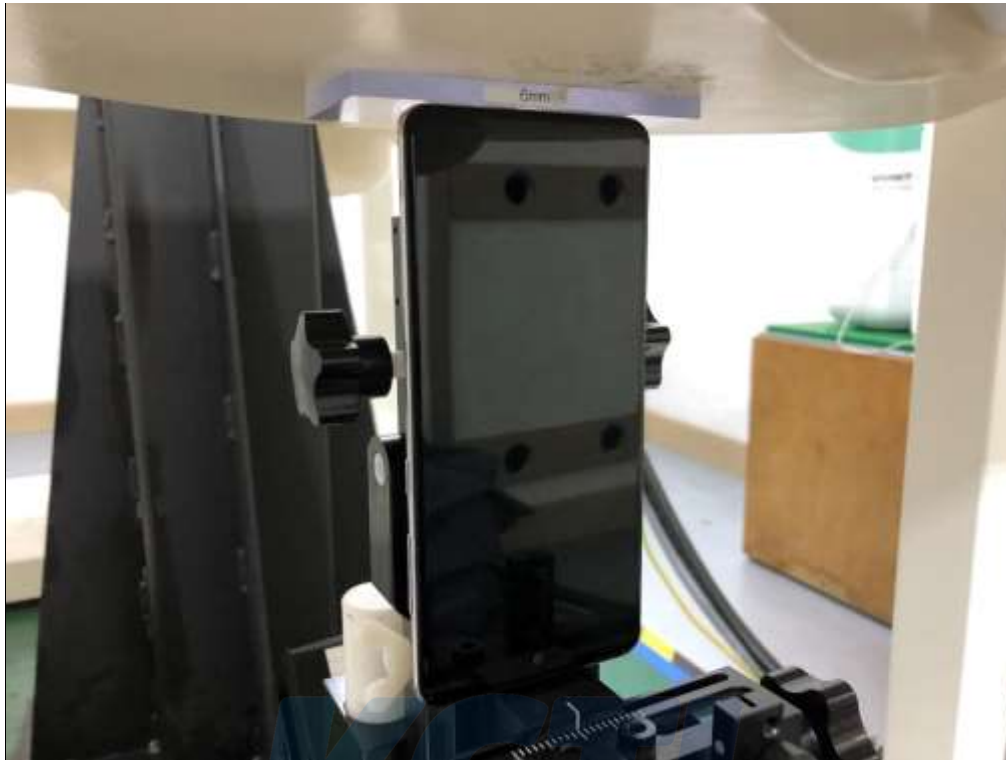
**Bottom (6mm) - Grip Sensor**
