APPENDIX B: TEST SETUP PHOTOGRAPHS

| FCC ID: A3LSMS938U | <b>WPT RF EXPOSURE EVALUATION REPORT</b> | <b>Reviewed by:</b><br>Quality Manager |
| <b>Test Dates:</b><br>10/14/2024 – 11/1/2024 | <b>Apparatus/Device:</b><br>Mobile Handset | <b>APPENDIX B:</b><br>Page 1 of 6 |

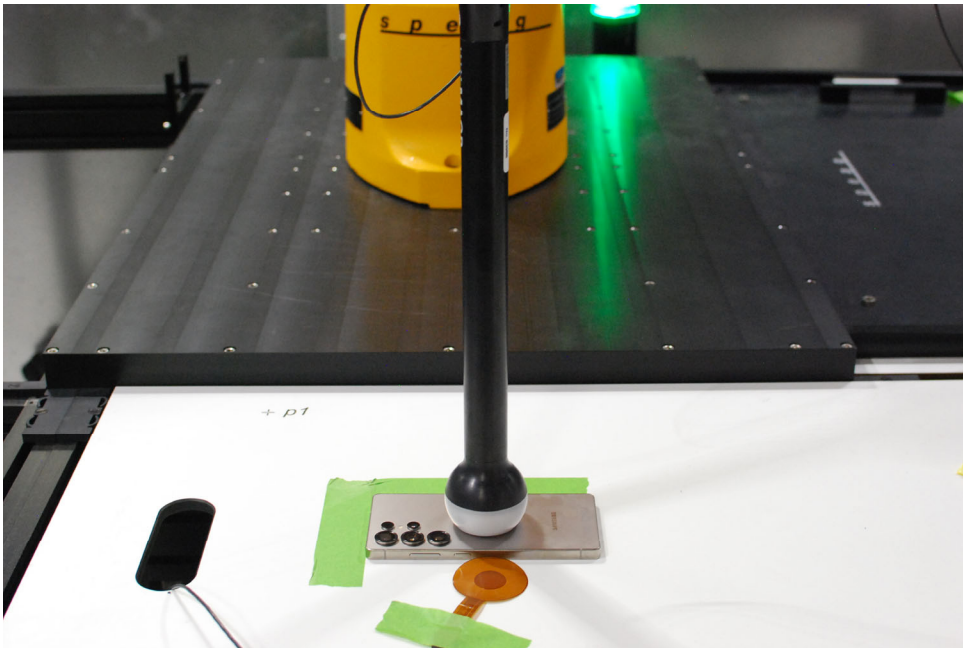
Test Setup Photo 1  
Ping Signal, Back side, 0mm

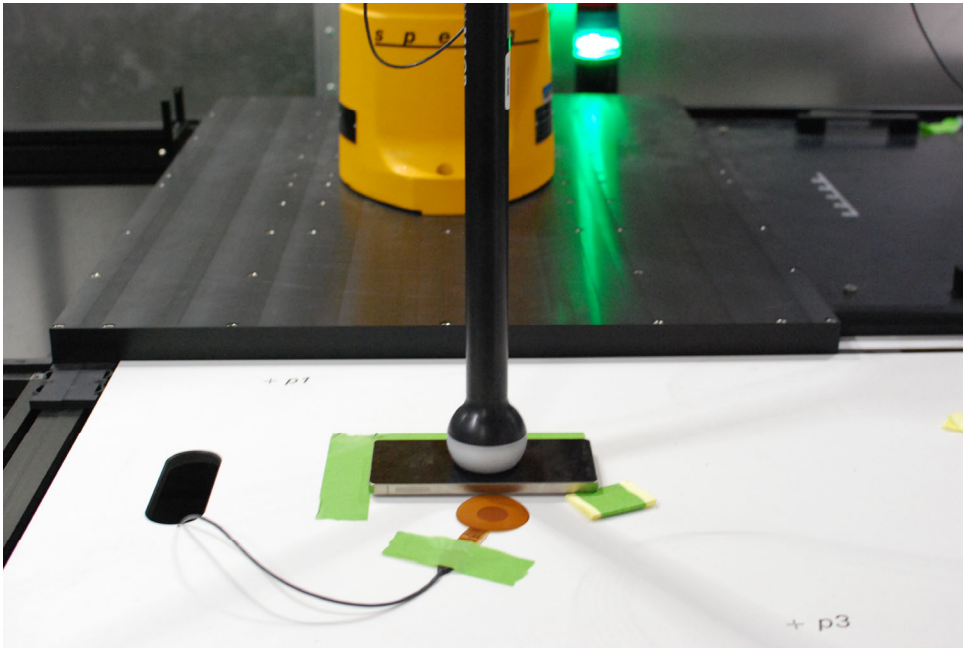
Test Setup Photo 2  
Ping Signal, Front side, 0mm

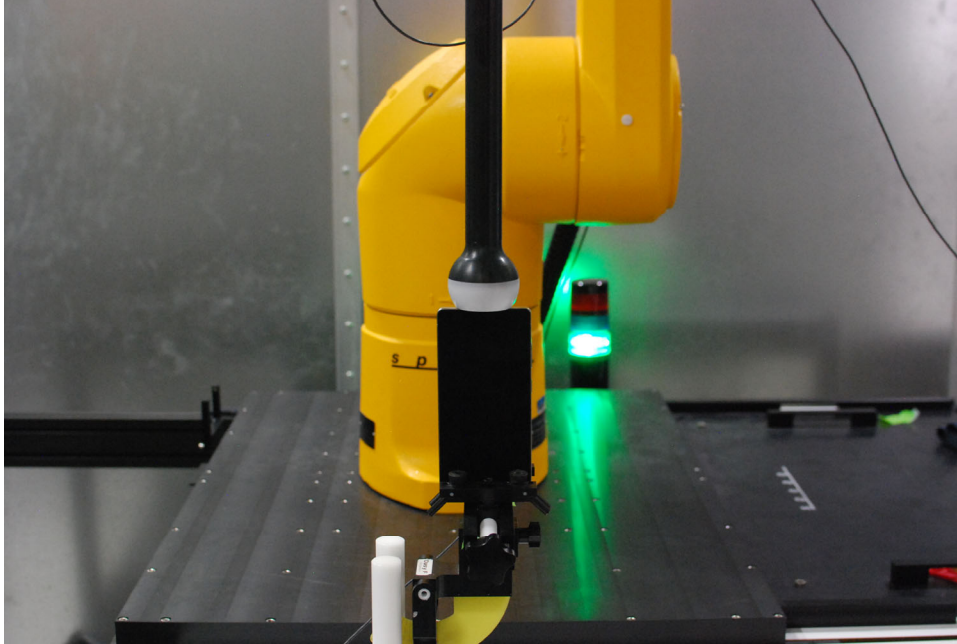
Test Setup Photo 3  
Ping Signal, Top Side, 0mm

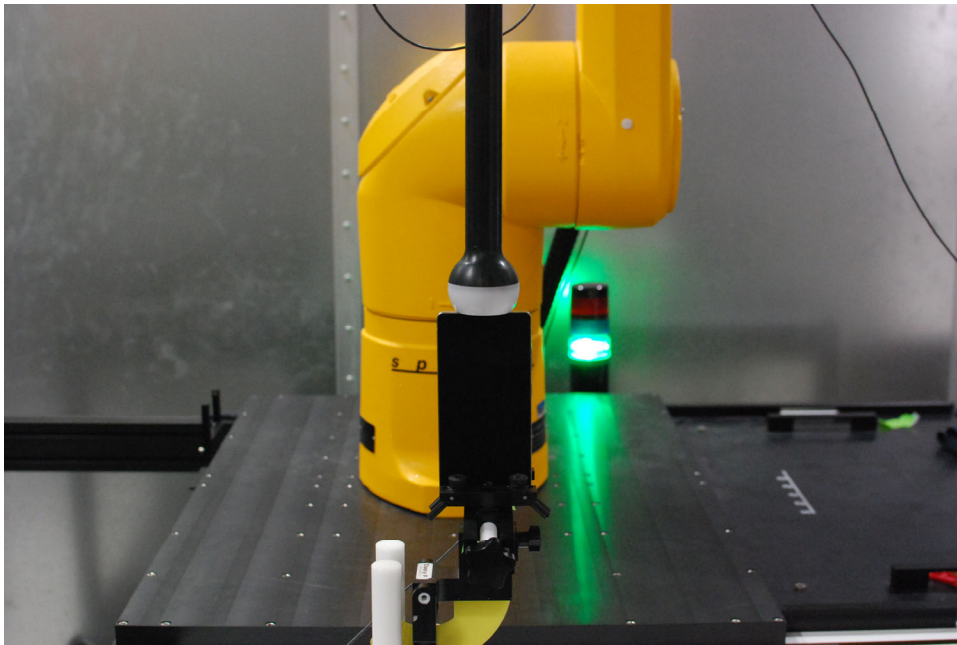
Test Setup Photo 4  
Ping Signal, Bottom Side, 0mm

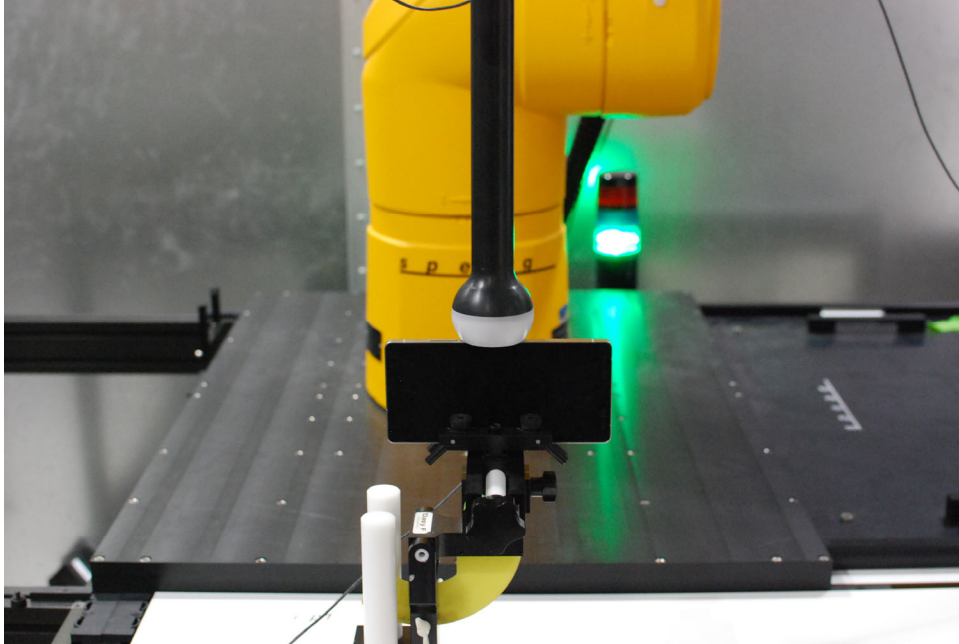
Test Setup Photo 5  
Ping Signal, Right Side, 0mm

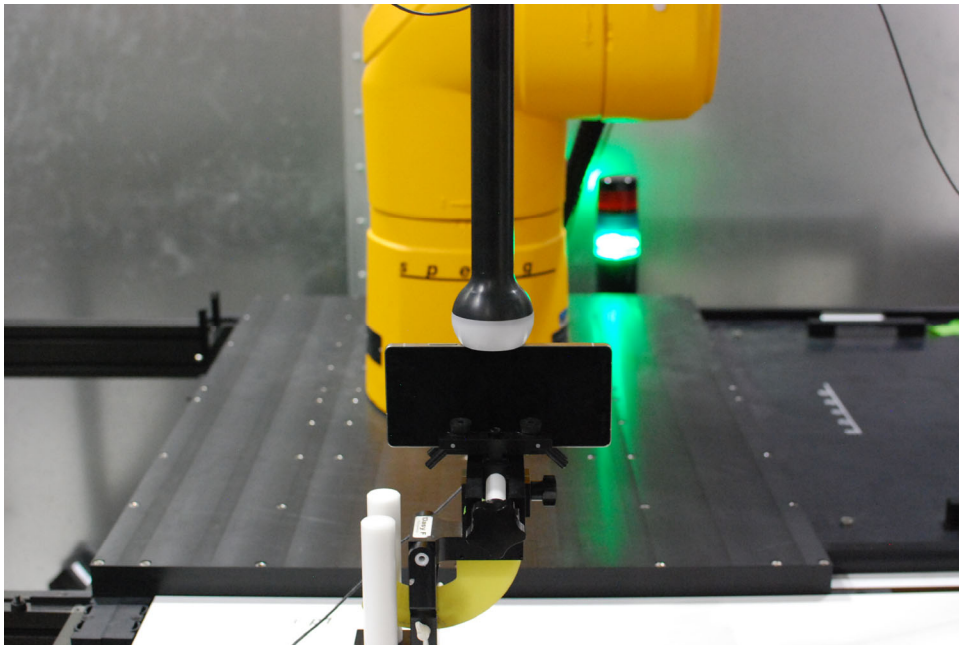
Test Setup Photo 6  
Ping Signal, Left Side, 0mm

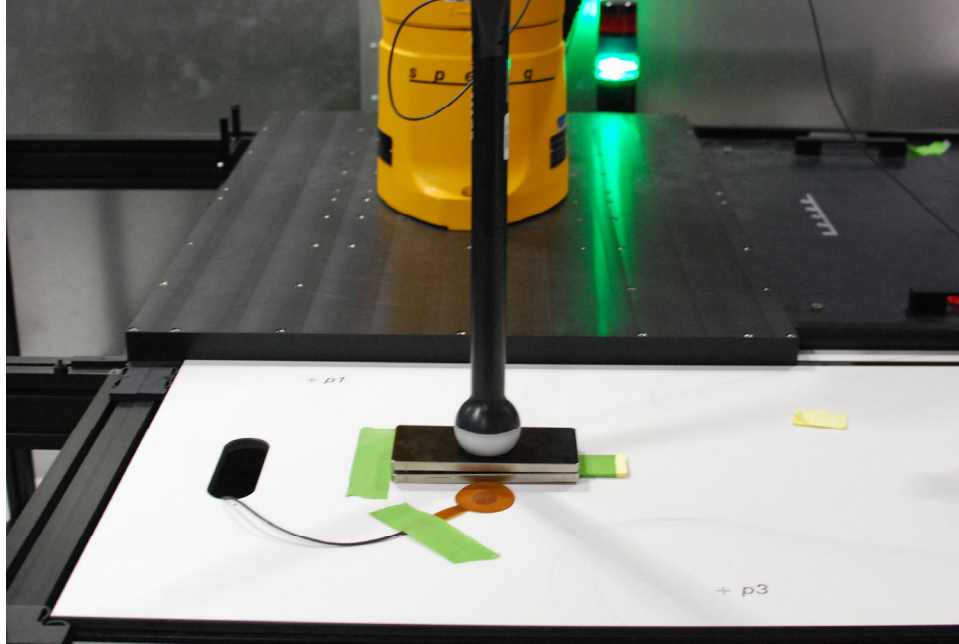
Test Setup Photo 7  
Device to Device (Inline), Back side, 0mm

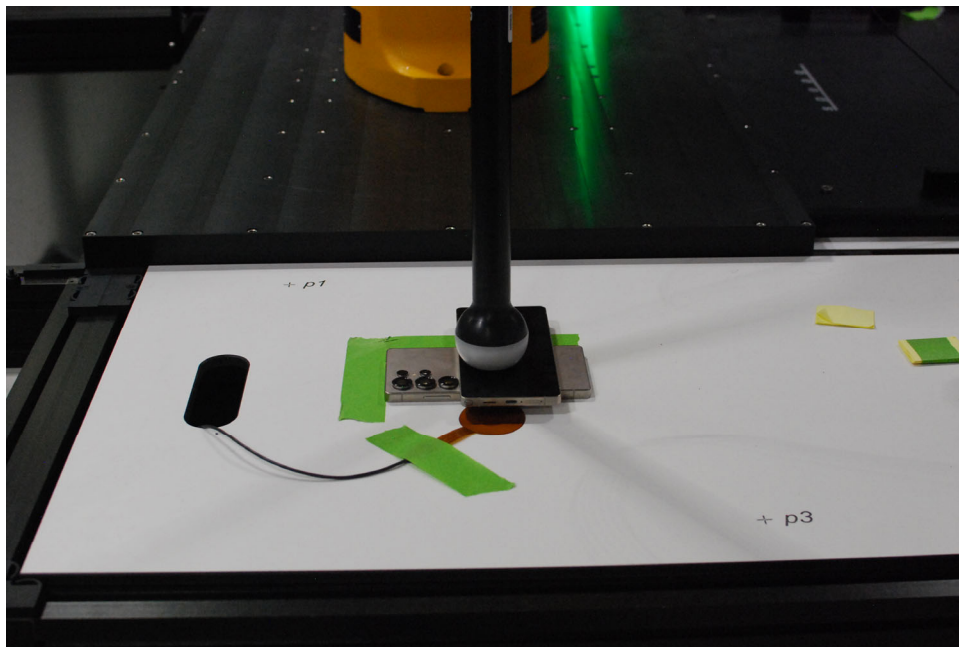
Test Setup Photo 8  
Device to Device (Offset), Back side, 0mm

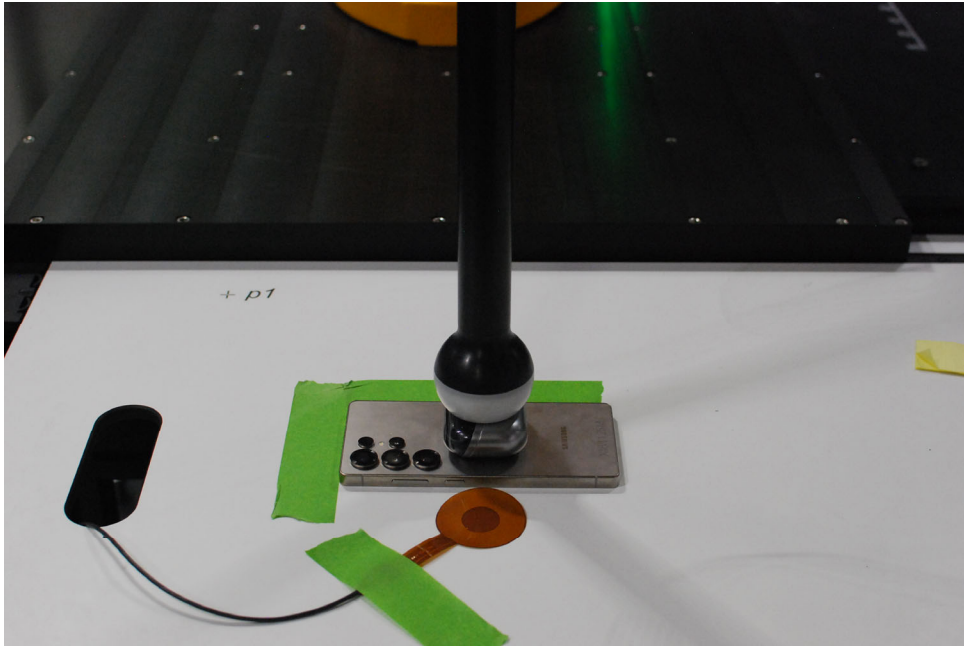
Test Setup Photo 9  
Device to Earbuds, Back side, 0mm

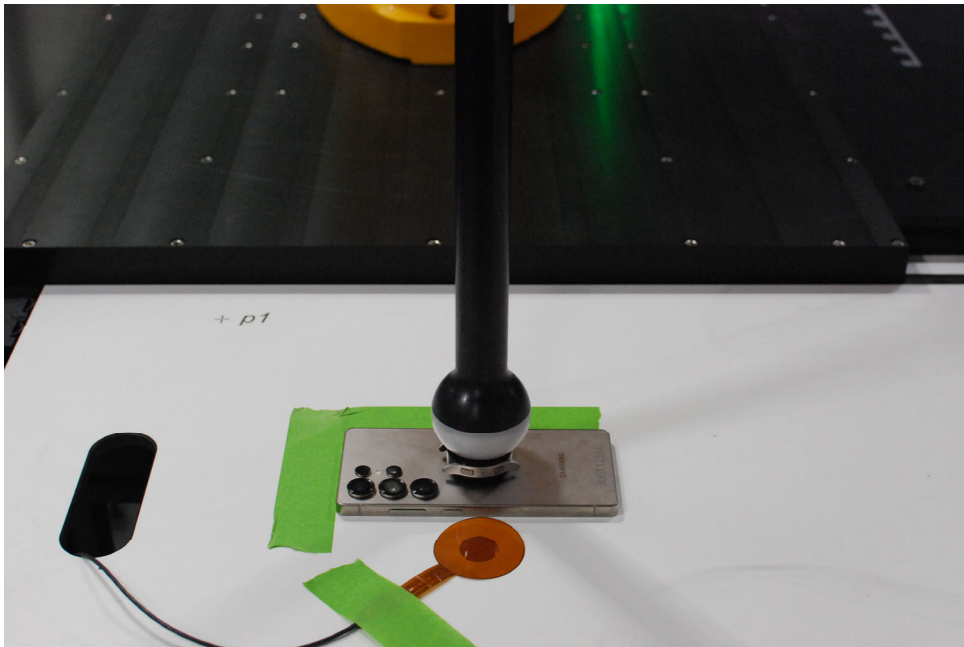
Test Setup Photo 10  
Device to Watch, Back side, 0mm

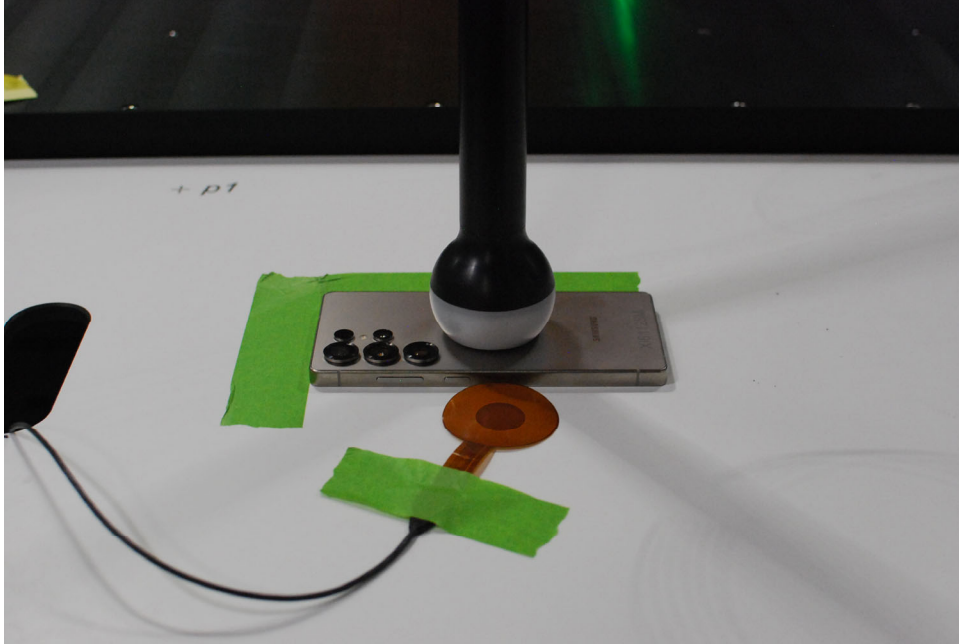
Test Setup Photo 11  
Digitizer, Back side, 0mm
