**Antenna 1 / Ant L / n260**

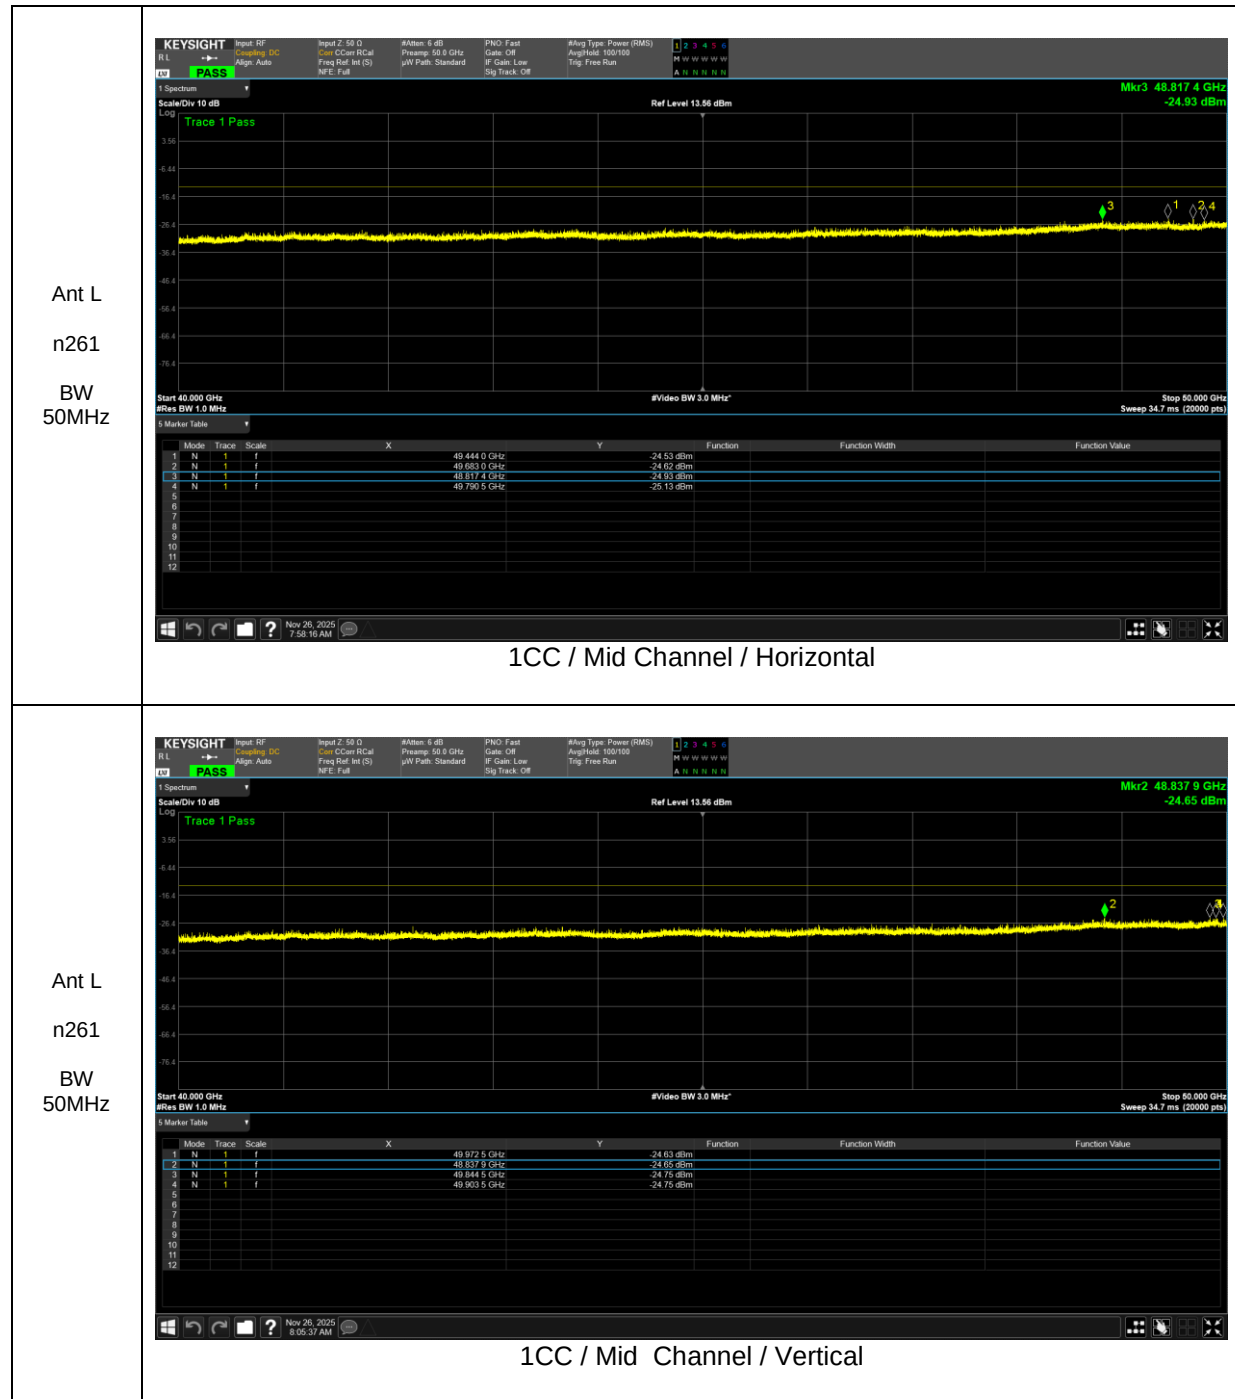
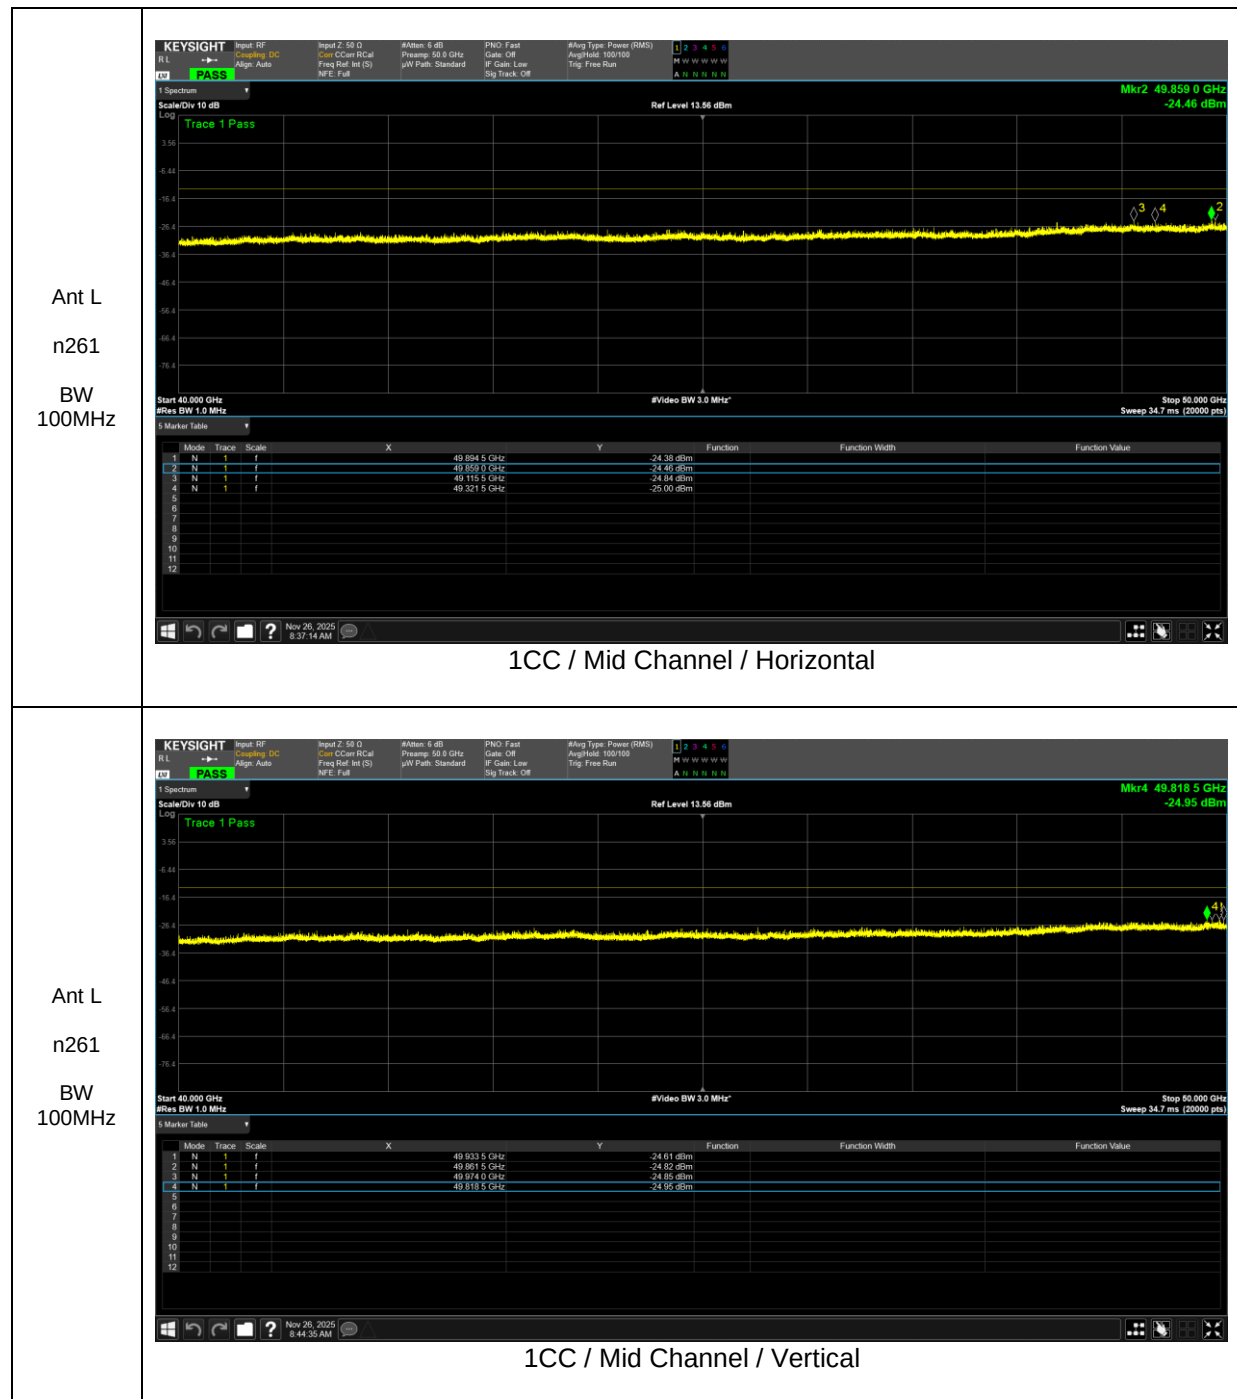
40 – 50 GHz Result

All channels were investigated, but no emission above the noise floor was detected.

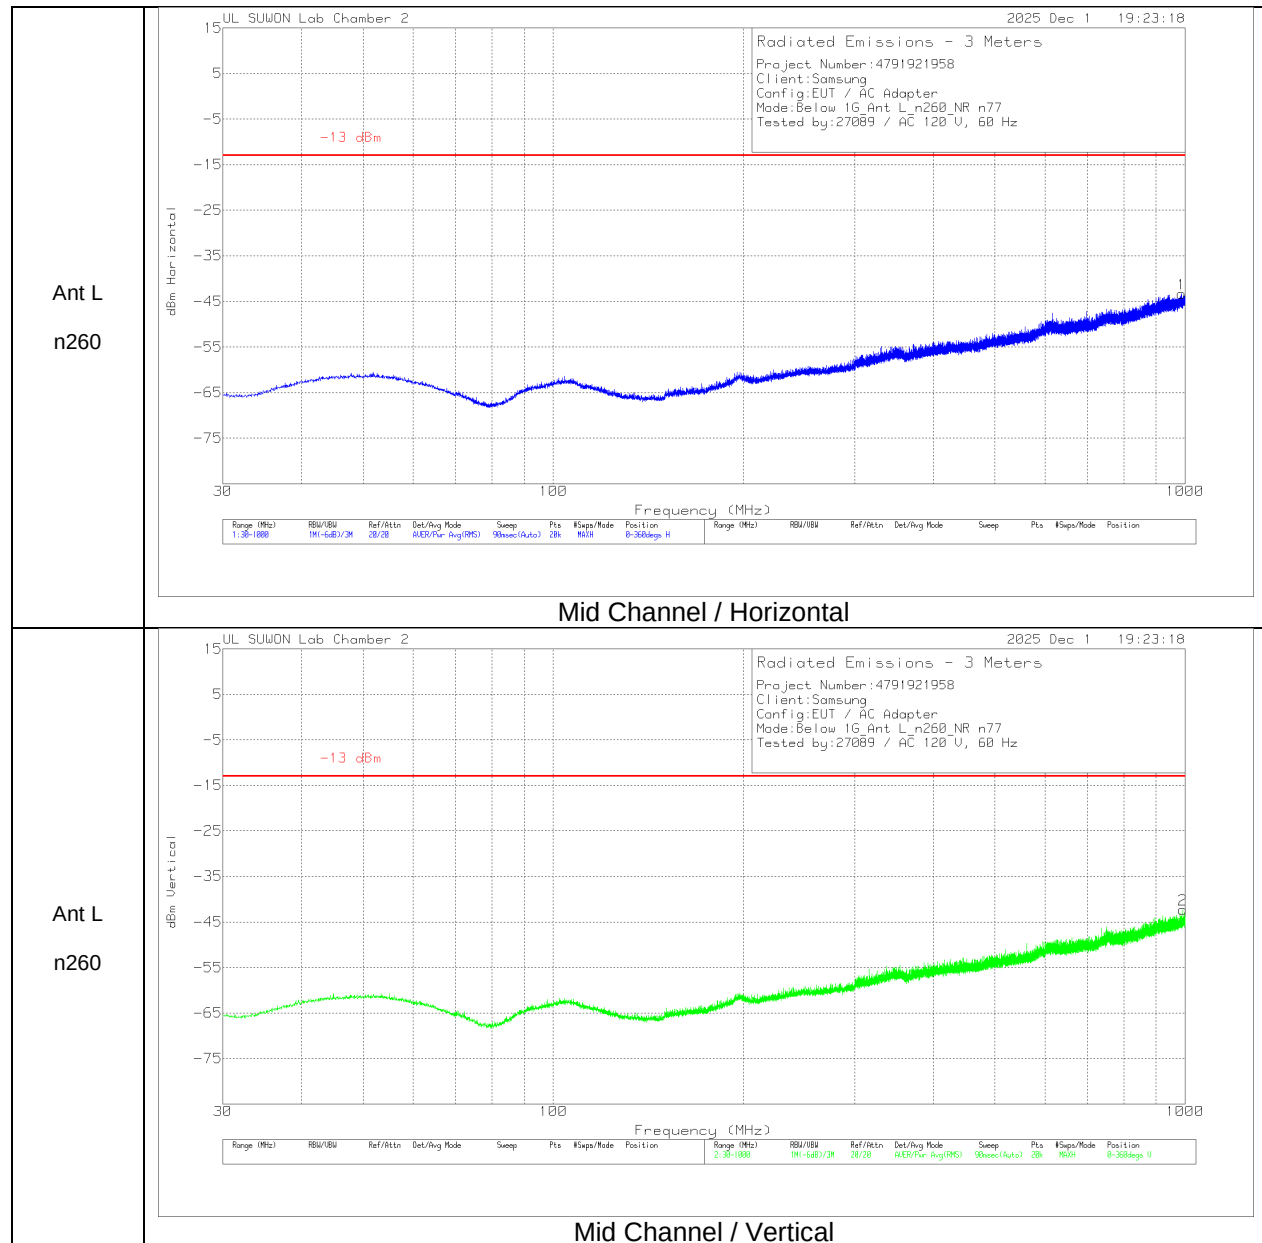
**30 – 1000 MHz Result**

No emissions were detected above noise floor this antenna and band.

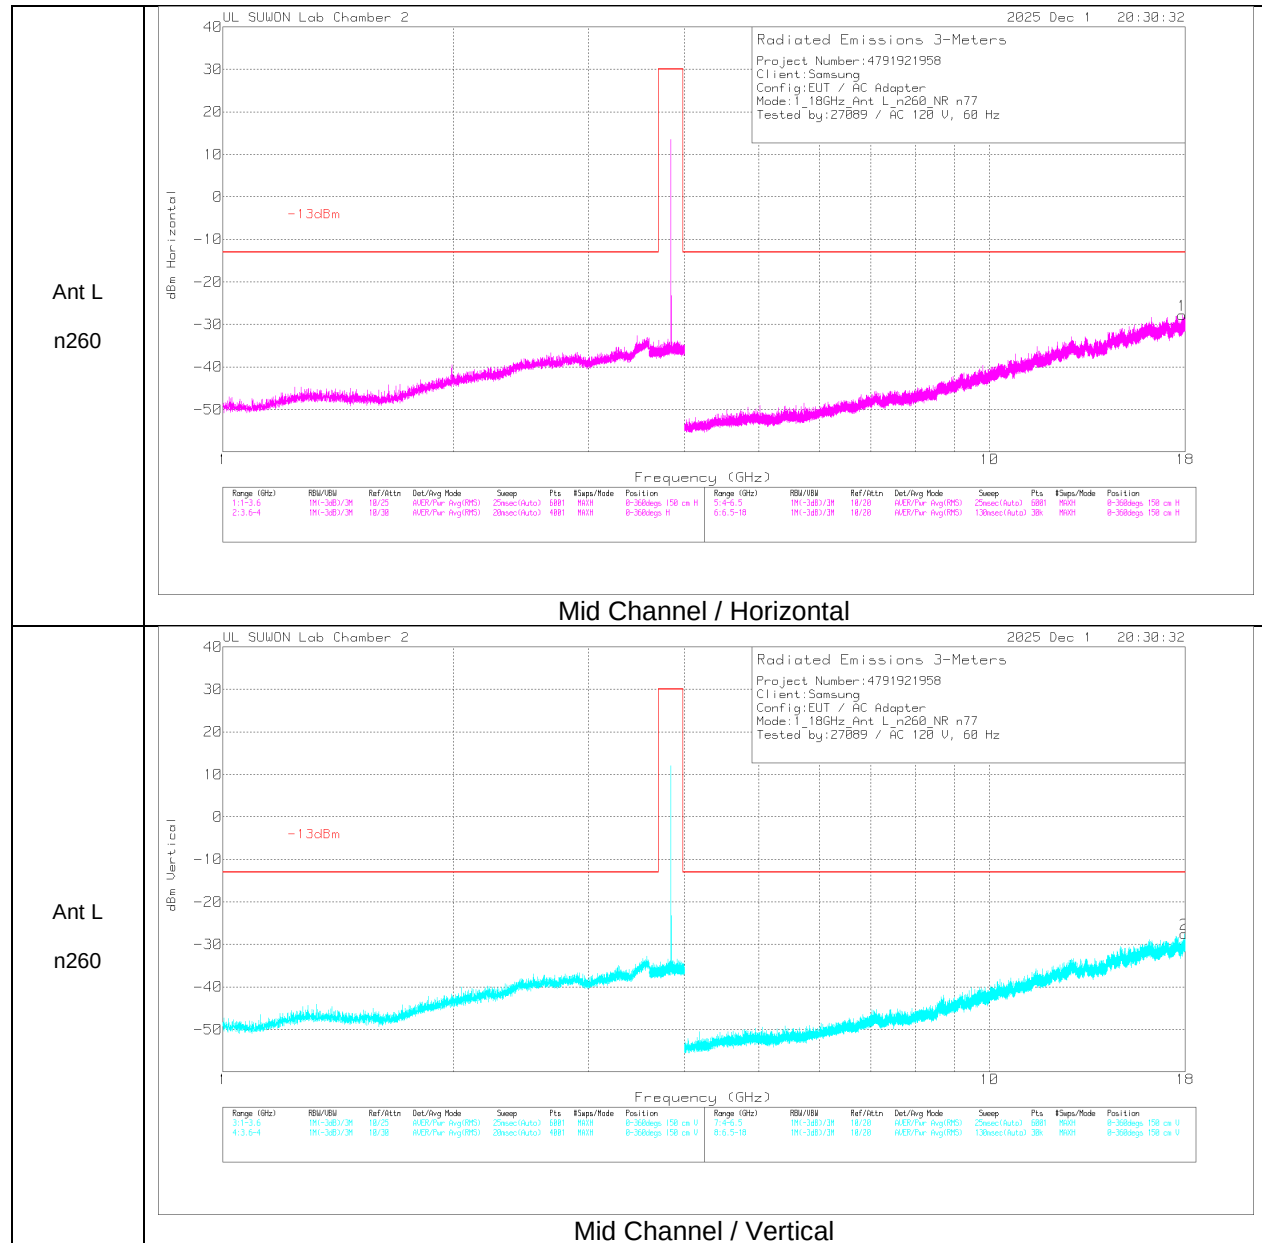
## 1 – 18 GHz Result

No emissions were detected above the noise floor which was at least 20dB below the specification limit.

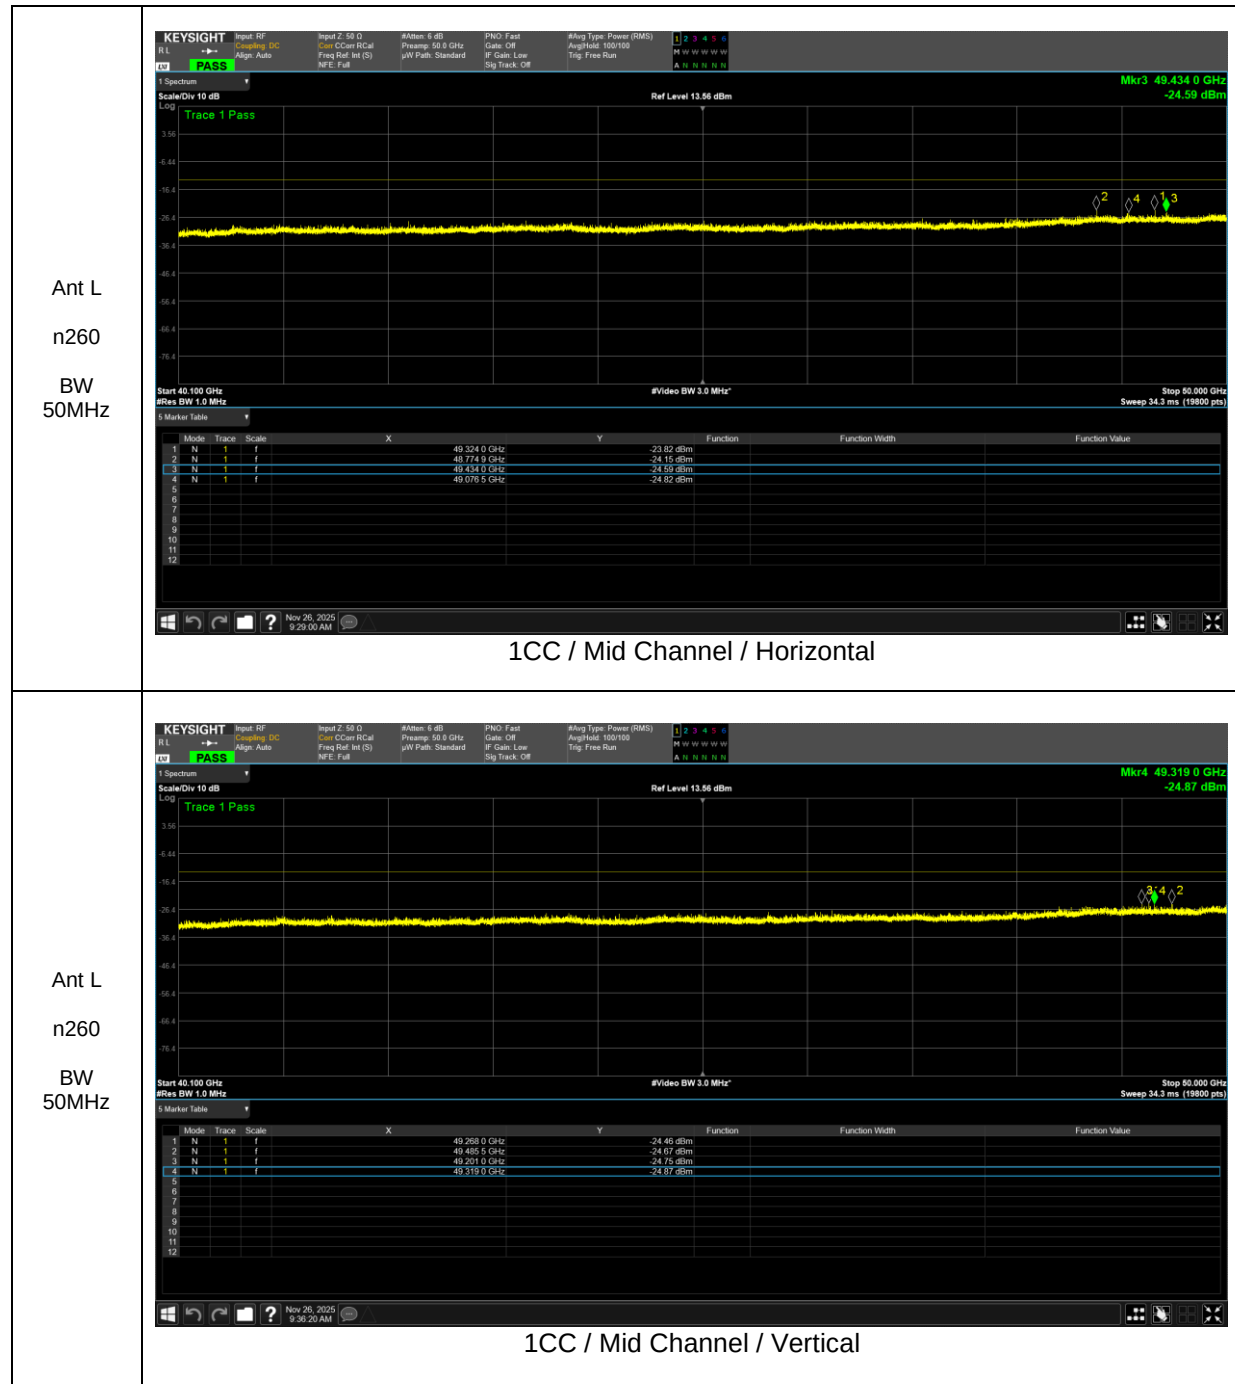
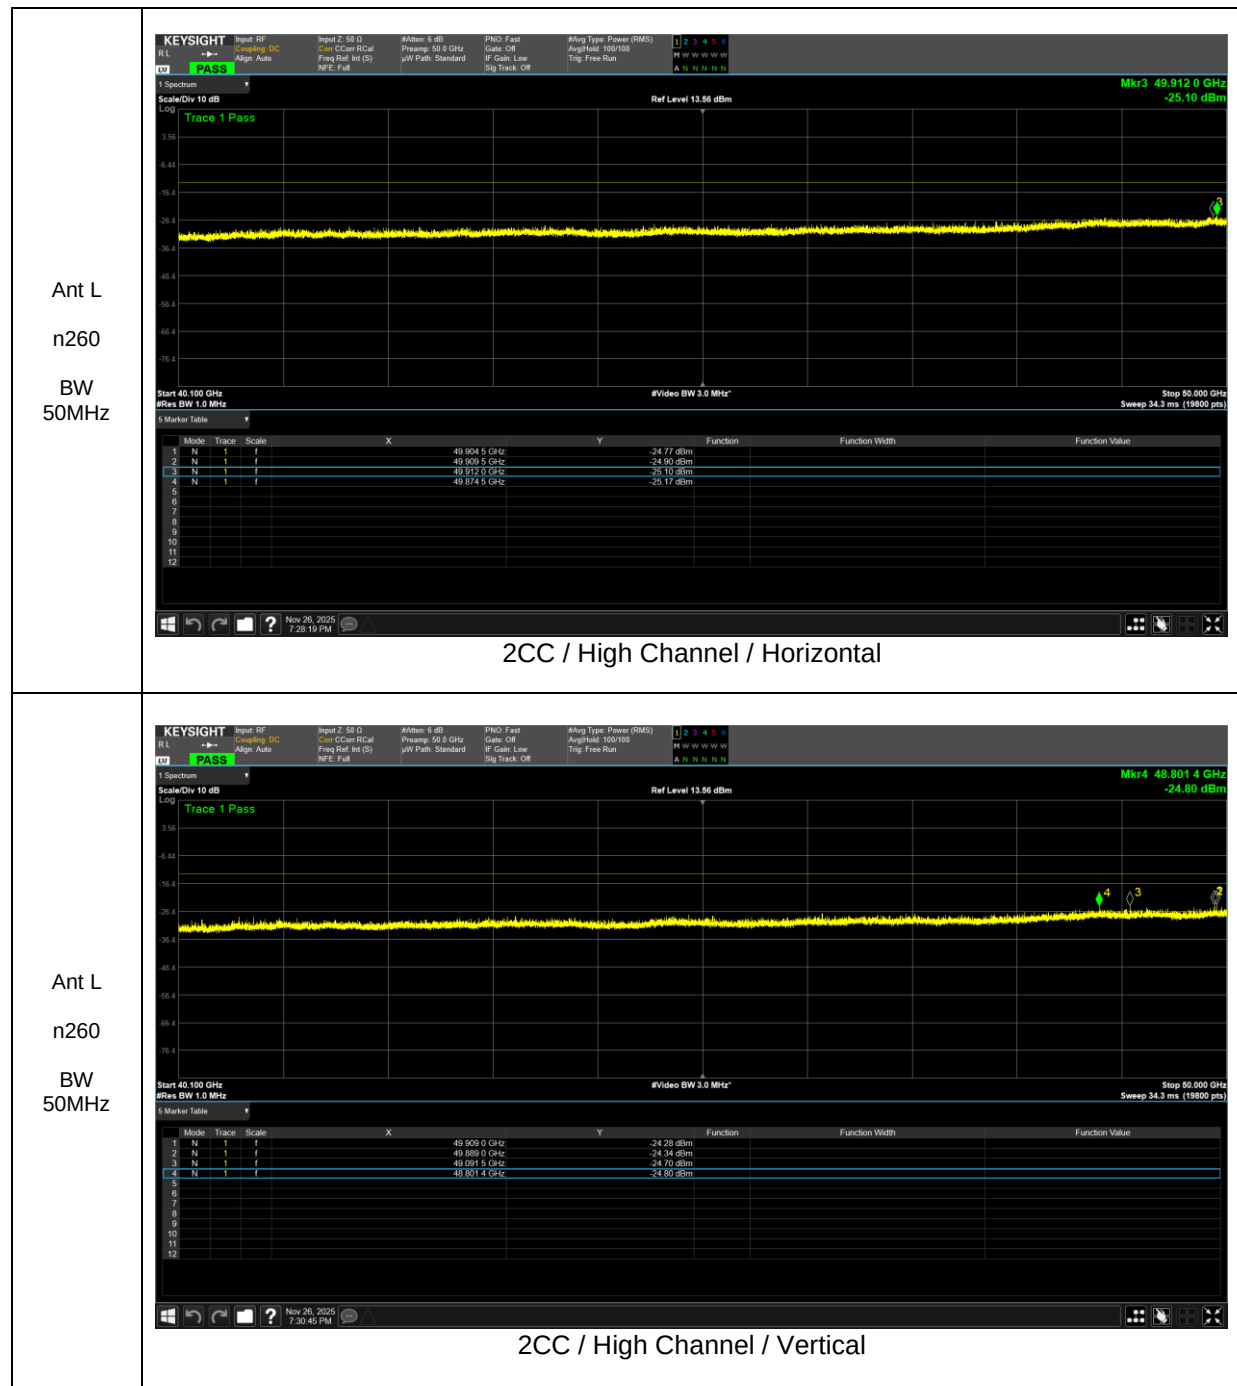
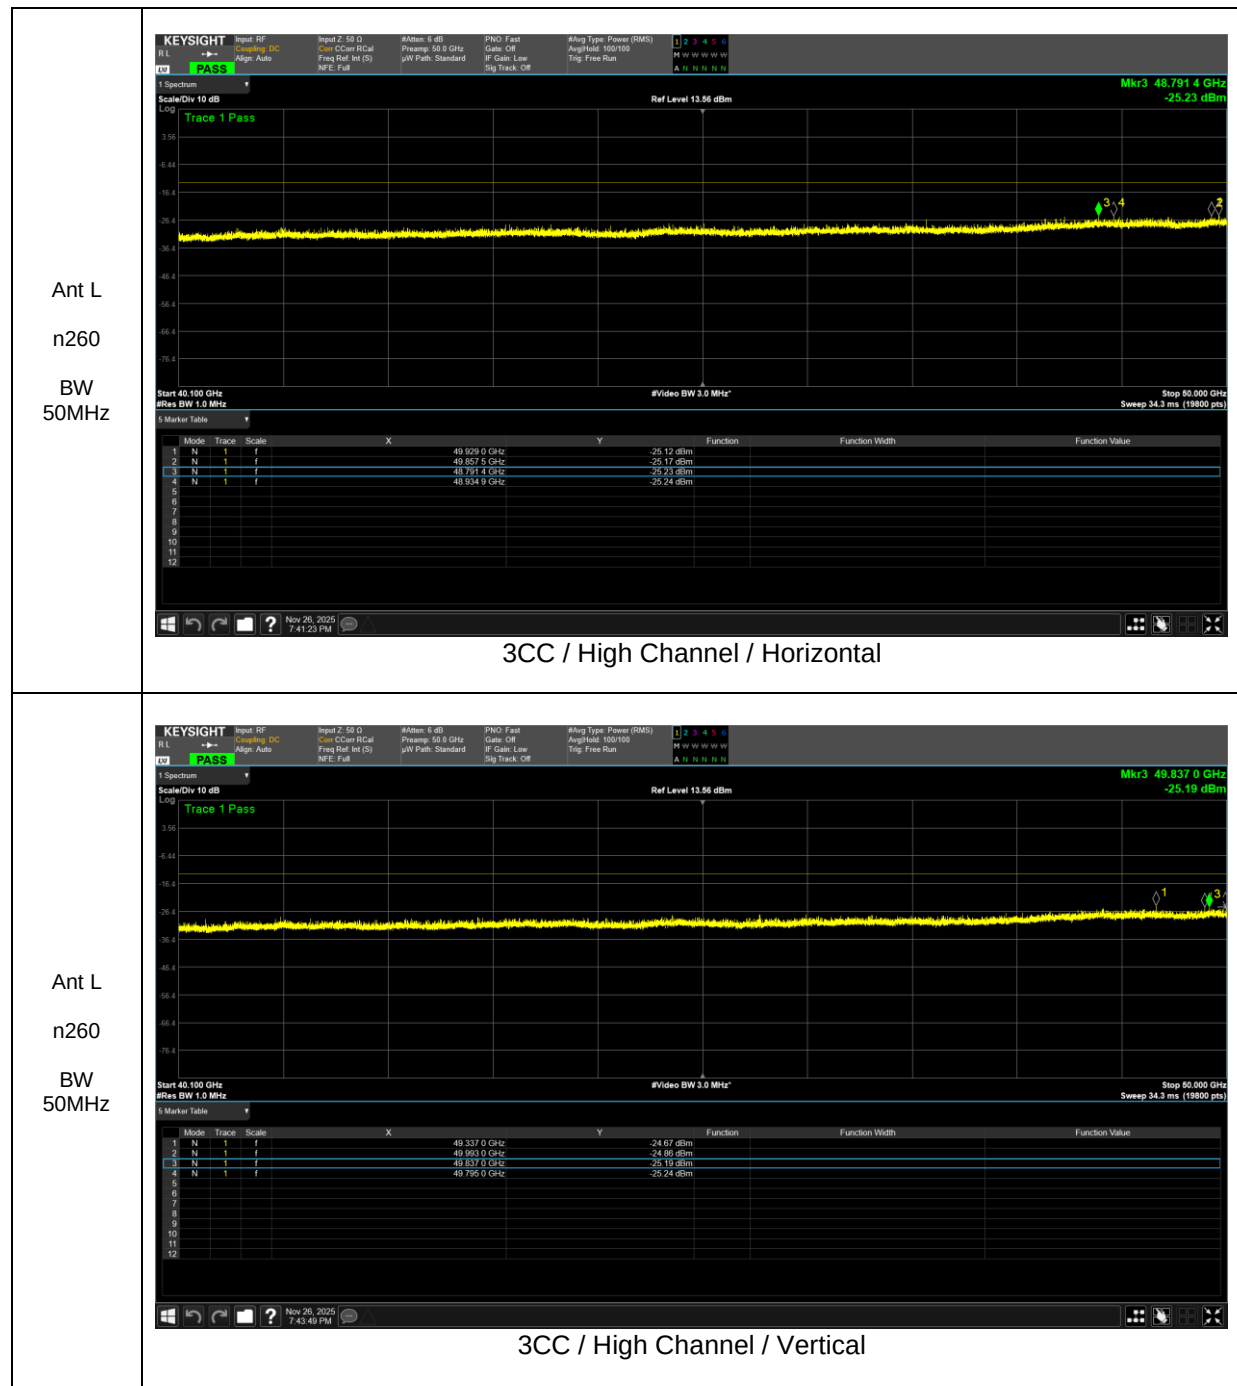
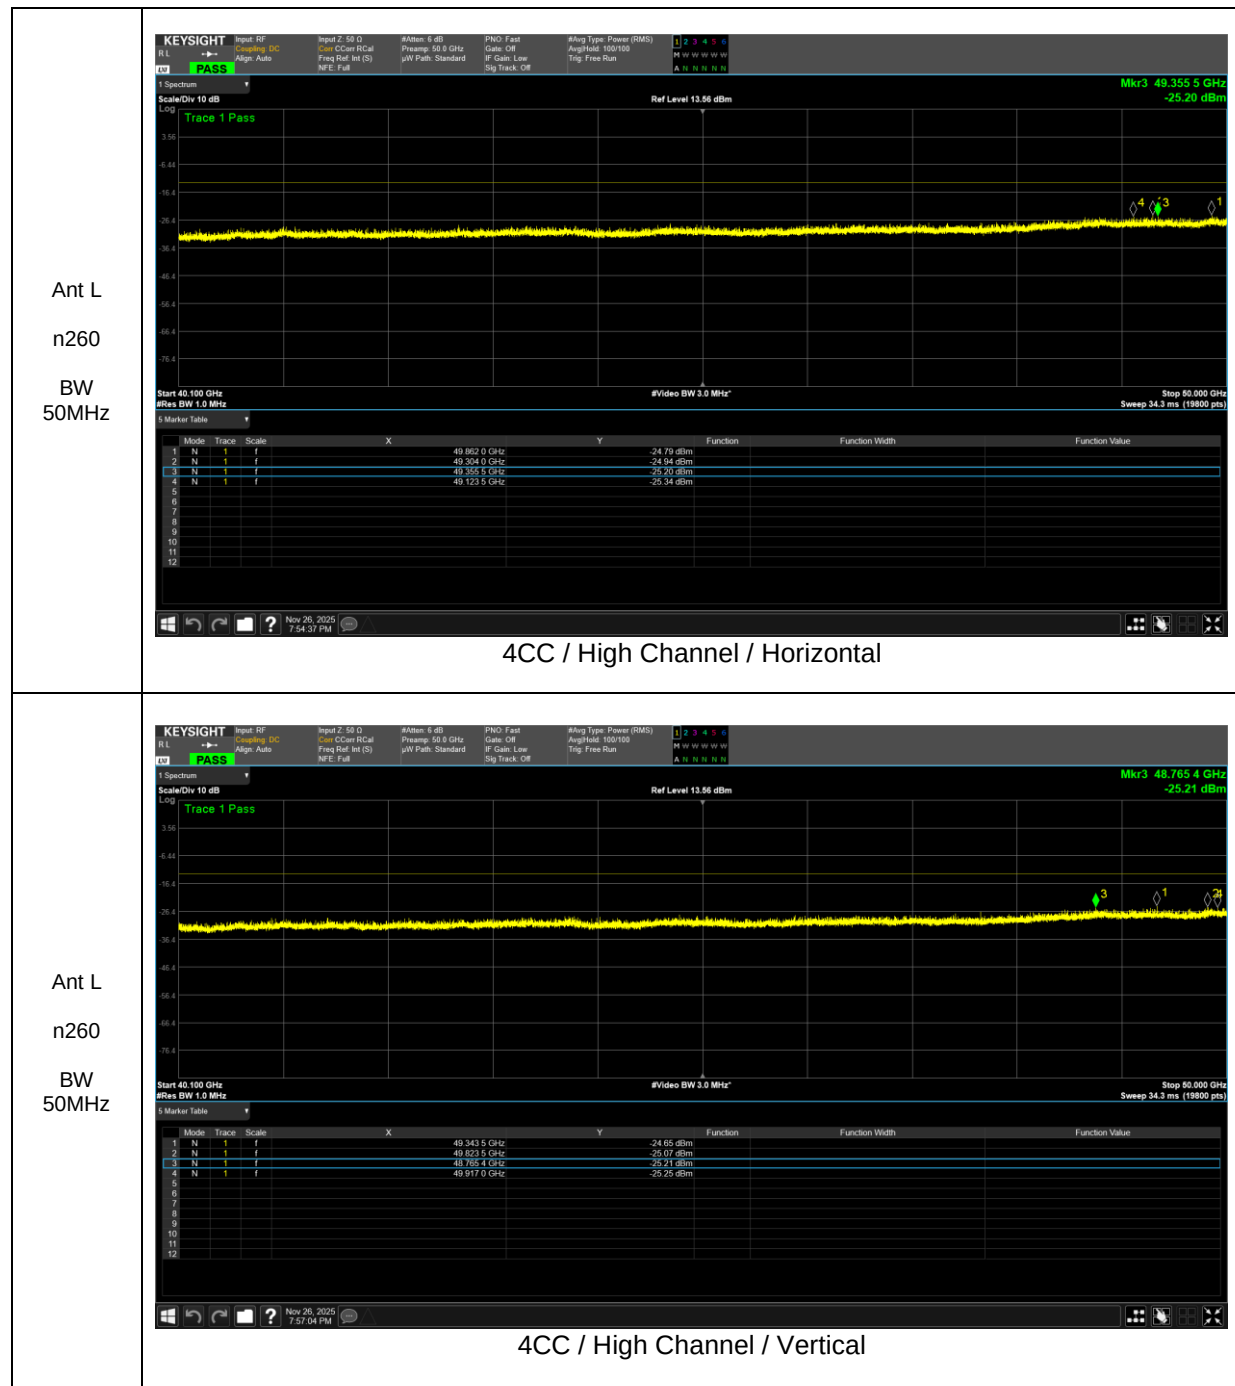
## 40.1 – 50 GHz Result

All channels were investigated, but no emission above the noise floor was detected.

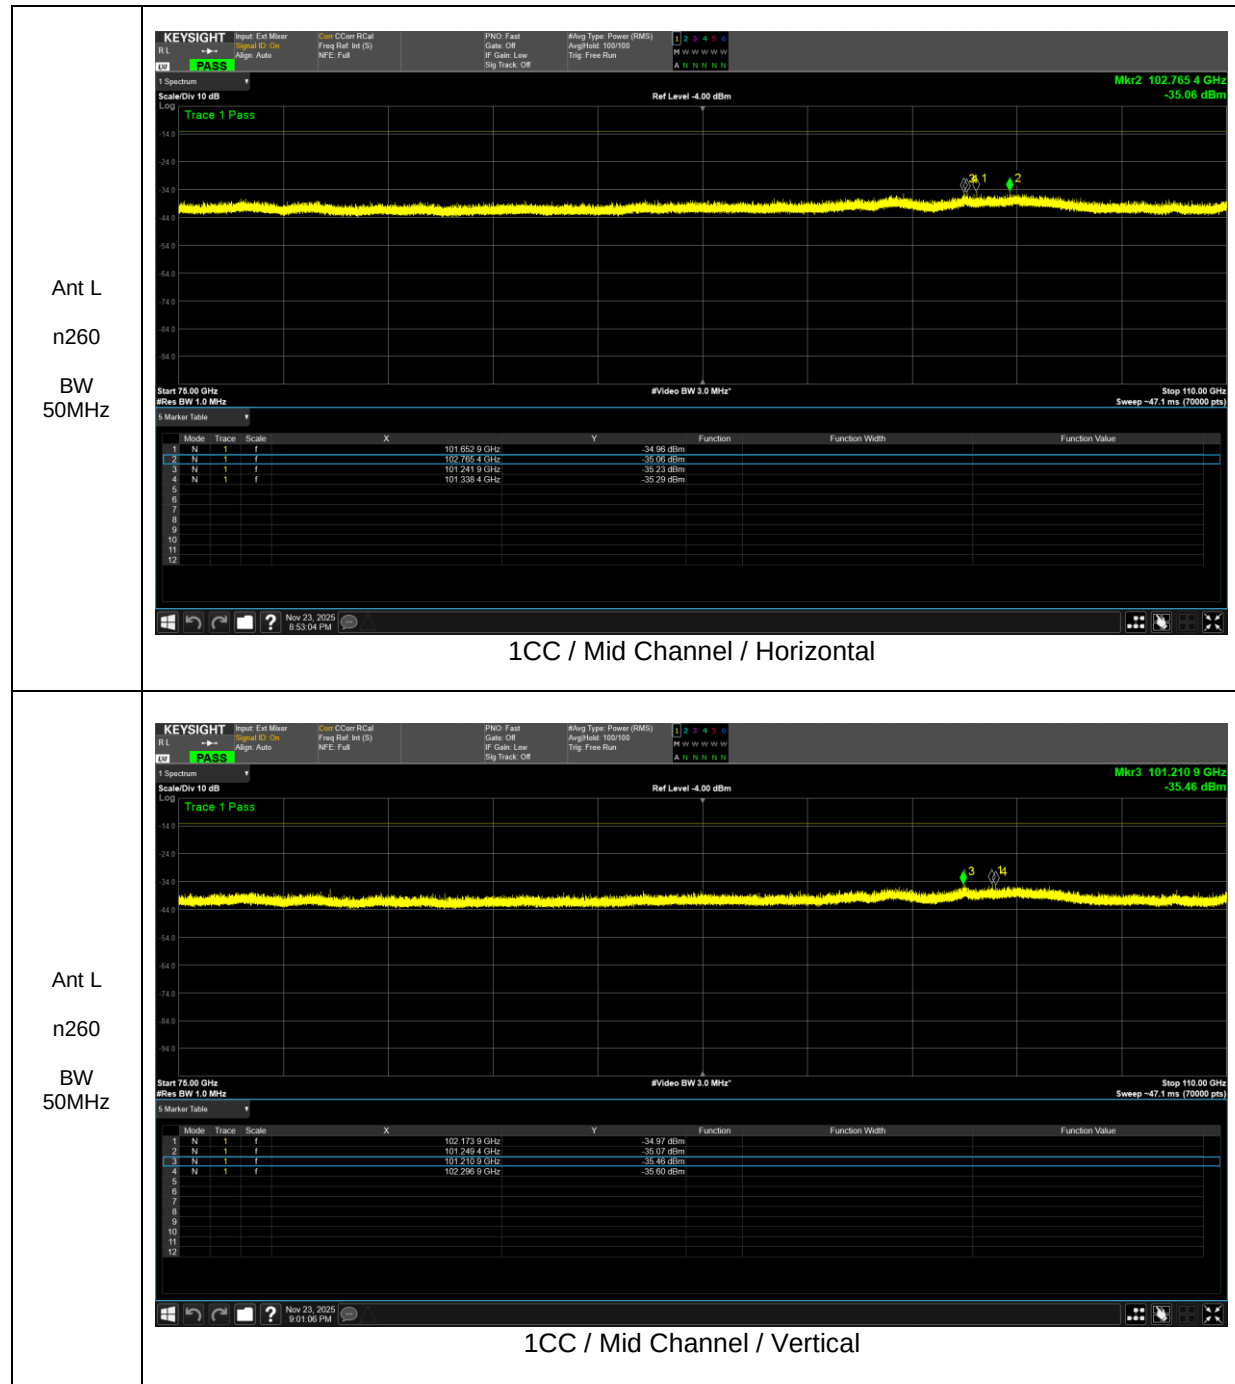
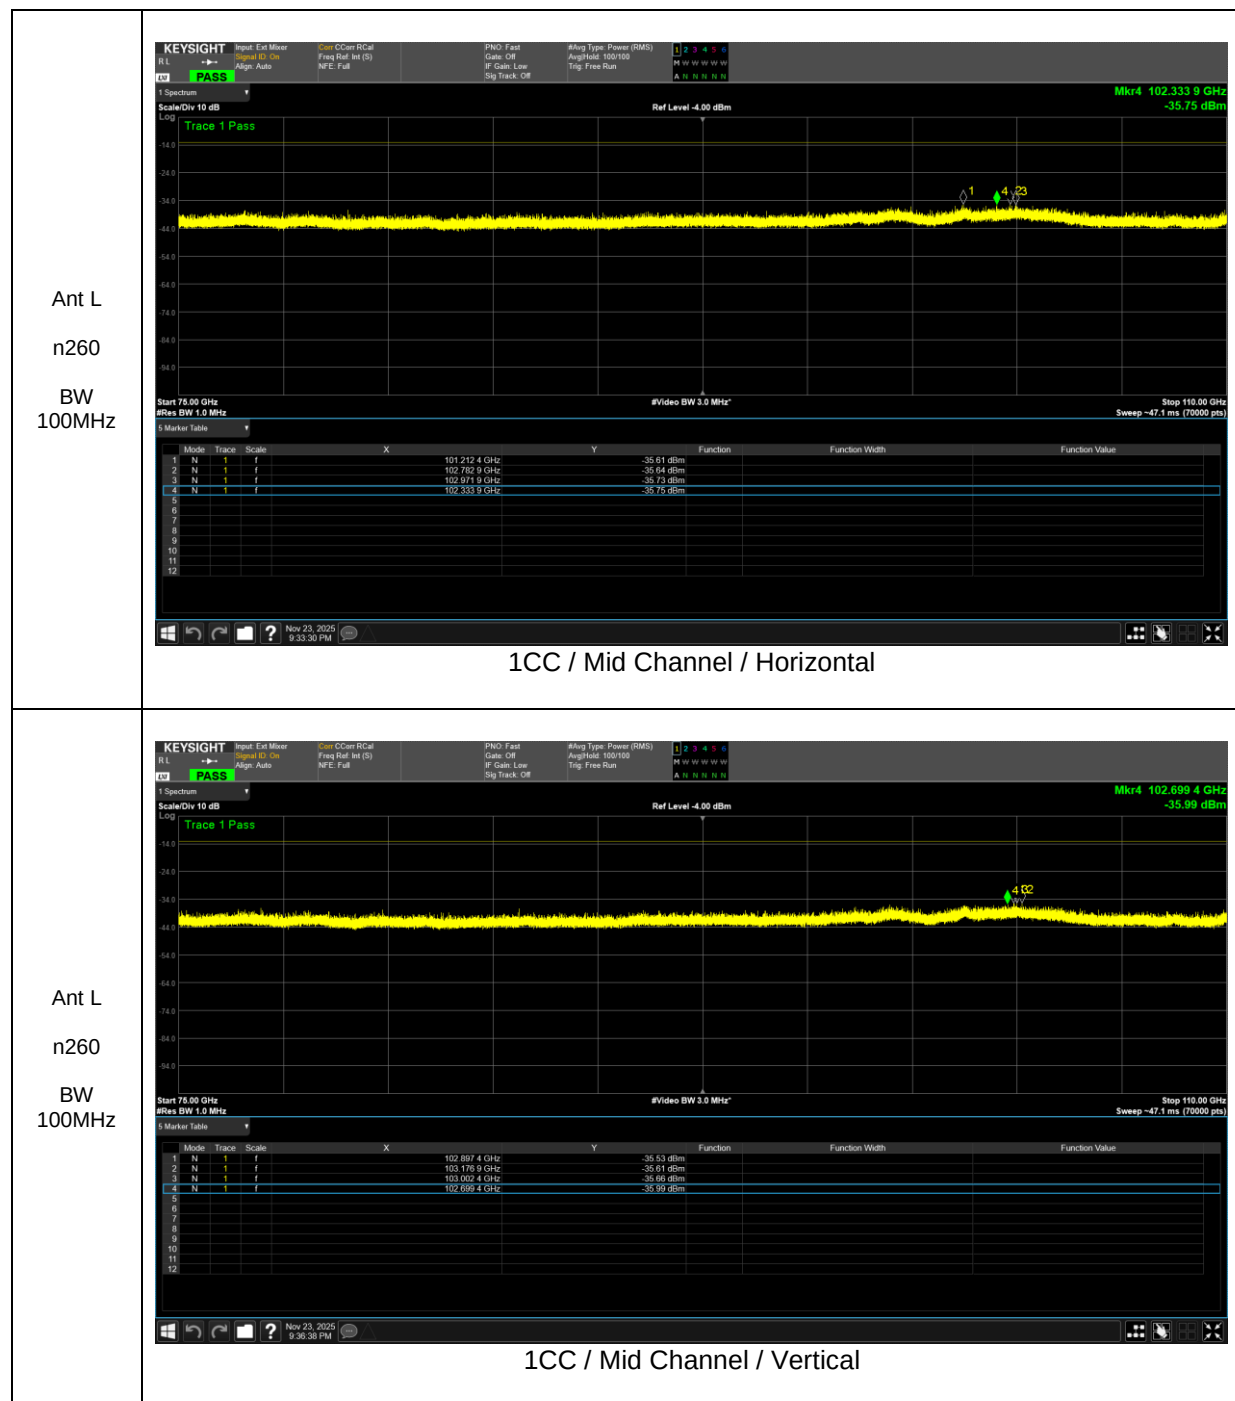
## 75 – 110 GHz Result

All channels were investigated, but no emission above the noise floor was detected.

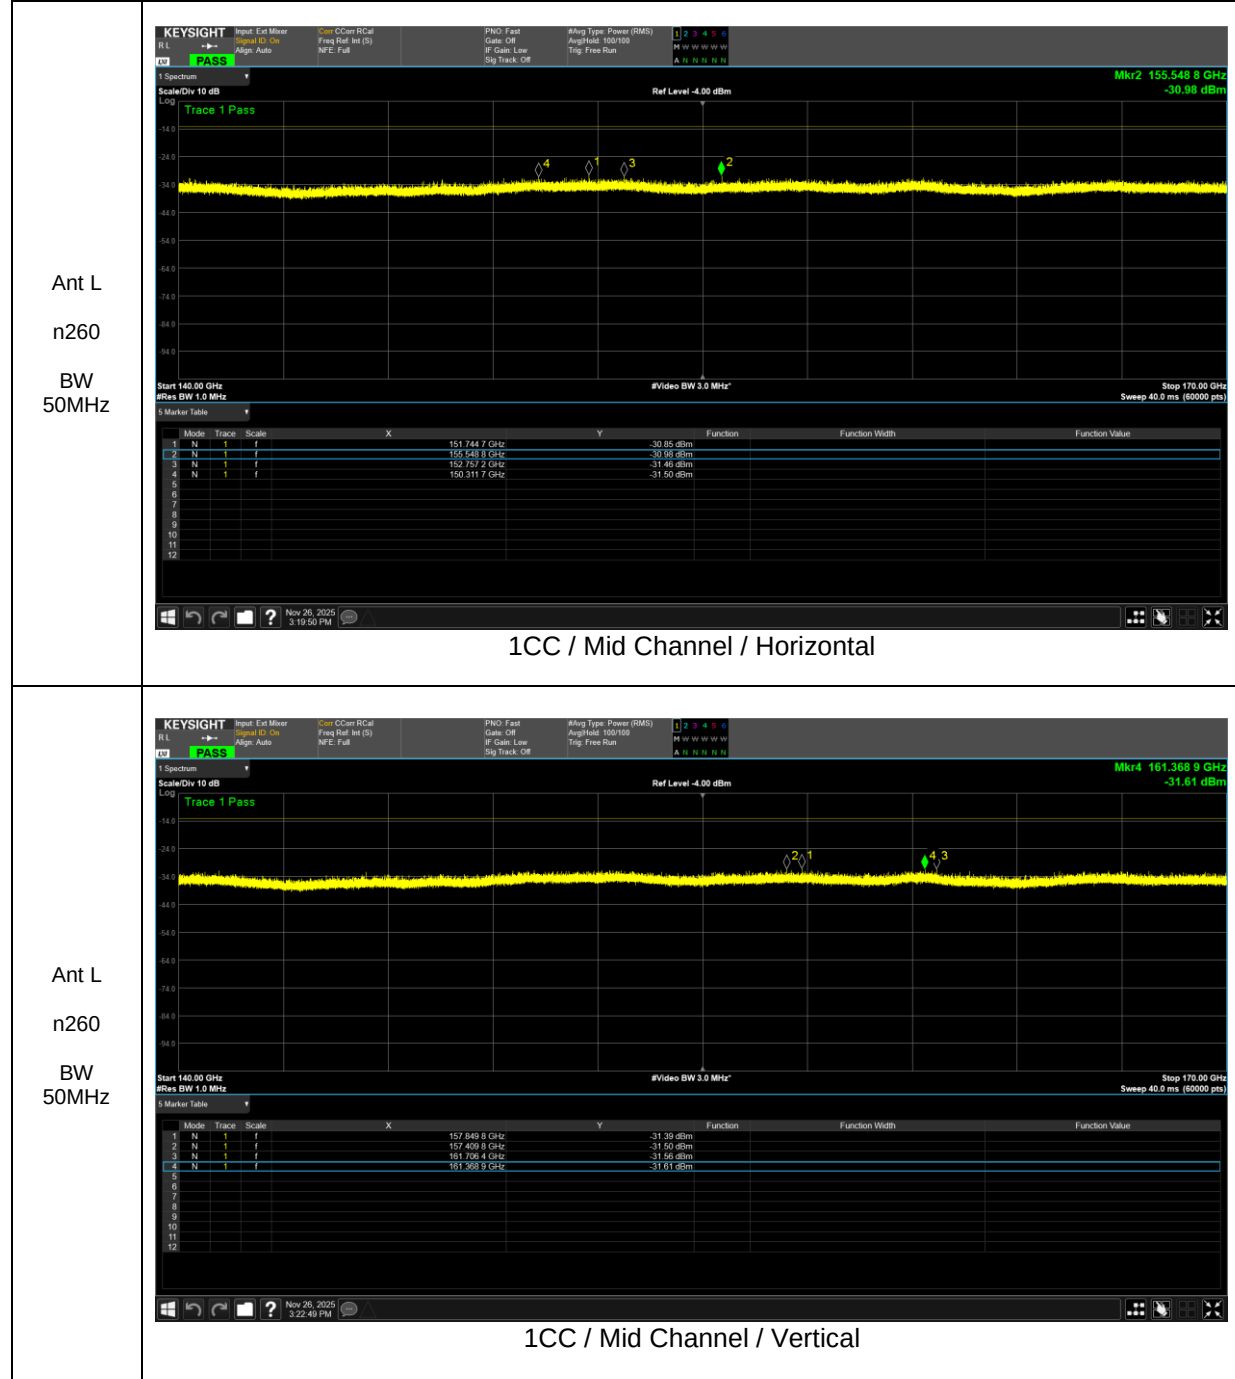
# 140 – 170 GHz Result

All channels were investigated, but no emission above the noise floor was detected.
