# Intertek Testing Services ETL SEMKO

Mode = Tx

Report No.: 9912828

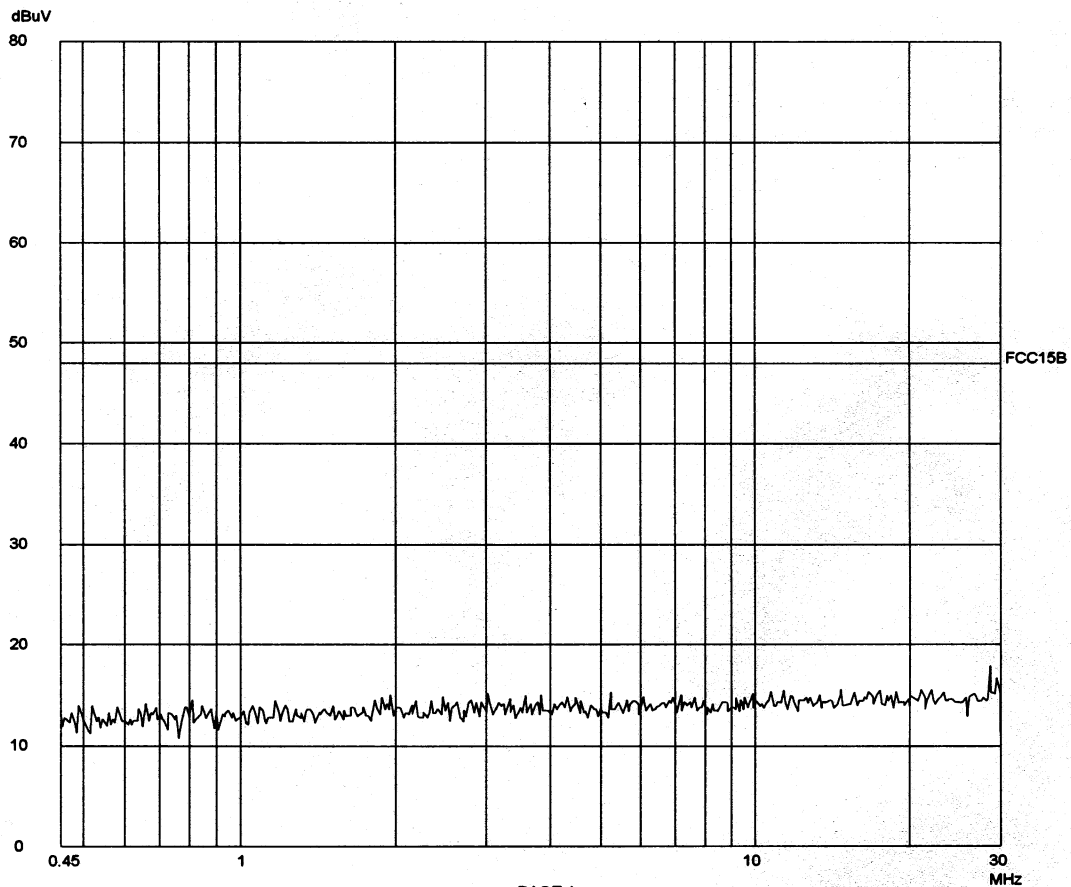
Scan Settings (1 Range)

| Frequencies | | | Receiver Settings | | | |
|---|---|---|---|---|---|---|
| 450k | 30M | 5k | 10k | PK | 20ms | AUTO |

Final Measurement: x QP

| Transducer No. | Start | Stop | Name |
|---|---|---|---|
| 3 | 9k | 30M | EI078 |

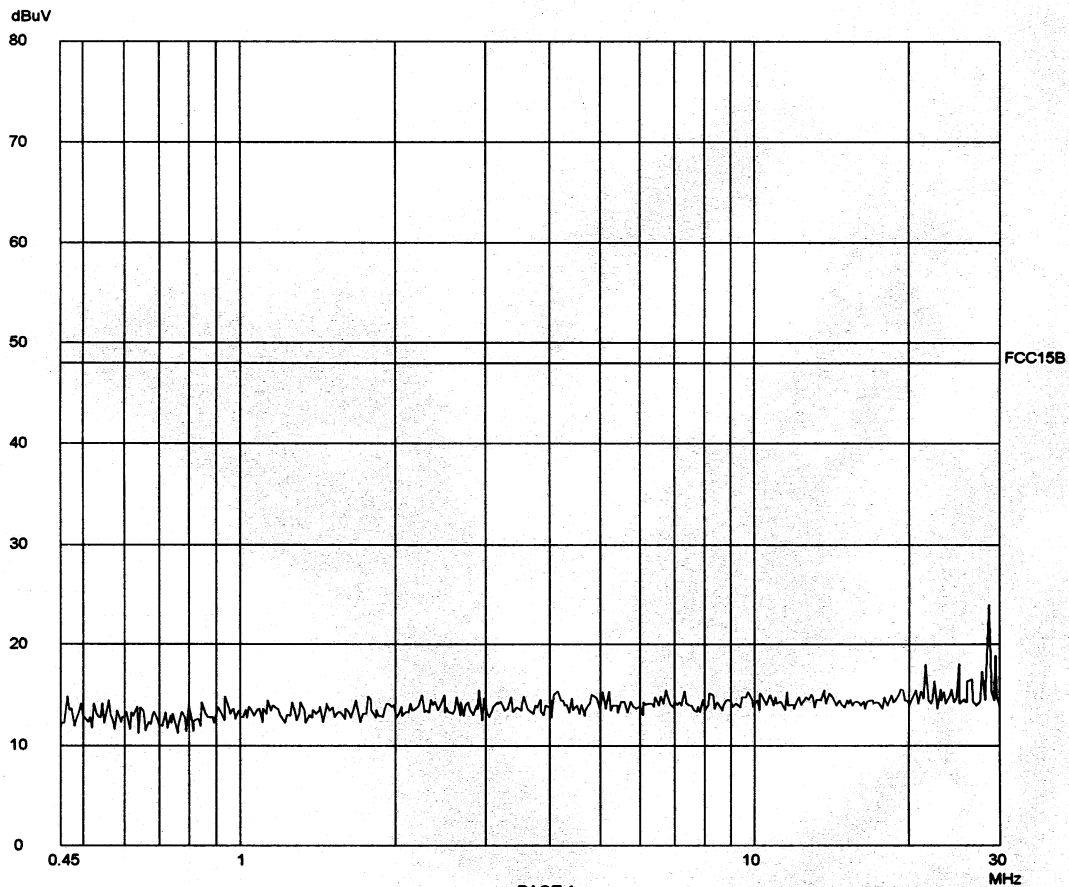
Mode = Charging

Scan Settings (1 Range)

| Frequencies | | | Receiver Settings | | | | | |
|---|---|---|---|---|---|---|---|---|
| 450k | 30M | 5k | 10k | PK | 20ms | AUTO | LN | OFF 60dB |

Final Measurement: x QP

| Transducer No. | Start | Stop | Name |
|---|---|---|---|
| 3 | 9k | 30M | EI078 |

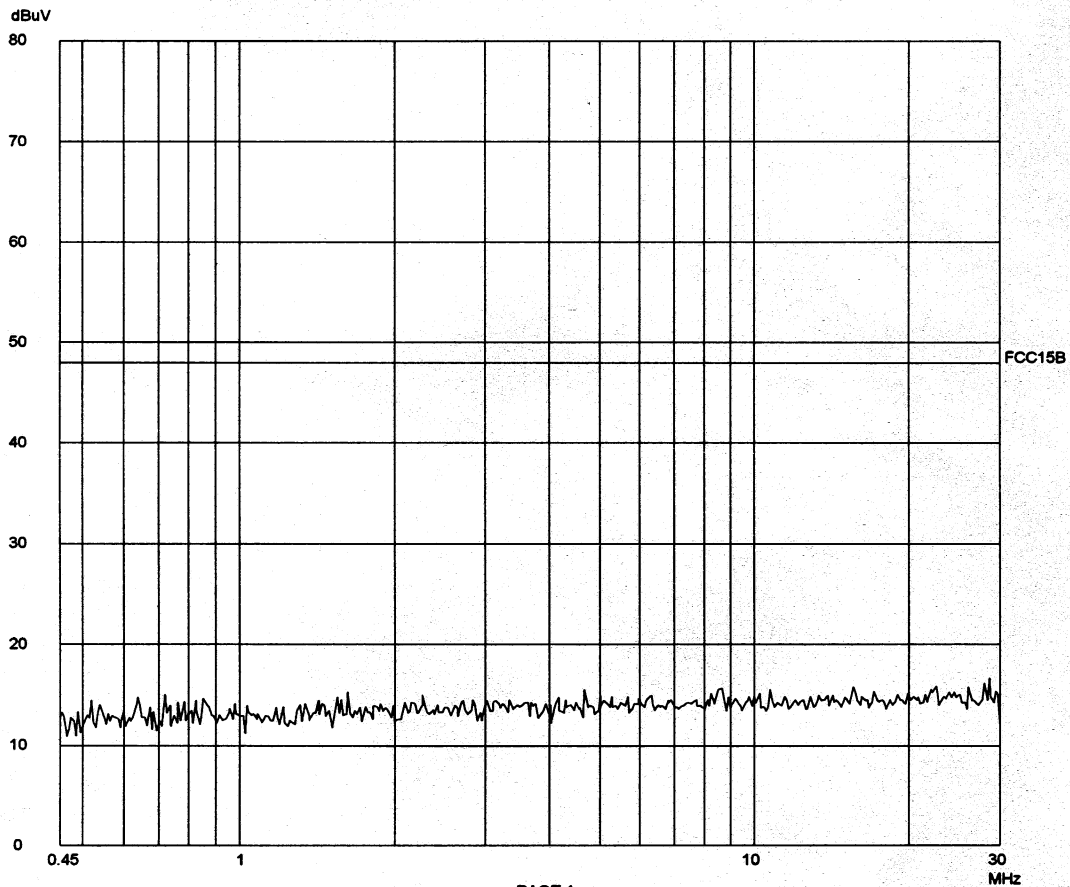
Mode = Stand by

Scan Settings (1 Range)

| Frequencies | | | Receiver Settings | | | | | |
|---|---|---|---|---|---|---|---|---|
| 450k | 30M | 5k | 10k | PK | 20ms | AUTO | LN OFF | 60dB |

Final Measurement: x QP

| Transducer No. | Start | Stop | Name |
|---|---|---|---|
| 3 | 9k | 30M | EI078 |
