### **APPENDIX 3: Photographs of test setup**

#### **Radiated emission**

## 4.2 Configuration and peripherals

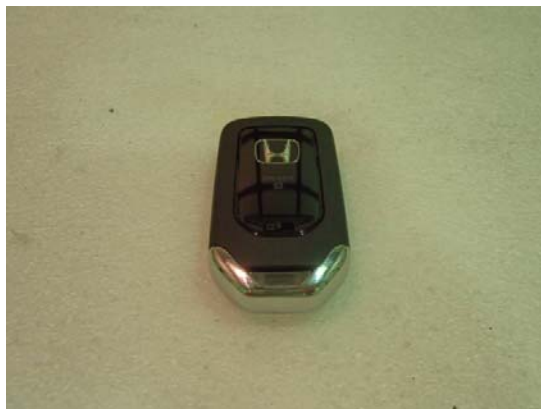
**X-axis**

**Worst case position**  
**(Horizontal: X-axis/Vertical : Y-axis)**

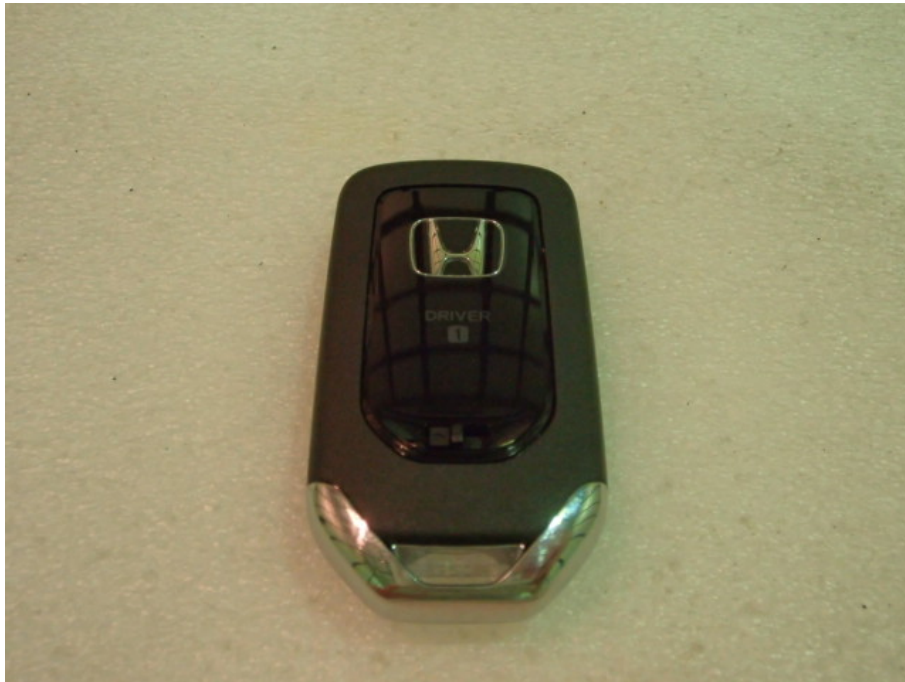
**Worst case position**

**Mechanical Key (Inserted) Worst**

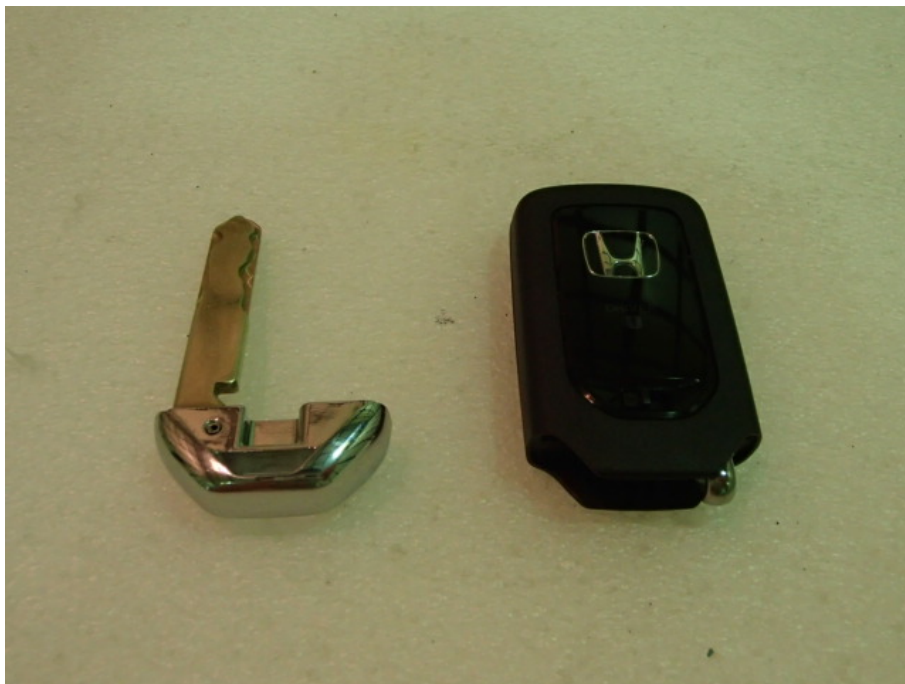
**Mechanical Key (Not Inserted)**
