### **APPENDIX 3: Photographs of test setup**

#### **Radiated emission** (Below 1 GHz)

**Radiated emission**  
(Above 1 GHz)

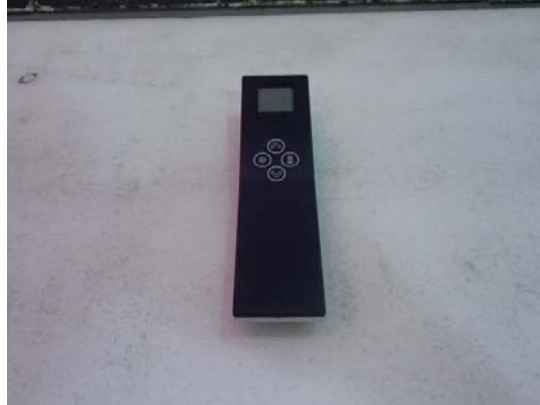
**X-axis**

**Worst case position**

**(Below 1GHz Horizontal: X-axis / Vertical: Y-axis)**

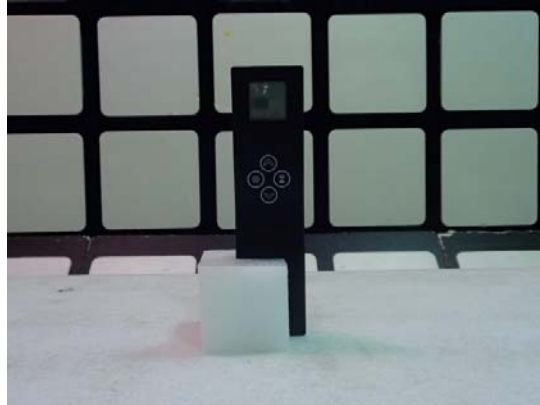
**Y-axis**

**(Above 1GHz Horizontal: Y-axis / Vertical: Z-axis)**
