### **APPENDIX 3: Photographs of test setup**

**UL Japan, Inc.**

**Ise EMC Lab.**

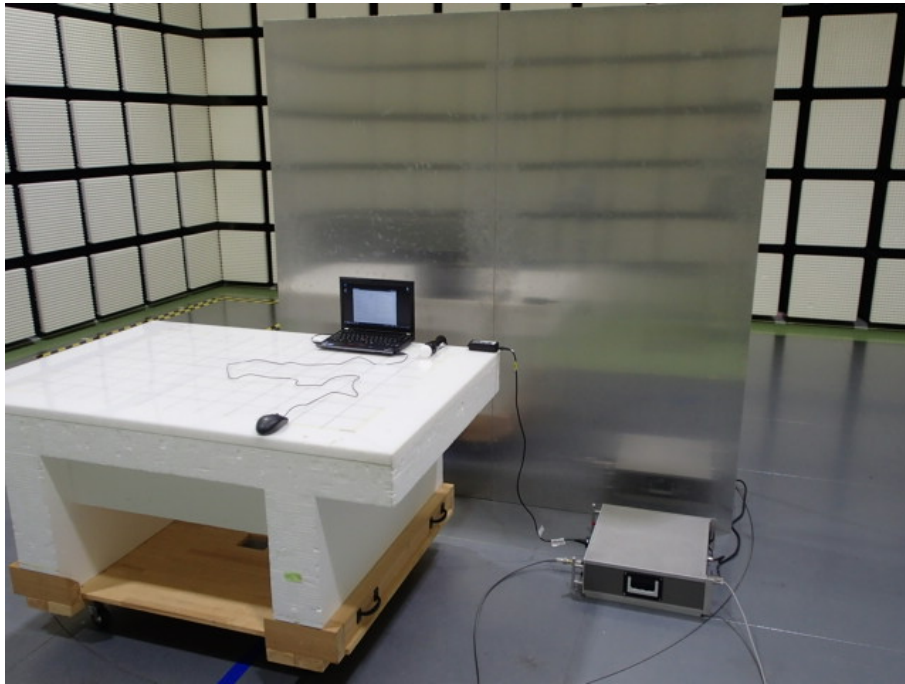
**Photo 1**

#### **Conducted Emission**

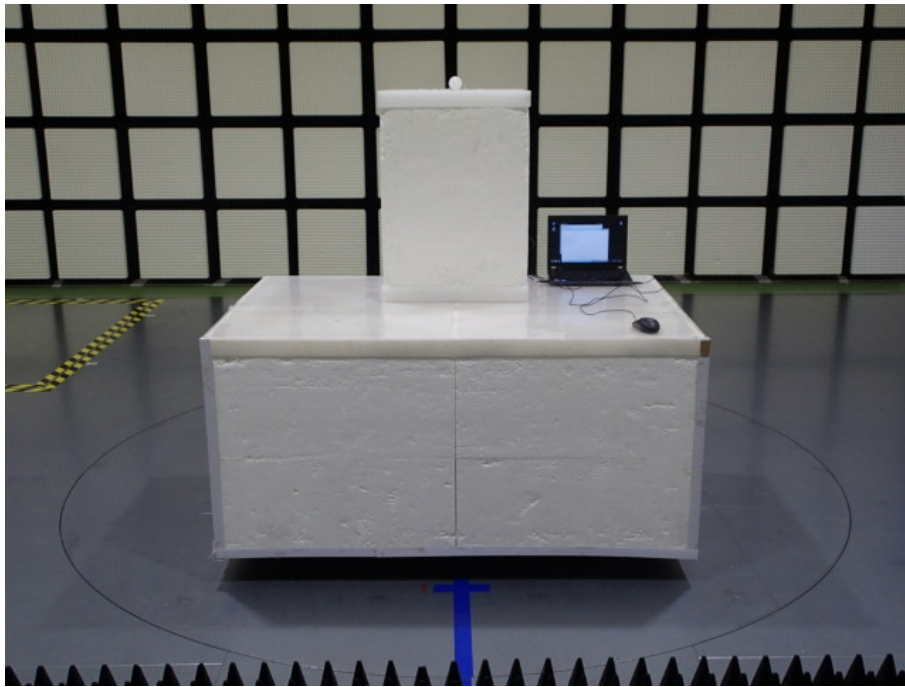
**Photo 1**

### Radiated Spurious Emission

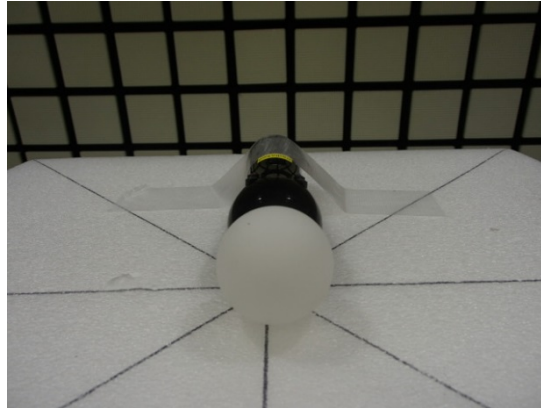
**X-axis**

**Worst Case Position (Horizontal: X-axis/ Vertical:Y-axis)**

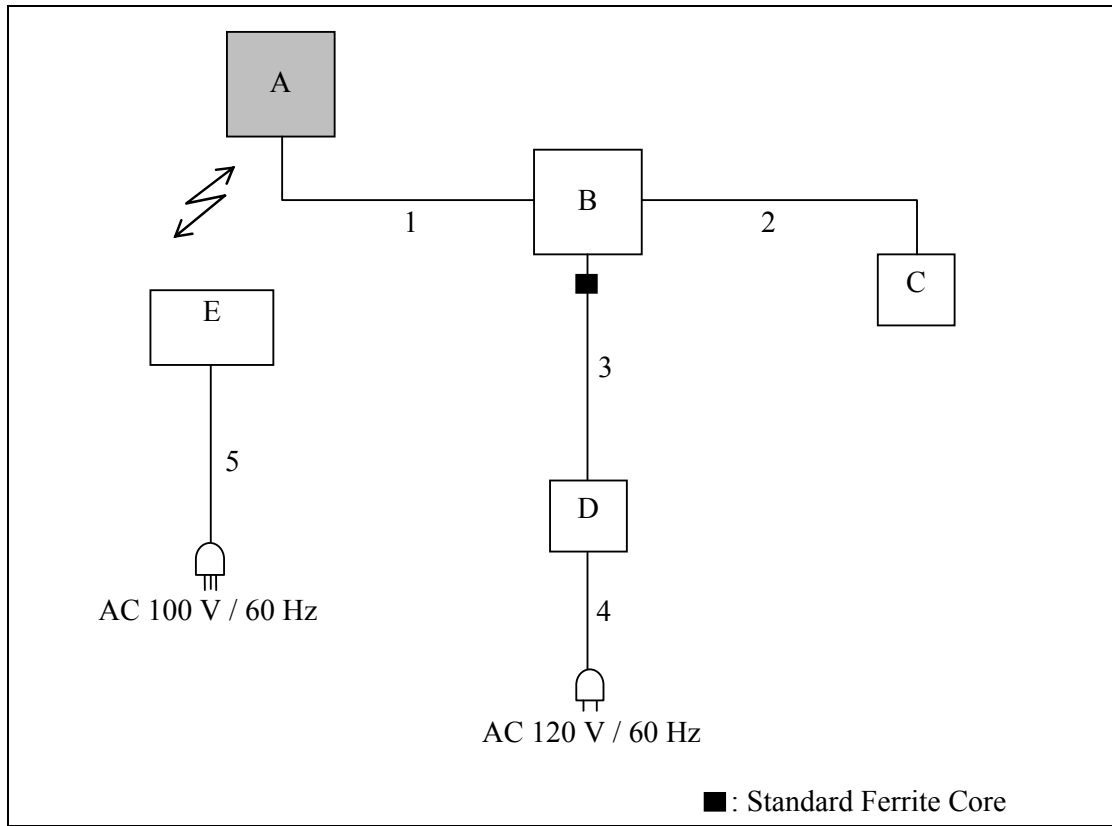
### Test Configuration and peripherals

\* Cabling and setup(s) were taken into consideration and test data was taken under worse case conditions.

#### Description of EUT and Support equipment

| No. | Item | Model number | Serial number | Manufacturer | Remarks |
| A | Wireless Controller | CECH-ZCM2U | YEP40DVT100113 for RE*<br>YEP40DVT100127 for AT* | Sony Interactive Entertainment Inc. | EUT |
| B | Laptop PC | ThinkPad X230 | R9-W6R3612/12 | Lenovo | - |
| C | Mouse | U0039 | 1329LZ0MJW8 | Logicool | - |
| D | AC Adapter | 45N0121 | 11S450121Z1HXU2CB96T | Lenovo | - |
| E | Bluetooth Tester | CBT | 100401 | Rohde & Schwarz | - |
