### **APPENDIX 3: Photographs of test setup**

#### **Conducted Emission**

### Radiated Spurious Emission

### Test Configuration and peripherals

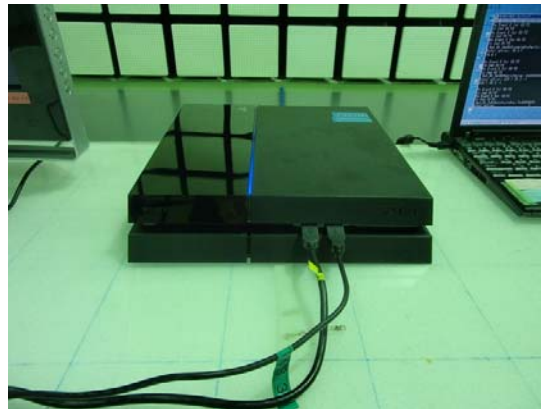
**X-axis**

**Worst Case Position (Horizontal: X-axis/ Vertical:Y-axis)**

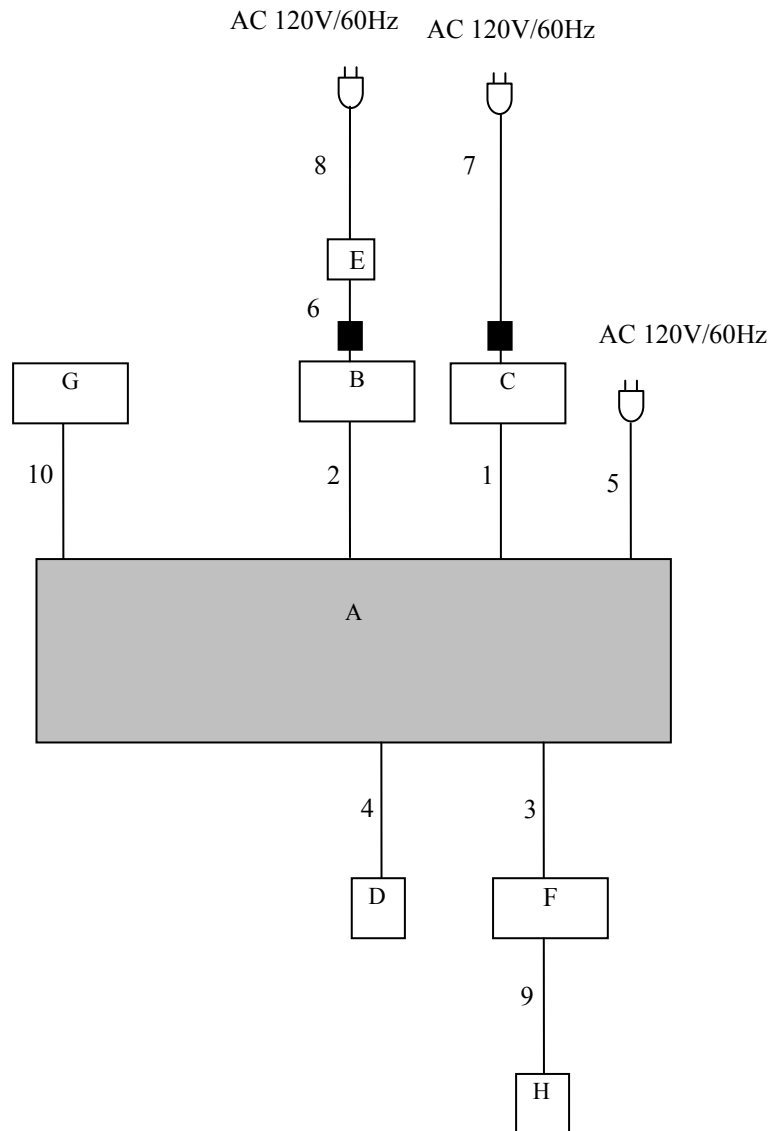
\* Cabling and setup were taken into consideration and test data was taken under worse case conditions.
