### **APPENDIX 3: Photographs of test setup**

#### **Conducted Spurious Emission**

### **Radiated Spurious Emission**

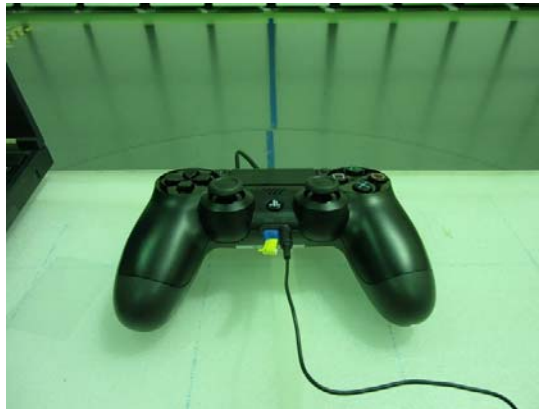
**X-axis**

**Worst Case Position (Horizontal: Z-axis/ Vertical: Y-axis)**

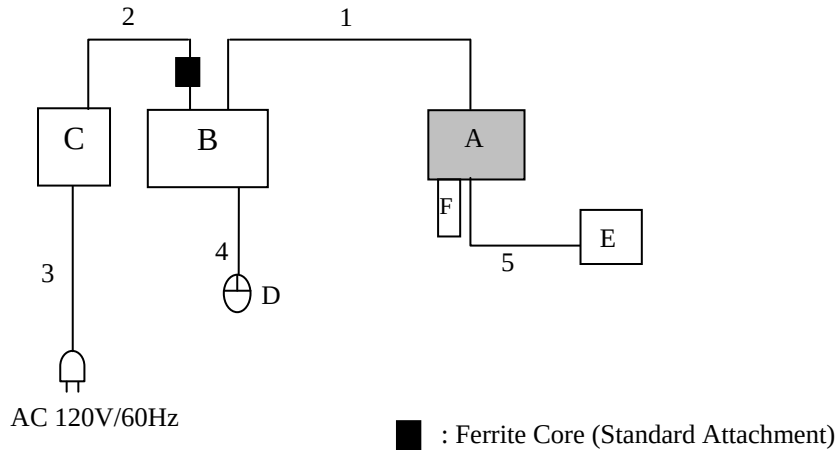
## Test Configuration and peripherals

\*Cabling and setup were taken into consideration and test data was taken under worse case conditions.

| No | Item | Model number | Serial number | Manufacturer | Remarks |
|---|---|---|---|---|---|
| A | Wireless Controller | CUH-ZCT1U | 00127 for AT<br>00128 for RE | Sony Computer Entertainment | EUT |

\*AT: Antenna Terminal Conducted test, RE: Radiated Emission test
