**Test Plot: Occupied Bandwidth (Input vs. Output)**

Job No.: 0L0367R Date: 04/09/01  
Specification: Temperature(°C): 22  
Tested By: David Light Relative Humidity(%) 50  
E.U.T.: MOR 801Bi Power  
Configuration: Transmit iDEN signal  
Serial Number: 0013  
Location: Lab 1 RBW: Refer to plots  
Detector Type: Peak VBW: Refer to plots

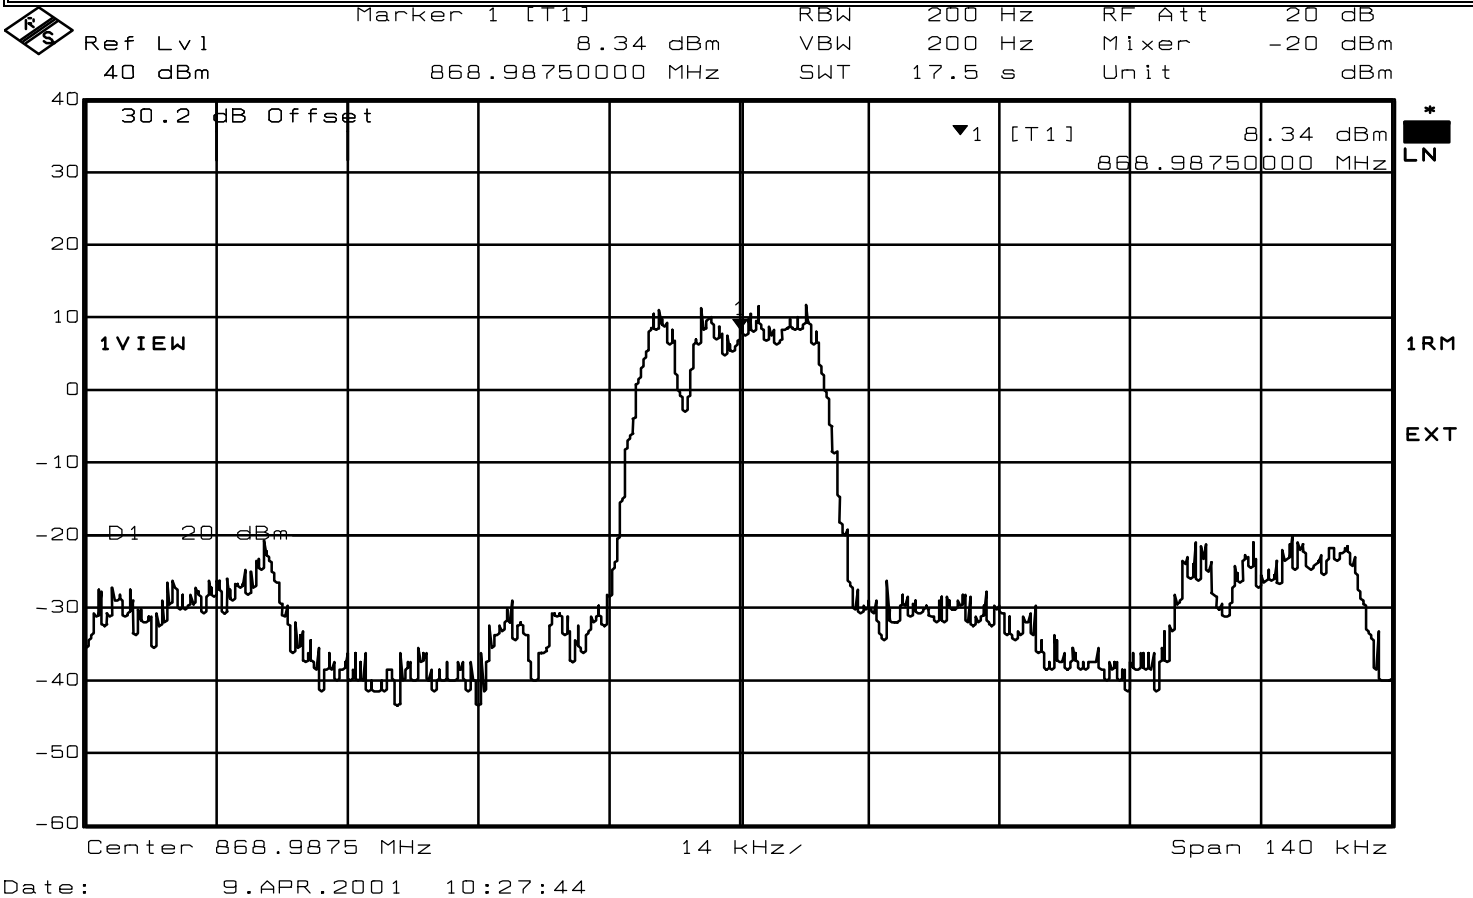
Page 2 of 4

Notes: **Output signal - iDEN Modulation**  
**Upper bandedge**
