KTL Dallas, Inc.

**Test Plot: Occupied Bandwidth (Input vs. Output)**

Job No.: 0L0367R Date: 04/06/01  
Specification: Temperature(°C): 22  
Tested By: David Light Relative Humidity(%) 50  
E.U.T.: MOR 801Bi Power  
Configuration: Transmit Voice signal  
Serial Number: 0013  
Location: Lab 1 RBW: Refer to plots  
Detector Type: Peak VBW: Refer to plots

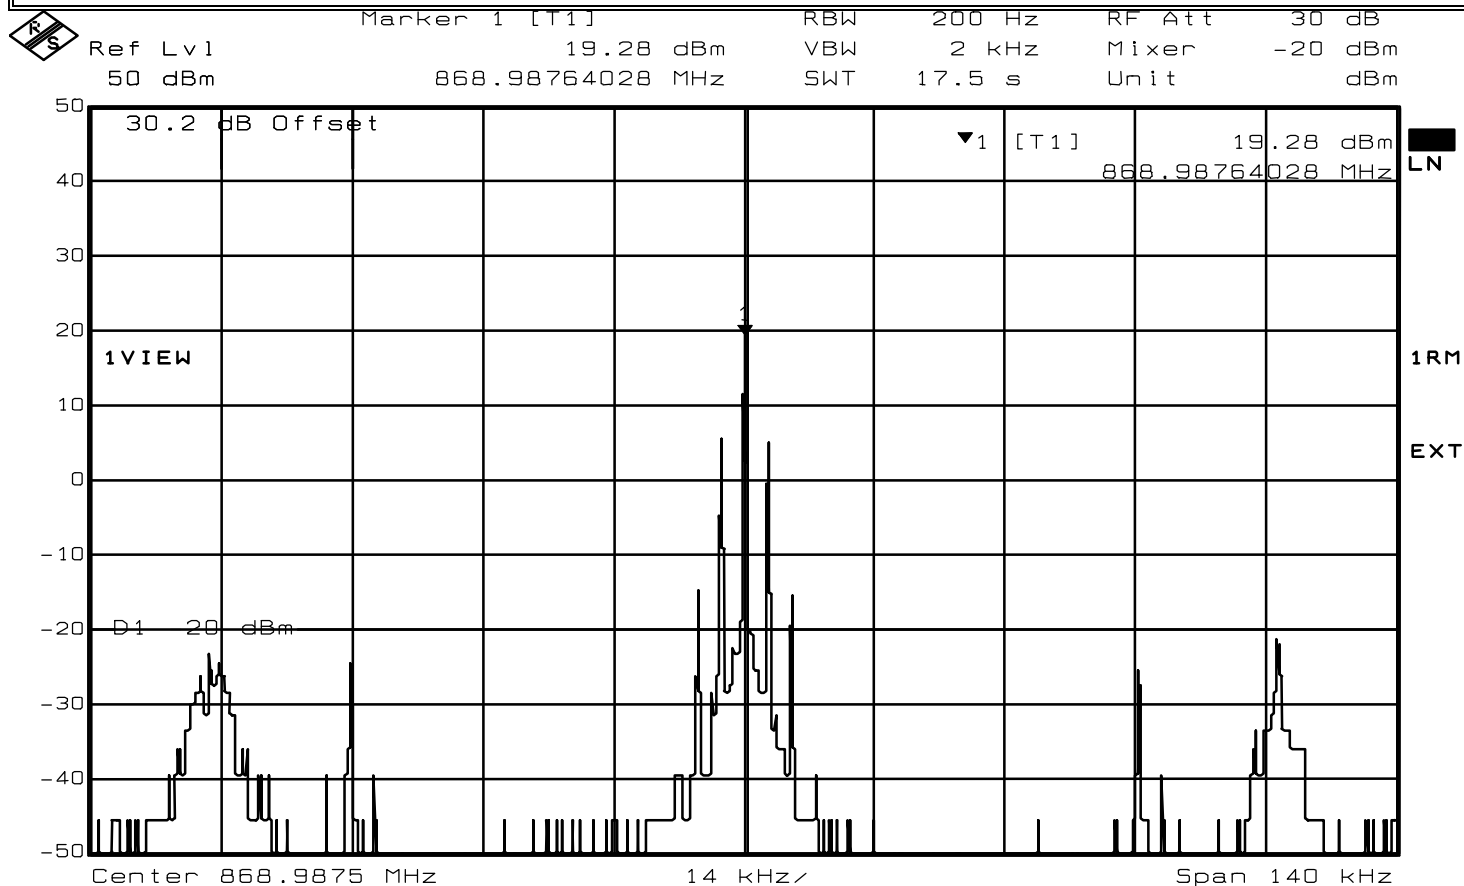
Notes: **Output signal - Voice Modulation****Upper bandedge**

hi pwr occupied bw voice (RETEST)

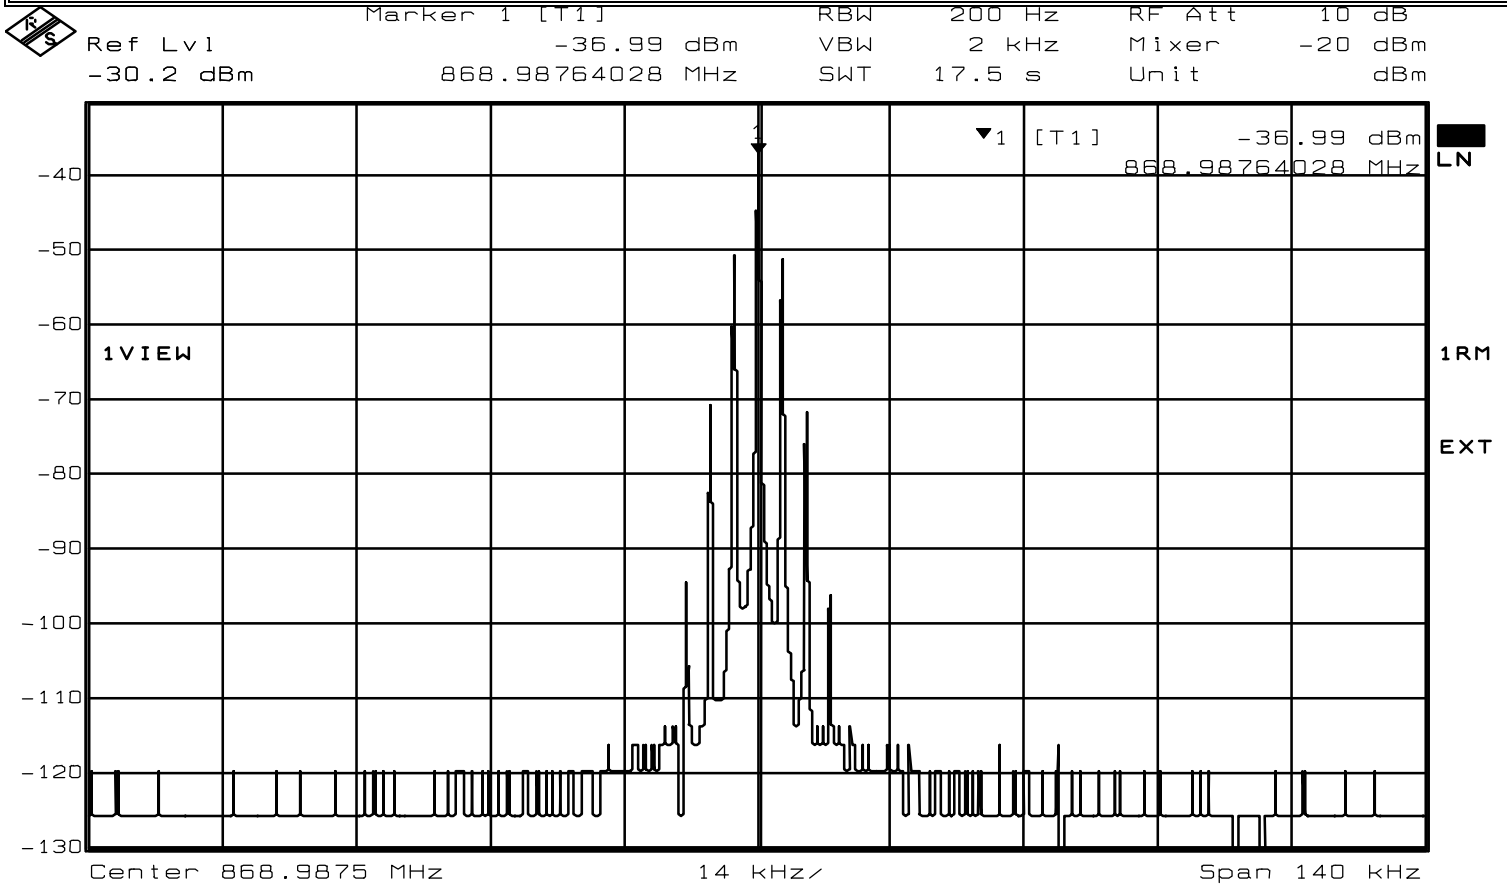
Notes: **Input signal - Voice Modulation**  
**Upper bandedge**

hi pwr occupied bw voice (RETEST)
