KTL Dallas, Inc.

**Test Plot: Occupied Bandwidth (Input vs. Output)**

Job No.: 0L0367R Date: 04/06/01  
Specification: Temperature(°C): 22  
Tested By: David Light Relative Humidity(%) 50  
E.U.T.: MOR 801Bi  
Configuration: Transmit Voice signal  
Serial Number: 0013  
Location: Lab 1 RBW: Refer to plots  
Detector Type: Peak VBW: Refer to plots

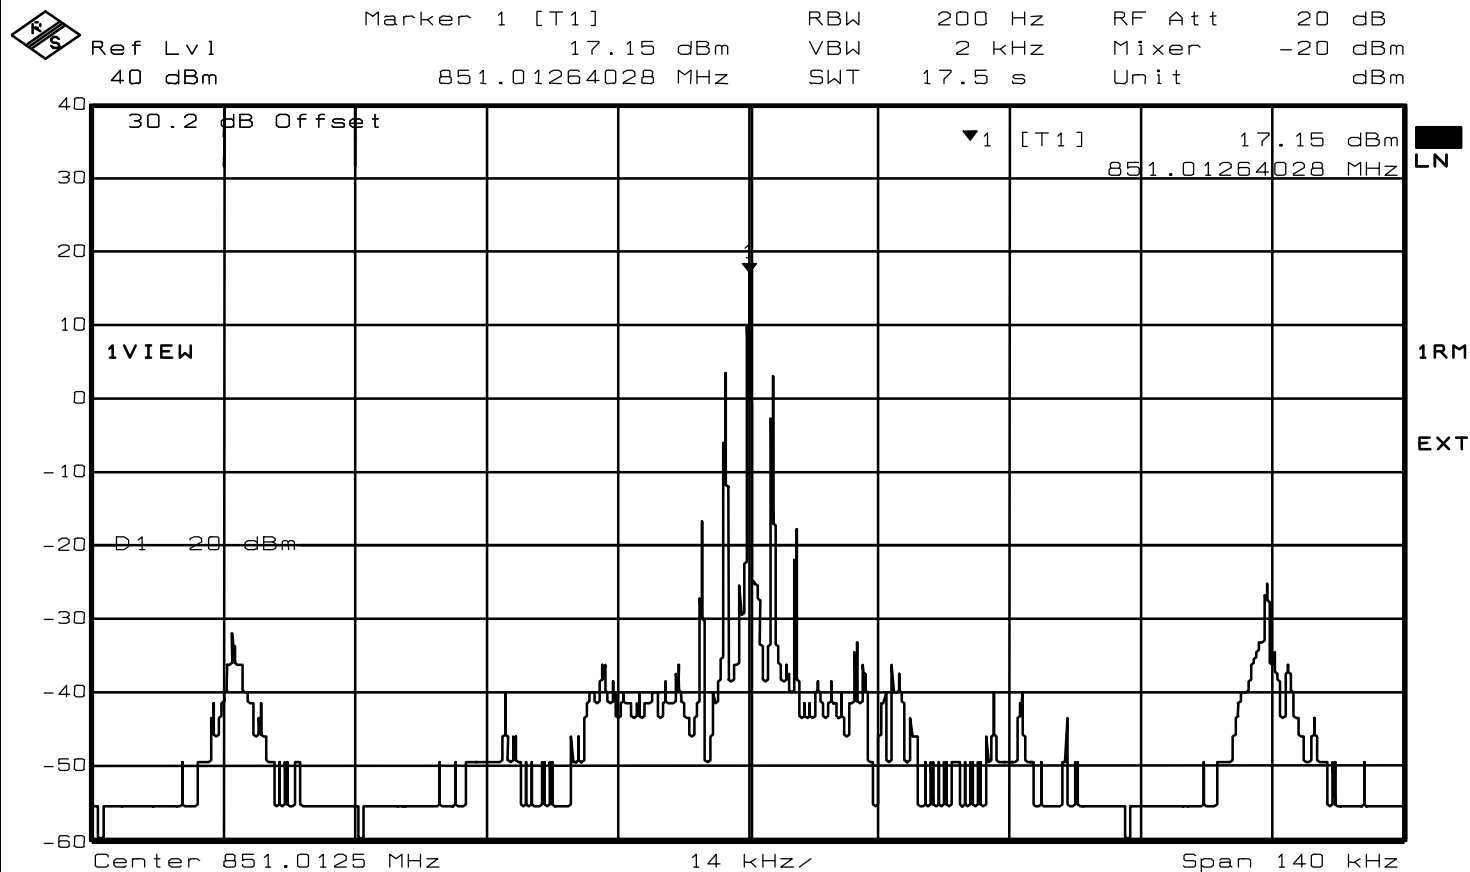
Notes: Output signal - Voice Modulation

Lower bandedge

occupied bw voice (RETEST)

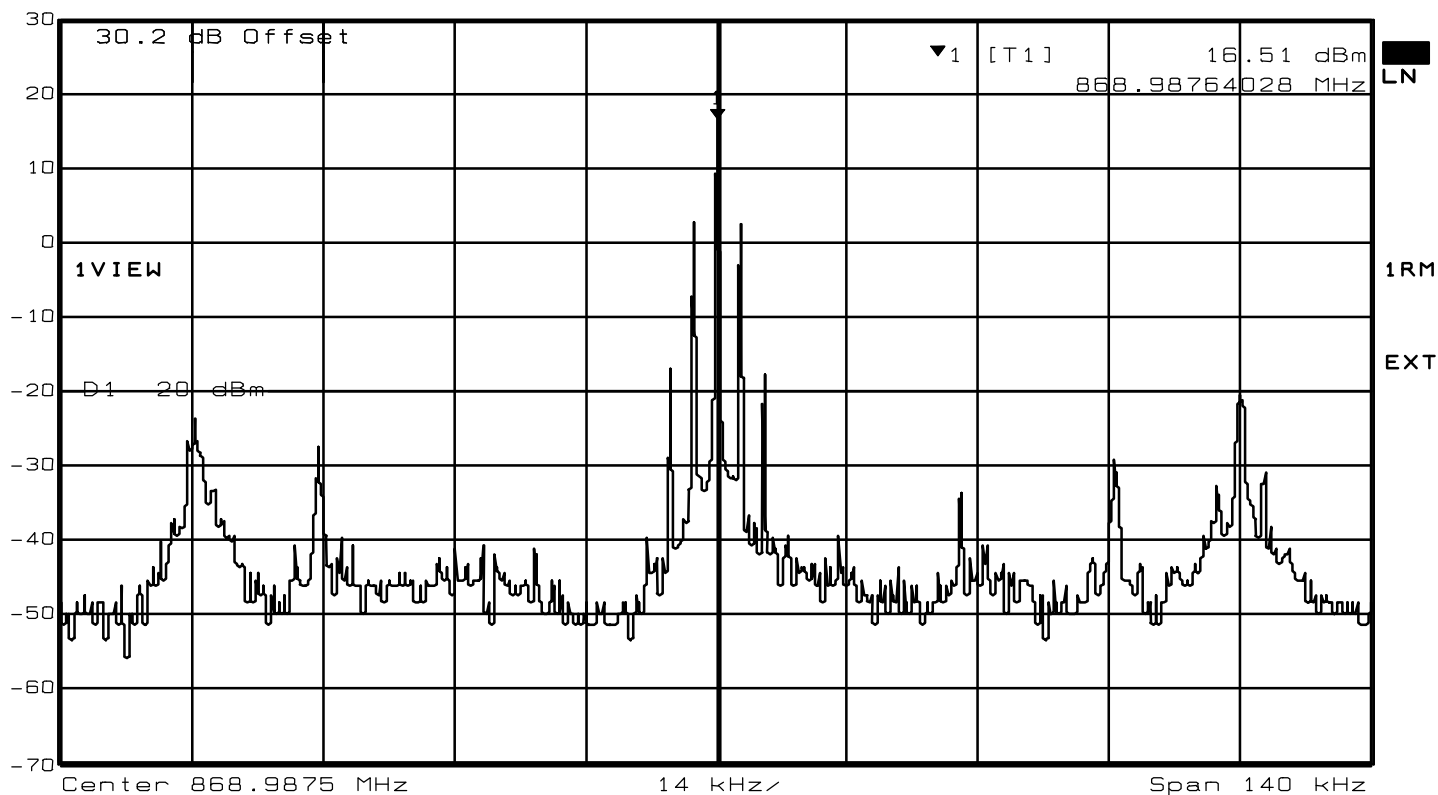
Marker 1 [T1] RBW 200 Hz RF Att 10 dB  
Ref Lvl 16.51 dBm VBW 2 kHz Mixer -20 dBm  
30 dBm 868.98764028 MHz SWT 17.5 s Unit dBm

Notes: **Output signal - Voice Modulation****Upper bandedge**

occupied bw voice (RETEST)

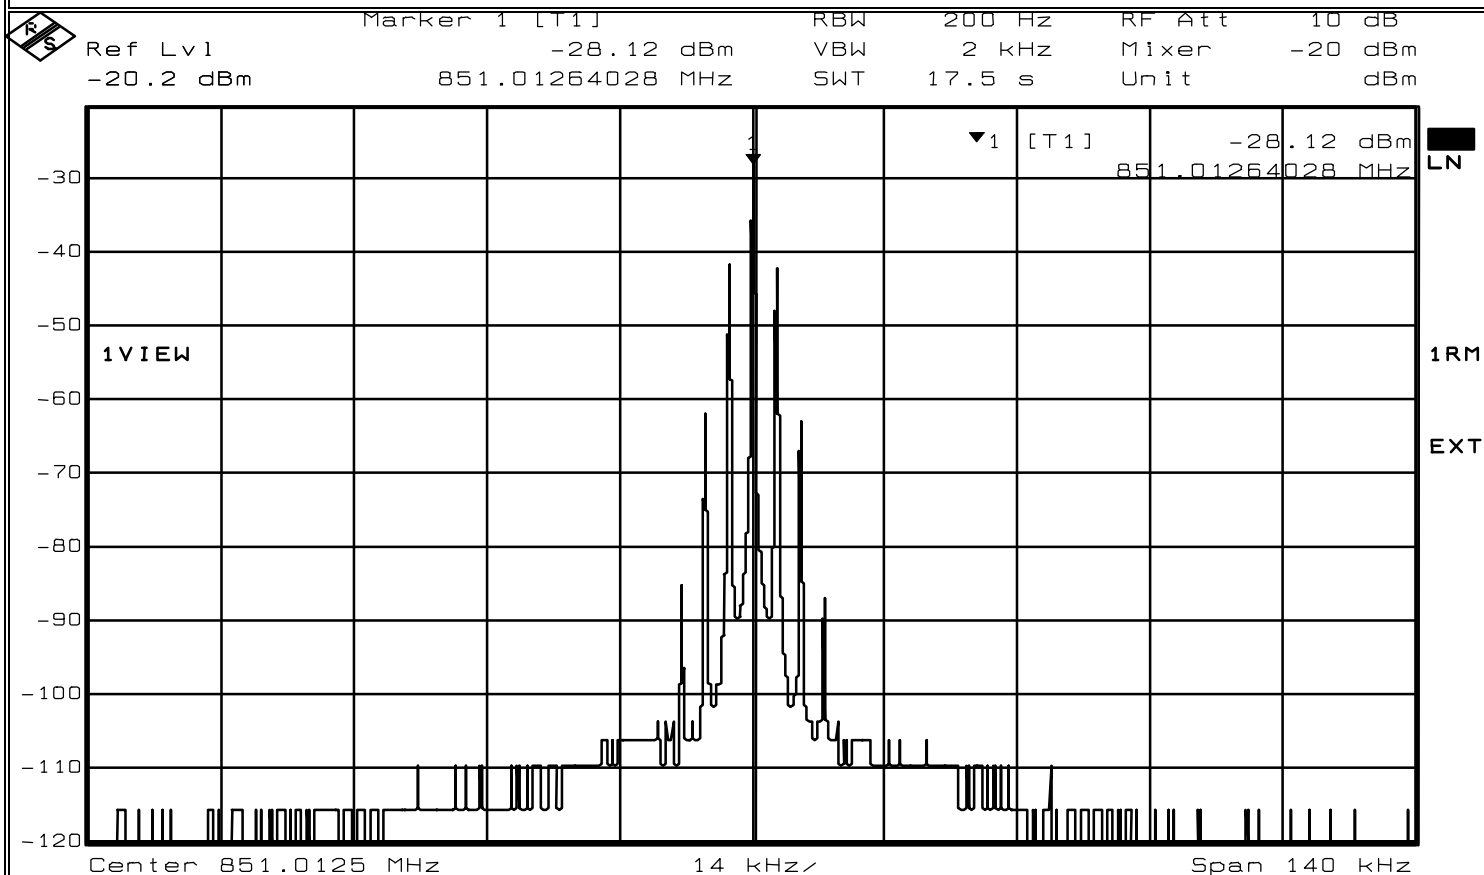
Notes: **Input signal - Voice Modulation**  
occupied **Lower band (Edge)**

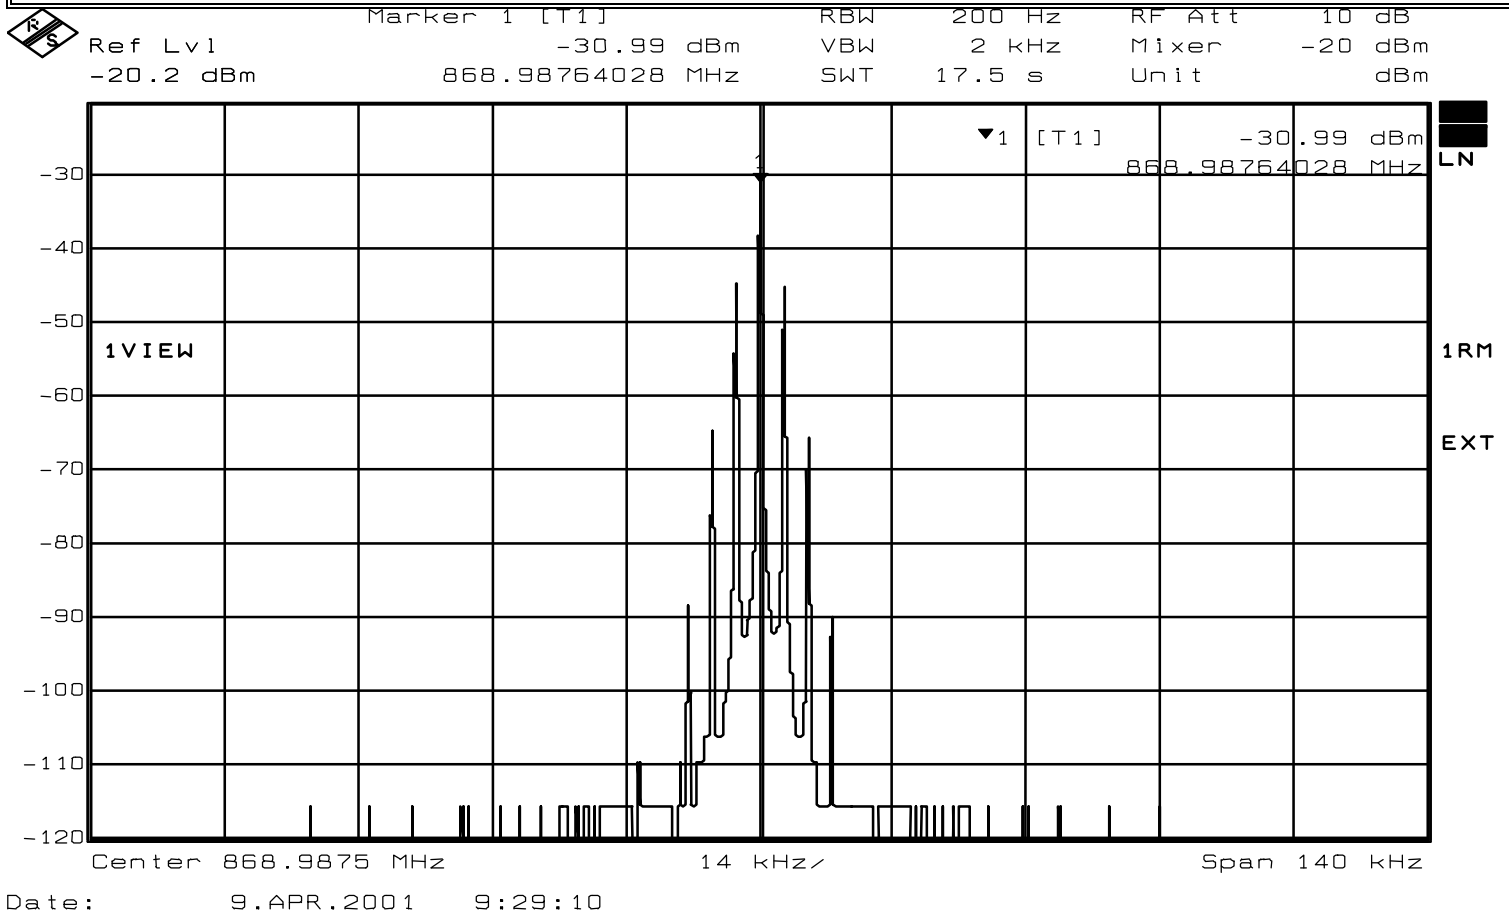
Notes: **Input signal - Voice Modulation**  
**Upper bandedge**

occupied bw voice (RETEST)
