# **VX1000**

## **Antenna Change**

**VX1000 R&D Team**

**Nov 09, 2005**

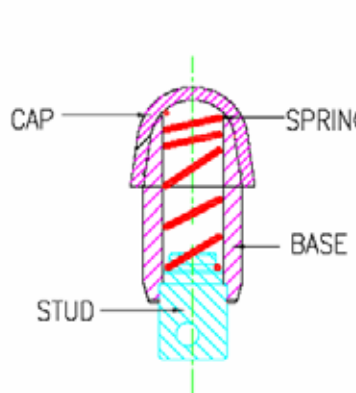
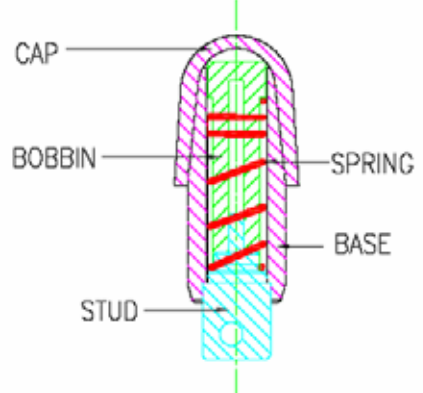
| CHANGES | IN DETAIL<br>Please refer to pictures in right side | BEFORE (H/W 1.0) | AFTER (H/W 1.1) |
|---|---|---|---|
| ANTENNA SHAPE | Externally, antenna shape is changed. | | |
| INTERNAL STRUCTURE | The main reason which antenna is changed is extended BOBBIN size in antenna. (Antenna length: 4 mm ↑) | | |
| MATCHING CIRCUIT | Matching circuit is changed like beside pictures. | | |
| EMI COATING | Different coating method | Spray Coating | Evaporation Coating |
