“Description of Measurement Facilities”

Norse Lab, Inc.

FCC 2.948(a)(b) Description of Measurement Facilities

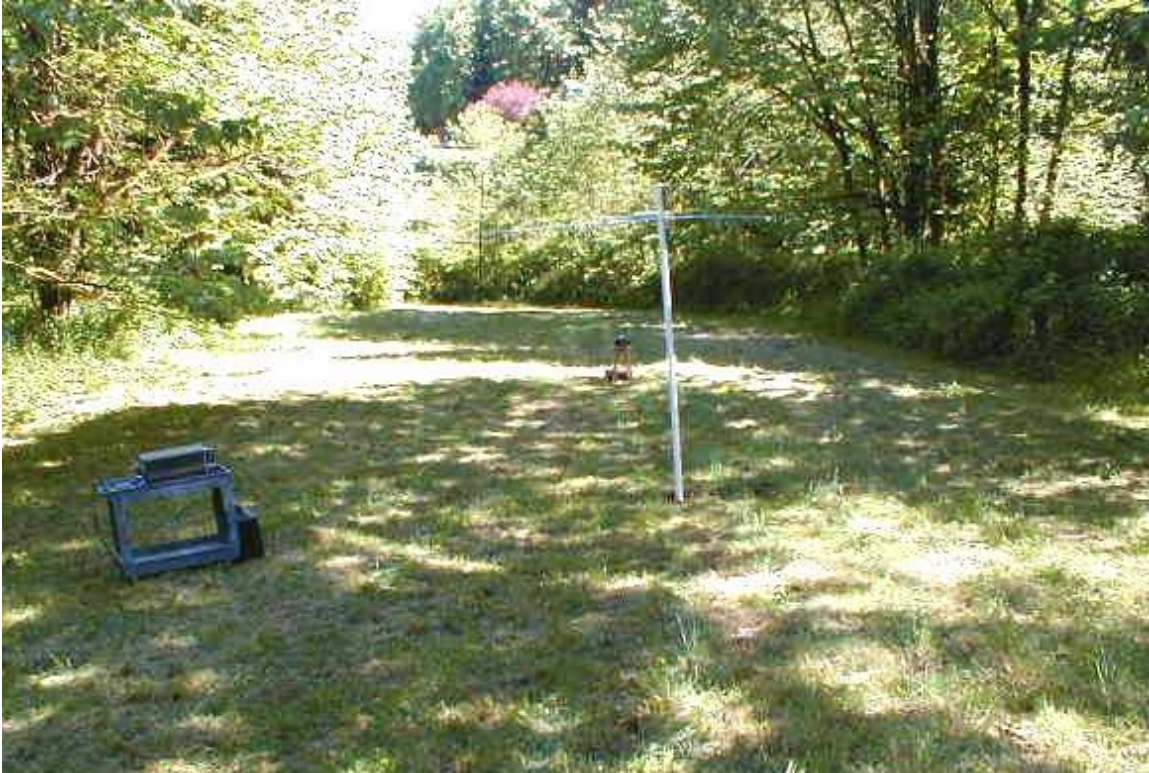
**FIGURE 1 NORTH VIEW**

The test site consists of an open grass field, surrounded on two sides by trees but otherwise open and free of structures. The site is located in the middle of a 12-acre plot of undeveloped land. Please see photographs (figures 1-6).

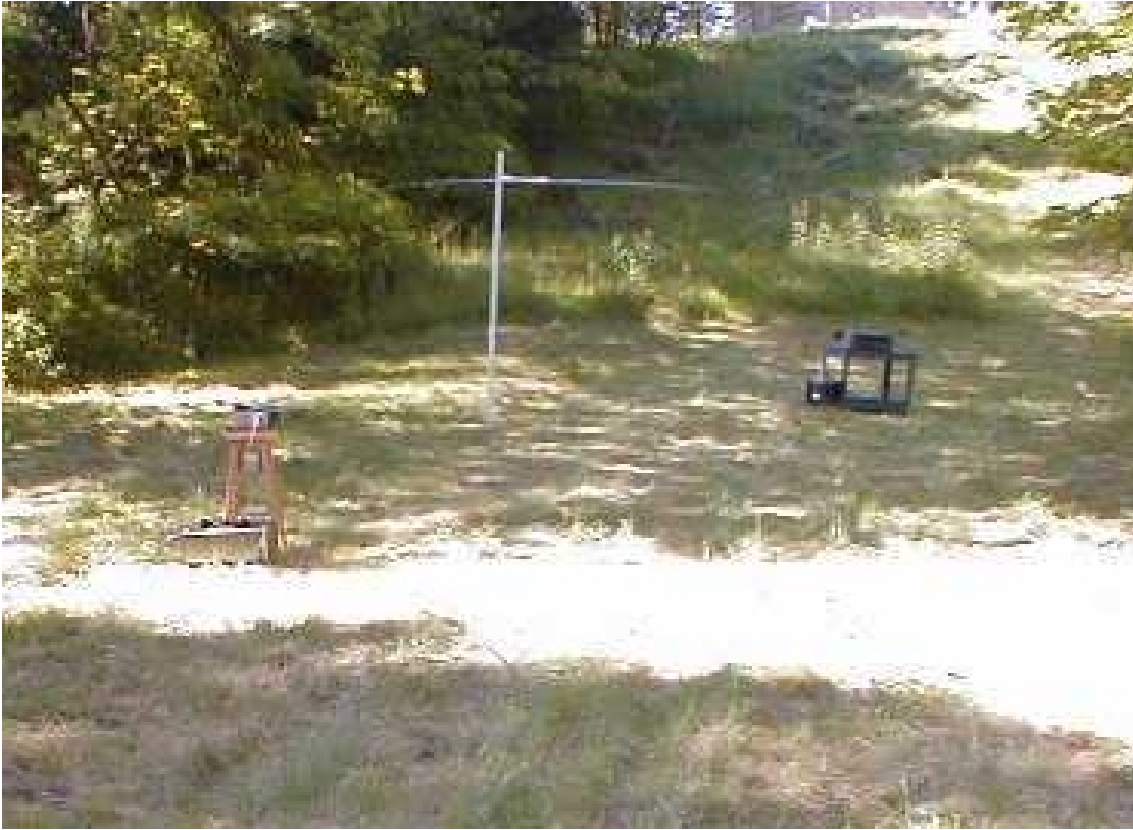
**FIGURE 2 SOUTH VIEW**

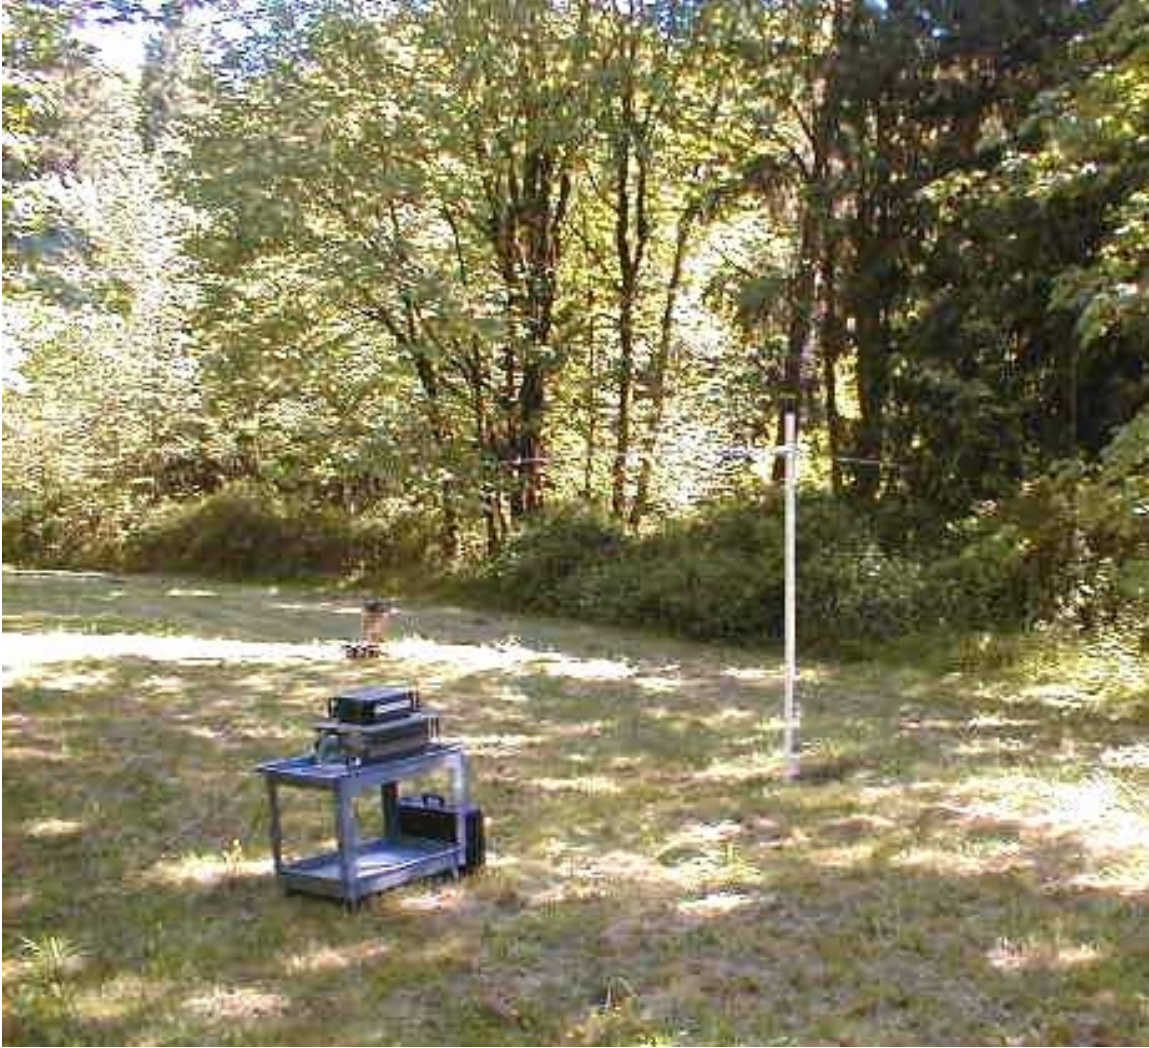
**FIGURE 3 NORTHEAST VIEW**

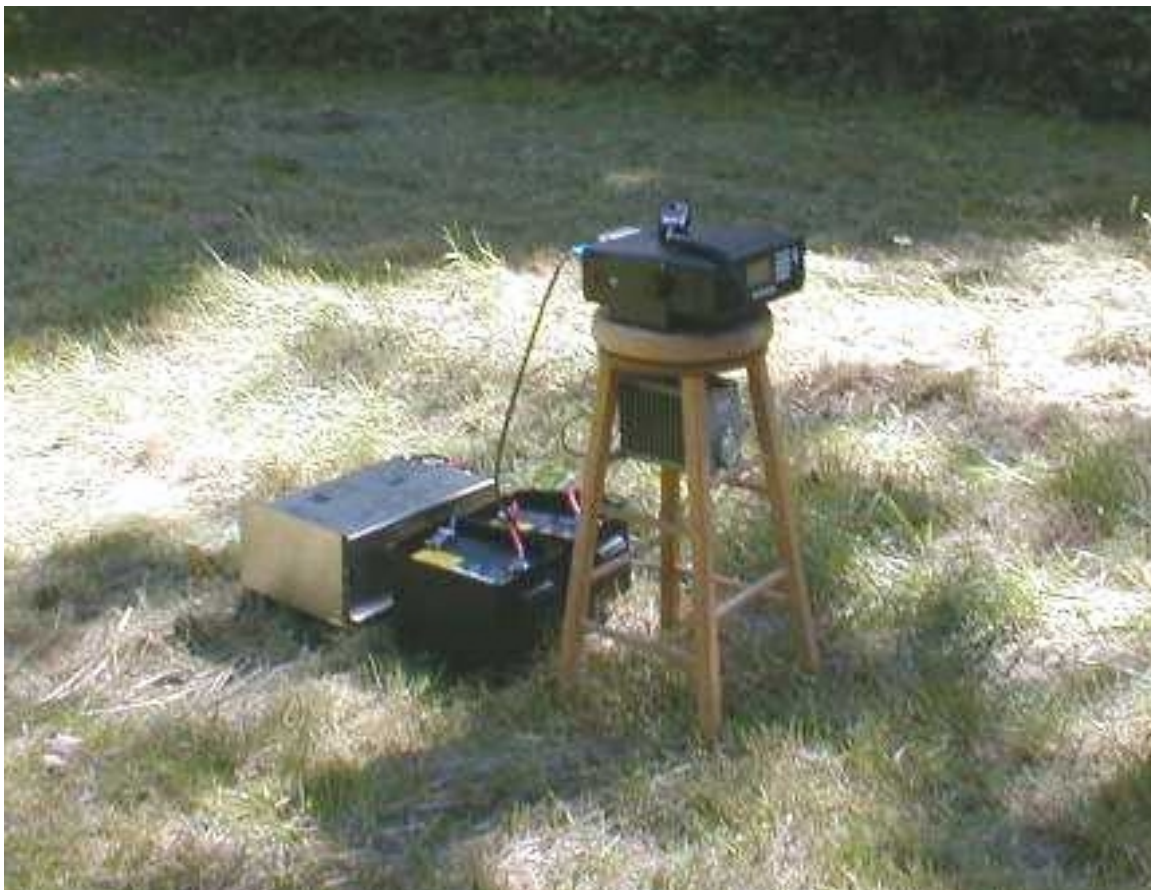
**FIGURE 4 TRANSCEIVER ON TURNTABLE WITH BATTERY SYSTEM**

The signal source/D.U.T was supported by a wooden turntable, 1 meter above ground. The table is rotated manually.

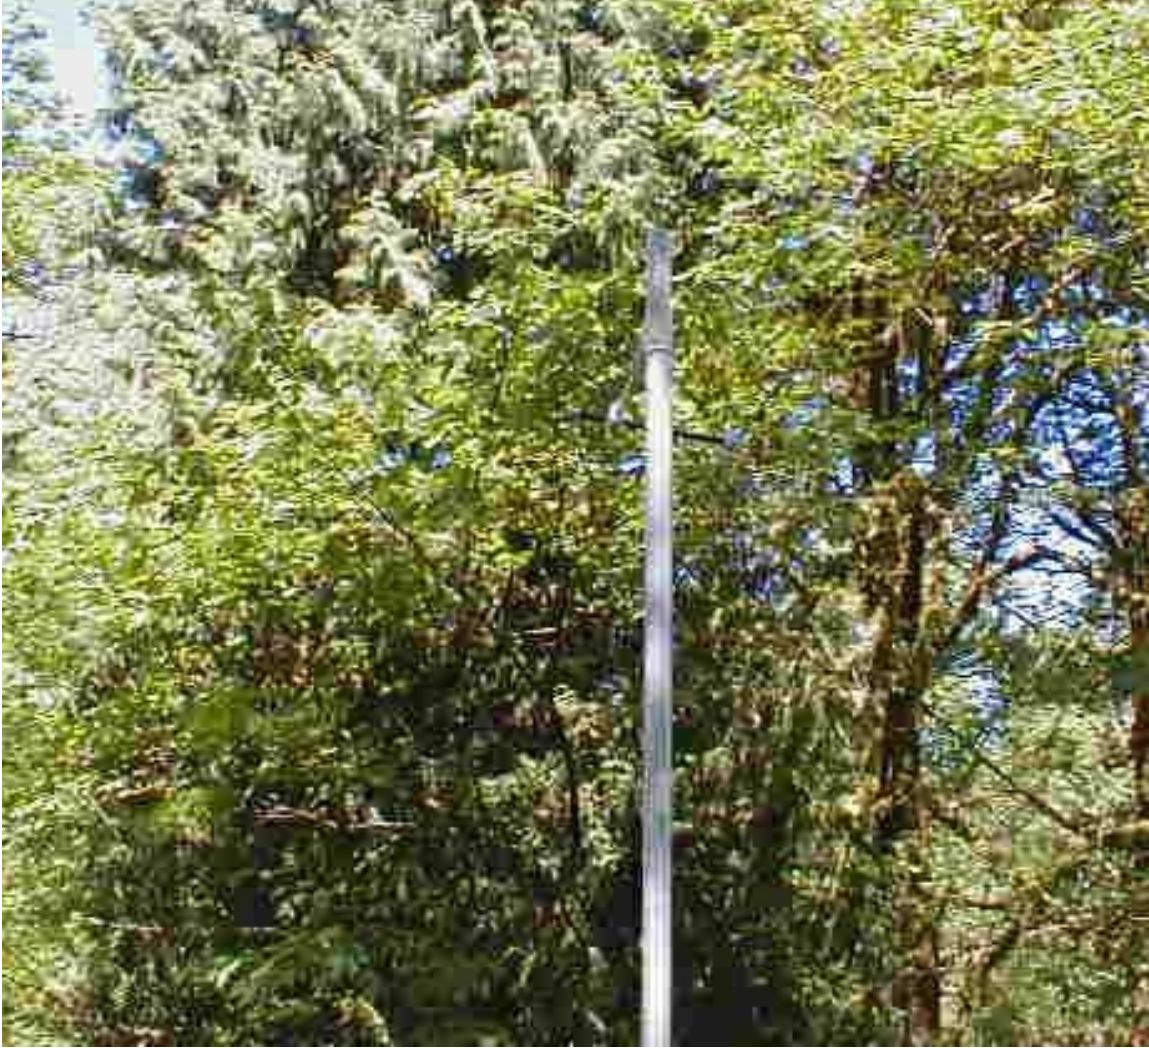
**FIGURE 5 ANTENNA/MAST DETAIL**

The dipole antenna masts are made from heavy-duty PVC pipe and were supported by wood material. The receiving antenna height is manually adjustable by a sliding carriage.

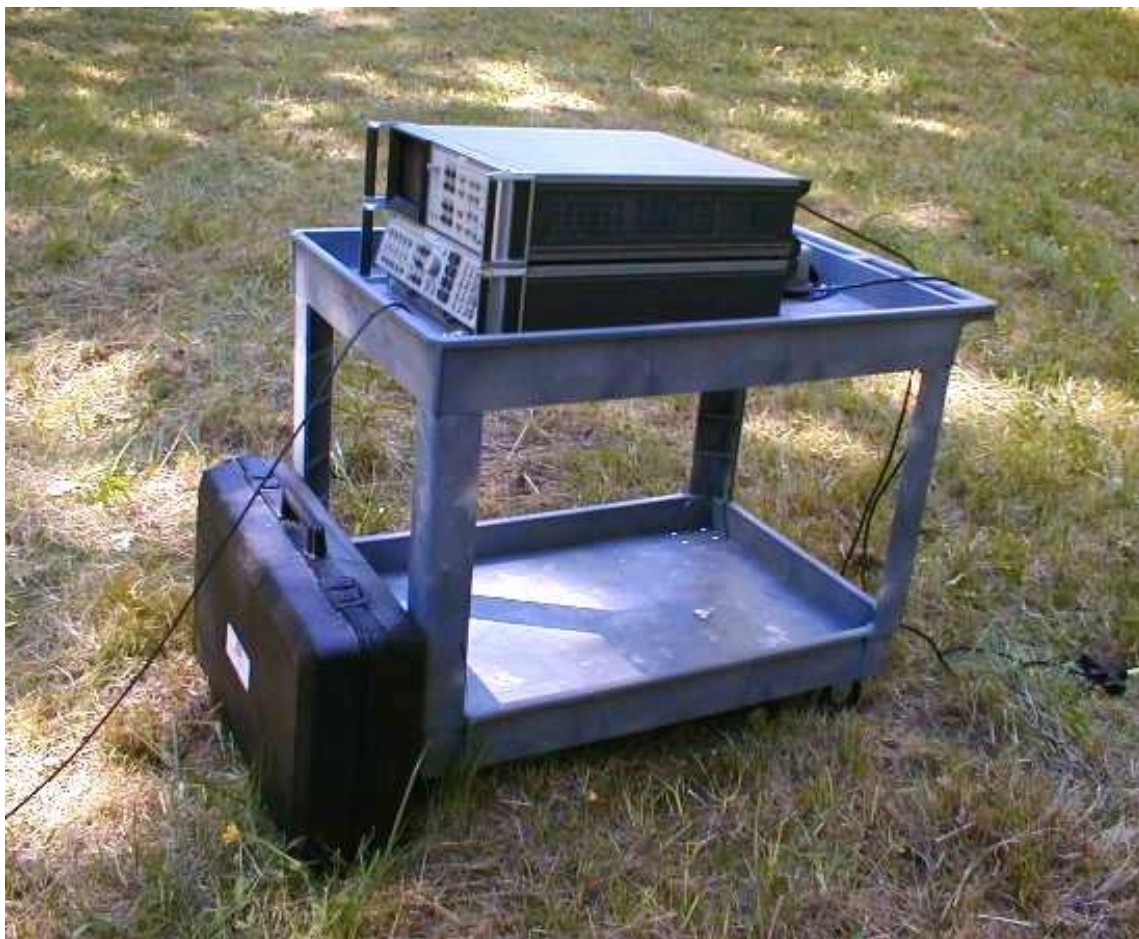
**FIGURE 6 DIPOLES AND SPECTRUM ANALYZER AT TEST STATION**

The spectrum analyzer was supported by a nonmetallic cart, 1 meter above ground and about 7 meters behind the receiving dipole antenna.
