### **APPENDIX 3: Photographs of test setup**

#### **Radiated emission**

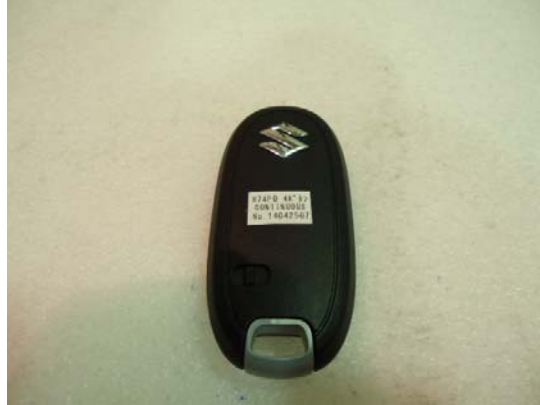
**X-axis**

**Worst case position**

(Below 1GHz : Horizontal: X-axis/Vertical : Z-axis)

(Above 1GHz : Horizontal: Z-axis/Vertical : Y-axis)

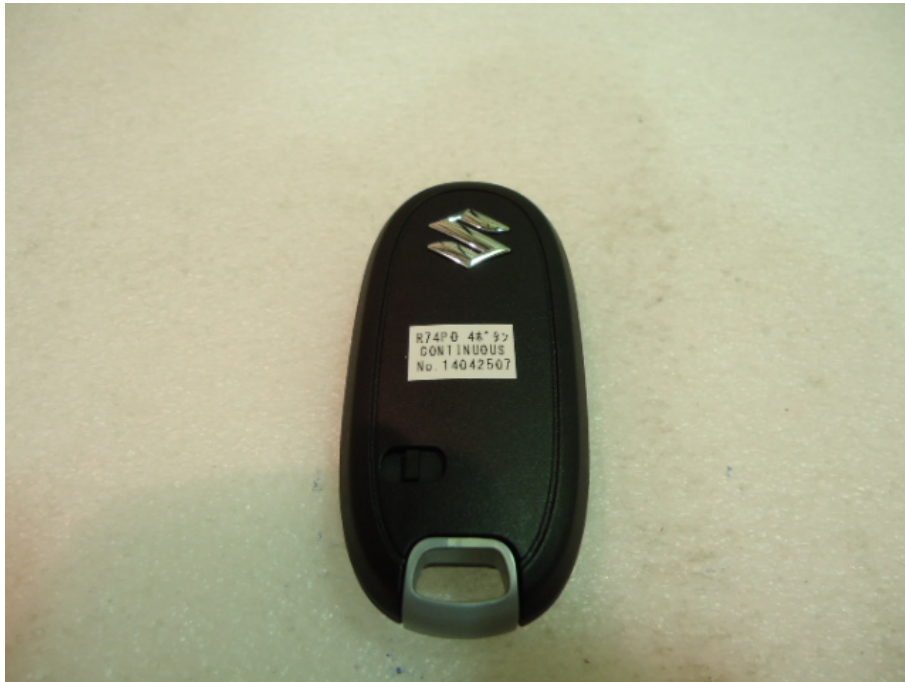
**Worst case position**

**With Key (Worst)**

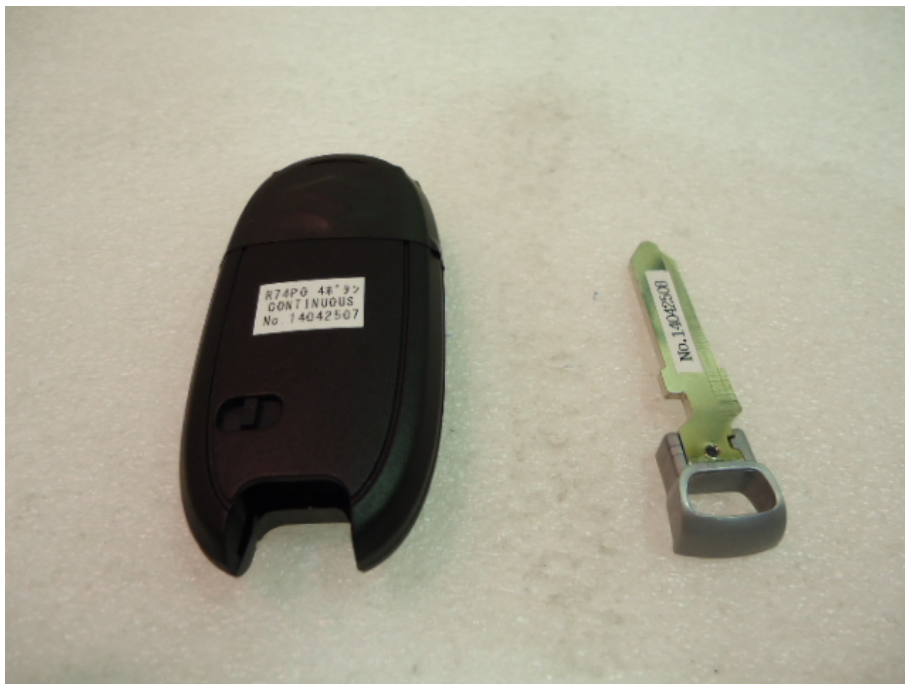
**Without Key**
