**Emission tests to FCC and IC requirements of HA04**

**Performed for Intermatic Inc.**

DELTA Test Report E501839-2  
DANAK-197370  
5 March 2004

containing only the photos of the test set-ups

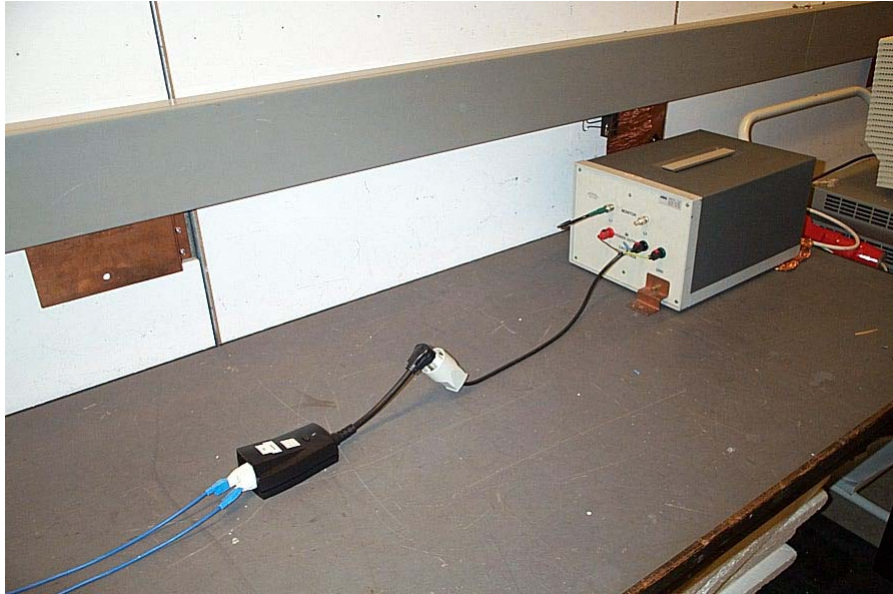
Photo 1 Set-up for conducted emission.  
Measurements performed in screened room. LISN bonded to vertical ground plane (wall).

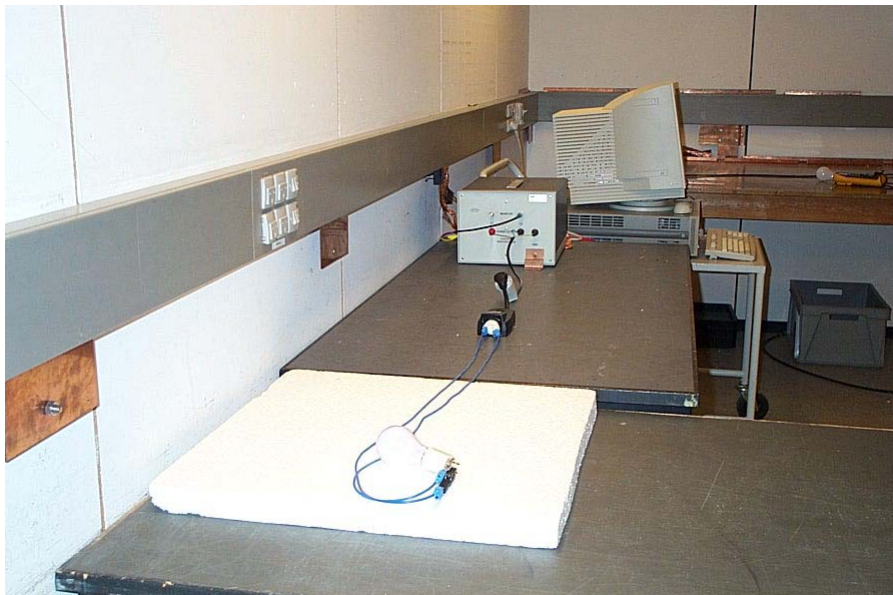
Photo 2 Set-up for conducted emission.  
Measurements performed in screened room. LISN bonded to vertical ground plane (wall).

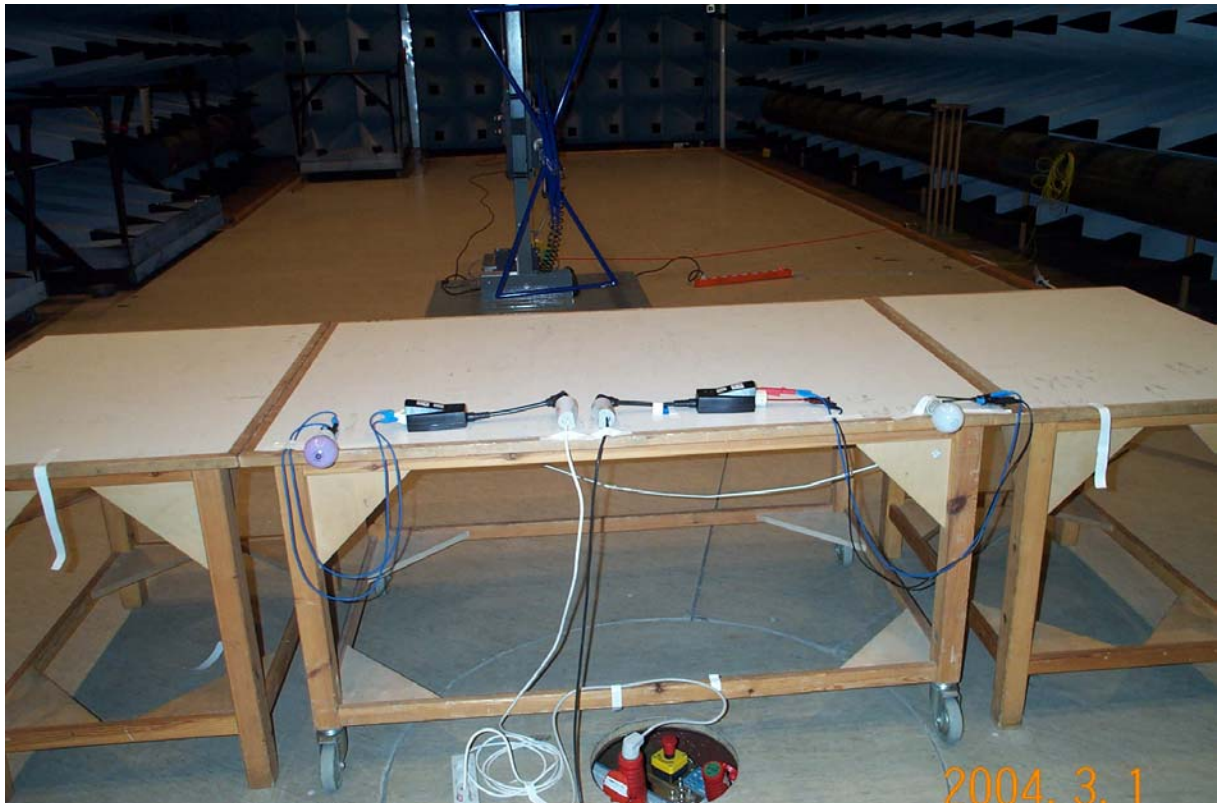
Photo 3 Set-up for measurements 30 – 1000 MHz. Date is 2004-02-12 Camera wrongly set.

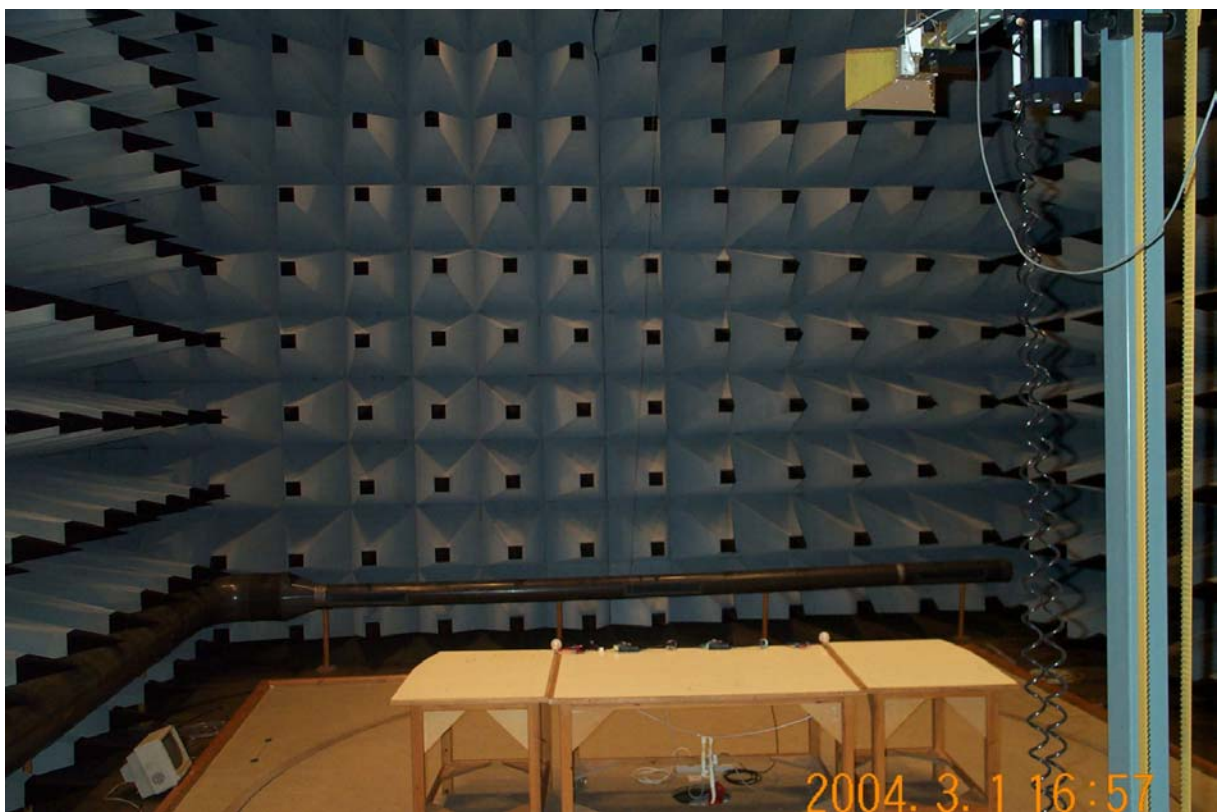
Photo 4 Set-up for measurements > 1 GHz.
