### 10. Photographs of Test Setup

## 11. Photographs of the EUT

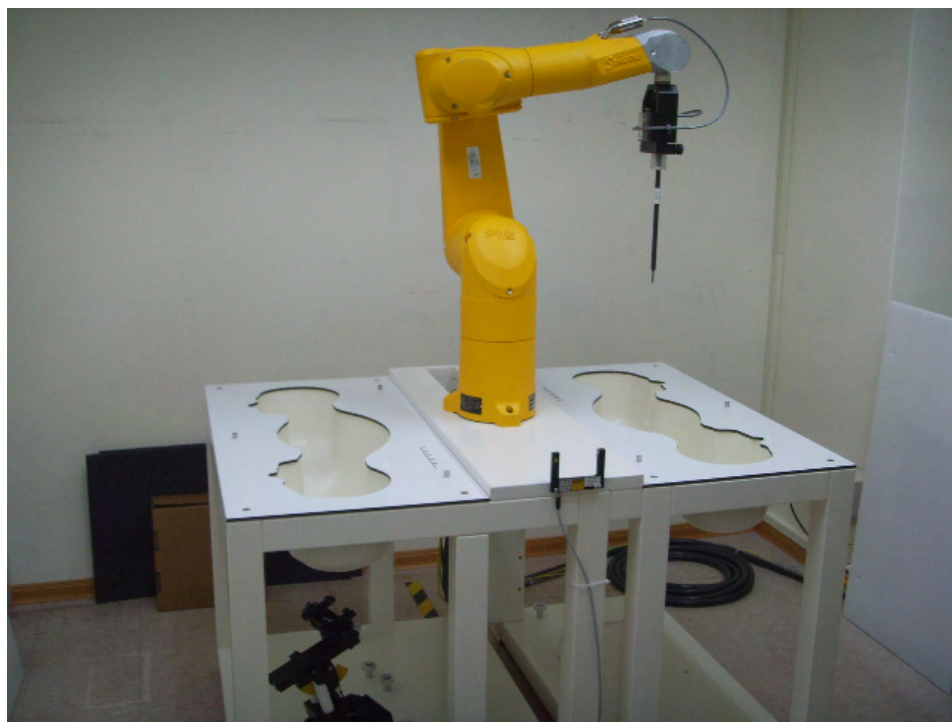
**Fig.1 Photograph of the SAR measurement System**

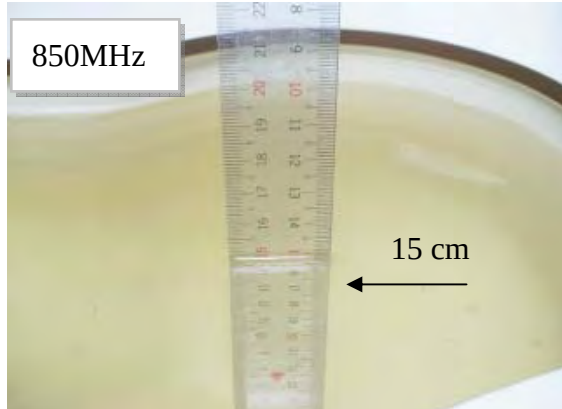
**Photograph of the Tissue Simulant Fluid liquid depth 15cm**

**Fig.2.1 Left-head Side**

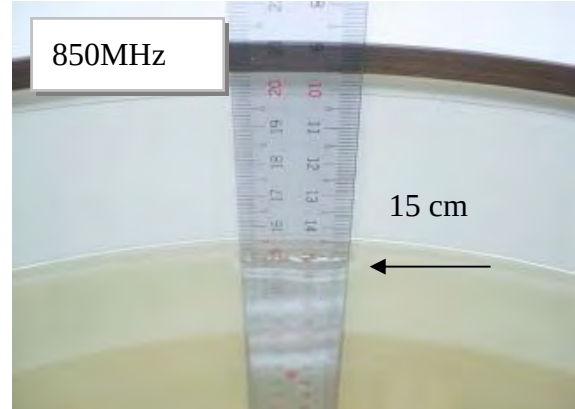
**Fig.2.2 Flat (Body)**

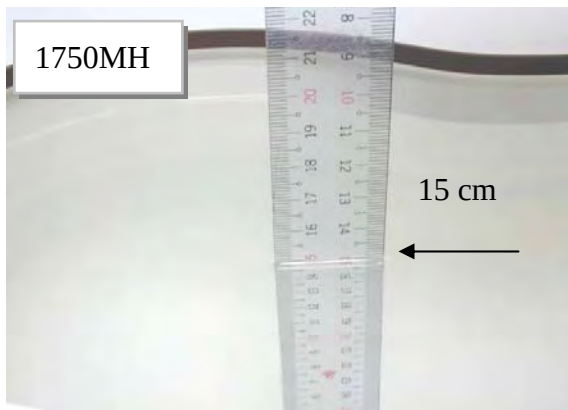
**Fig.2.3 Right-head Side**

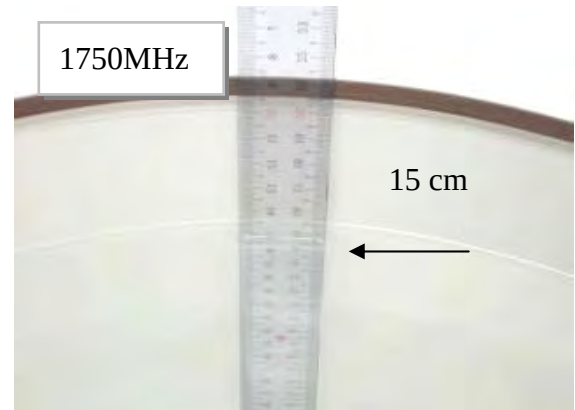
**Fig.2.4 Flat (Body)**

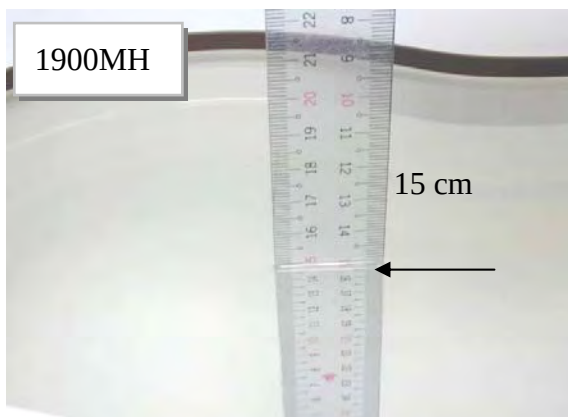
**Fig.2.5 Right-head Side**

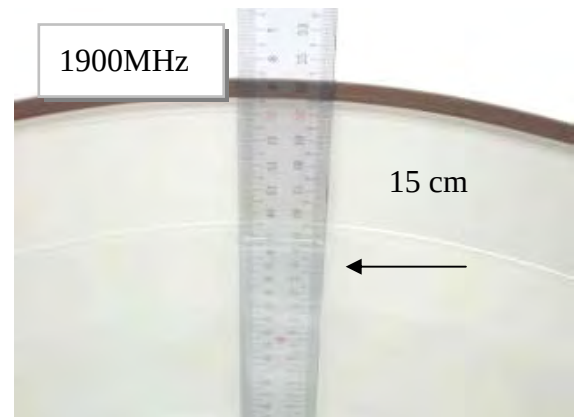
**Fig.6.4 Flat (Body)**

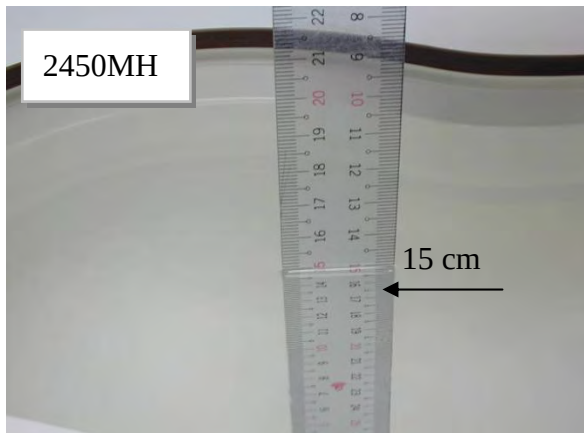
**Fig.2.7 Right-head Side**

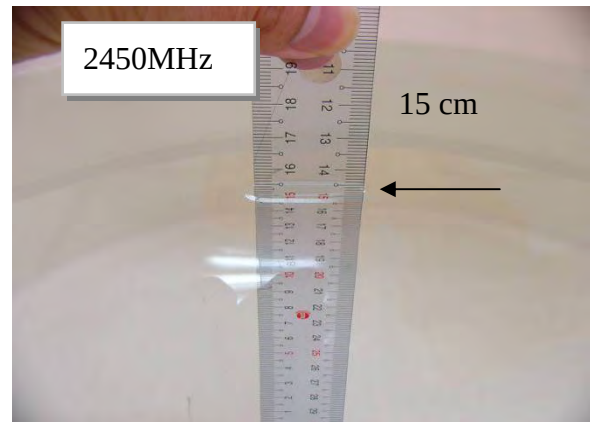
**Fig.2.8 Flat (Body)**

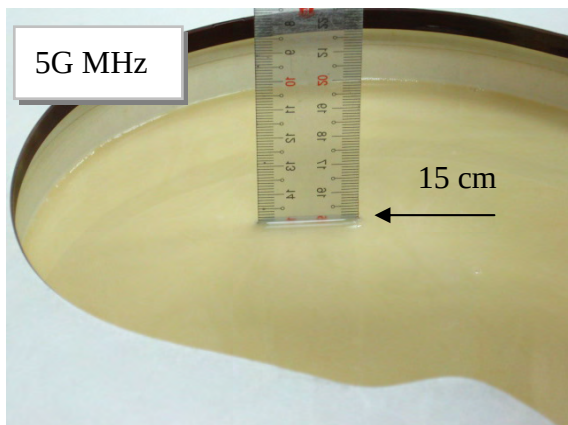
**Fig.2.9 Right-head Side**

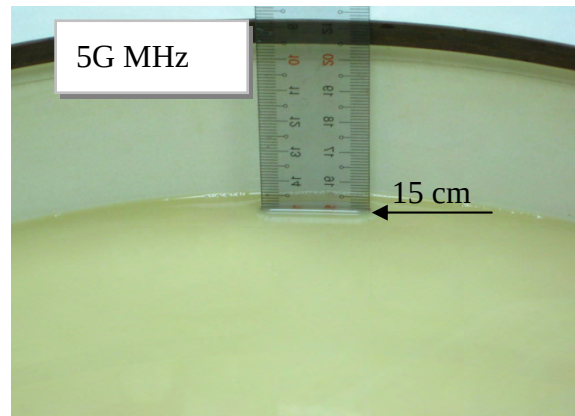
**Fig.2.10 Flat (Body)**

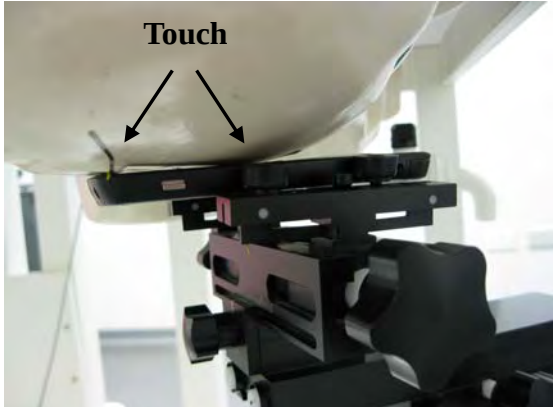
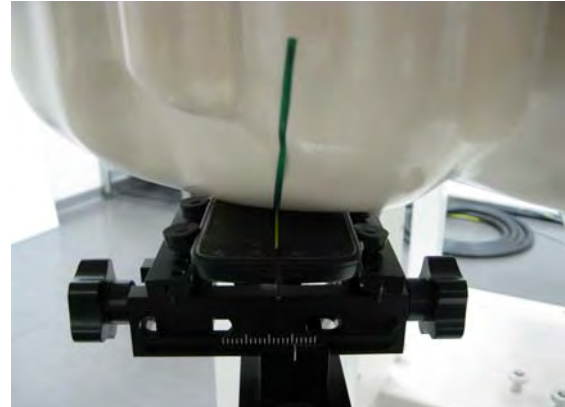
**Fig.3 Right Head Section / Cheek-Touch Position**

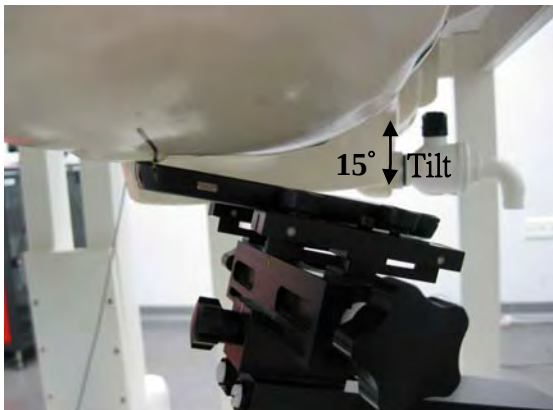
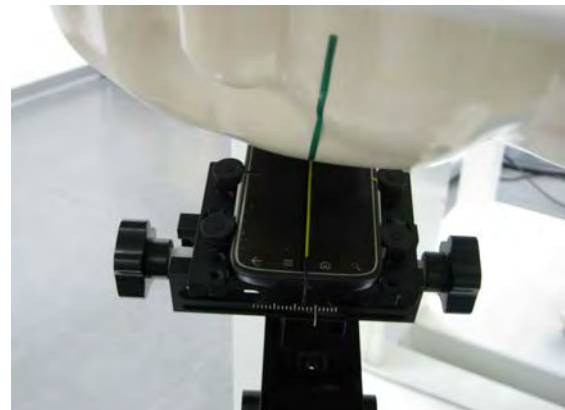
**Fig.4 Right Head Section / Ear-Tilt Position(15°)**

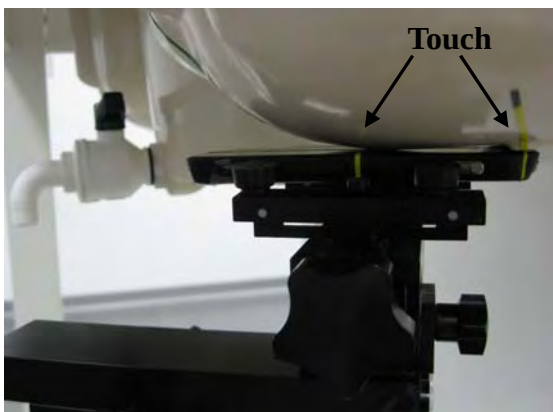
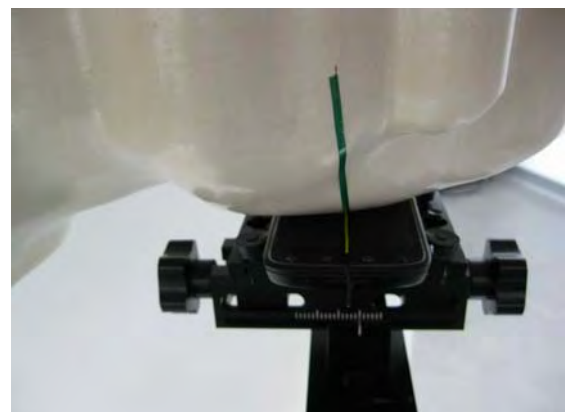
**Fig.5 Left Head Section / Cheek-Touch Position**

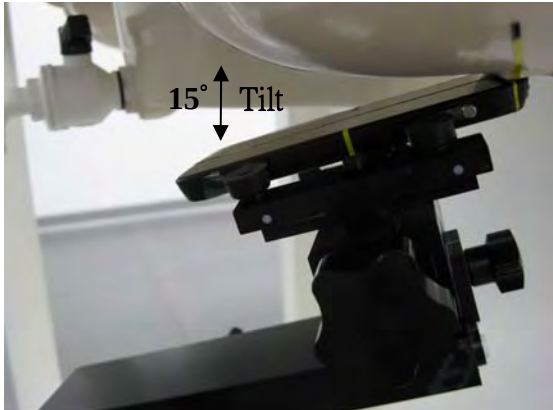
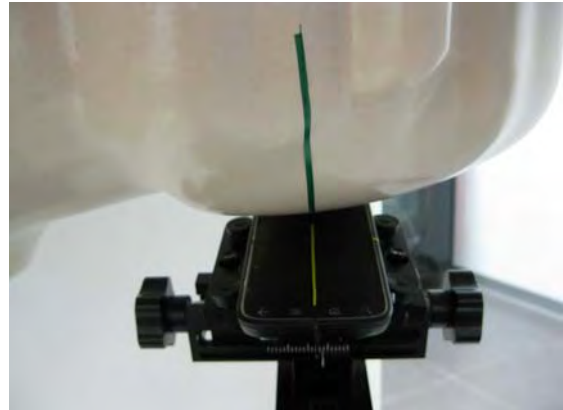
Fig.6 Left Head Section / Ear-Tilt Position(15°)

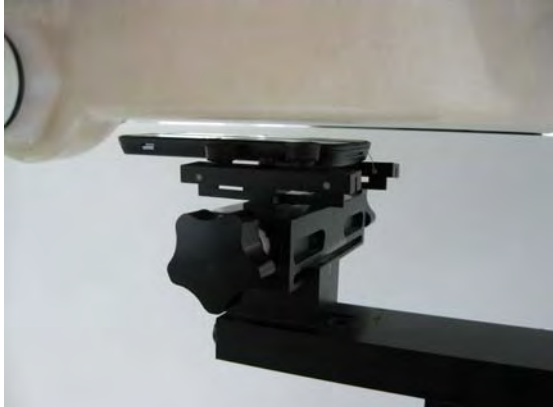
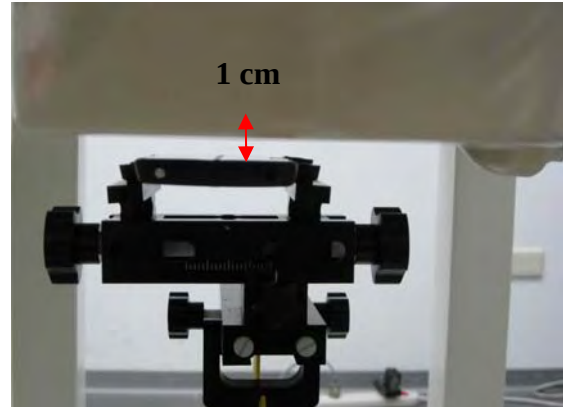
**Hotspot mode - distance between flat phantom and mobile phone is 1 cm**

**Fig.7 EUT front to flat phantom**

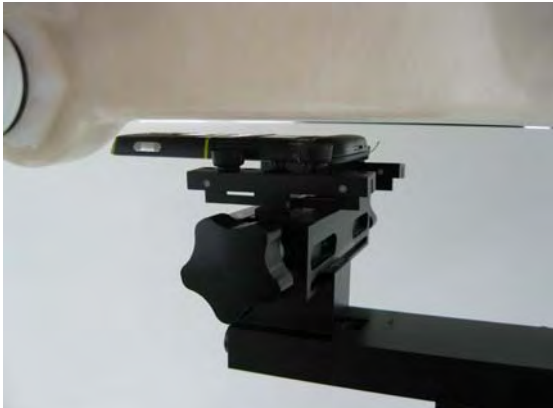
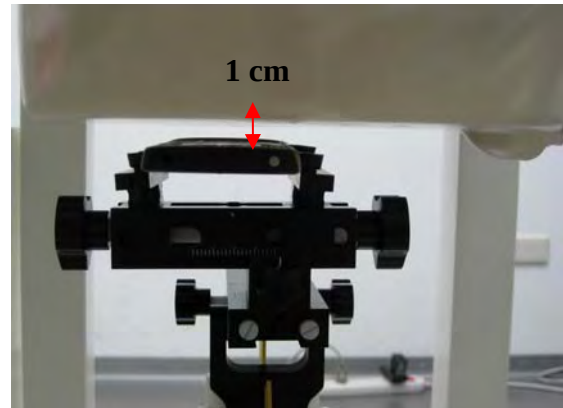
**Fig.8 EUT rear to flat phantom**

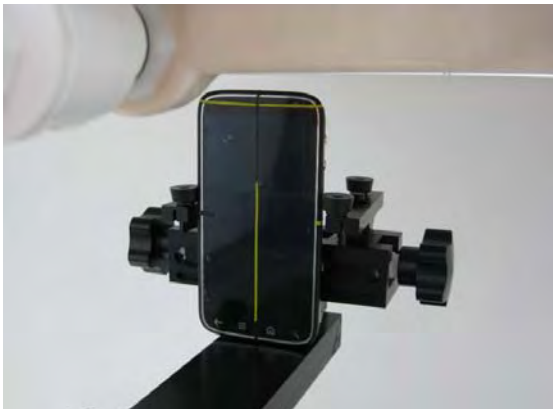
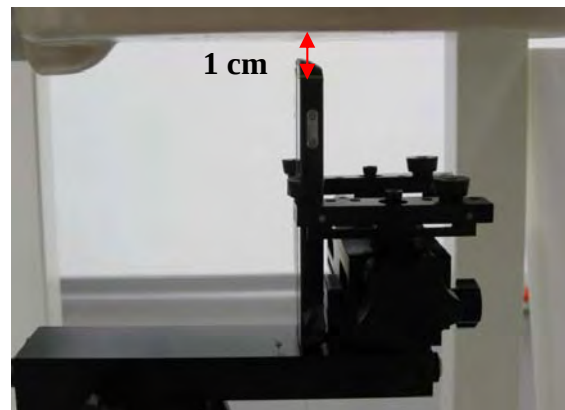
**Fig.9 EUT Top to flat phantom**

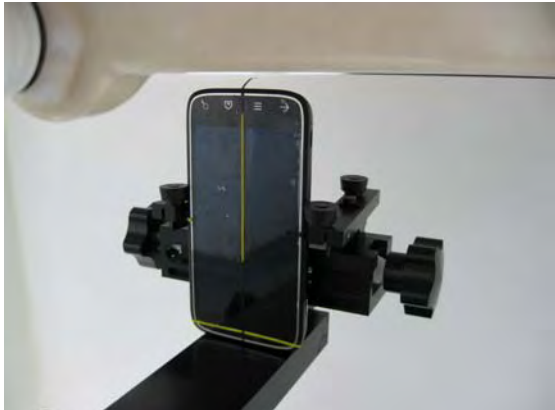
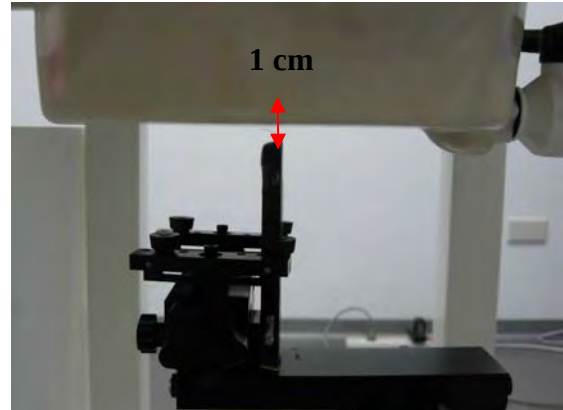
**Fig.10 EUT Bottom to flat phantom**

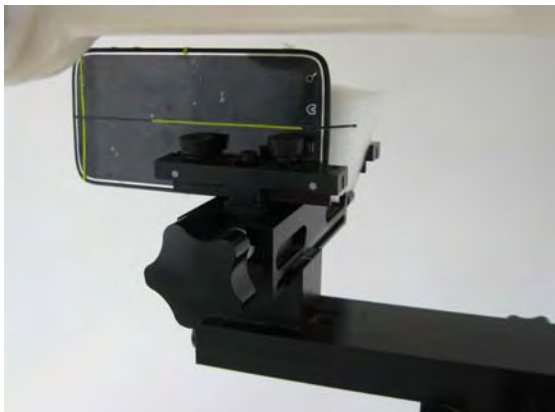
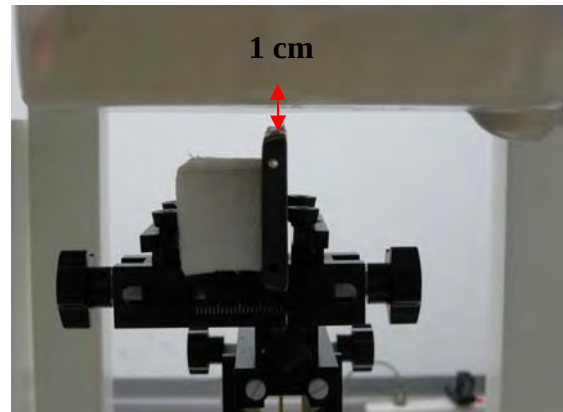
**Fig.11 EUT Right to flat phantom**

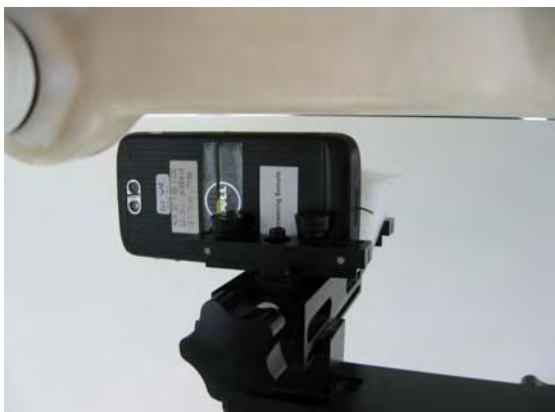
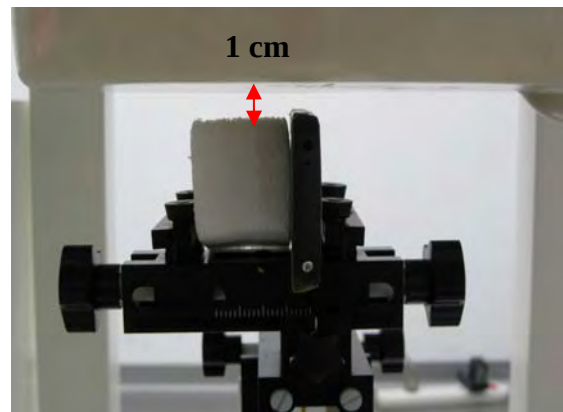
**Fig.12 EUT Left to flat phantom**

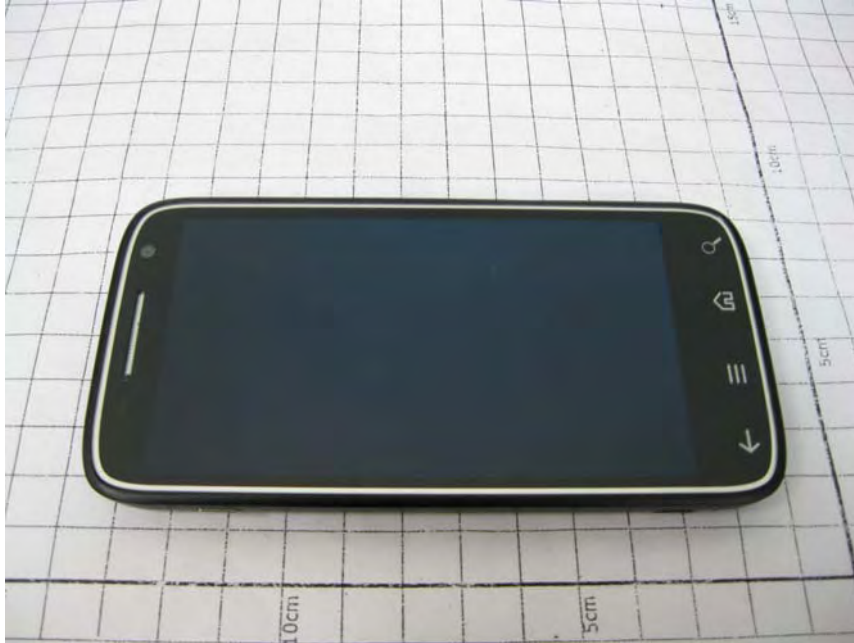
**Fig.13 Front view of device**

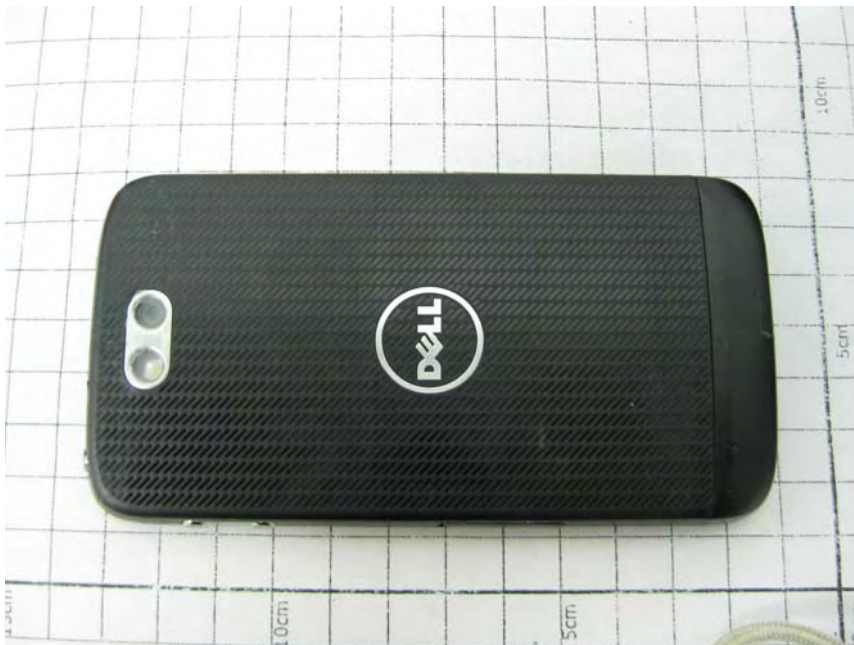
**Fig.14 Back view of device**

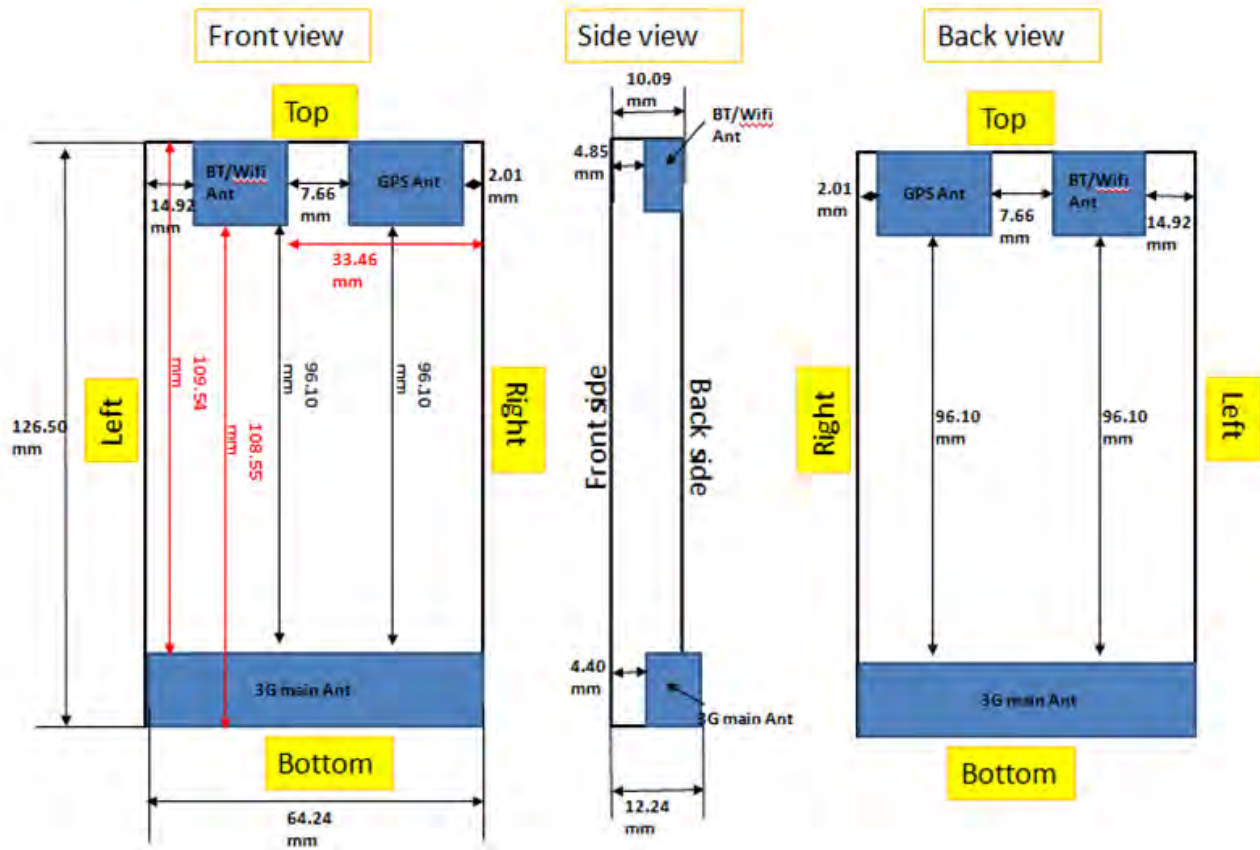
Fig.15 Antenna position & Antenna distance

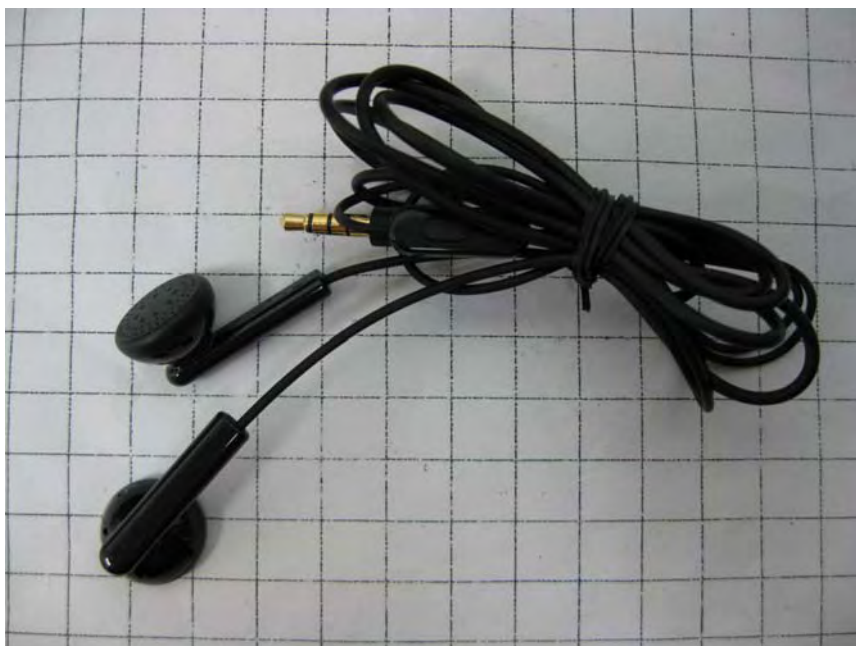
Fig.16 Headset

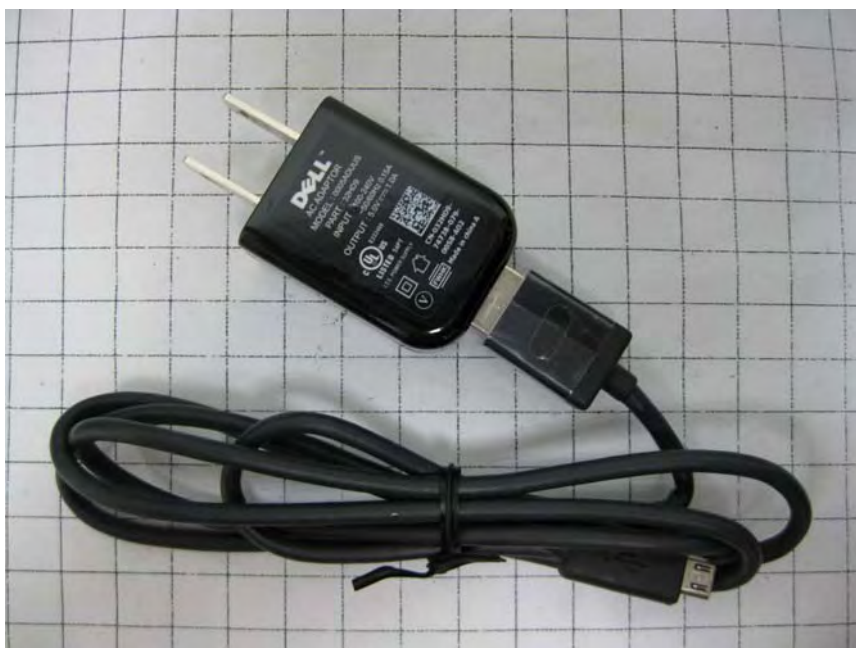
Fig.17 Charger of EUT
