FCC ID: EHK615R

Report No.: 9810531

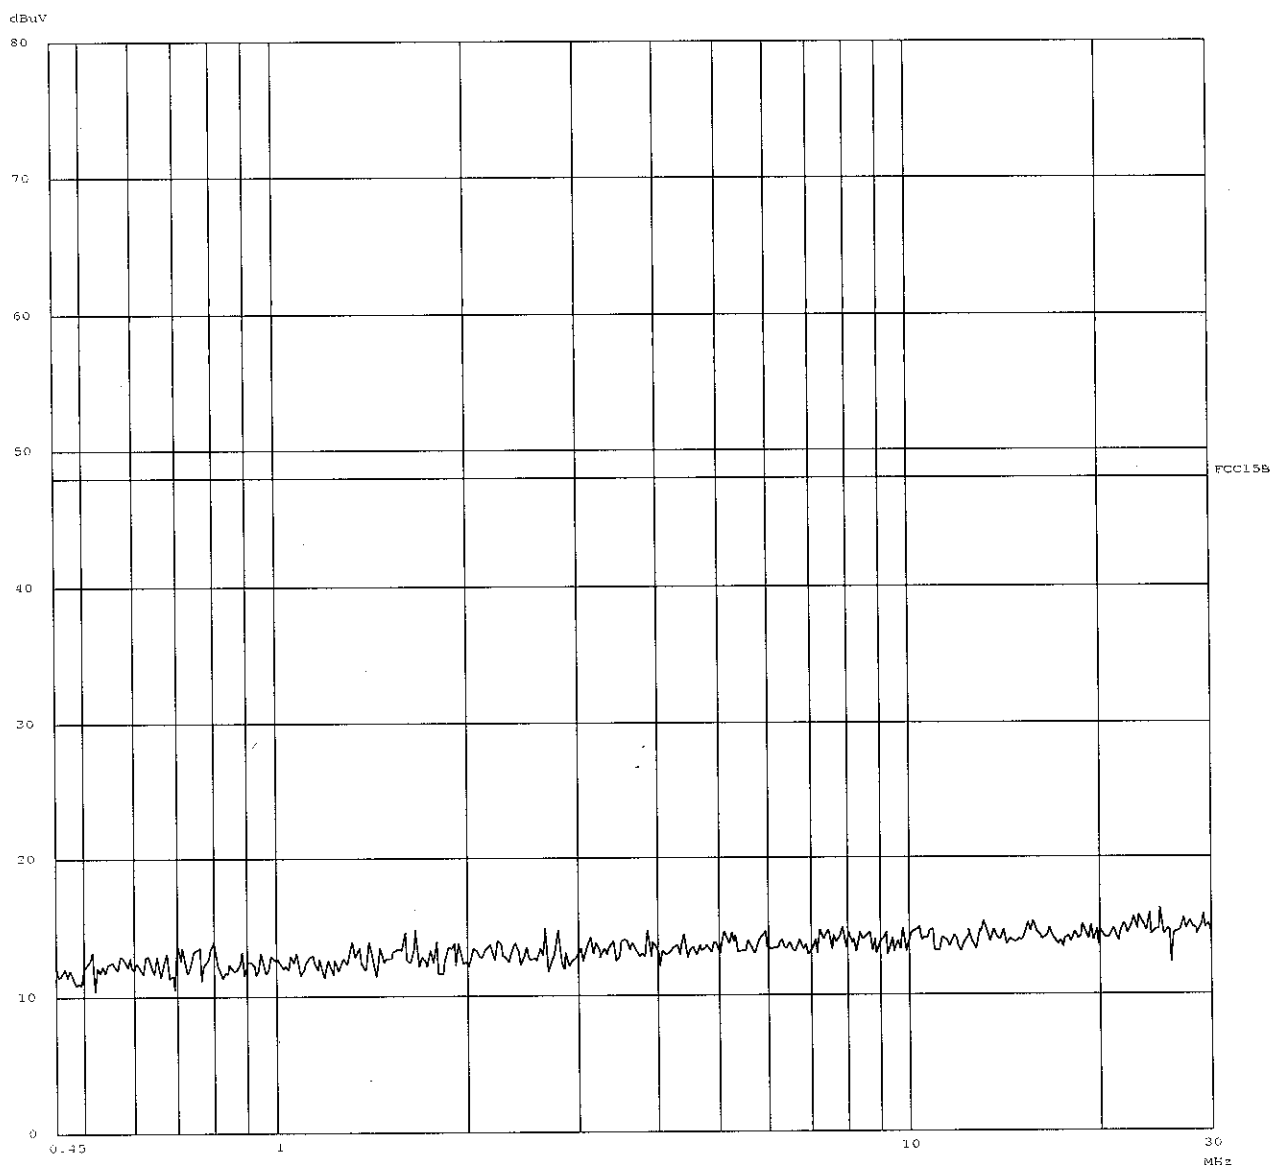
Scan Settings (1 Range)

| Frequencies | | | Receiver Settings | | | | | |
| Start | Stop | Step | IF BW | Detector | M-Time | Atten | Preamp | OpRge |
| 450k | 30M | 5k | 10k | PK | 20ms | AUTO | LN OFF | 60dB |

Final Measurement: N QP

Meas Time: 1 s  
Subranges: 16  
Acc Margin: 20dB
