Report No.: 9810707

FCC ID: EHK615T

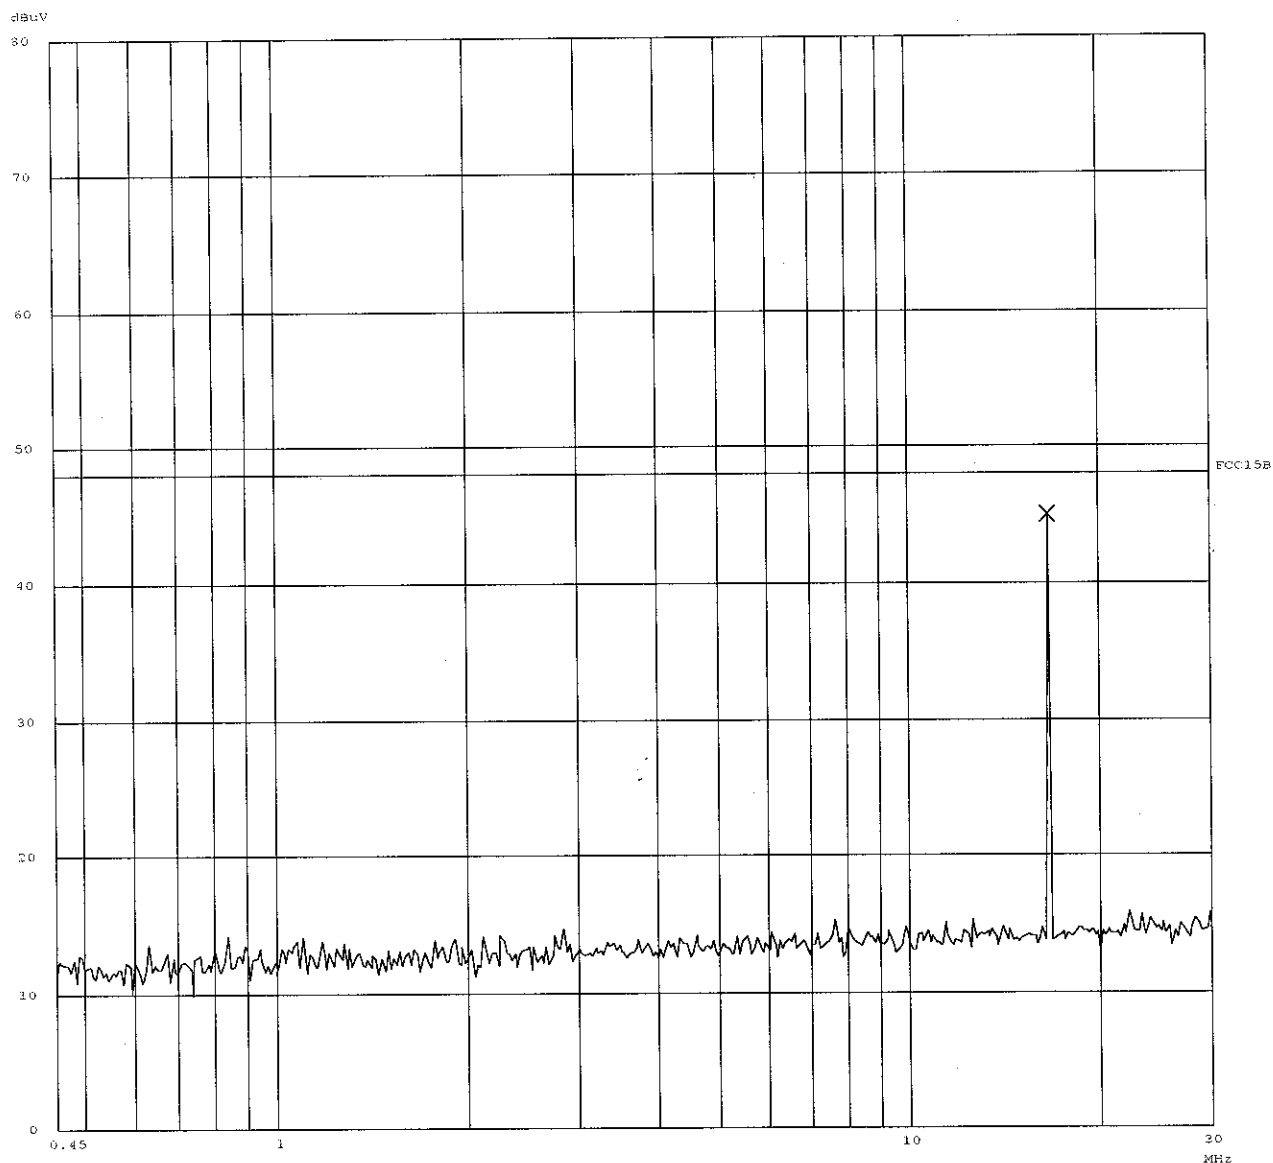
PAGE 1

Scan Settings (1 Range)

| Frequencies | | | | Receiver Settings | | | |
| Start | Stop | Step | IF BW | Detector | M-Time | Atten | Preamp |
| 450k | 30M | 5k | 10k | PK | 20ms | AUTO | LN OFF |

Final Measurement: X QF  
 Meas Time: 1 s  
 Subranges: 16  
 Acc Margin: 20dB

Final Measurement Results:

| Frequency<br>MHz | QP Level<br>dBuV | QP Limit<br>dBuV |
| 16.62000 | 44.9 | 48.0 |
