**Application for Certification  
For an RF amplifier**

**RF amplifier**

**FCC ID: RFK-LMSWDJHNEX**

**REPORT # RV58031A-001**

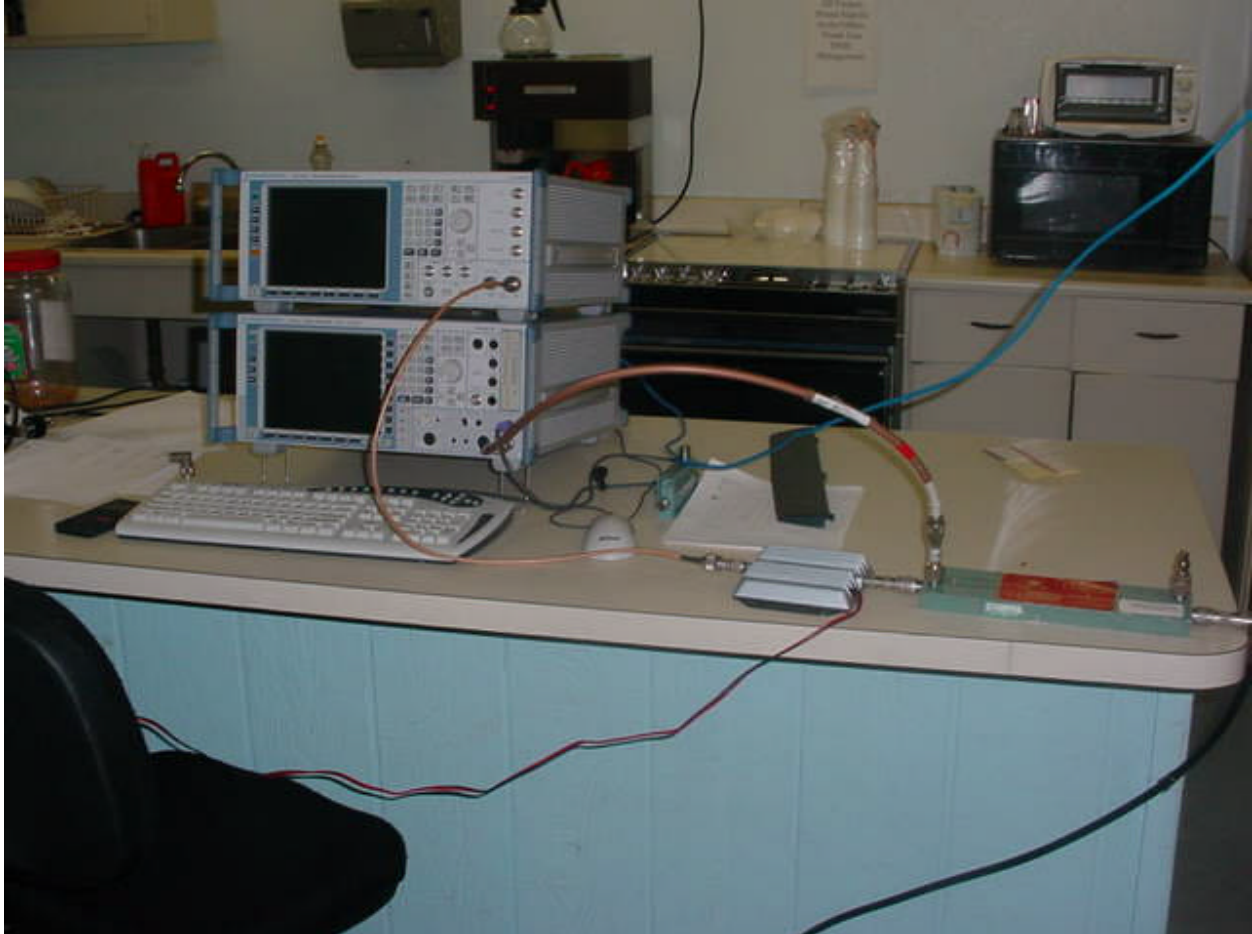
**PHOTO: RF POWER OUTPUT, EMISSIONS LIMITATIONS  
GSM/TDMA, OCCUPIED BANDWIDTH  
GSM/TDMA, CONDUCTED SPURIOUS  
EMISSIONS AT ANTENNA TERMINALS**
