## Appendix F: Number of hopping frequencies

Test Report No.: EFGX20080028-01-E01

Eurofins Electrical Testing Service (Shenzhen) Co., Ltd.

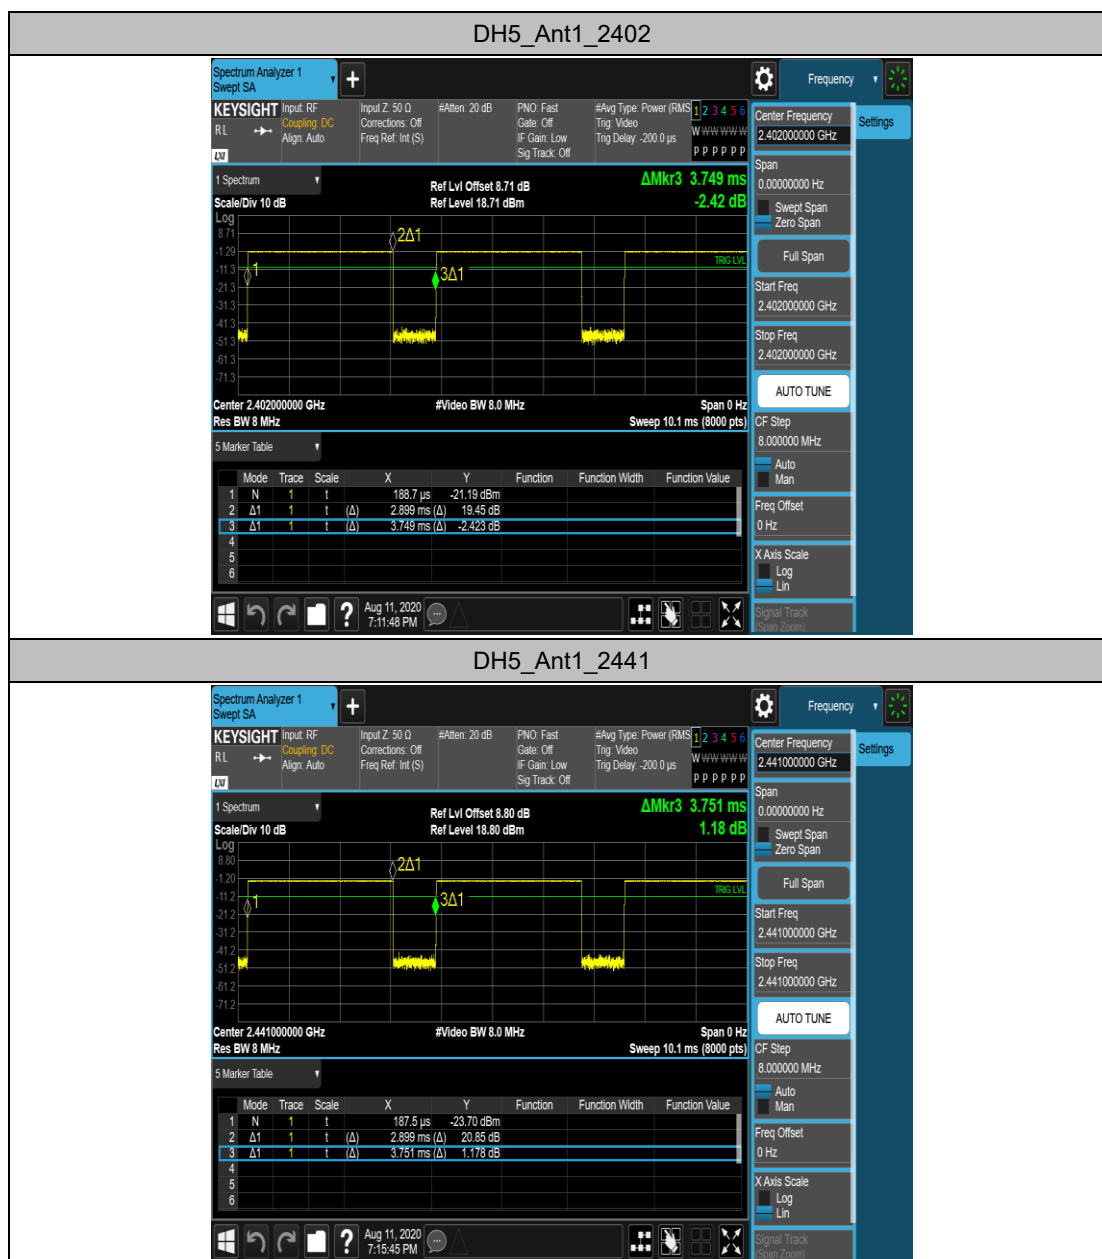
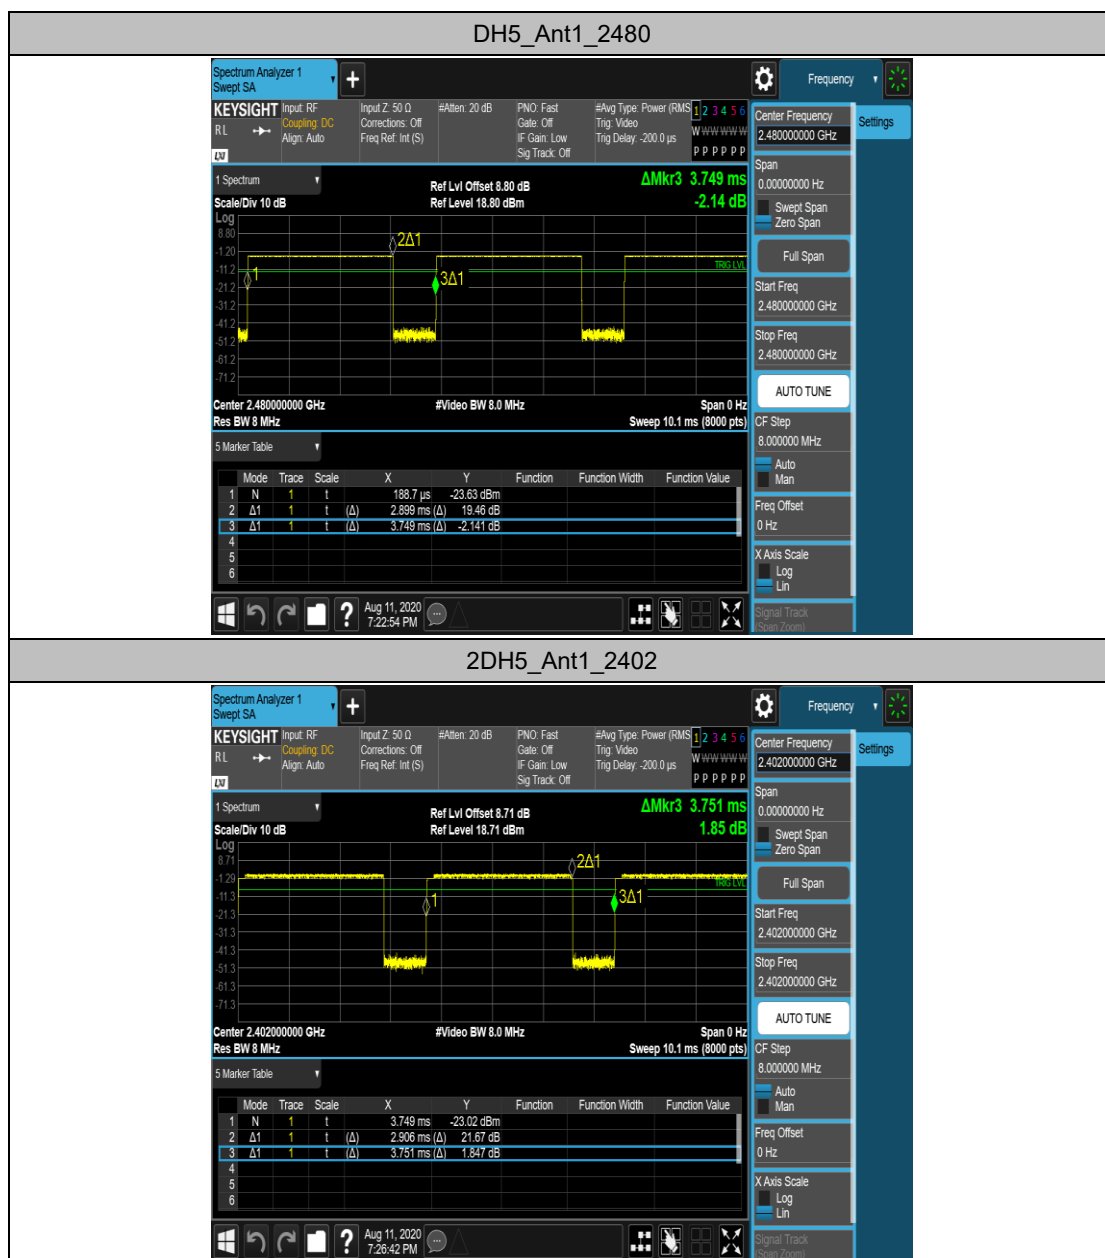
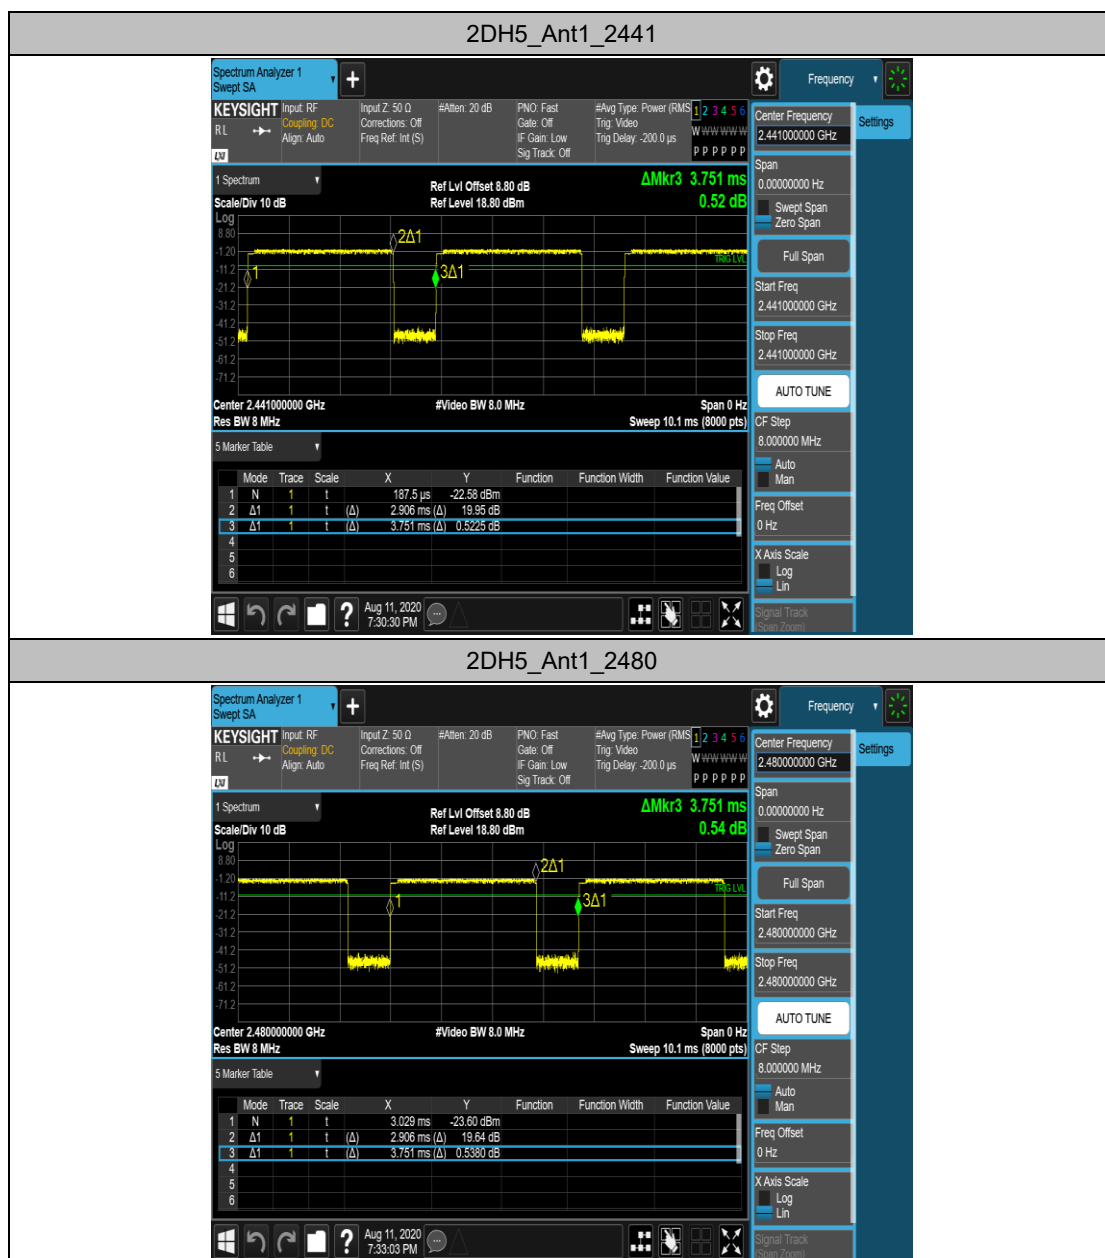
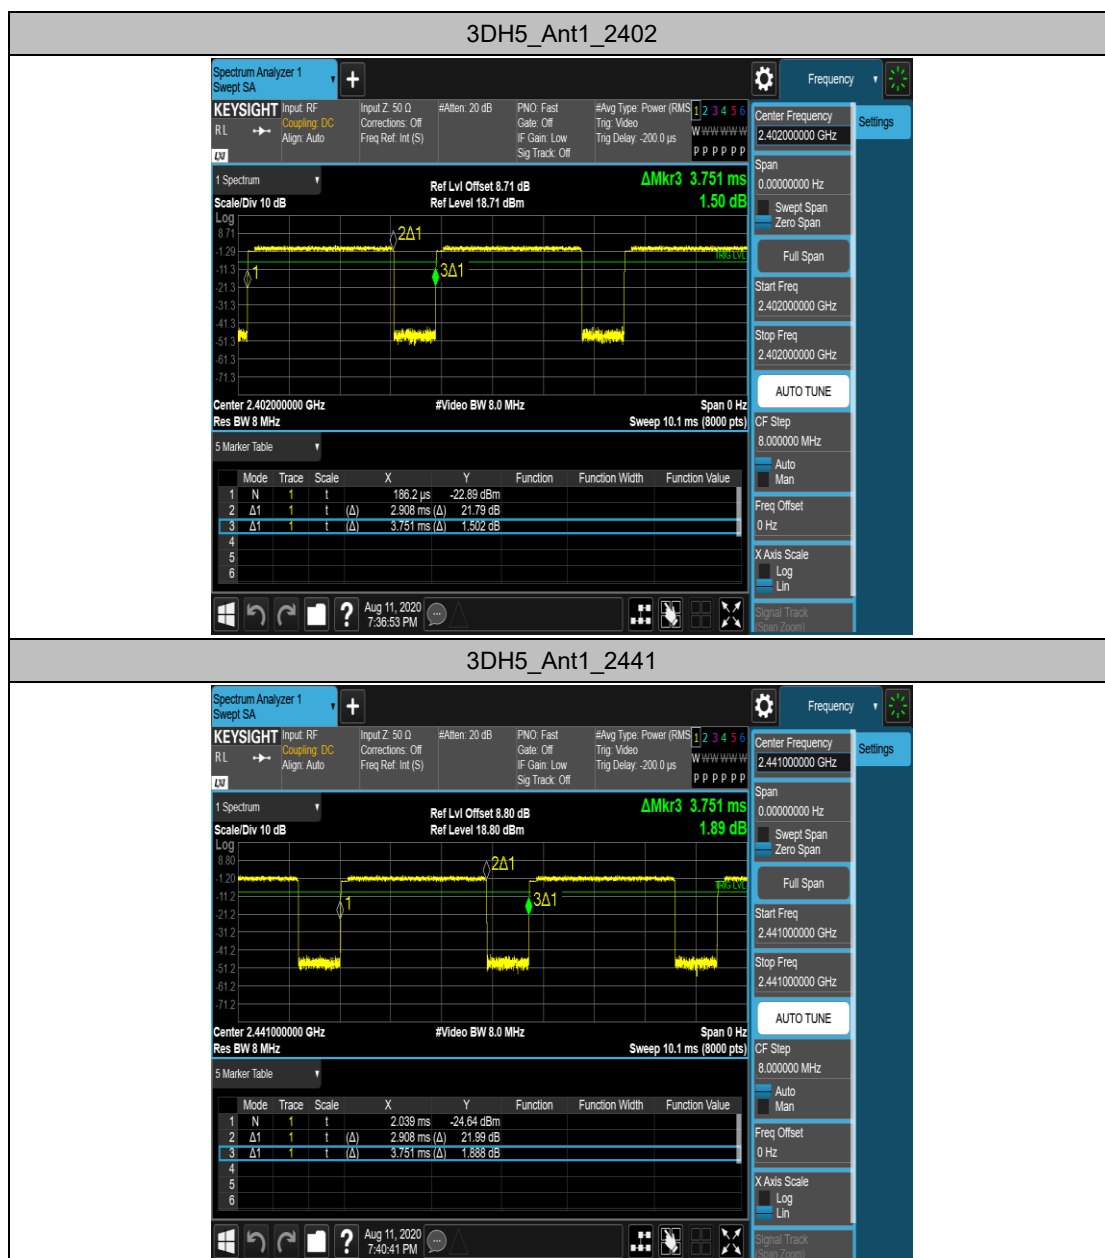
## Test Graphs

## Appendix I: Duty Cycle

| TestMode | Antenna | Channel | Transmission Duration [ms] | Transmission Period [ms] | Duty Cycle [%] |
|---|---|---|---|---|---|
| DH5 | Ant1 | 2402 | 2.90 | 3.75 | 77.33 |
| | | 2441 | 2.90 | 3.75 | 77.30 |
| | | 2480 | 2.90 | 3.75 | 77.33 |
