### 10. Photographs of Test Setup

## 11. Photographs of the EUT

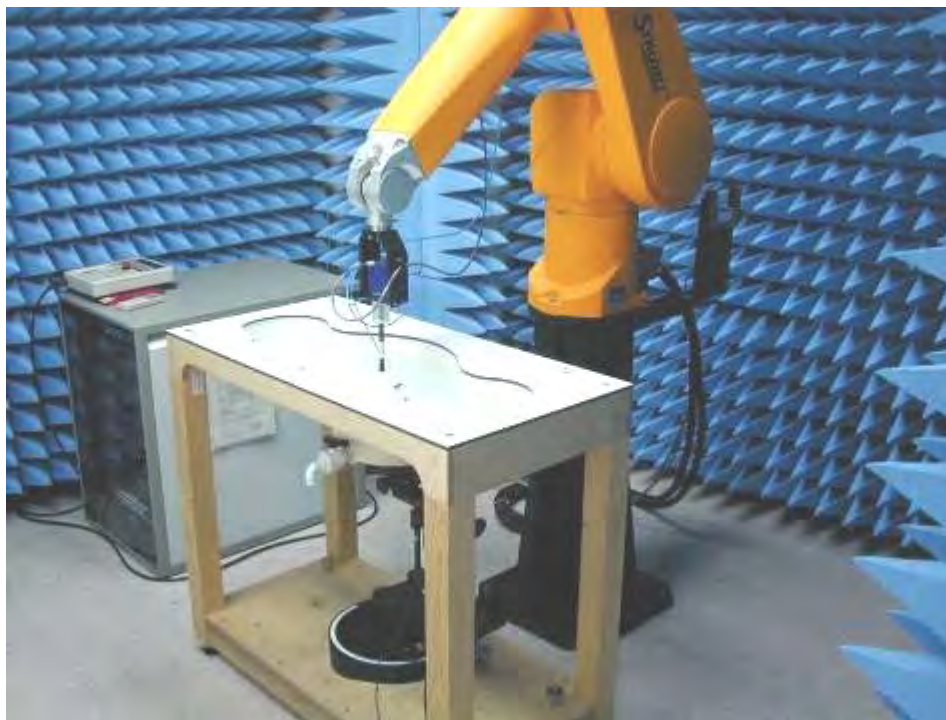
Fig.1 Photograph of the SAR measurement System

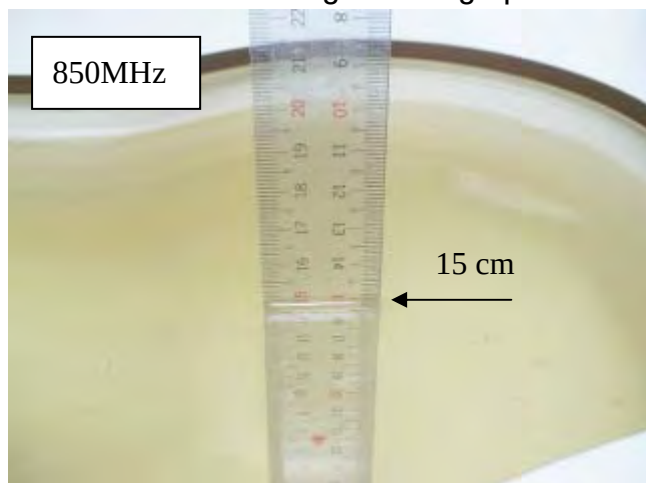
Fig.2.1 Photograph of the Tissue Simulant Fluid liquid depth 15cm for Left-head Side

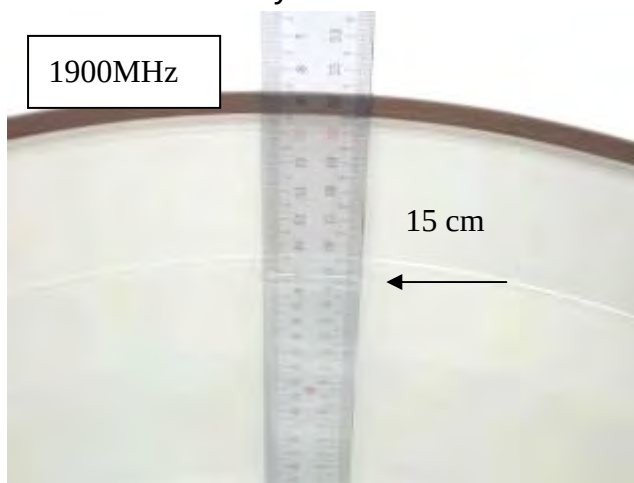
Fig.2.2 Photograph of the Tissue Simulant Fluid liquid depth 15cm for Right-head Side

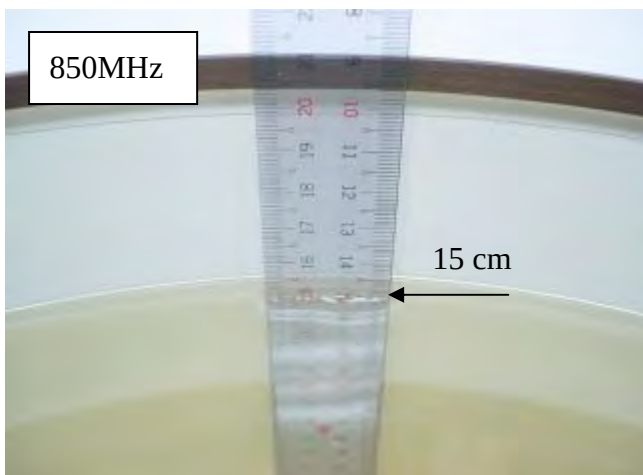
Fig.2.3 Photograph of the Tissue Simulant Fluid liquid depth 15cm for Flat (Body)

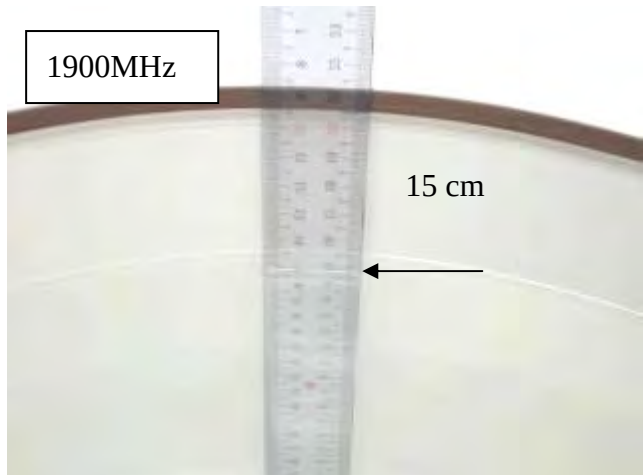
Fig.2.4 Photograph of the Tissue Simulant Fluid liquid depth 15cm for Flat (Body)

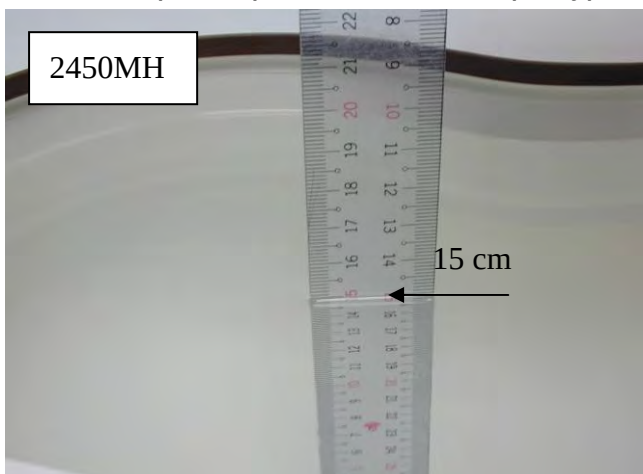
Fig.2.5 Photograph of the Tissue Simulant Fluid liquid depth 15cm for Left-head Side

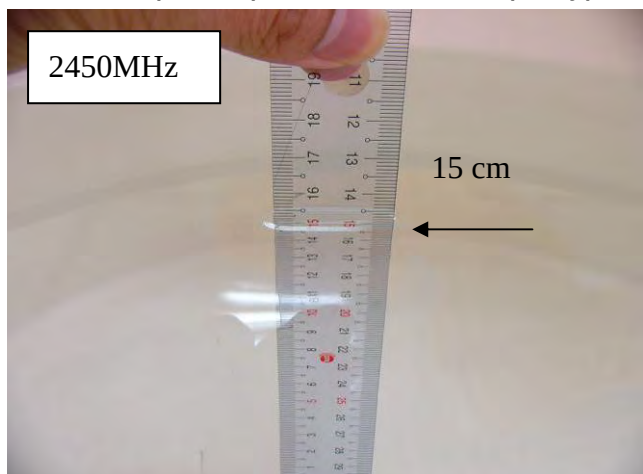
Fig.2.6 Photograph of the Tissue Simulant Fluid liquid depth 15cm for Flat (Body)

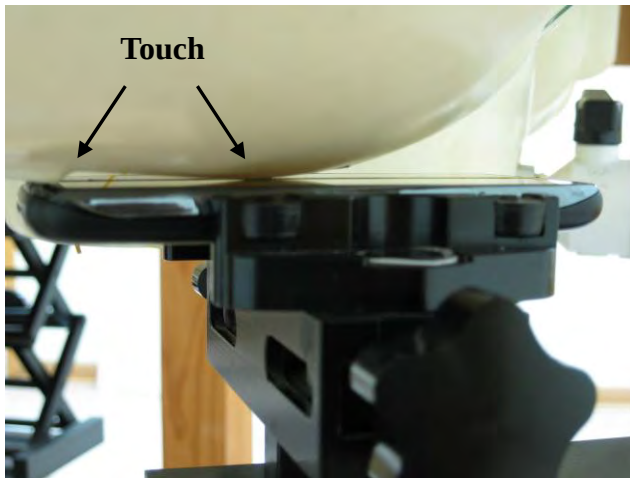
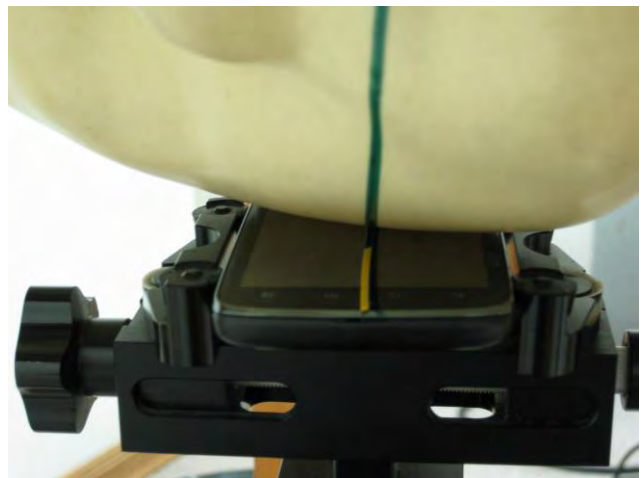
Fig.3 Right Head Section / Cheek-Touch Position

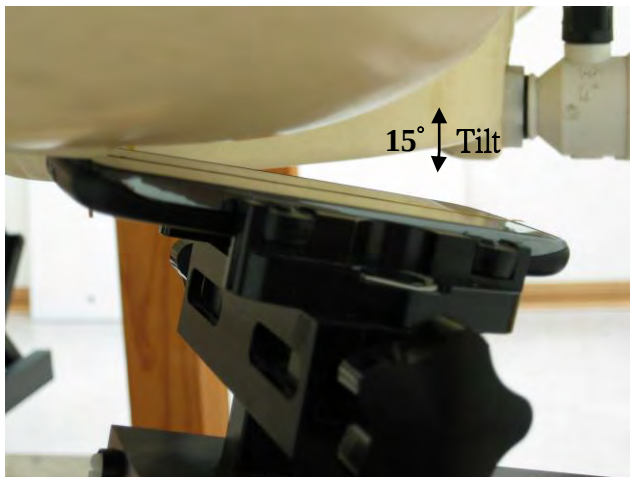
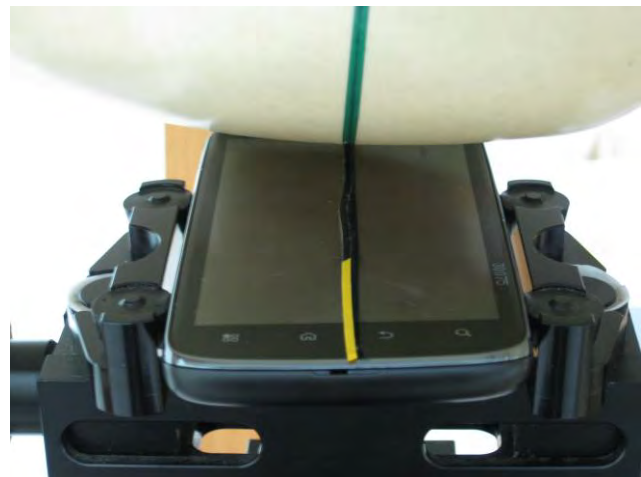
Fig.4 Right Head Section / Ear-Tilt Position(15°)

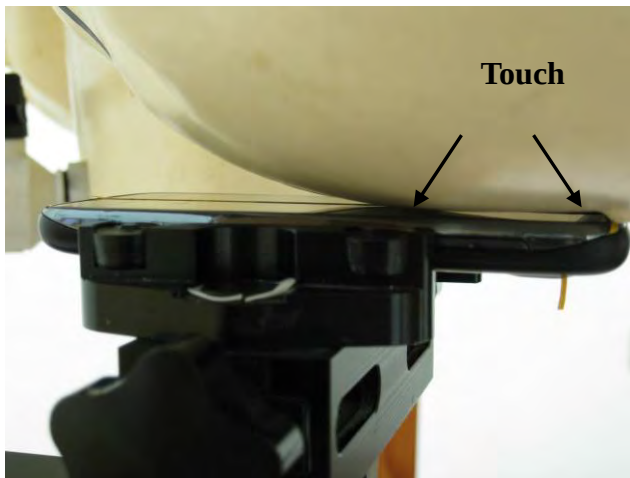
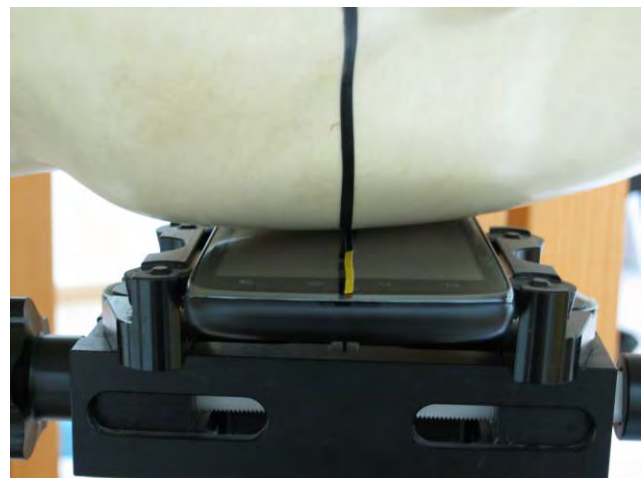
Fig.5 Left Head Section / Cheek-Touch Position

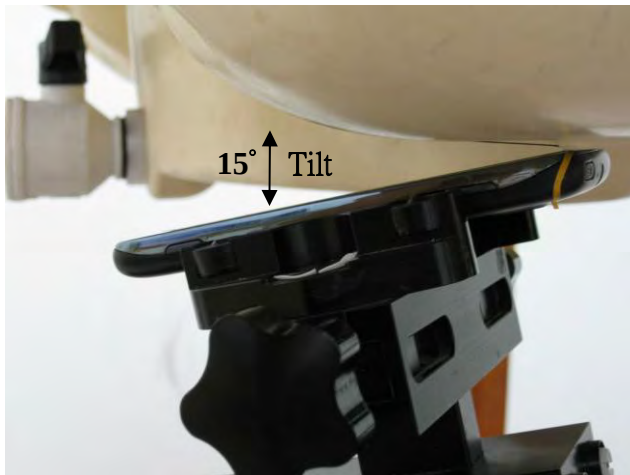
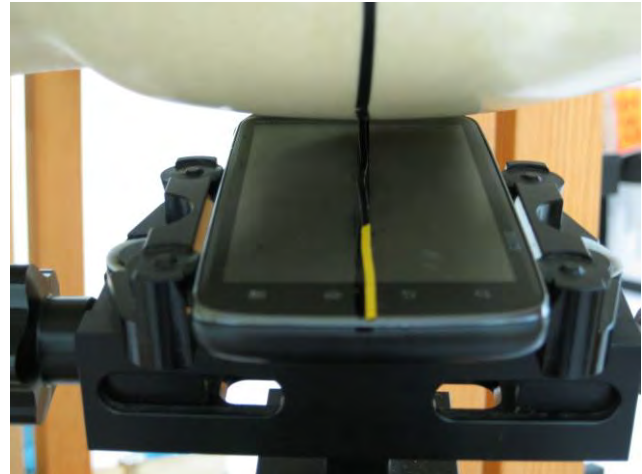
Fig.6 Left Head Section / Ear-Tilt Position(15°)

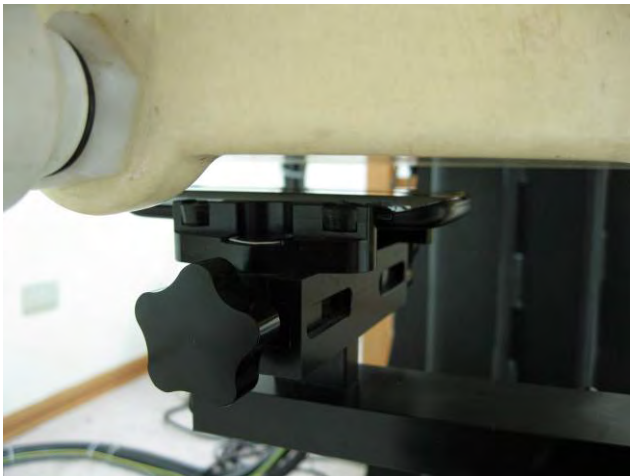
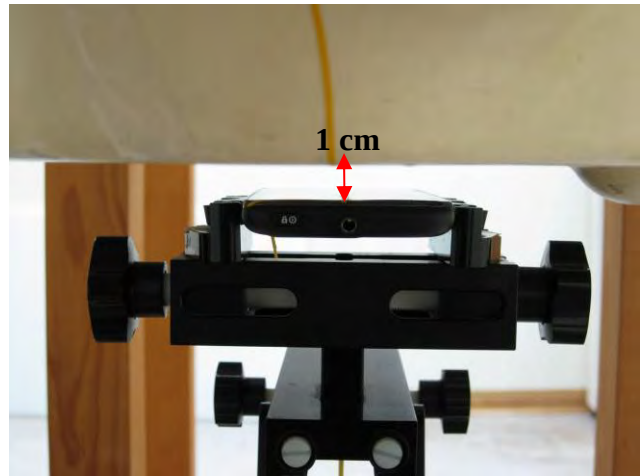
Fig.7 Hotsopt mode- EUT front to flat phantom and distance between flat phantom and mobile phone is 1 cm.

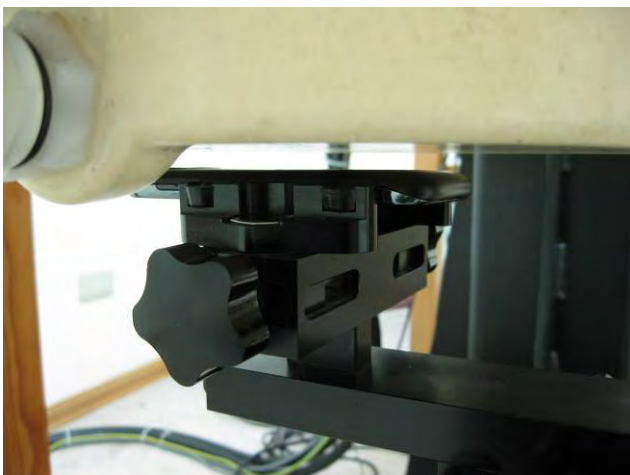
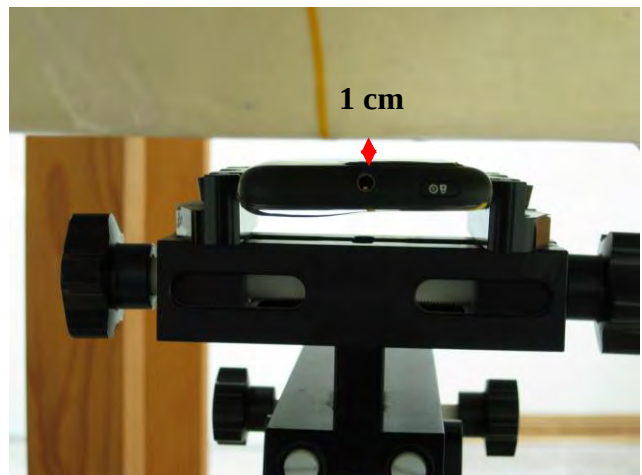
Fig.8 Hotsopt mode- EUT back to flat phantom and distance between flat phantom and mobile phone is 1 cm.

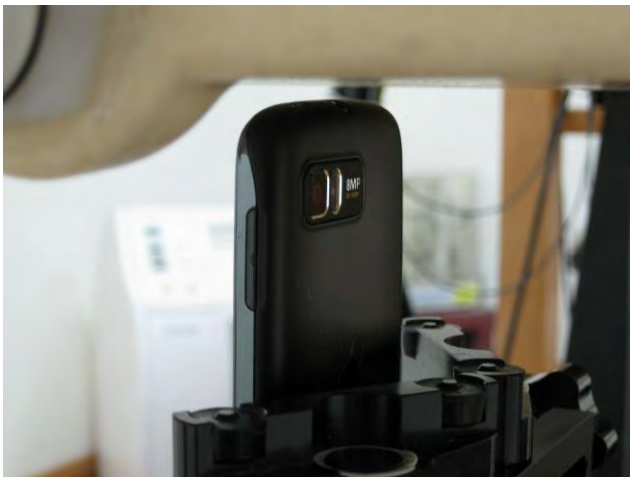
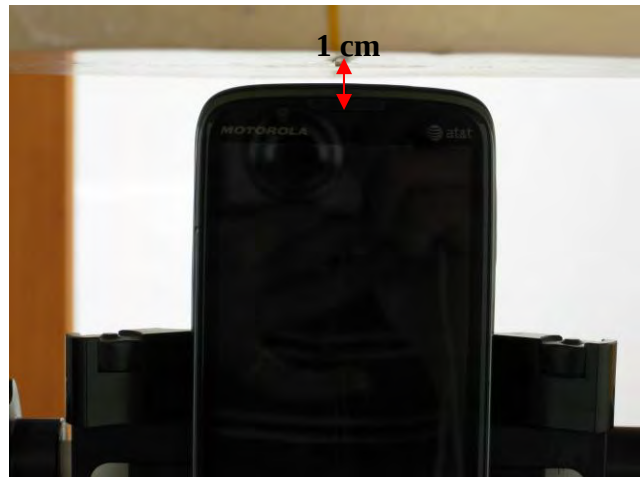
Fig.9 Hotspot mode- EUT Top to flat phantom and distance between flat phantom and mobile phone is 1 cm.

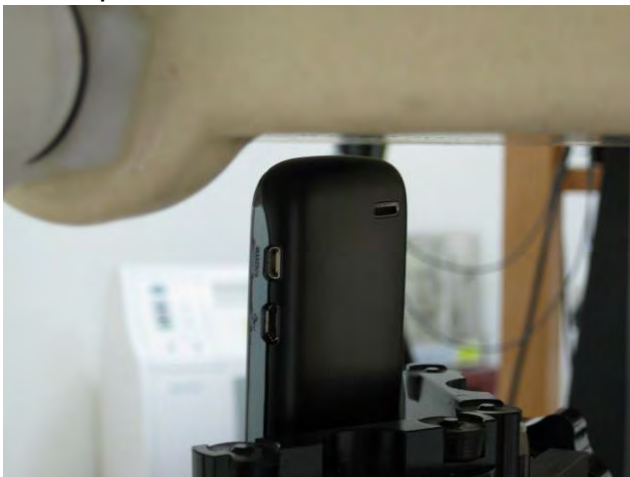
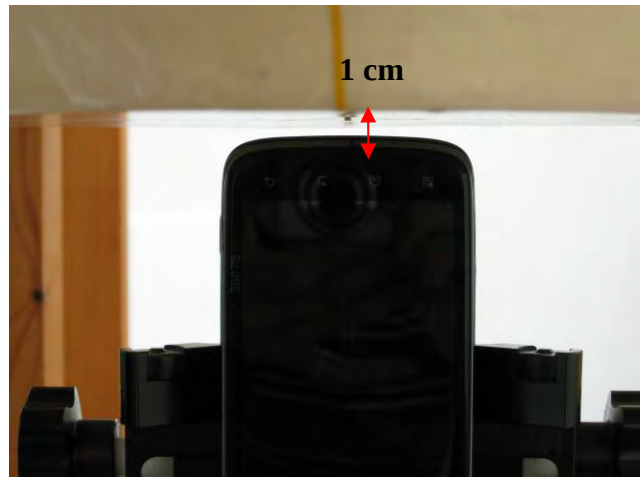
Fig.10 Hotspot mode- EUT Bottom to flat phantom and distance between flat phantom and mobile phone is 1 cm.

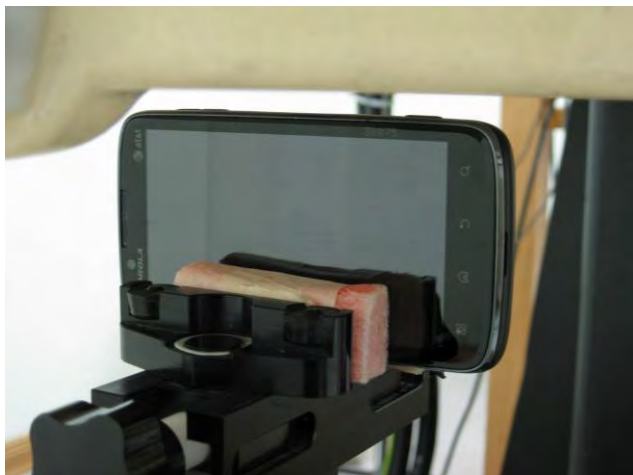
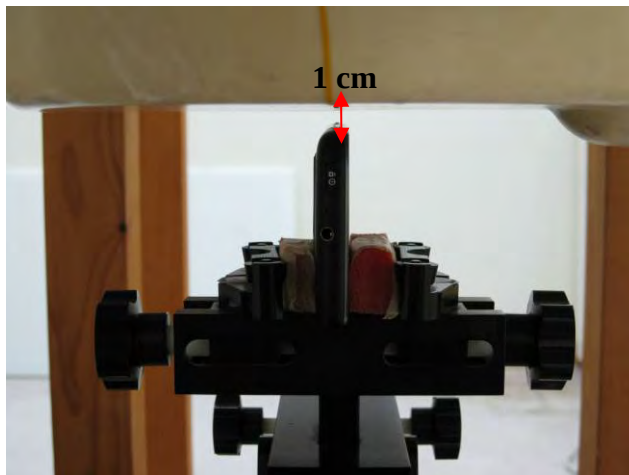
Fig.11 Hotsopt mode- EUT Right to flat phantom and distance between flat phantom and mobile phone is 1 cm.

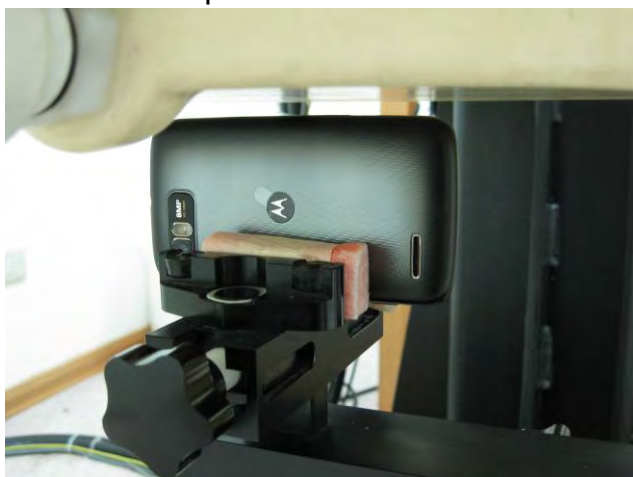
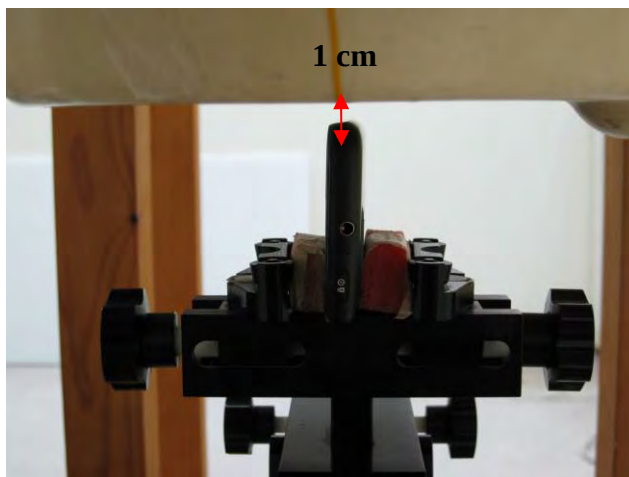
Fig.12 Hotsopt mode- EUT Left to flat phantom and distance between flat phantom and mobile phone is 1 cm.

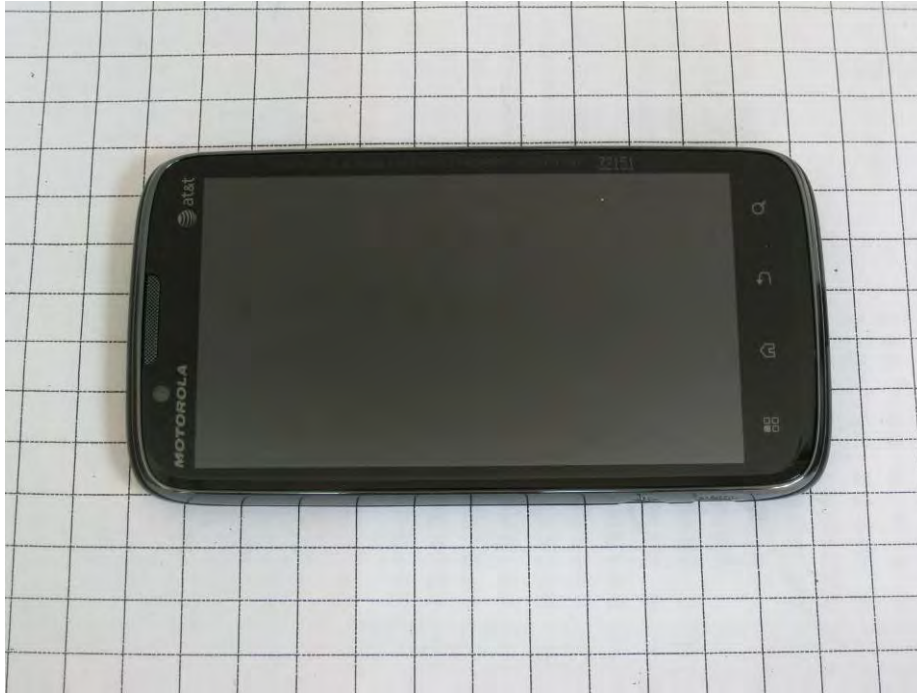
Fig.13 Front view of device

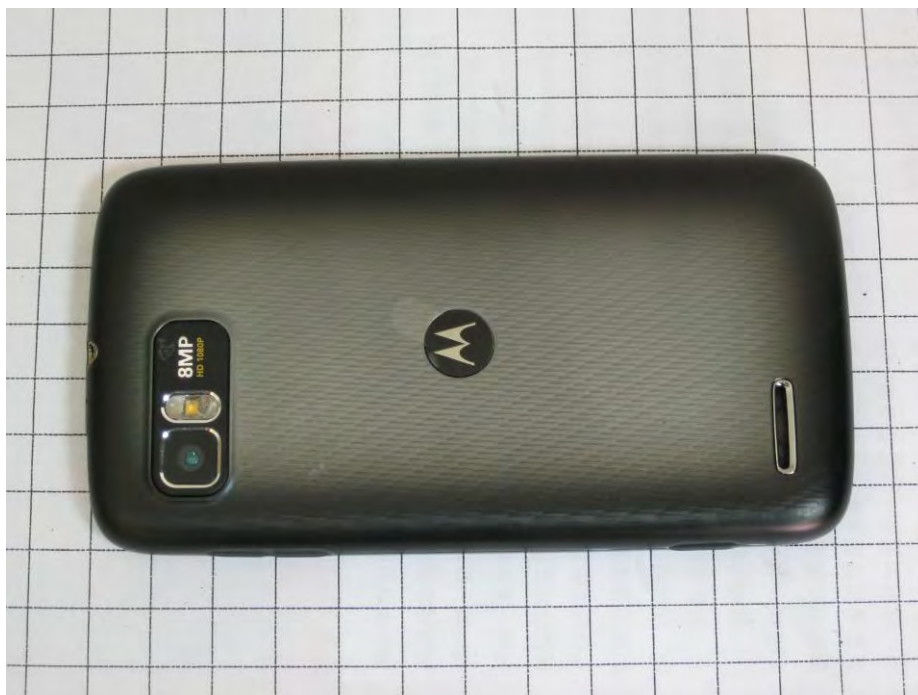
Fig.14 Back view of device

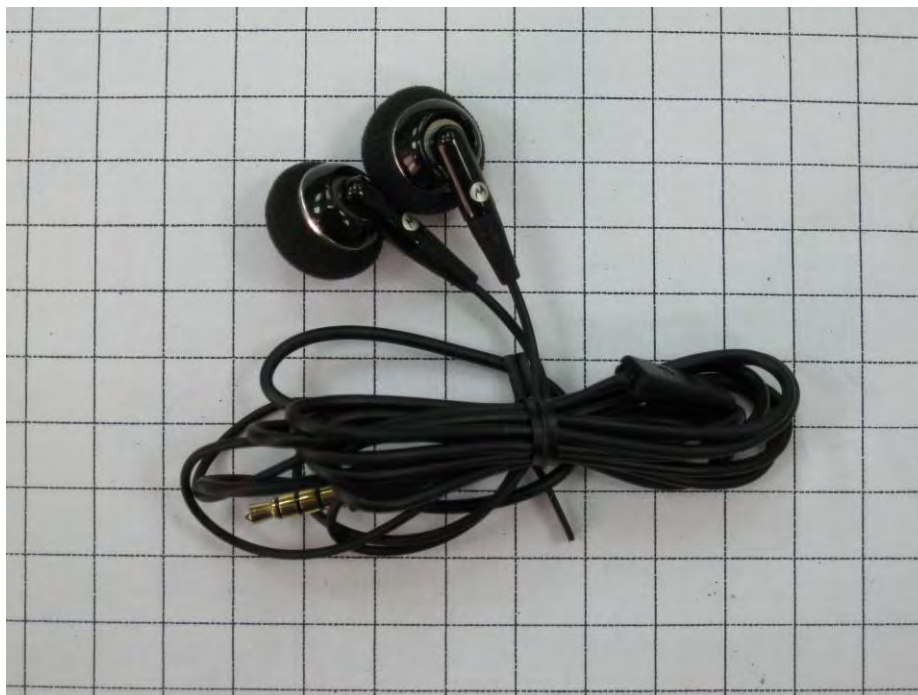
Fig.17 Headset

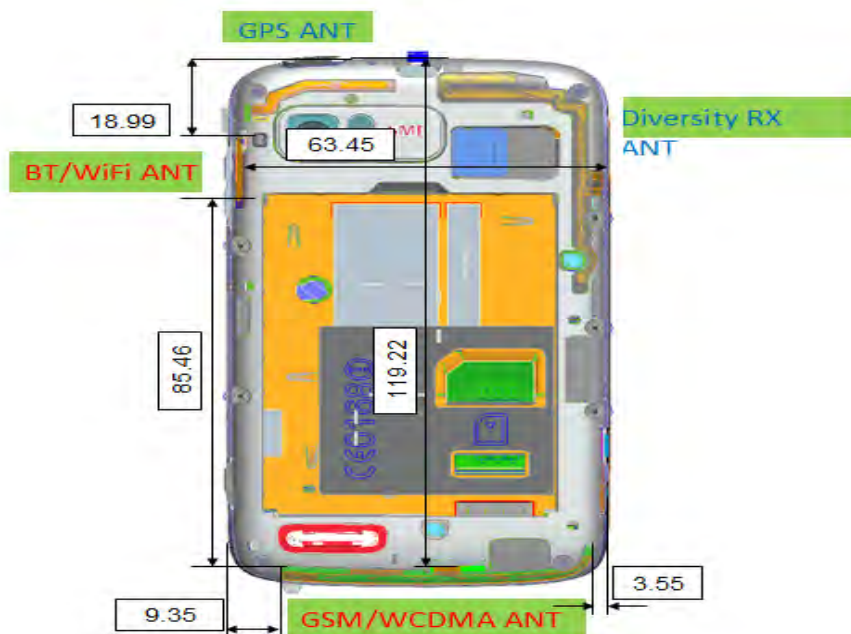
Fig.18 Antenna position of EUT
