## APPENDIX

### 10. Photographs of Test Setup

## 11. Photographs of the EUT

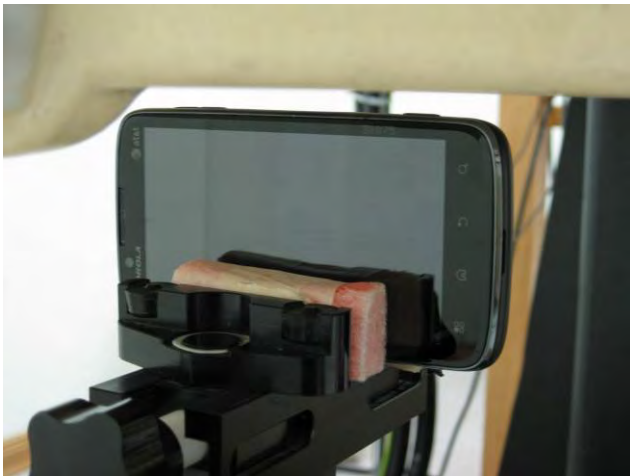
Fig.11 Hotsopt mode- EUT Right to flat phantom and distance between flat phantom and mobile phone is 1 cm.

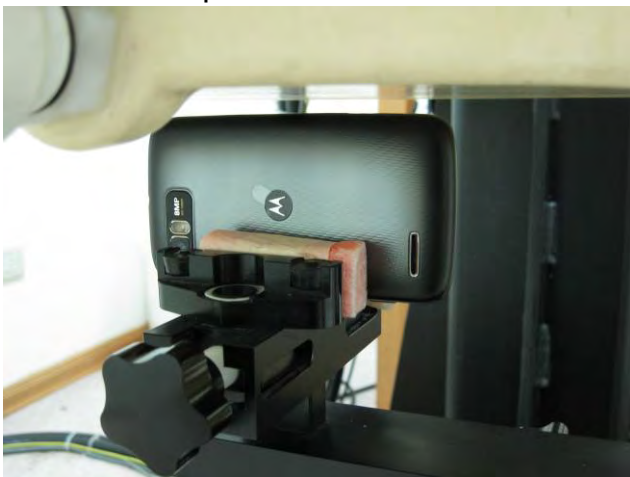
Fig.12 Hotsopt mode- EUT Left to flat phantom and distance between flat phantom and mobile phone is 1 cm.

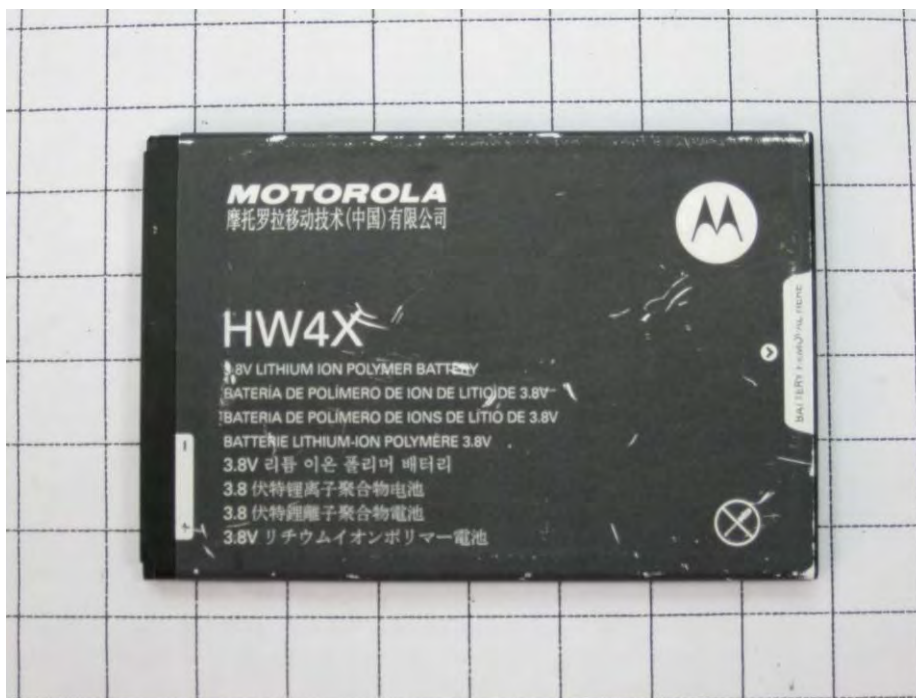
Fig.15 Front view of Battery

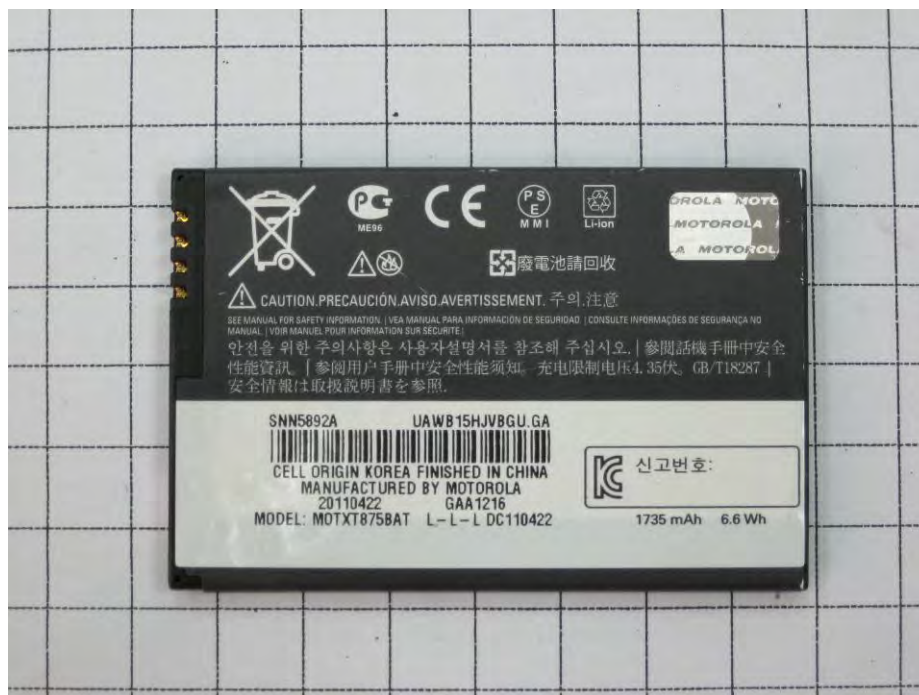
Fig.16 Back view of Battery
