## Radiated Emission Measurement

File : 1\_WiFi 5G\_ant1\_TX 802 Data : #1

Condition : FCC\_part 15 RE-Class C\_30-1000MHz

EUT : W6M21910-19416

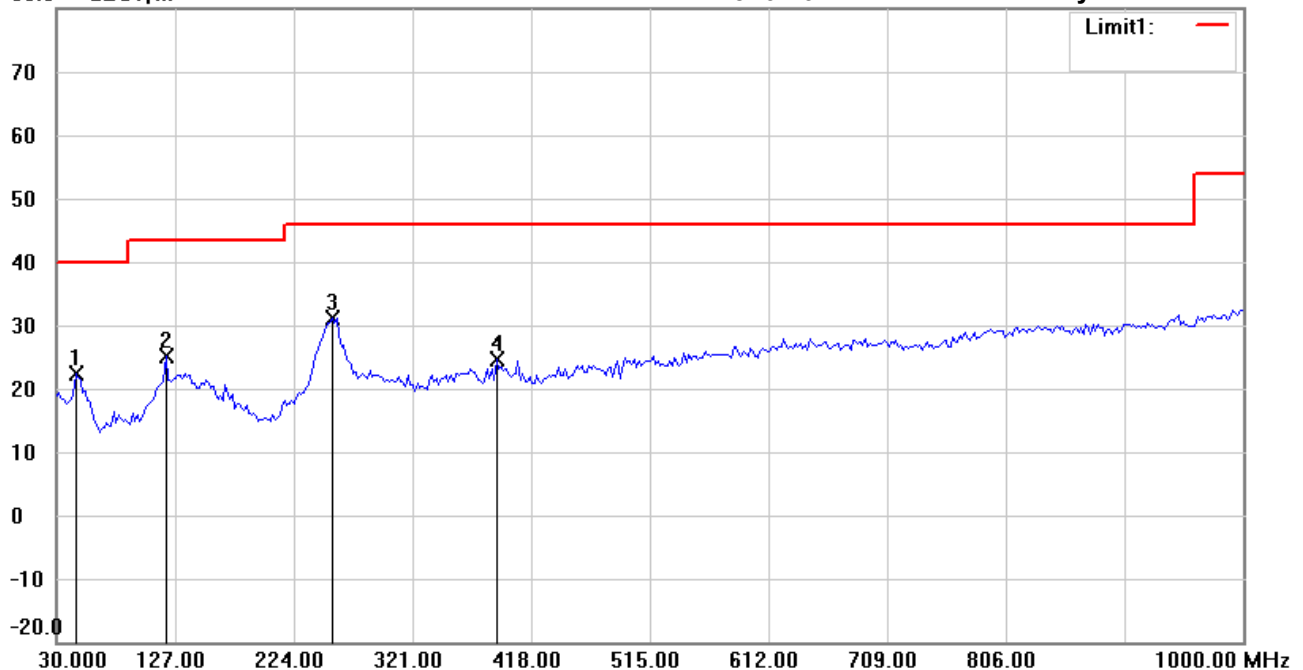
Condition : FCC\_part 15 RE-Class C\_30-1000MHz

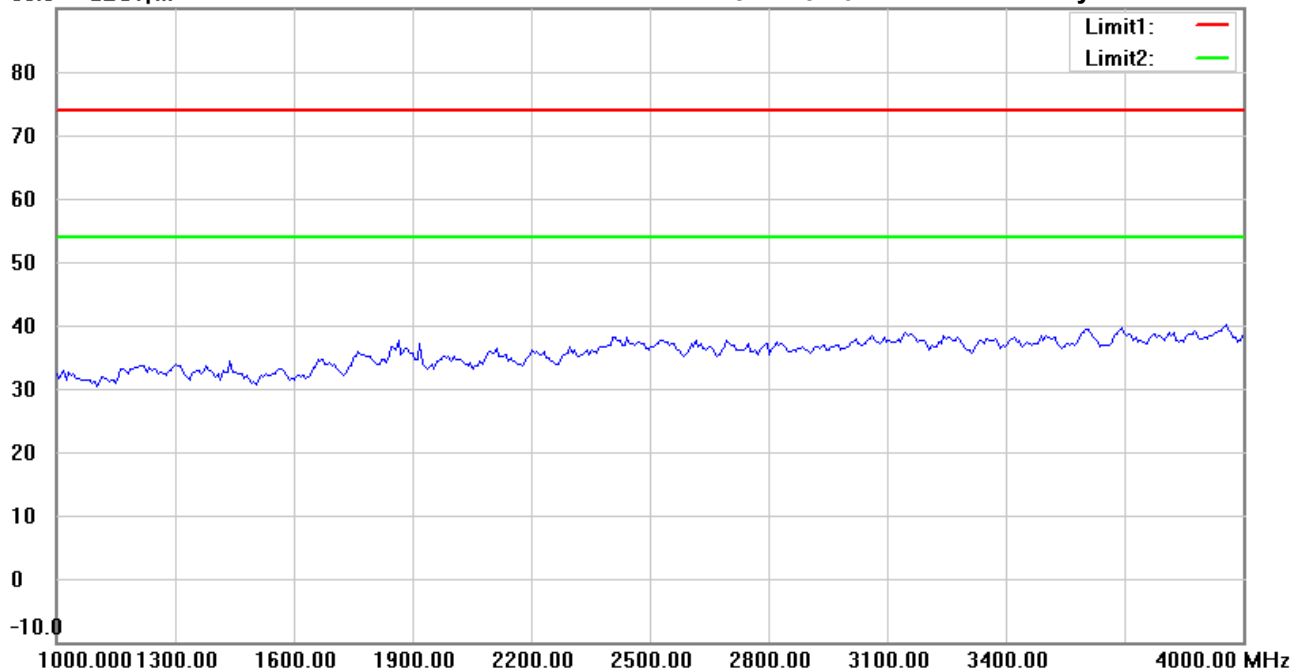
Condition : FCC\_part 15E RE\_Above 1GHz\_PK

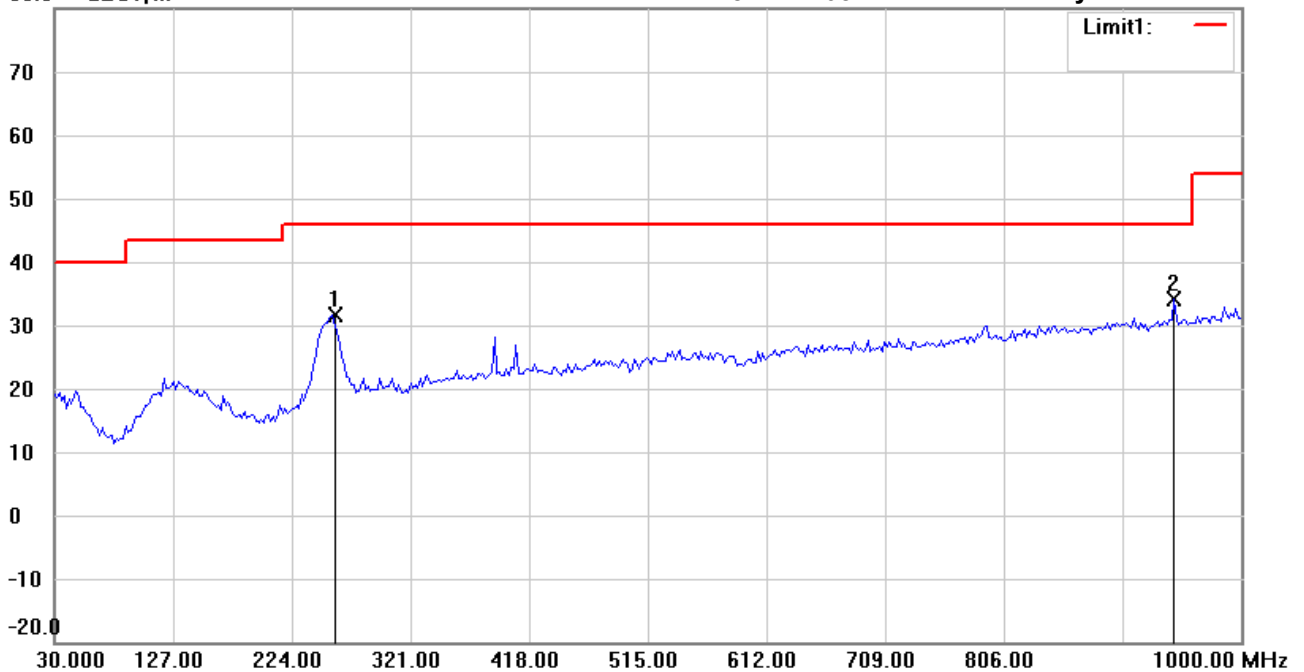
Condition : FCC\_part 15 RE-Class E\_30-1000MHz

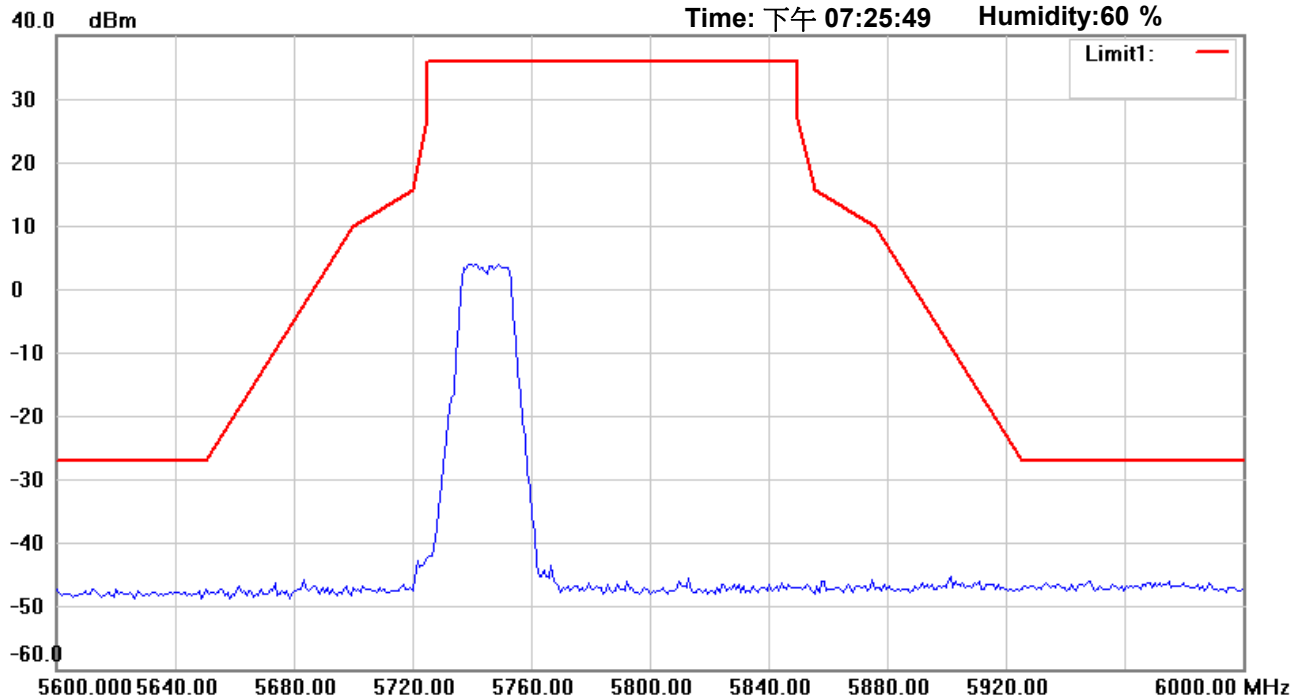
Condition : FCC\_5G Band4 Mask
