# Radiated Emission Measurement

Condition : FCC\_part 15E RE\_Above 1GHz\_PK

EUT : W6M21906-19108

Test Mode : TX 802.11n40 CH159

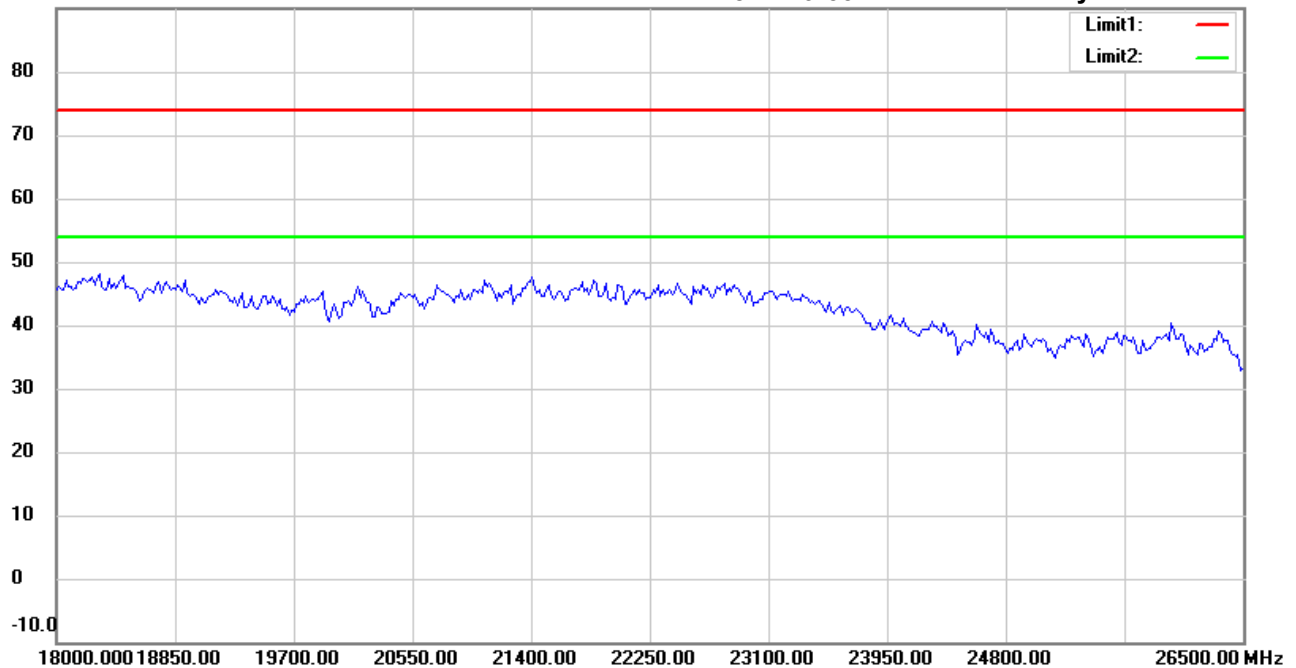
Data :#5

Polarization: *Horizontal*

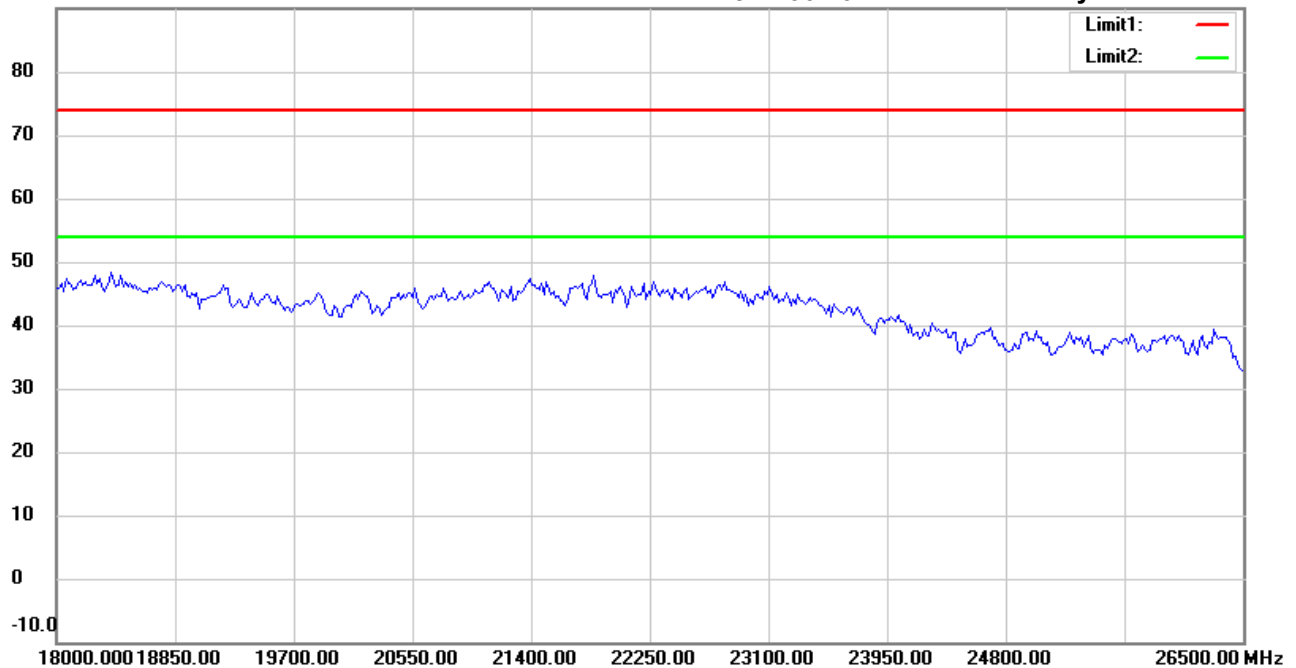
Data :#11

Condition : FCC\_part 15E RE\_Above 1GHz\_PK

Test Mode : TX 802.11n40 CH159

Polarization: **Vertical**

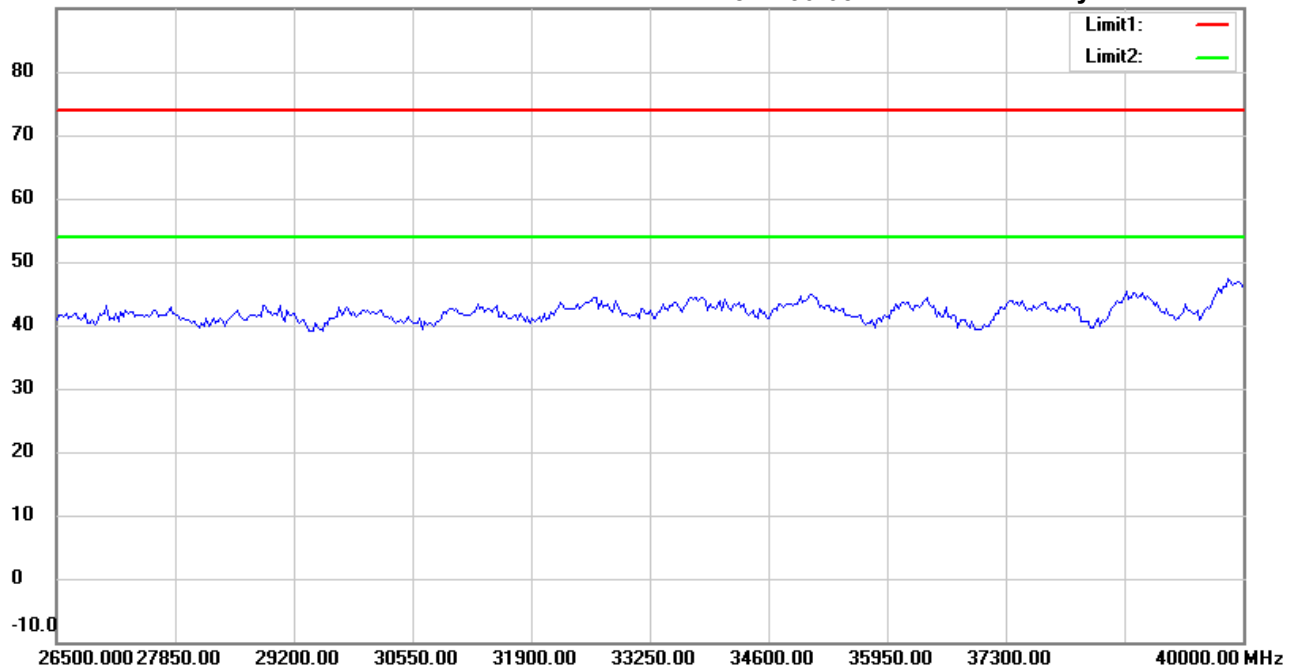
Data : #6

Condition : FCC\_part 15E RE\_Above 1GHz\_PK

Test Mode : TX 802.11n40 CH159

Polarization: *Horizontal*

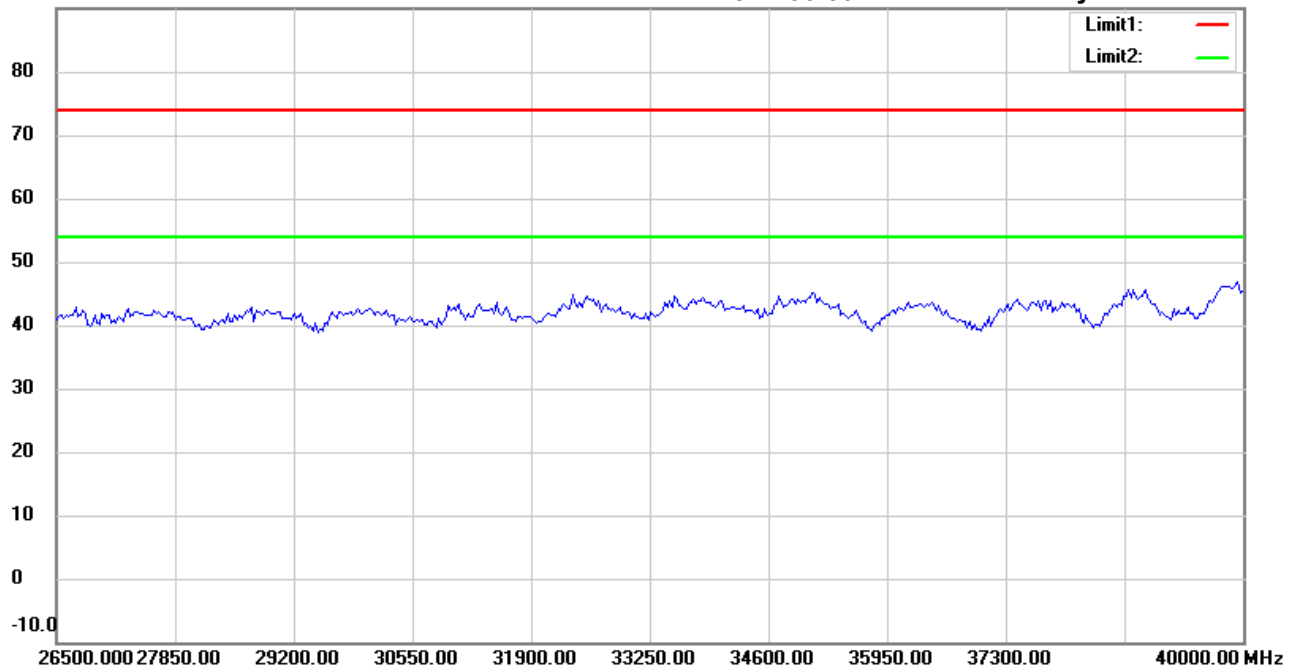
Data : #12

Condition : FCC\_part 15E RE\_Above 1GHz\_PK

Test Mode : TX 802.11n40 CH159

Polarization: Vertical

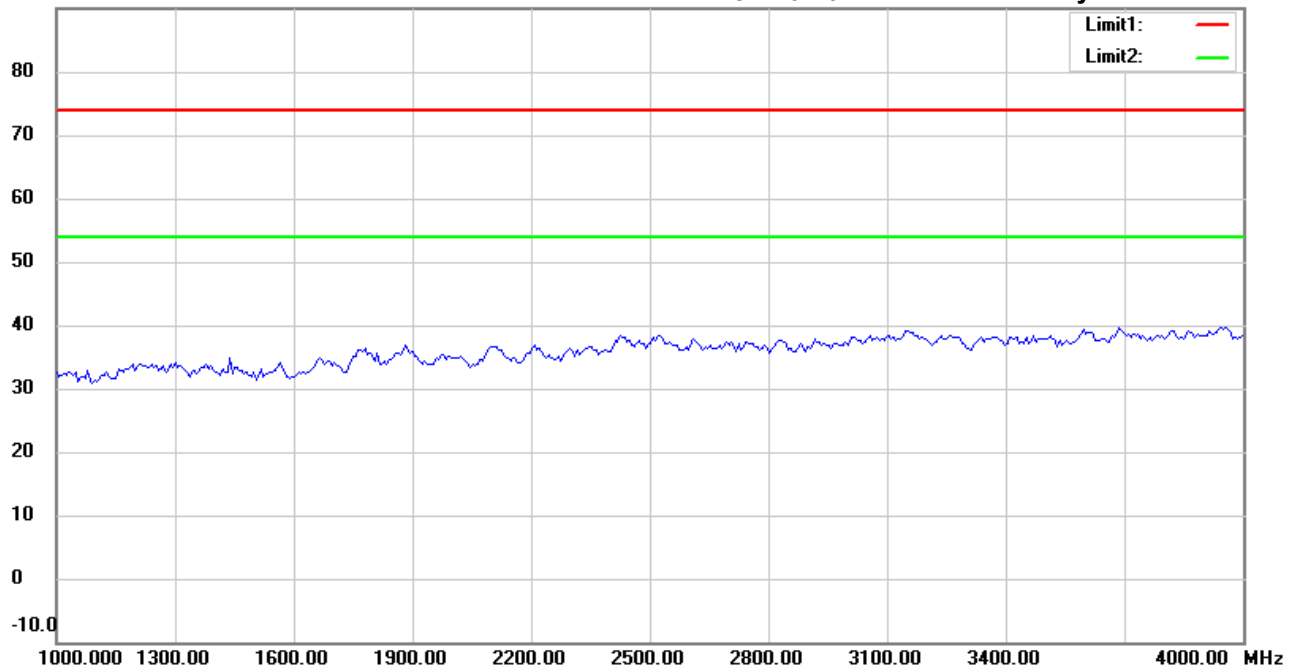
Data : #1

Condition : FCC\_part 15E RE\_Above 1GHz\_PK

Test Mode : TX 802.11ac CH42

Polarization: *Horizontal*

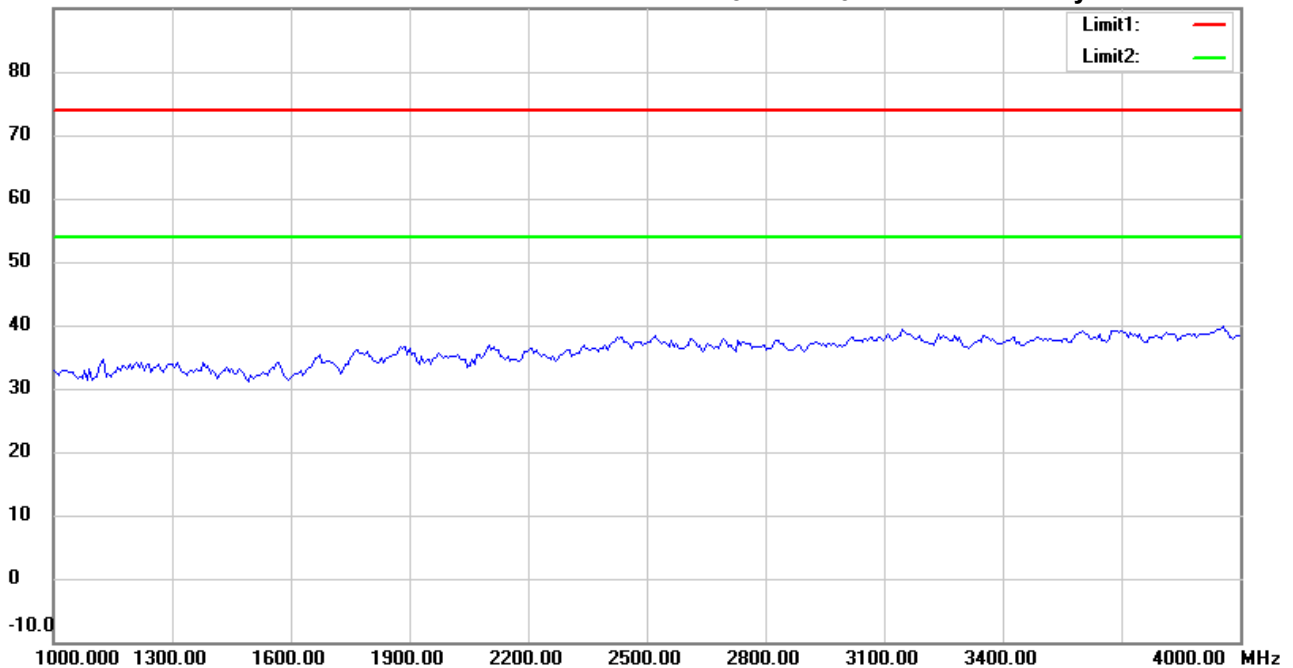
Data :#7

Condition : FCC\_part 15E RE\_Above 1GHz\_PK

Test Mode : TX 802.11ac CH42

Polarization: **Vertical**

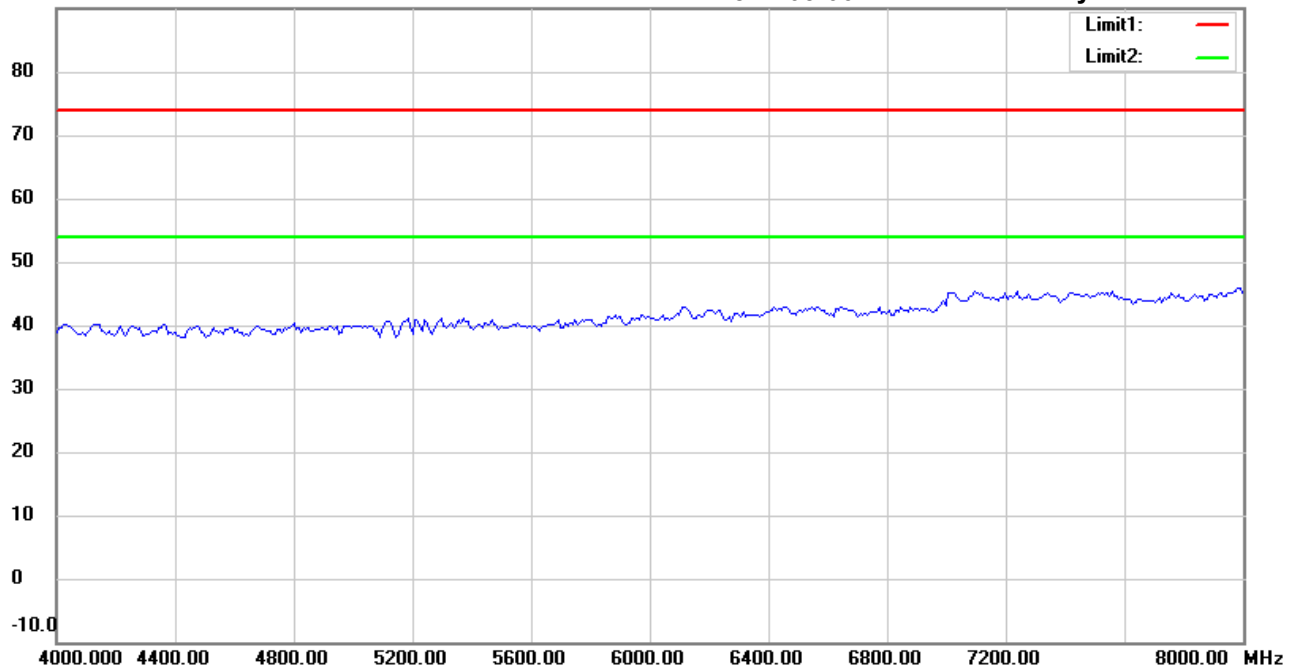
Data : #2

Condition : FCC\_part 15E RE\_Above 1GHz\_PK

Test Mode : TX 802.11ac CH42

Polarization: *Horizontal*

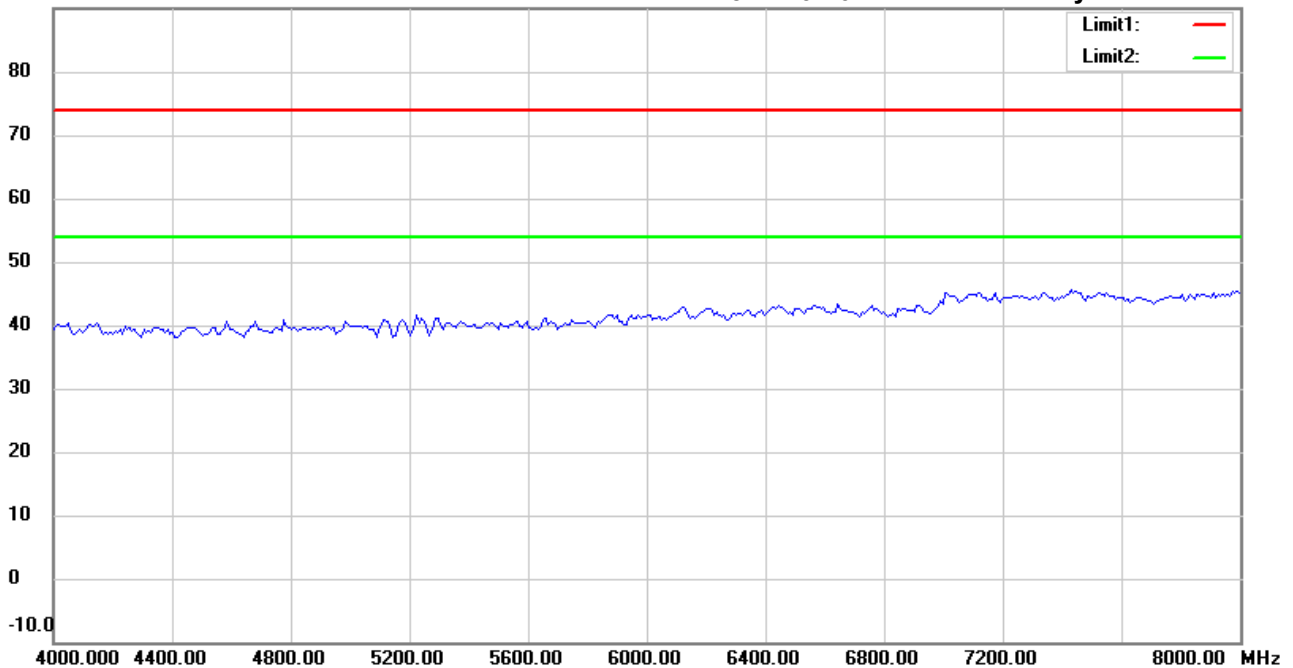
Data :#8

Condition : FCC\_part 15E RE\_Above 1GHz\_PK

Test Mode : TX 802.11ac CH42

Polarization: **Vertical**

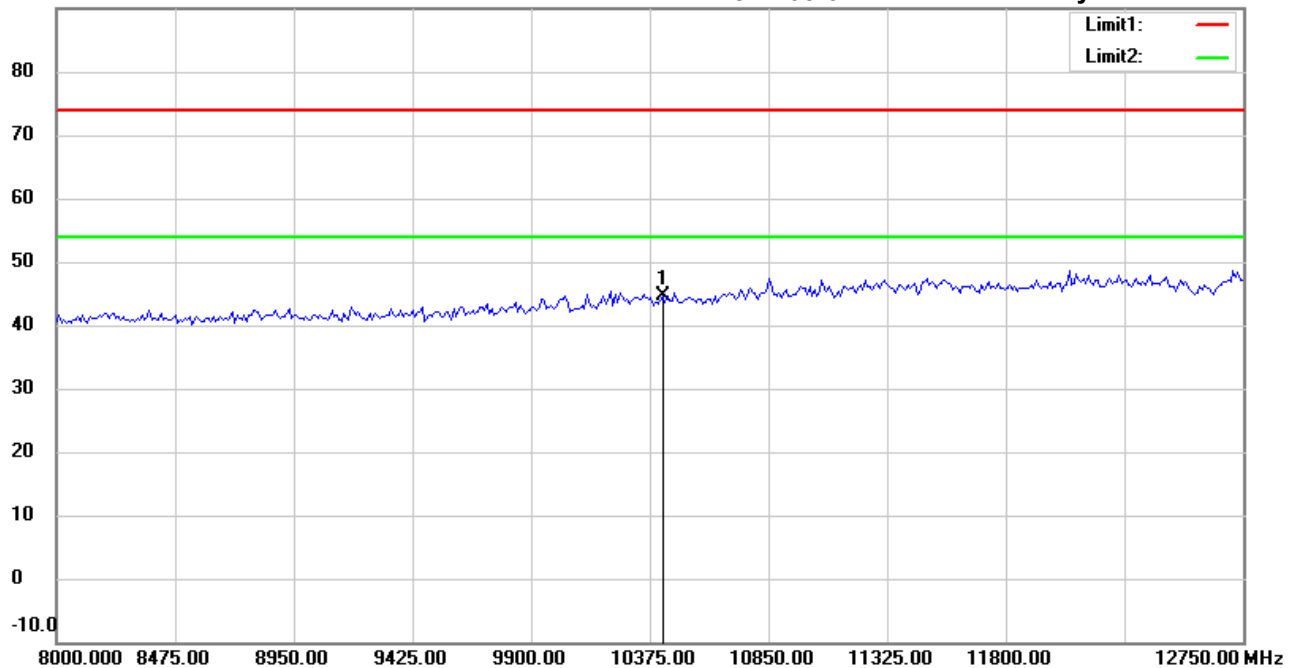
Data : #3

Condition : FCC\_part 15E RE\_Above 1GHz\_PK

Test Mode : TX 802.11ac CH42

Polarization: *Horizontal*

| Mk. | Frequency (MHz) | Reading (dBuV) | Detector | Corr. factor (dB/m) | Result (dBuV/m) | Limit (dBuV/m) | Ant.Pos (cm) | Tab.Pos (deg.) | Margin (dB) | Comment |
|---|---|---|---|---|---|---|---|---|---|---|
| * | 10420.000 | 36.41 | peak | 8.27 | 44.68 | 74.00 | 150 | 105 | -29.32 | |

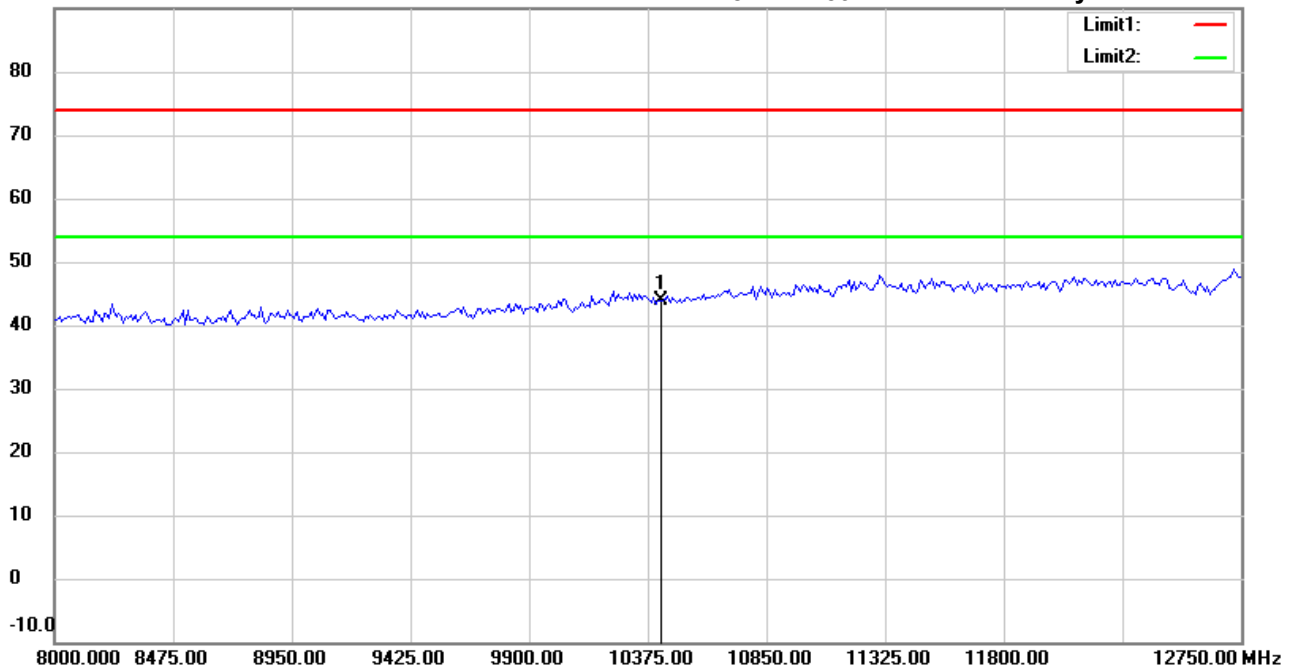
Data : #9

Condition : FCC\_part 15E RE\_Above 1GHz\_PK

Test Mode : TX 802.11ac CH42

Polarization: **Vertical**

| Mk. | Frequency (MHz) | Reading (dBuV) | Detector | Corr. factor (dB/m) | Result (dBuV/m) | Limit (dBuV/m) | Ant.Pos (cm) | Tab.Pos (deg.) | Margin (dB) | Comment |
|---|---|---|---|---|---|---|---|---|---|---|
| * | 10420.000 | 35.55 | peak | 8.27 | 43.82 | 74.00 | 150 | 245 | -30.18 | |

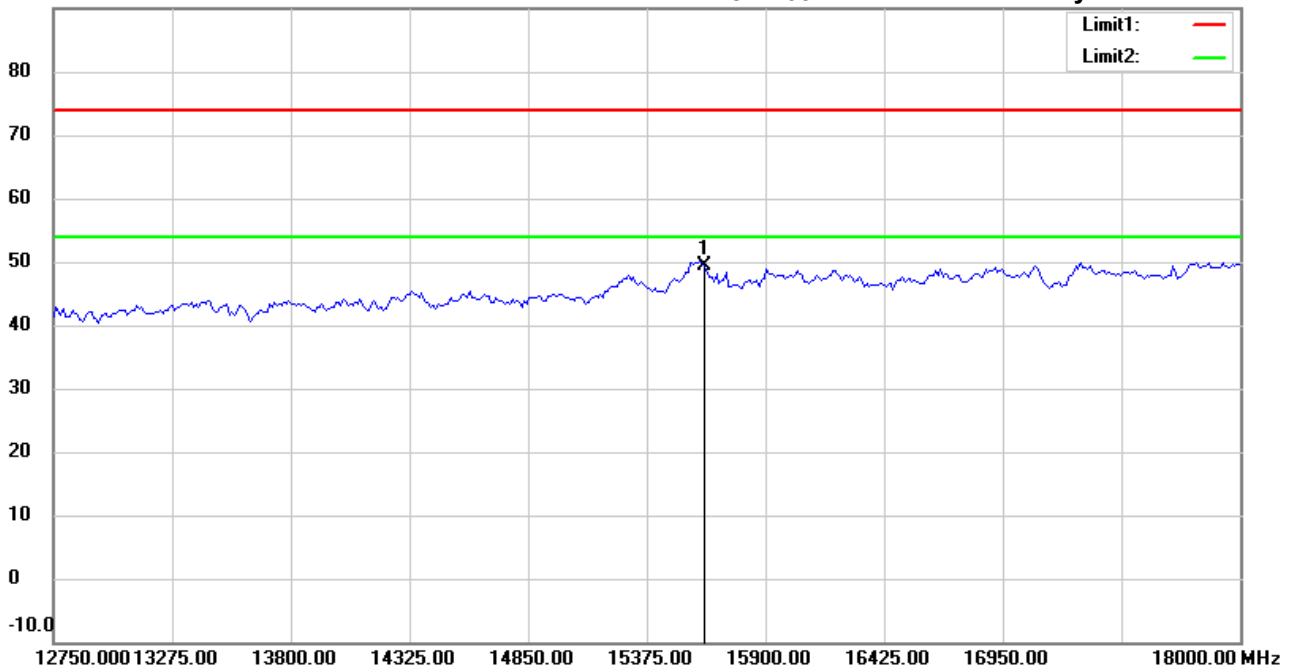
Data :#4

Condition : FCC\_part 15E RE\_Above 1GHz\_PK

Test Mode : TX 802.11ac CH42

Polarization: **Horizontal**

| Mk. | Frequency (MHz) | Reading (dBuV) | Detector | Corr. factor (dB/m) | Result (dBuV/m) | Limit (dBuV/m) | Ant.Pos (cm) | Tab.Pos (deg.) | Margin (dB) | Comment |
|---|---|---|---|---|---|---|---|---|---|---|
| * | 15630.000 | 30.25 | peak | 19.06 | 49.31 | 74.00 | 150 | 140 | -24.69 | |

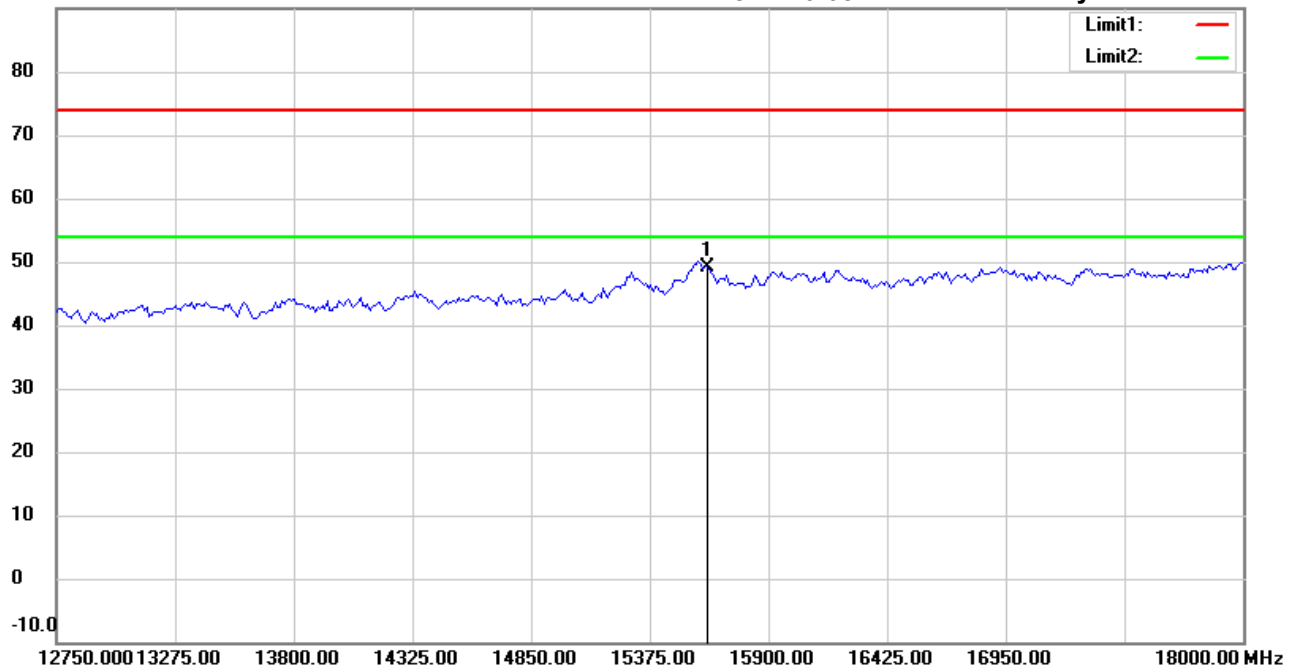
Data :#10

Condition : FCC\_part 15E RE\_Above 1GHz\_PK

Test Mode : TX 802.11ac CH42

Polarization: **Vertical**

| Mk. | Frequency (MHz) | Reading (dBuV) | Detector | Corr. factor (dB/m) | Result (dBuV/m) | Limit (dBuV/m) | Ant.Pos (cm) | Tab.Pos (deg.) | Margin (dB) | Comment |
|---|---|---|---|---|---|---|---|---|---|---|
| * | 15630.000 | 30.01 | peak | 19.06 | 49.07 | 74.00 | 150 | 20 | -24.93 | |

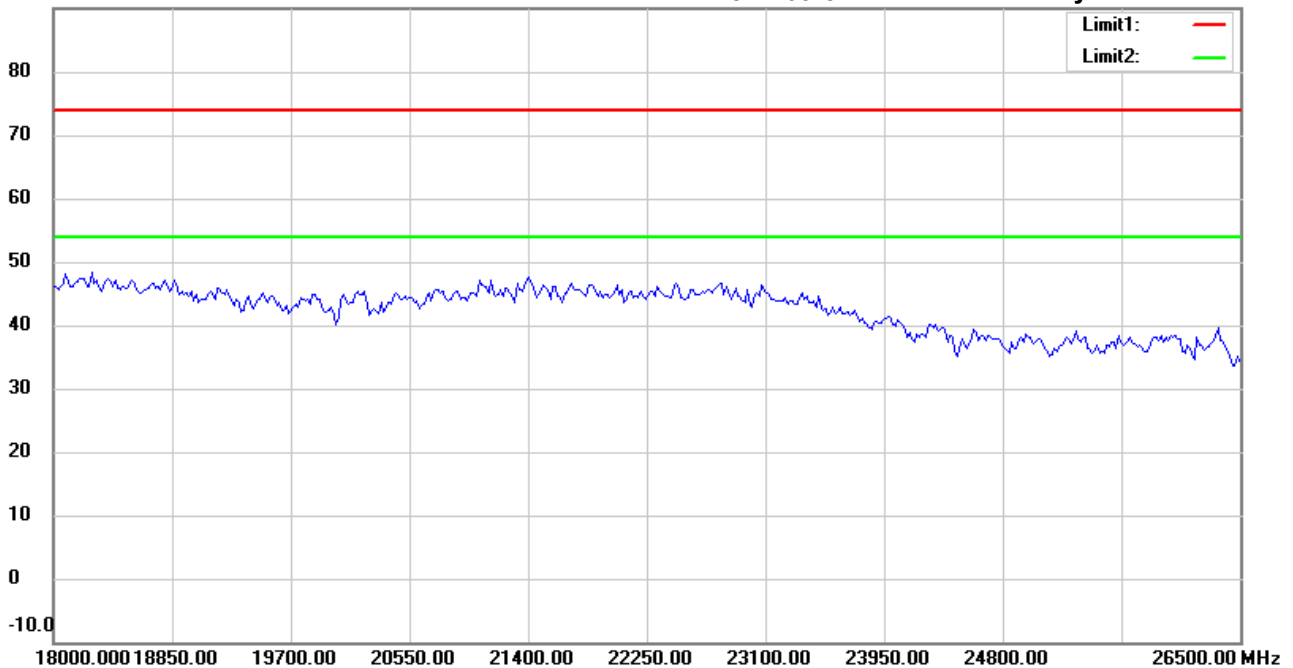
Data :#5

Condition : FCC\_part 15E RE\_Above 1GHz\_PK

Test Mode : TX 802.11ac CH42

Polarization: *Horizontal*

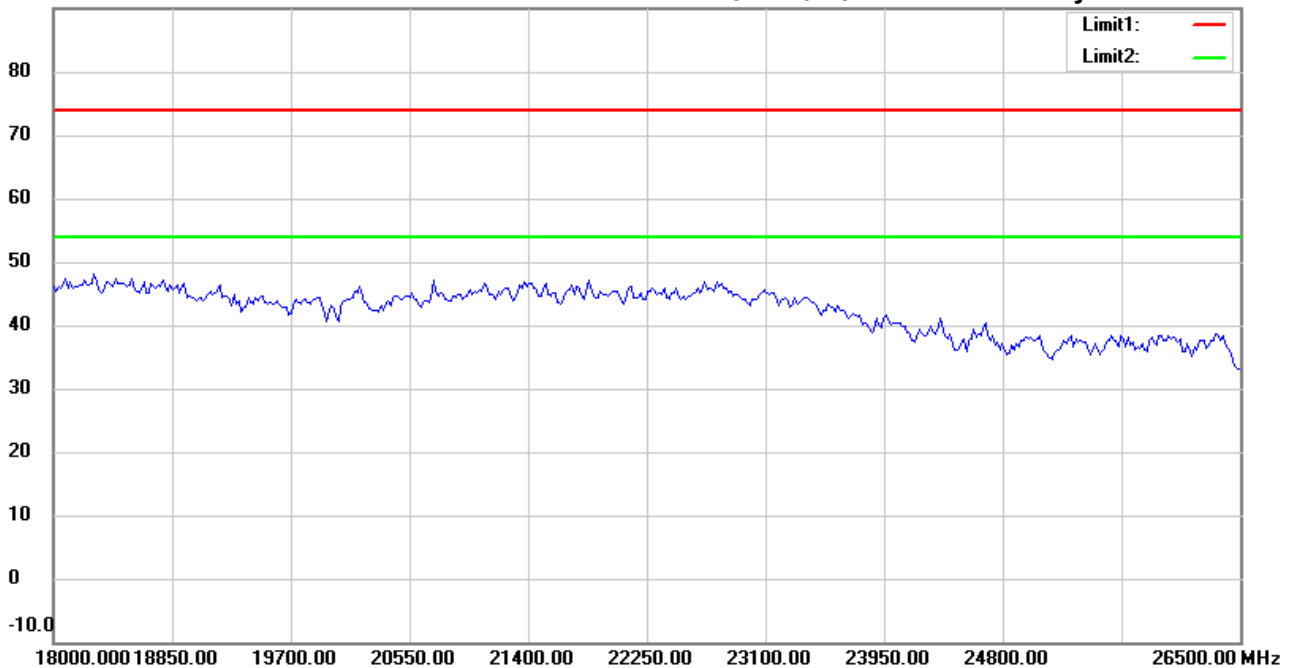
Data :#11

Condition : FCC\_part 15E RE\_Above 1GHz\_PK

Test Mode : TX 802.11ac CH42

Polarization: Vertical

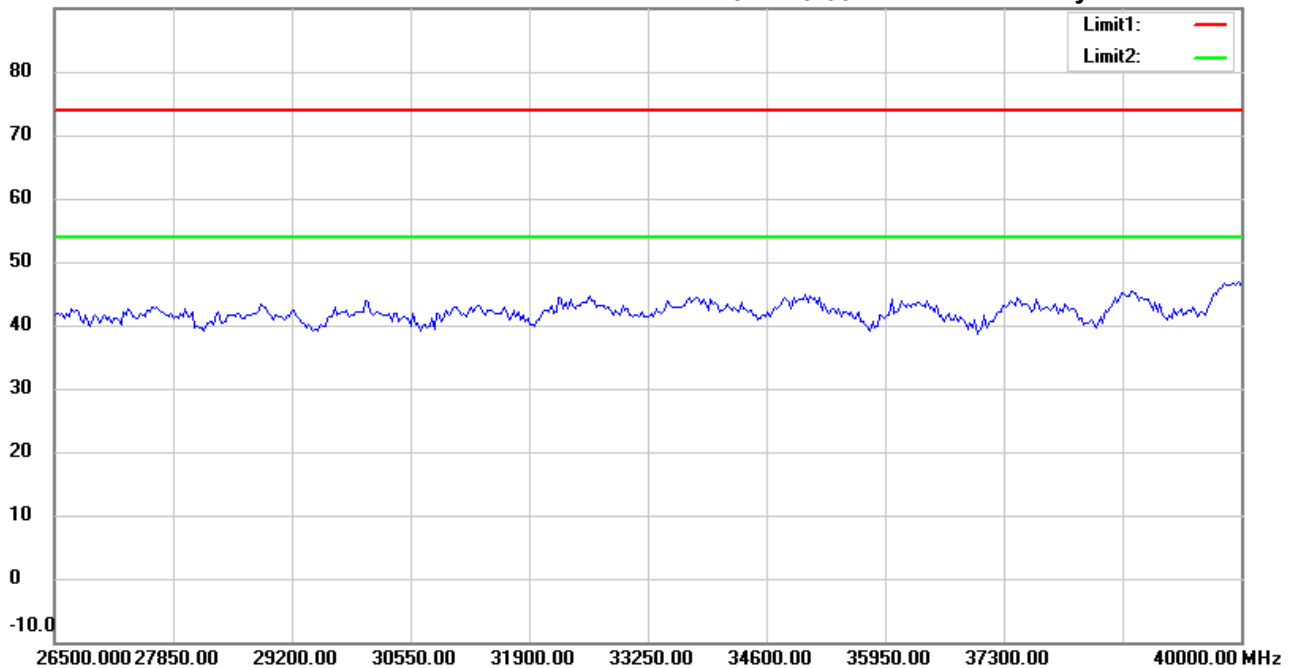
Data :#6

Condition : FCC\_part 15E RE\_Above 1GHz\_PK

Test Mode : TX 802.11ac CH42

Polarization: *Horizontal*

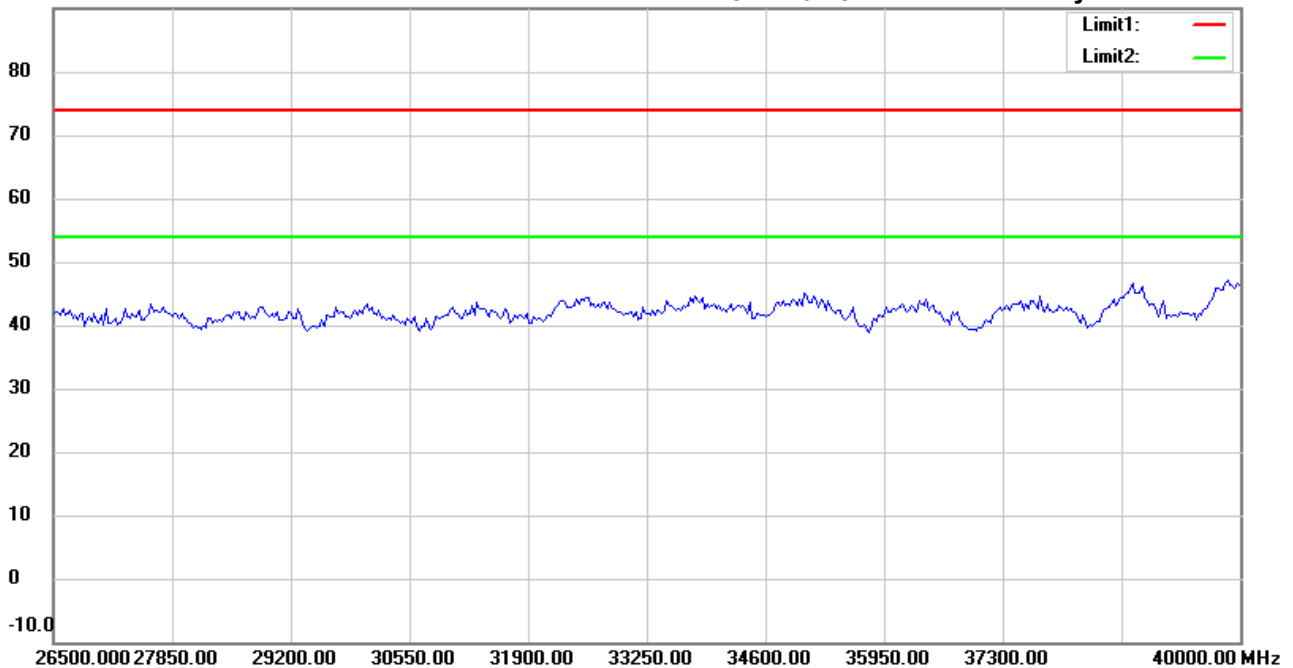
Data : #12

Condition : FCC\_part 15E RE\_Above 1GHz\_PK

Test Mode : TX 802.11ac CH42

Polarization: Vertical

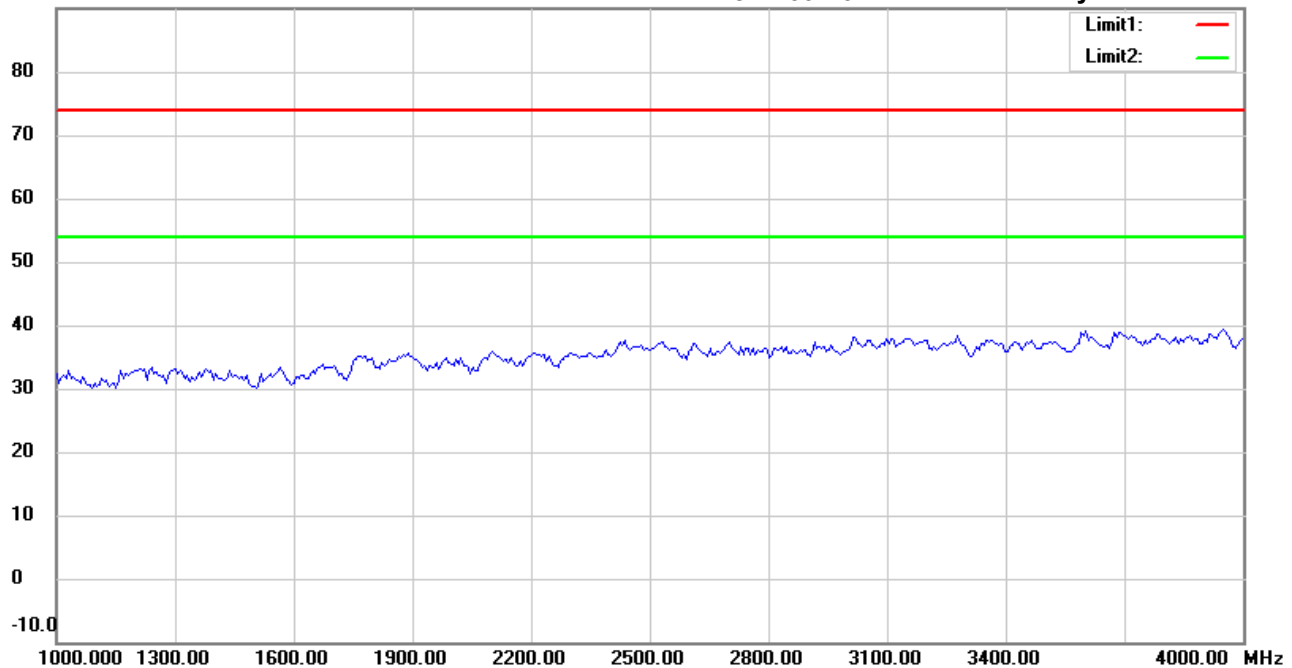
Data : #1

Condition : FCC\_part 15E RE\_Above 1GHz\_PK

Test Mode : TX 802.11ac CH155

Polarization: *Horizontal*

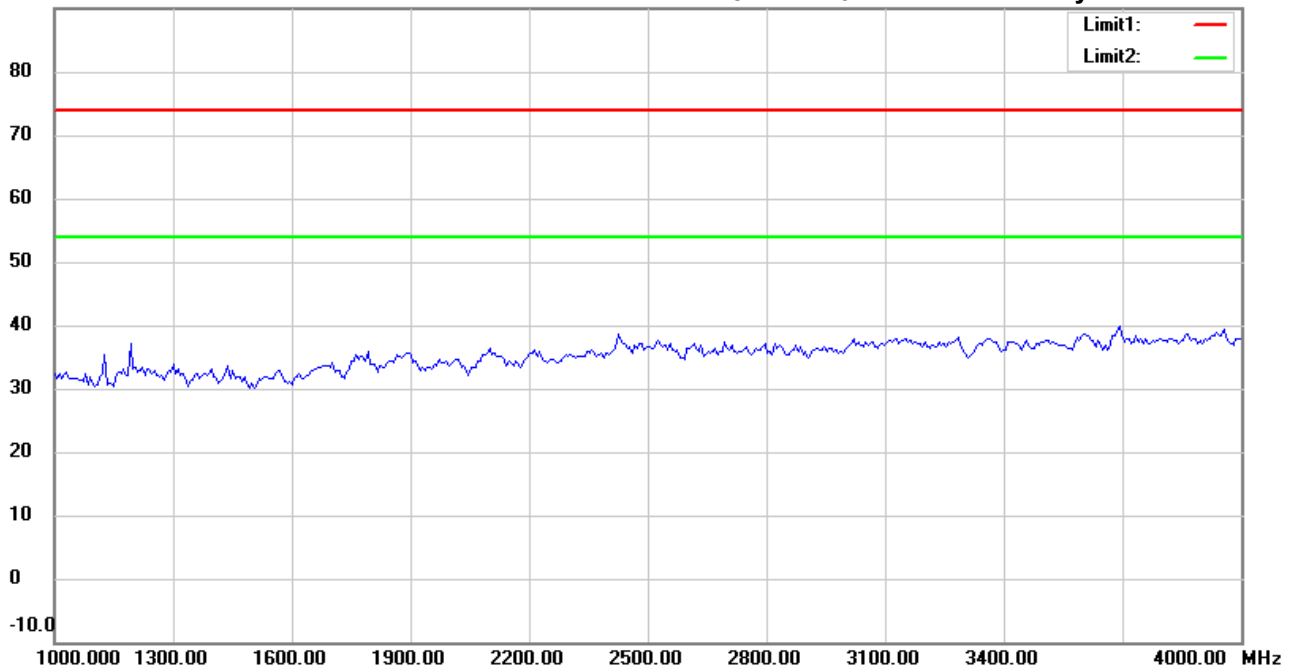
Data : #7

Condition : FCC\_part 15E RE\_Above 1GHz\_PK

Test Mode : TX 802.11ac CH155

Polarization: *Vertical*

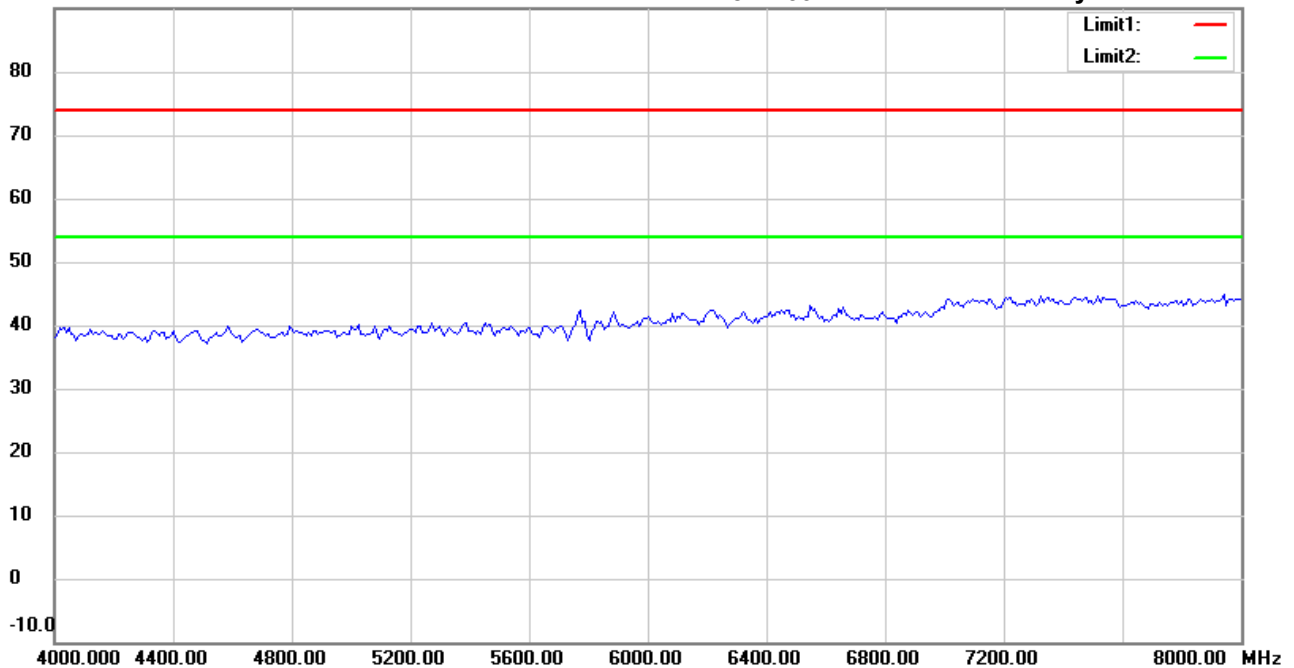
Data : #2

Condition : FCC\_part 15E RE\_Above 1GHz\_PK

Test Mode : TX 802.11ac CH155

Polarization: *Horizontal*

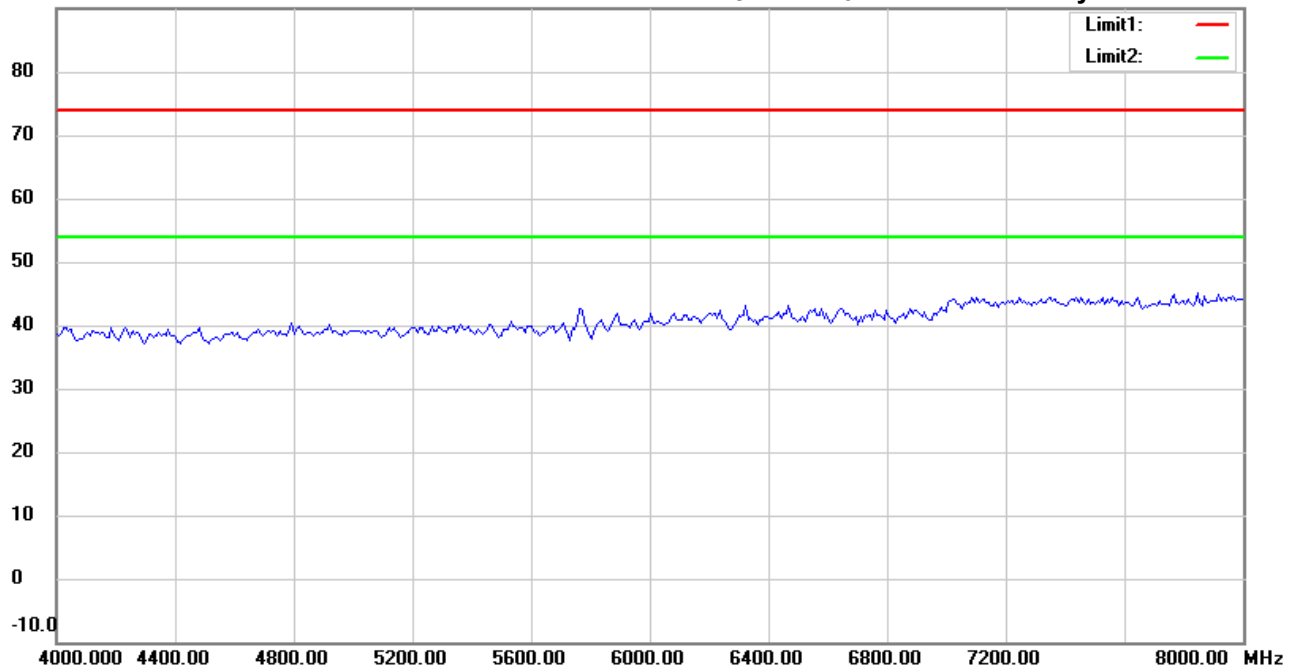
Data :#8

Condition : FCC\_part 15E RE\_Above 1GHz\_PK

Test Mode : TX 802.11ac CH155

Polarization: **Vertical**

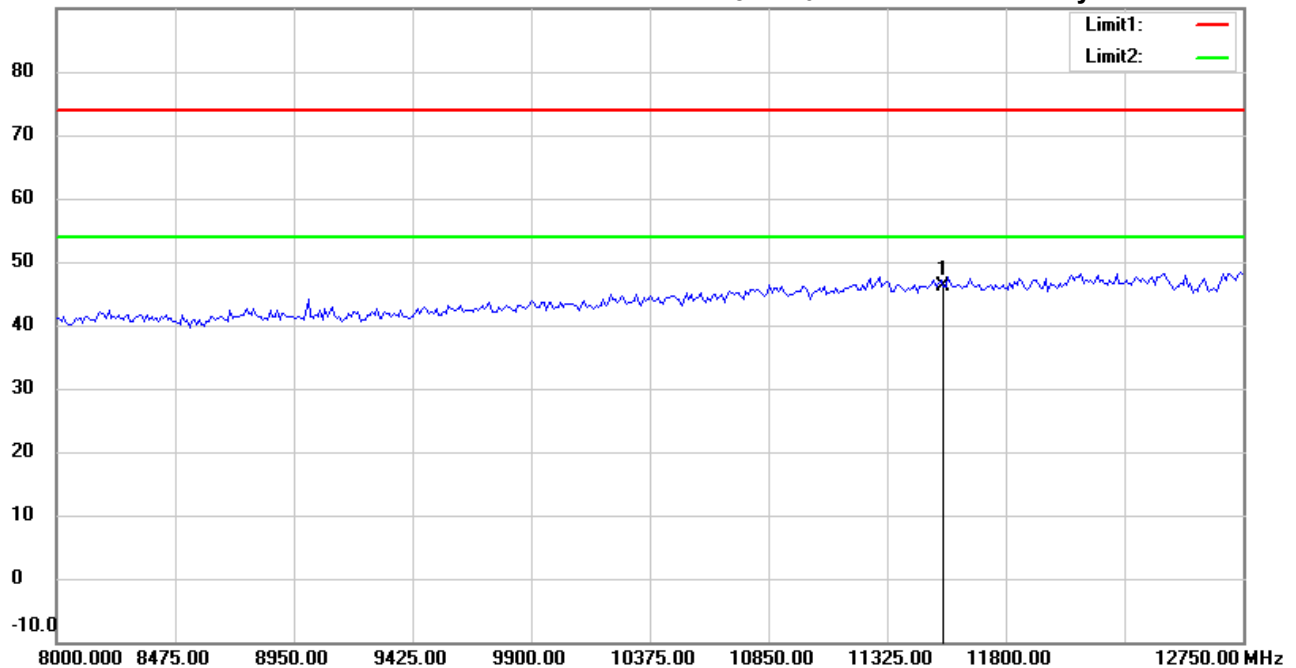
Data :#3

Condition : FCC\_part 15E RE\_Above 1GHz\_PK

Test Mode : TX 802.11ac CH155

Polarization: **Horizontal**

| Mk. | Frequency (MHz) | Reading (dBuV) | Detector | Corr. factor (dB/m) | Result (dBuV/m) | Limit (dBuV/m) | Ant.Pos (cm) | Tab.Pos (deg.) | Margin (dB) | Comment |
|---|---|---|---|---|---|---|---|---|---|---|
| * | 11550.000 | 34.89 | peak | 11.21 | 46.10 | 74.00 | 150 | 280 | -27.90 | |

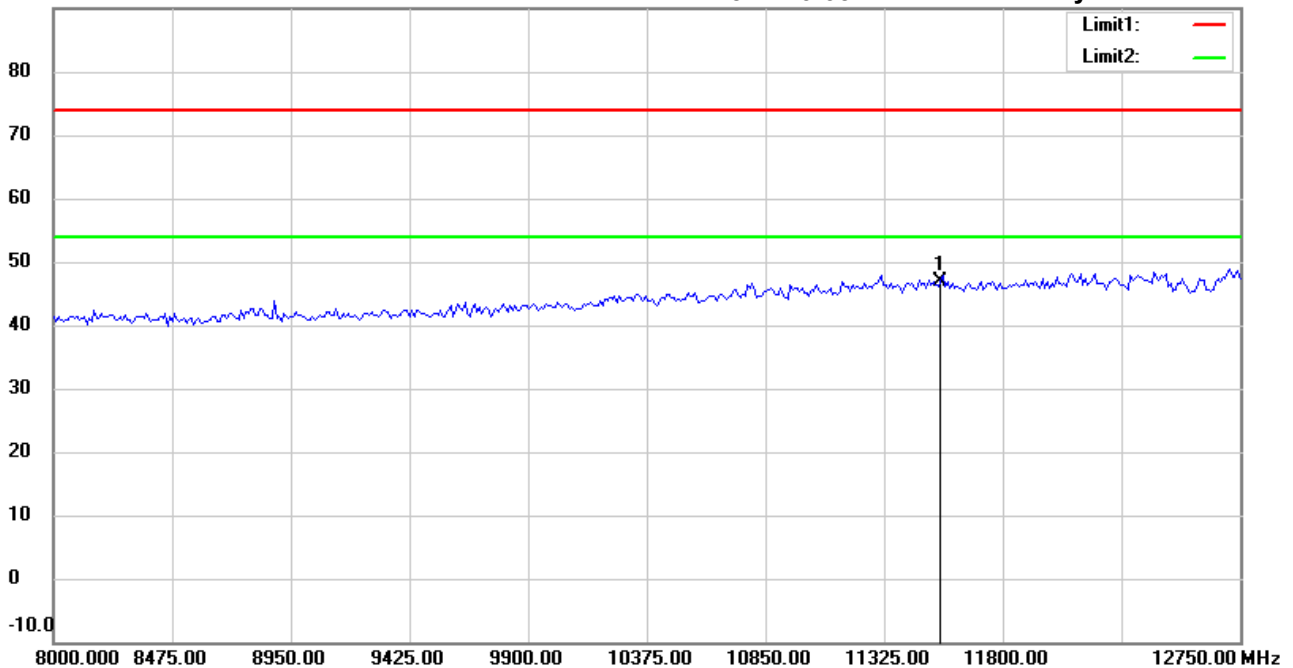
Data : #9

Condition : FCC\_part 15E RE\_Above 1GHz\_PK

Test Mode : TX 802.11ac CH155

Polarization: Vertical

| Mk. | Frequency (MHz) | Reading (dBuV) | Detector | Corr. factor (dB/m) | Result (dBuV/m) | Limit (dBuV/m) | Ant.Pos (cm) | Tab.Pos (deg.) | Margin (dB) | Comment |
|---|---|---|---|---|---|---|---|---|---|---|
| * | 11550.000 | 35.73 | peak | 11.21 | 46.94 | 74.00 | 150 | 60 | -27.06 | |

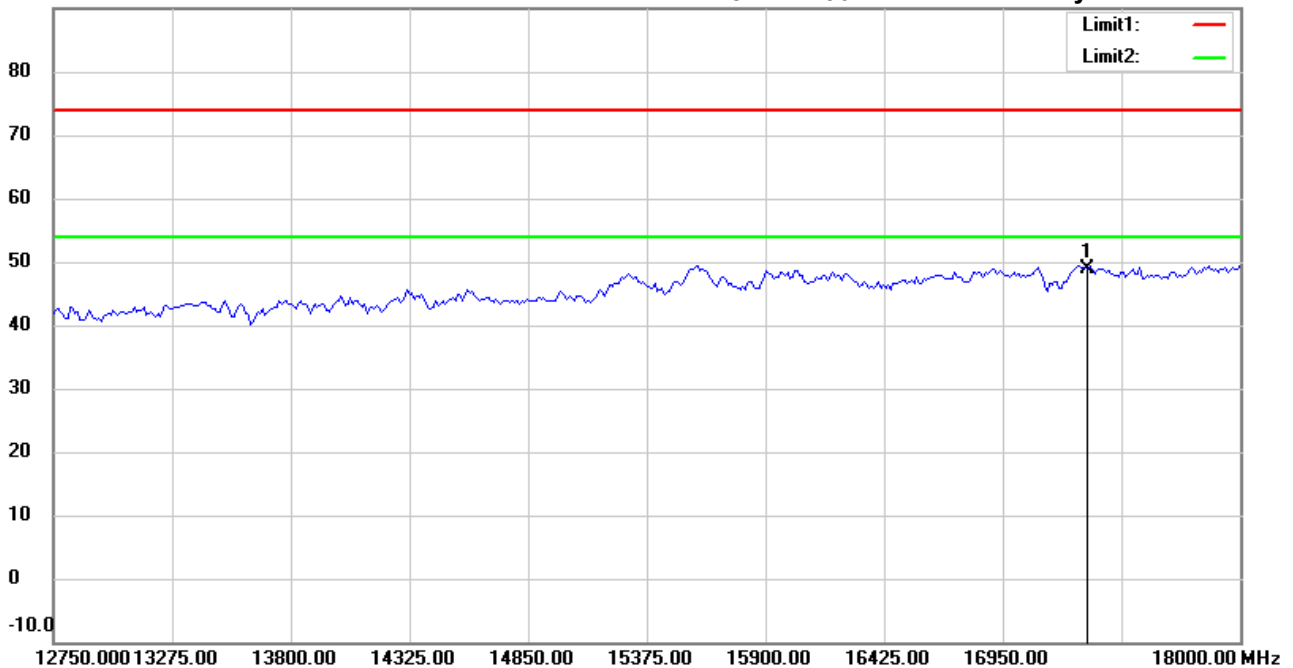
Data :#4

Condition : FCC\_part 15E RE\_Above 1GHz\_PK

Test Mode : TX 802.11ac CH155

Polarization: *Horizontal*

| Mk. | Frequency (MHz) | Reading (dBuV) | Detector | Corr. factor (dB/m) | Result (dBuV/m) | Limit (dBuV/m) | Ant.Pos (cm) | Tab.Pos (deg.) | Margin (dB) | Comment |
|---|---|---|---|---|---|---|---|---|---|---|
| * | 17325.000 | 28.25 | peak | 20.72 | 48.97 | 74.00 | 150 | 5 | -25.03 | |

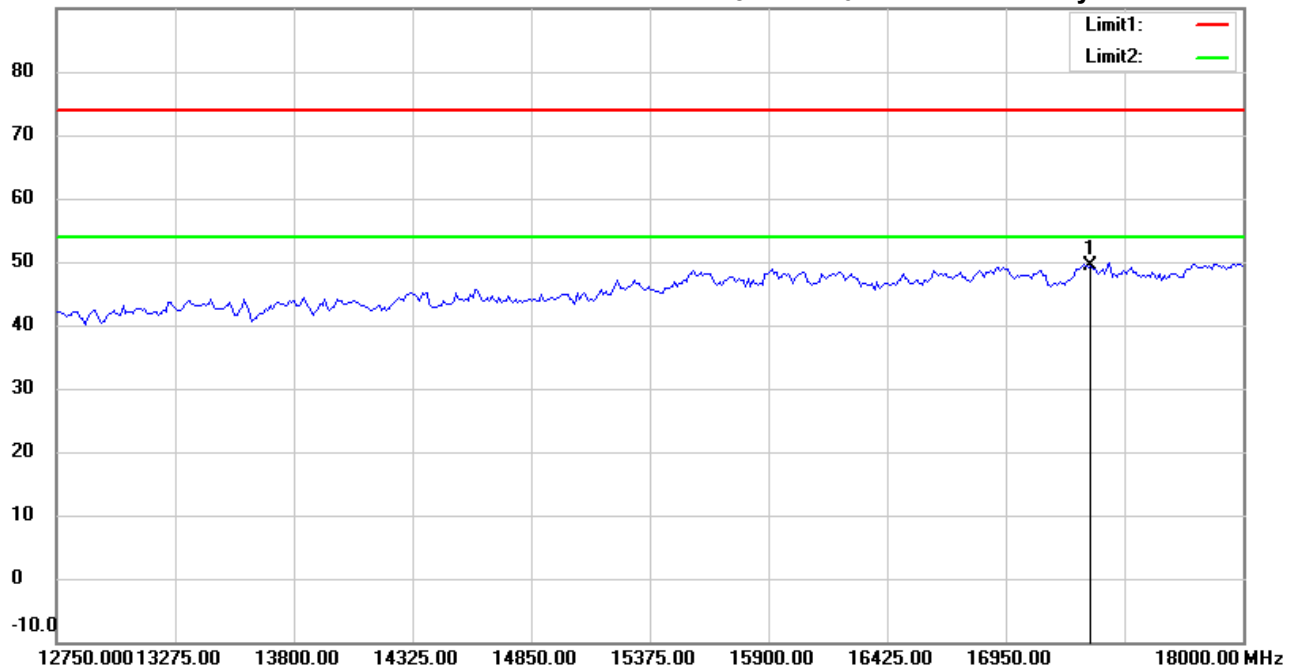
Data :#10

Condition : FCC\_part 15E RE\_Above 1GHz\_PK

Test Mode : TX 802.11ac CH155

Polarization: **Vertical**

| Mk. | Frequency (MHz) | Reading (dBuV) | Detector | Corr. factor (dB/m) | Result (dBuV/m) | Limit (dBuV/m) | Ant.Pos (cm) | Tab.Pos (deg.) | Margin (dB) | Comment |
|---|---|---|---|---|---|---|---|---|---|---|
| * | 17325.000 | 28.76 | peak | 20.72 | 49.48 | 74.00 | 150 | 235 | -24.52 | |

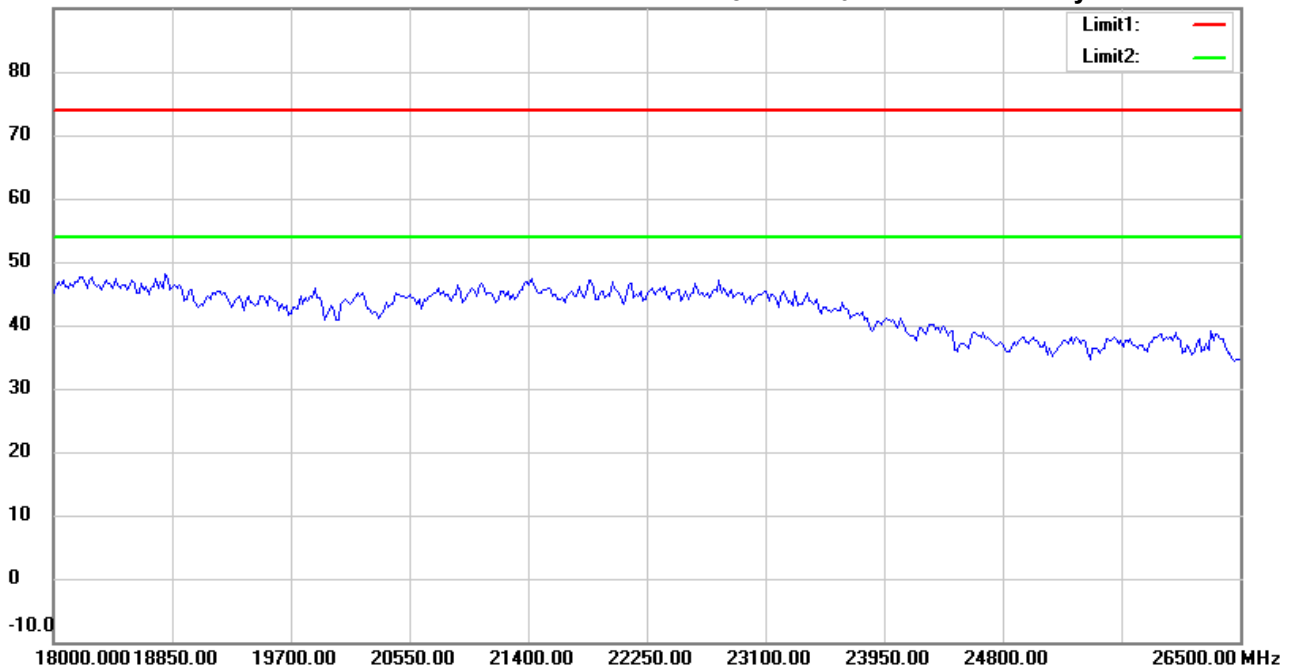
Data : #5

Condition : FCC\_part 15E RE\_Above 1GHz\_PK

Test Mode : TX 802.11ac CH155

Polarization: *Horizontal*
