# Radiated Emission Measurement

Condition : FCC\_part 15E RE\_Above 1GHz\_PK

EUT : W6M21906-19108

Test Mode : TX 802.11n40 CH159

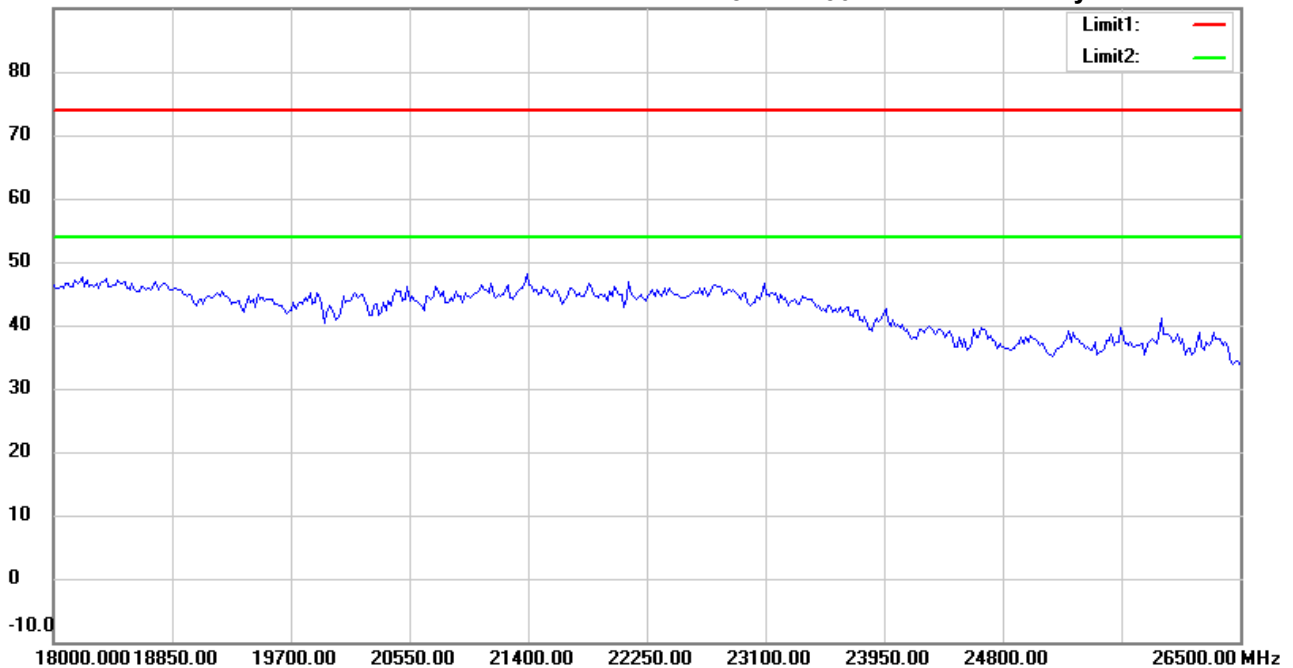
Condition : FCC\_part 15E RE\_Above 1GHz\_PK

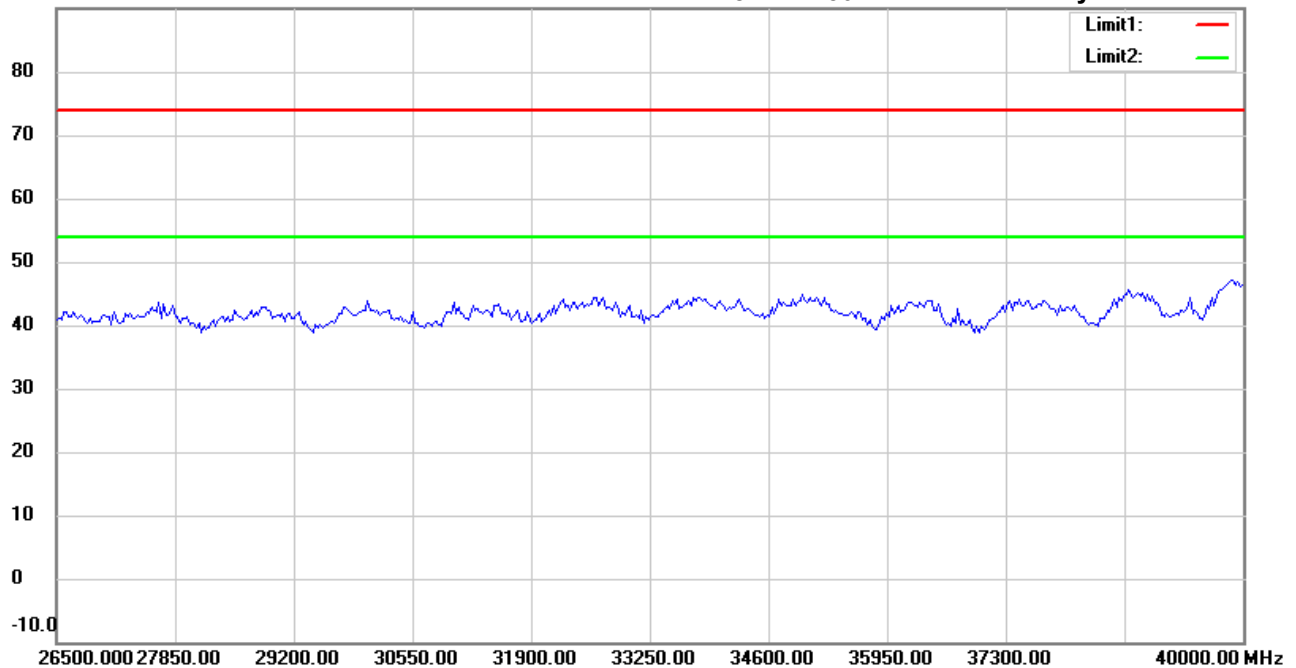
Condition : FCC\_part 15E RE\_Above 1GHz\_PK

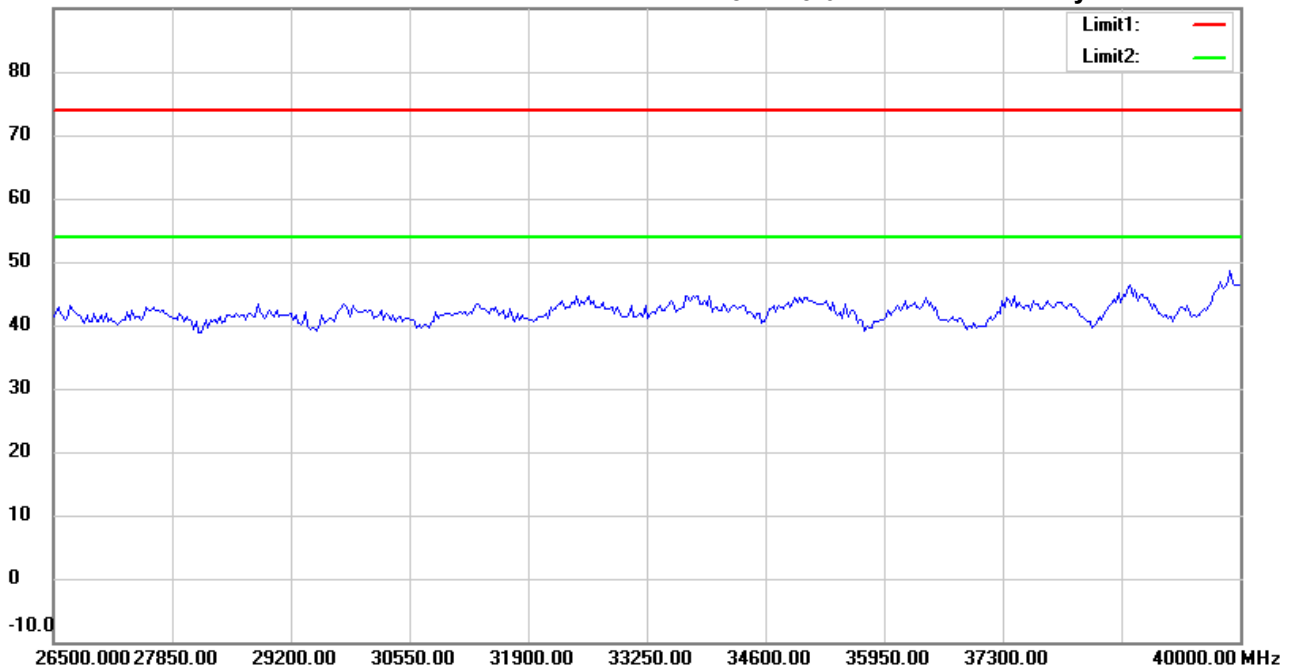
Condition : FCC\_part 15E RE\_Above 1GHz\_PK

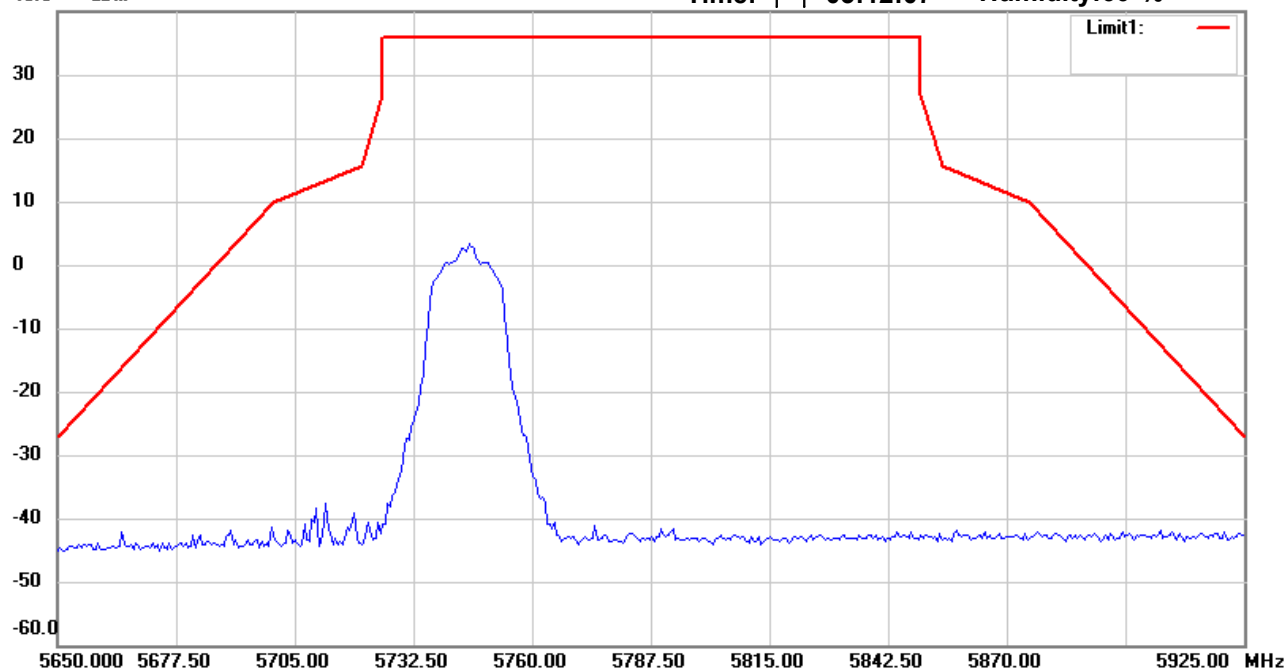
Condition : FCC\_5G Band4 Mask

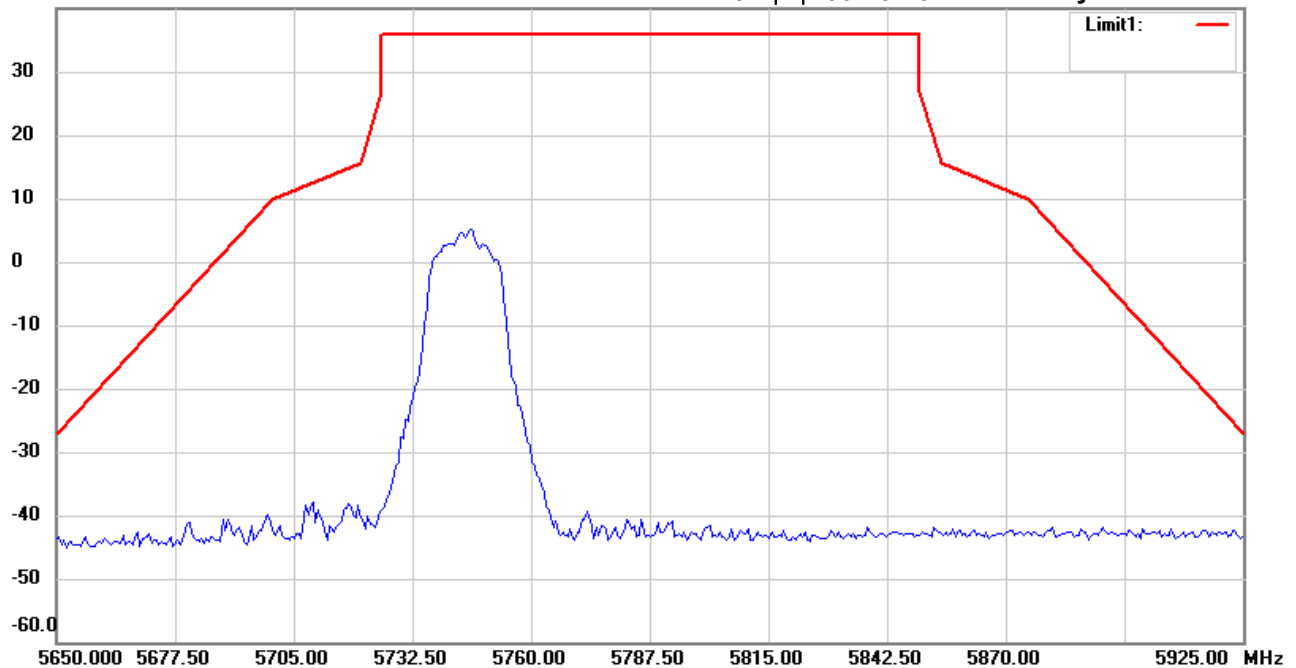
Condition : FCC\_5G Band4 Mask

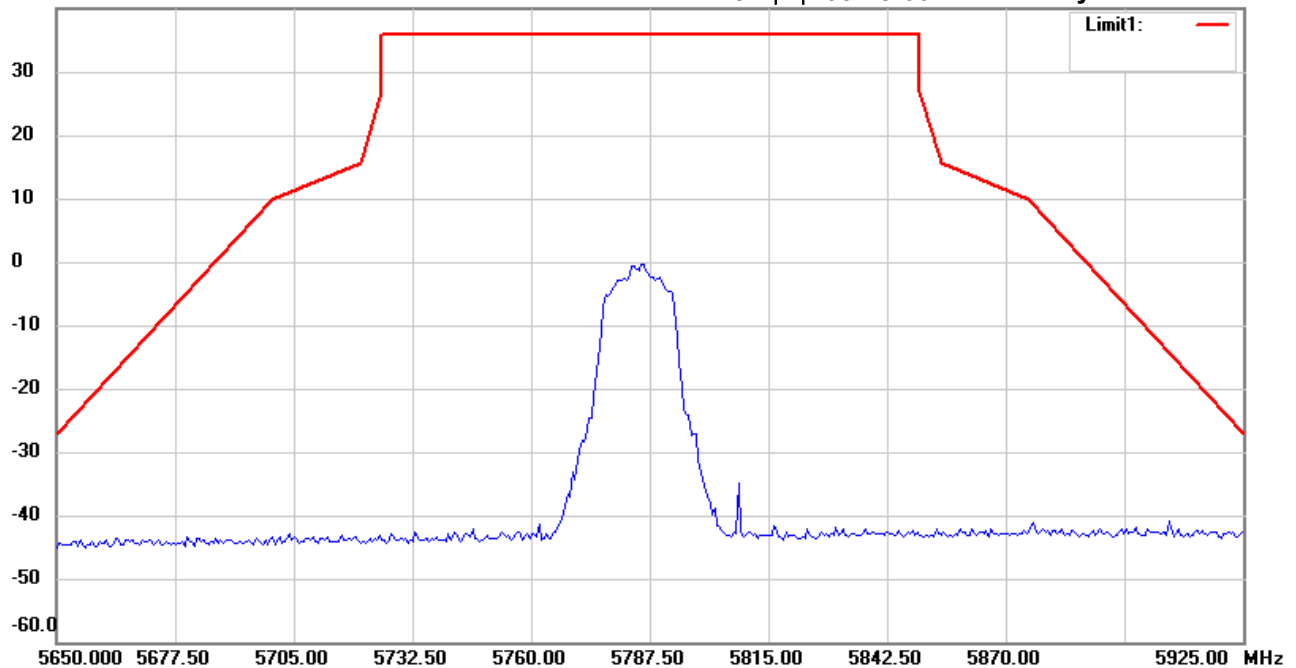
Condition : FCC\_5G Band4 Mask

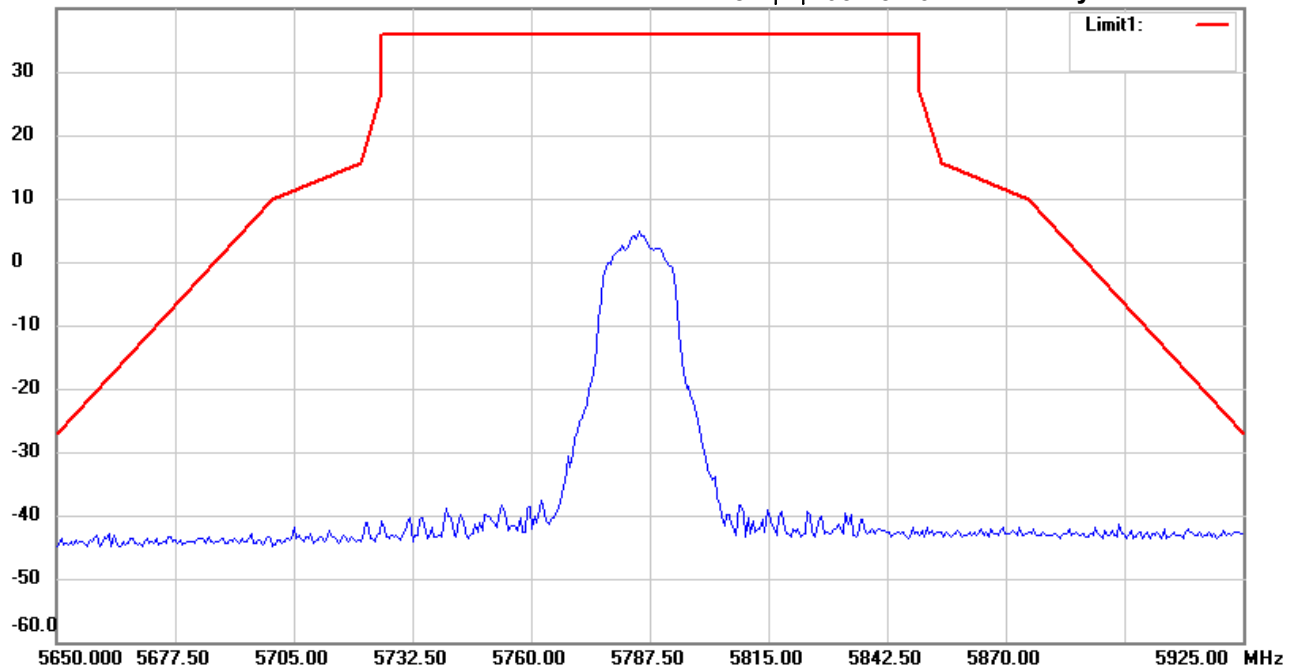
Condition : FCC\_5G Band4 Mask

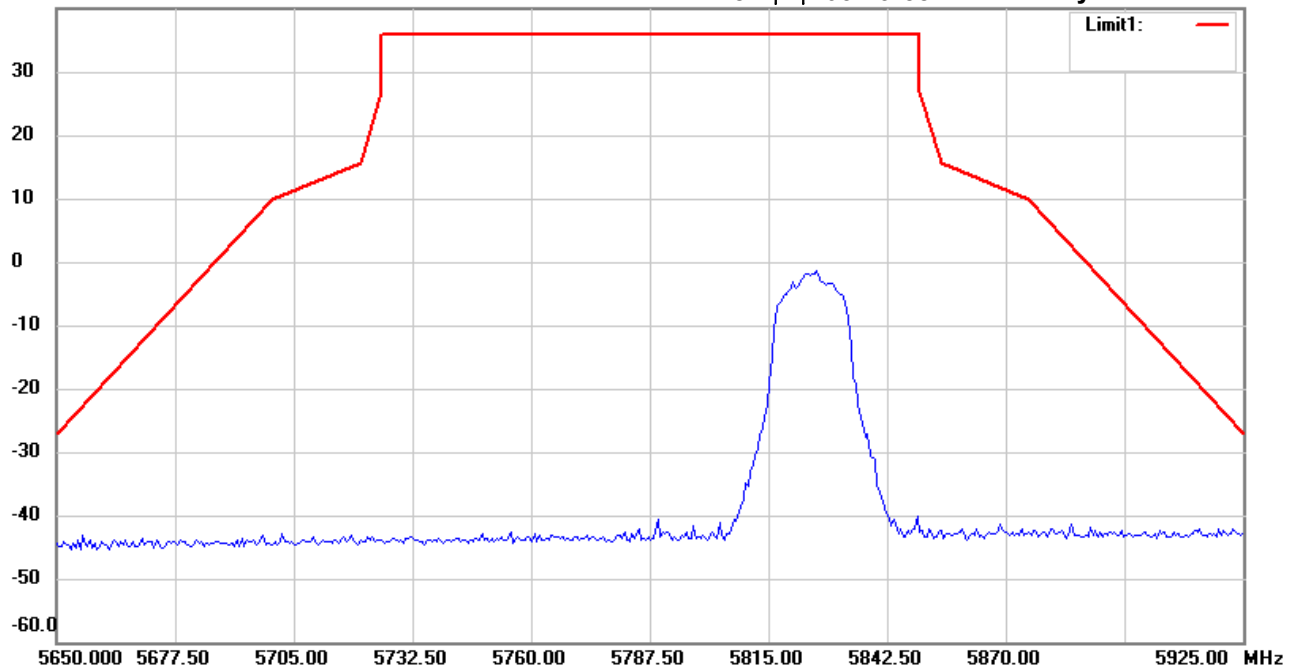
Condition : FCC\_5G Band4 Mask

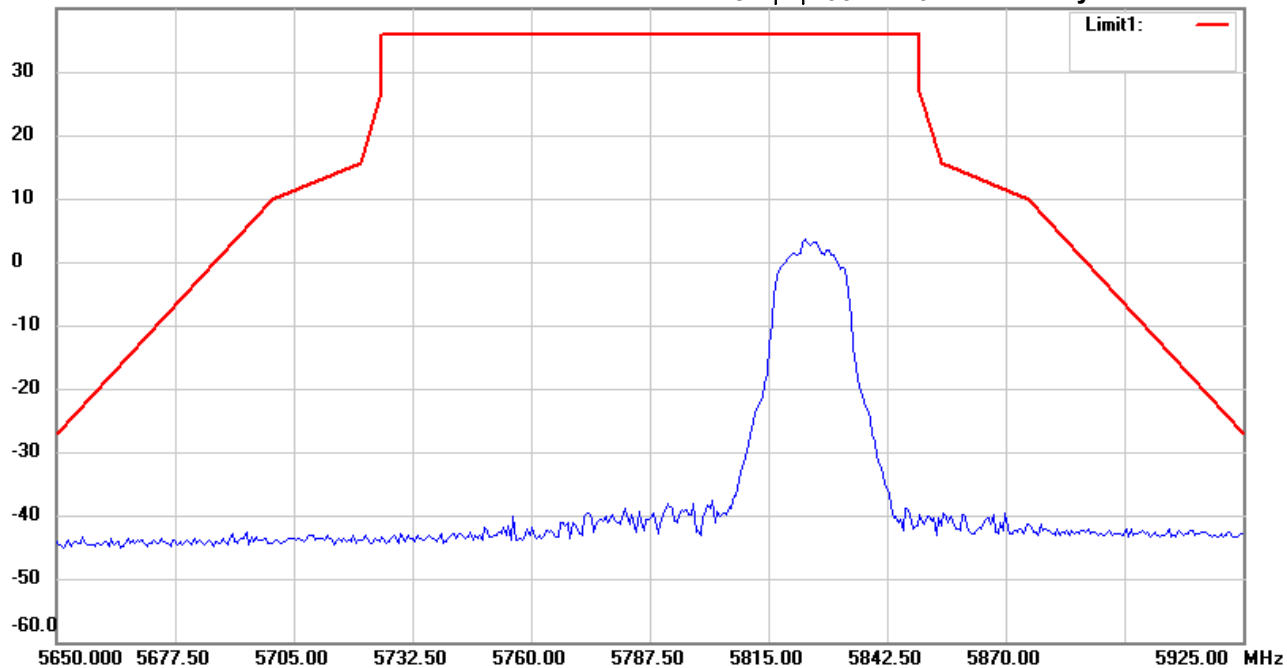
Condition : FCC\_5G Band4 Mask

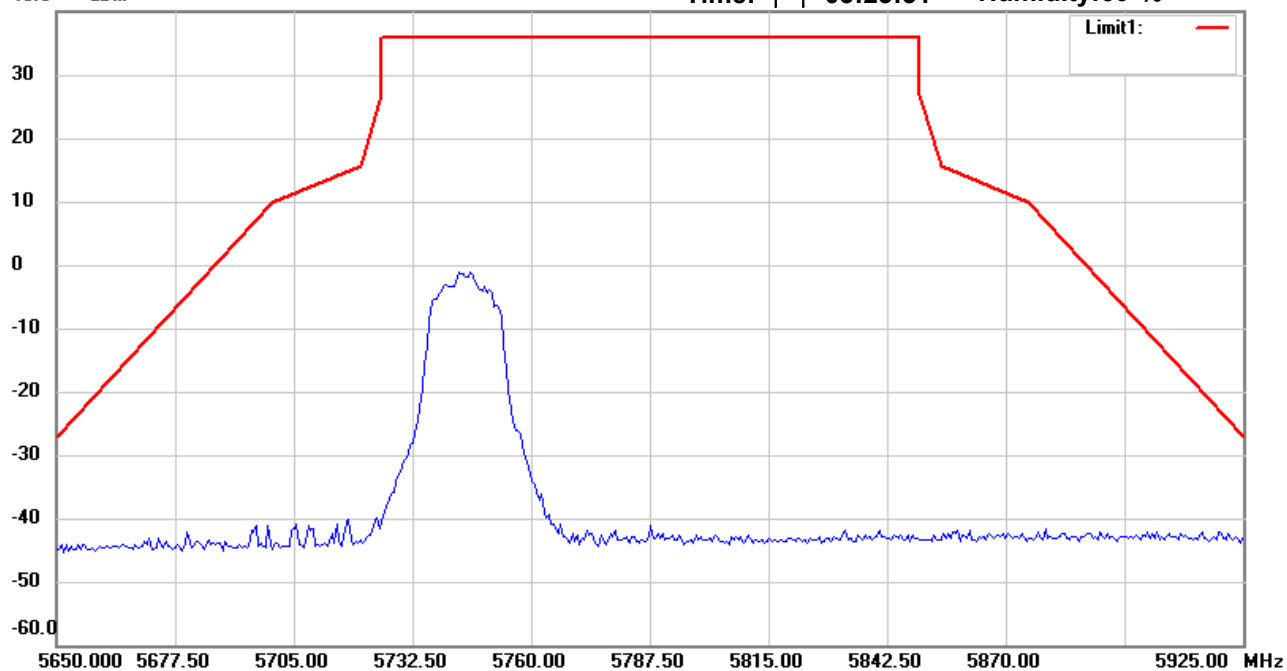
Condition : FCC\_5G Band4 Mask

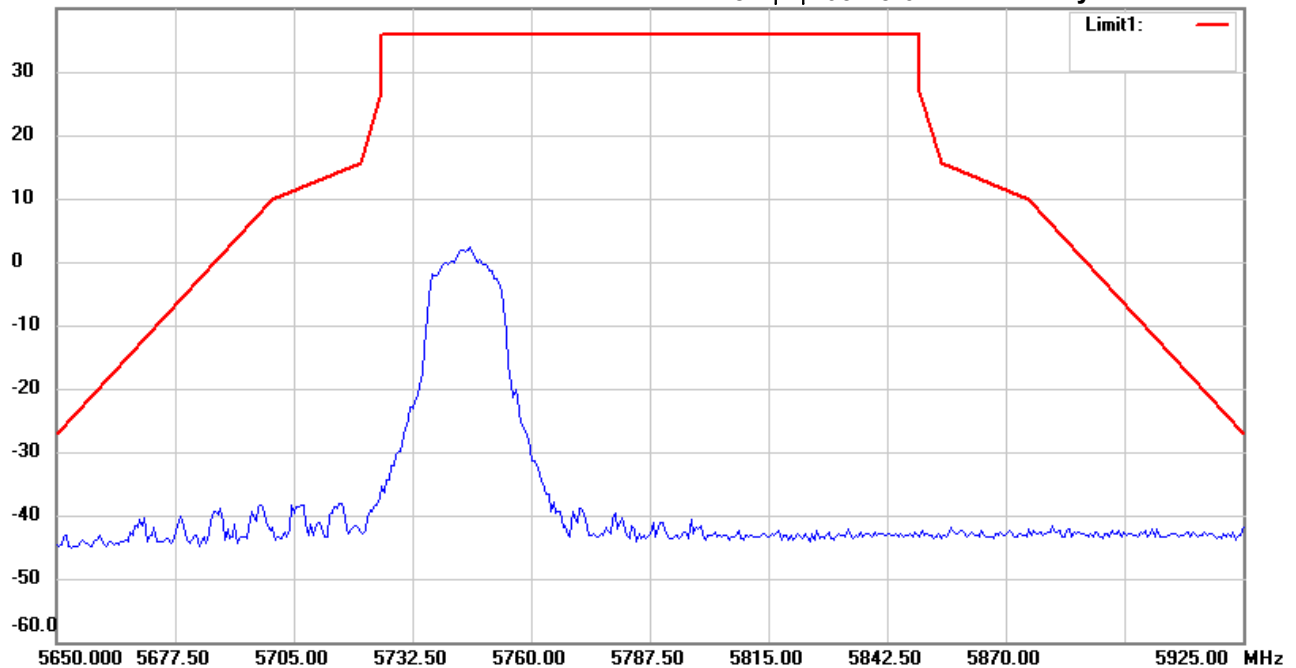
Condition : FCC\_5G Band4 Mask

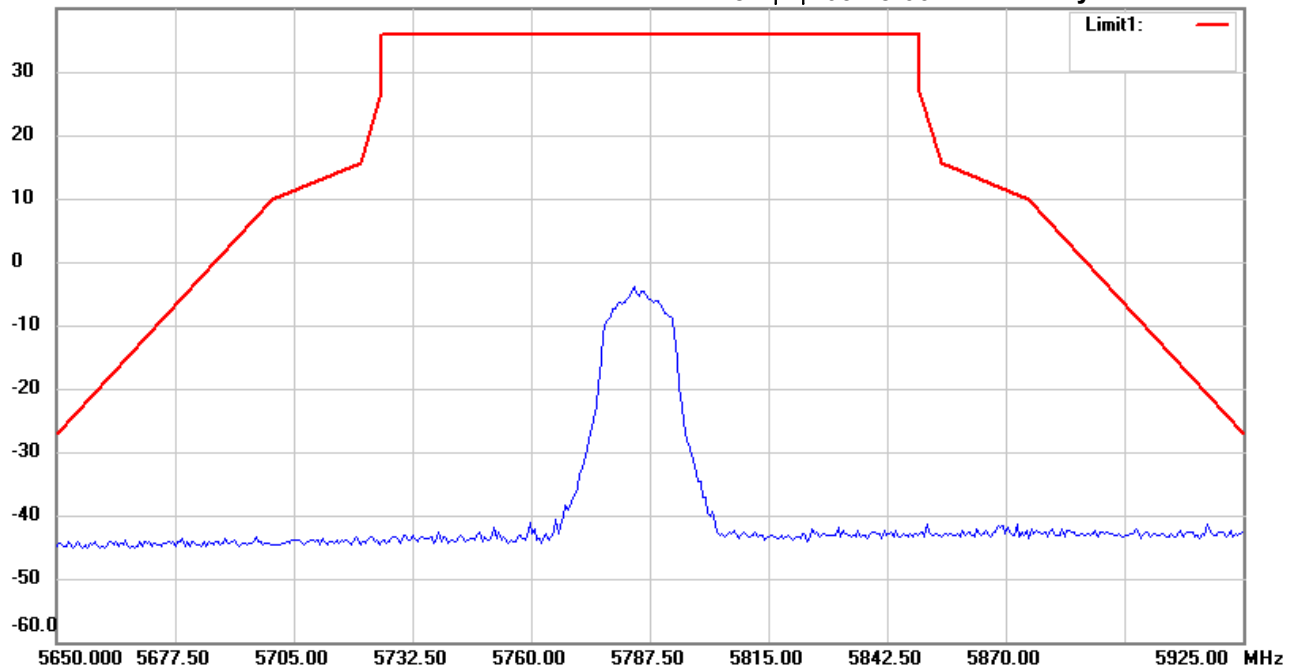
Condition : FCC\_5G Band4 Mask

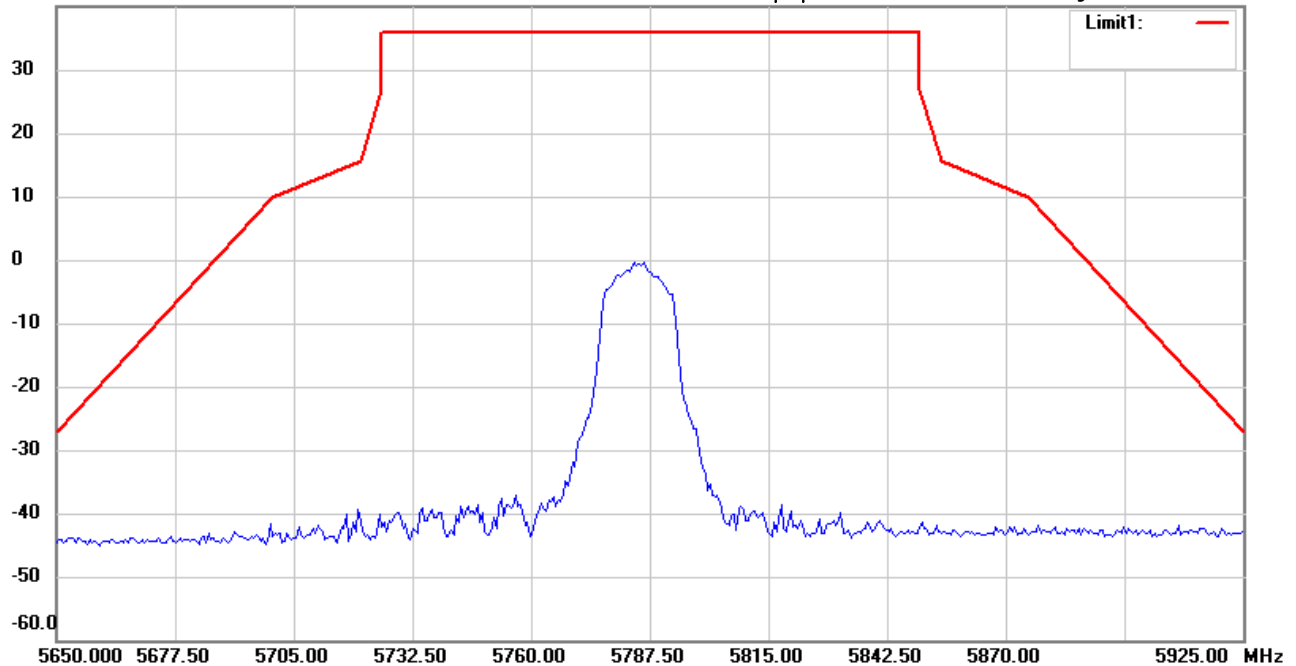
Condition : FCC\_5G Band4 Mask

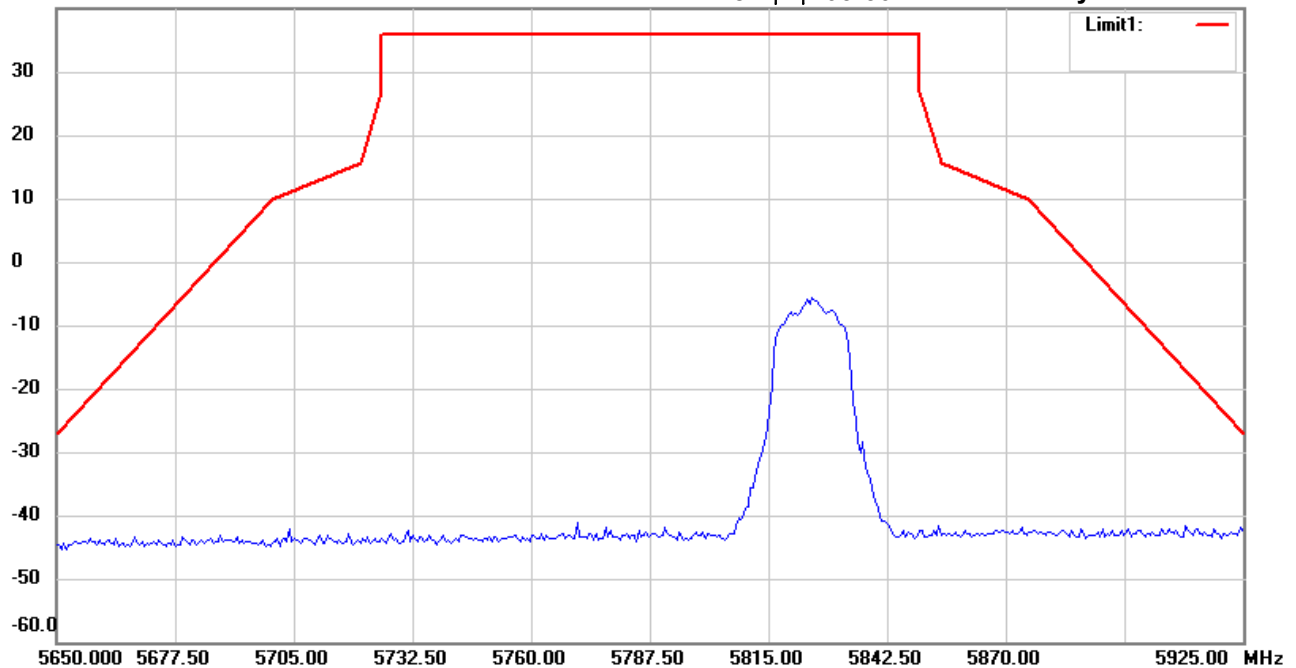
Condition : FCC\_5G Band4 Mask

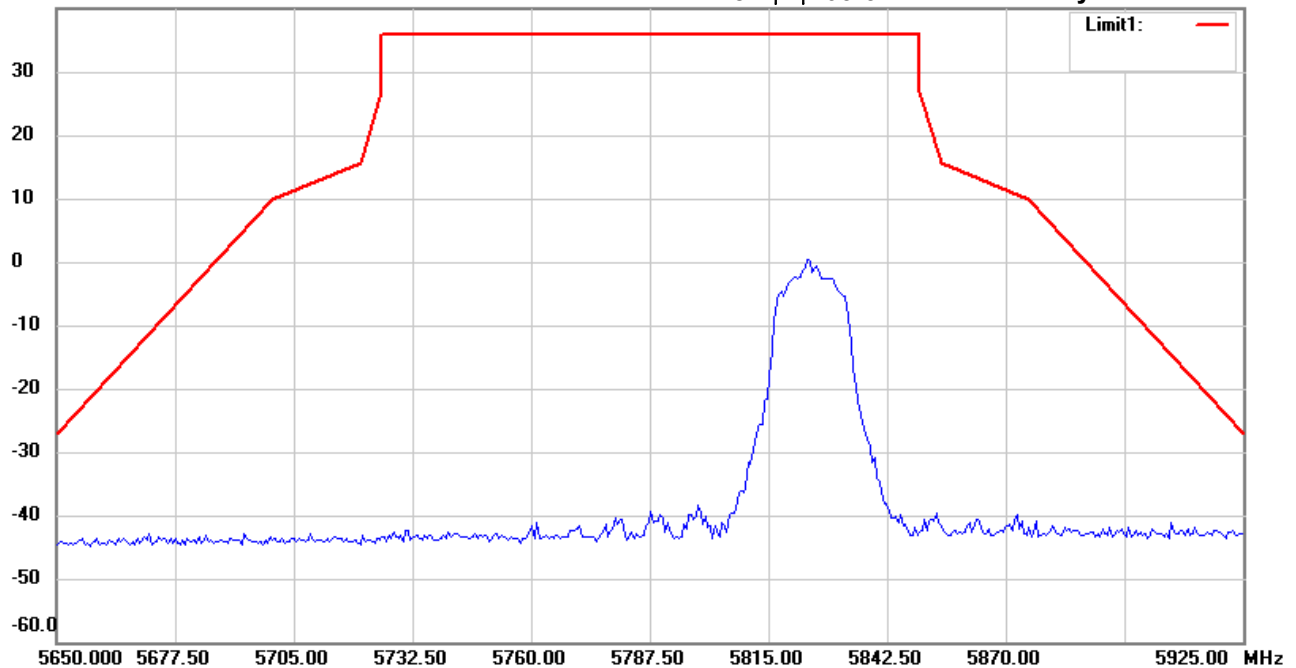
Condition : FCC\_5G Band4 Mask

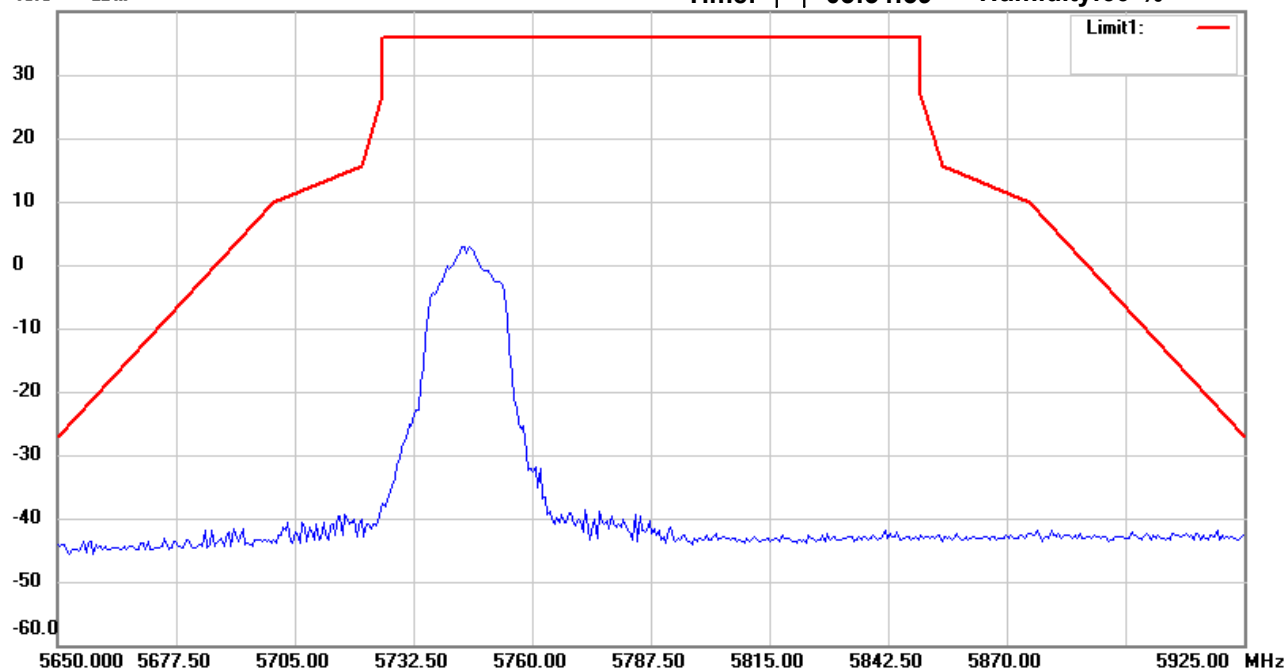
Condition : FCC\_5G Band4 Mask

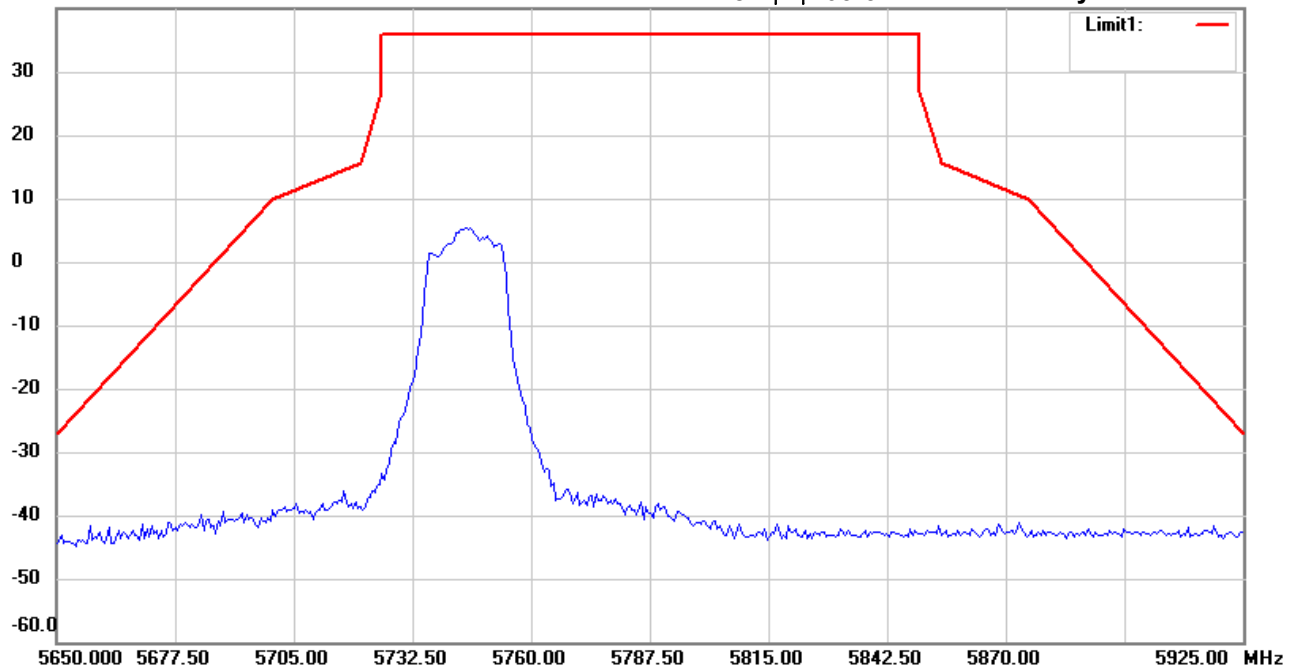
Condition : FCC\_5G Band4 Mask

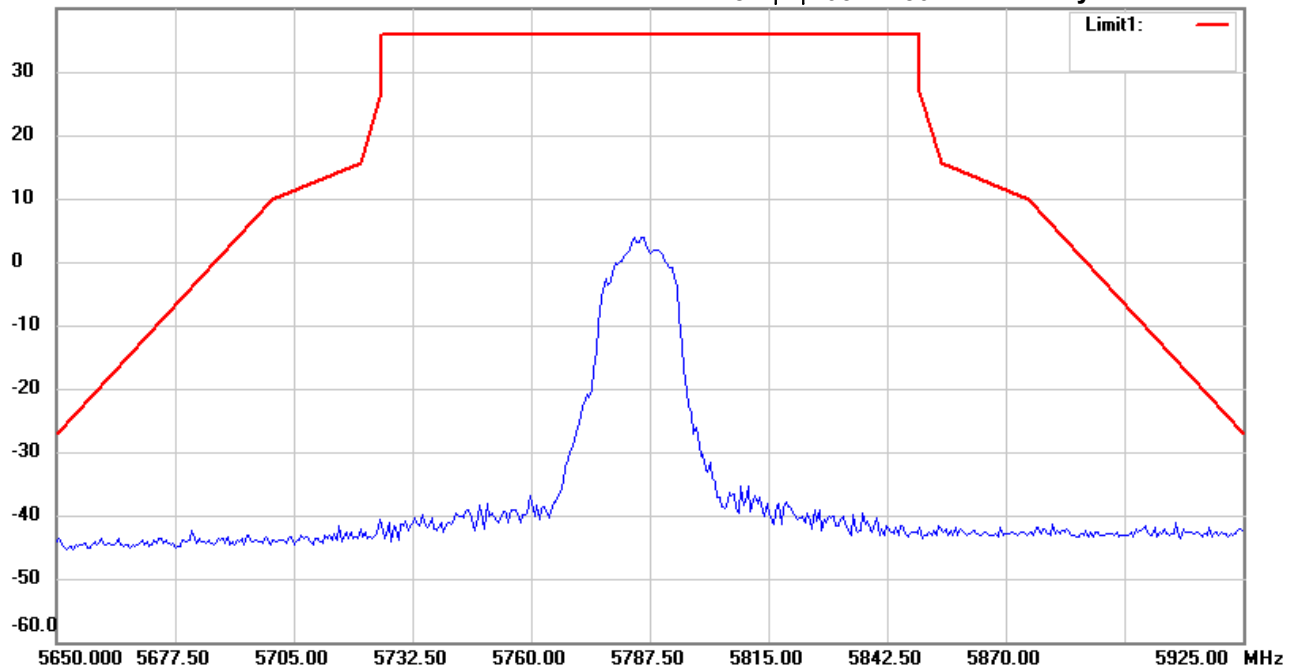
Condition : FCC\_5G Band4 Mask

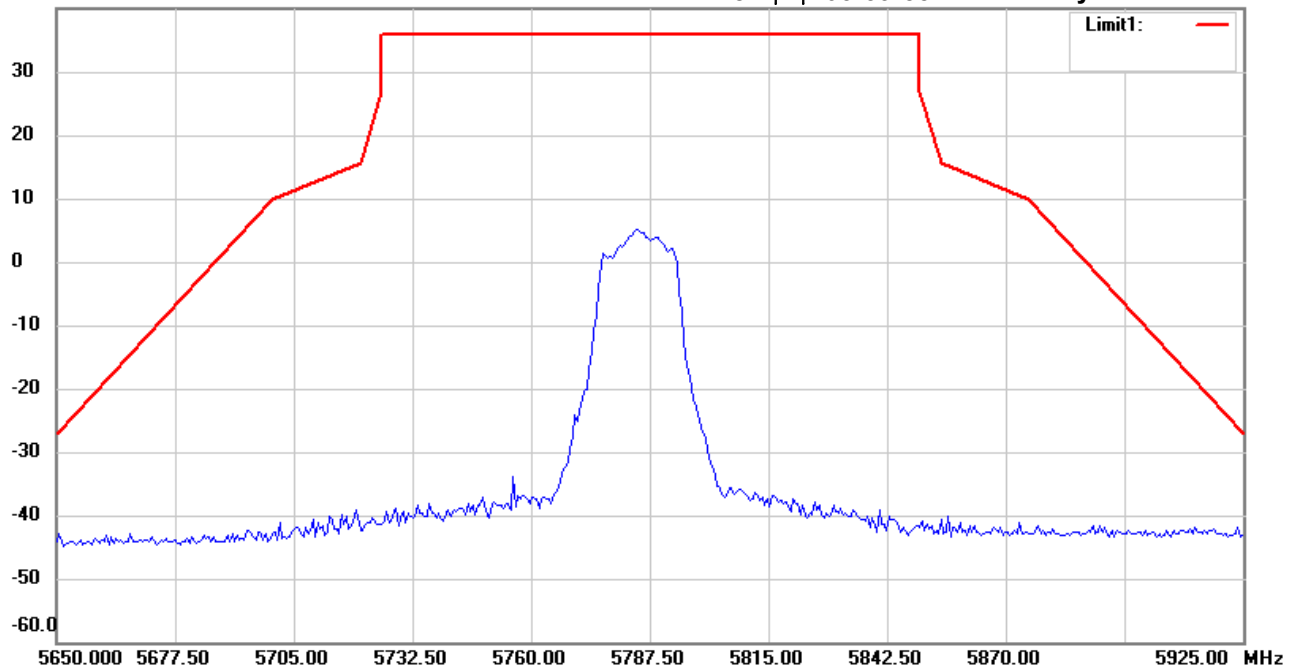
Condition : FCC\_5G Band4 Mask

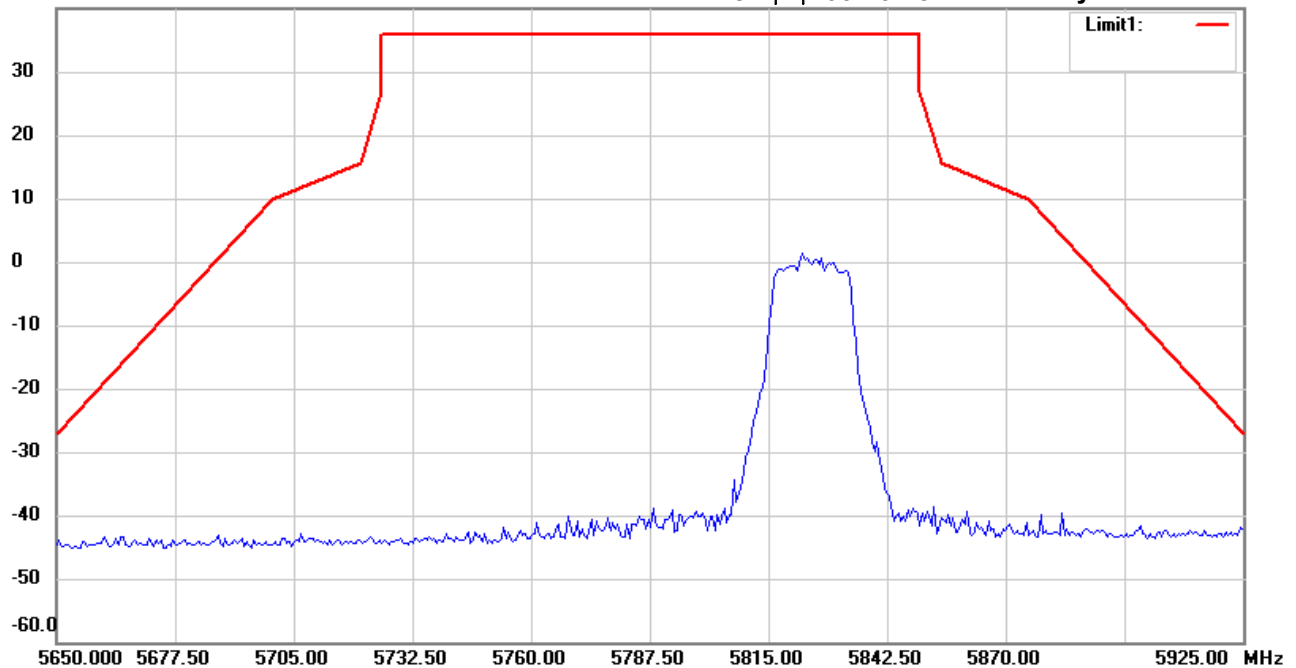
Condition : FCC\_5G Band4 Mask

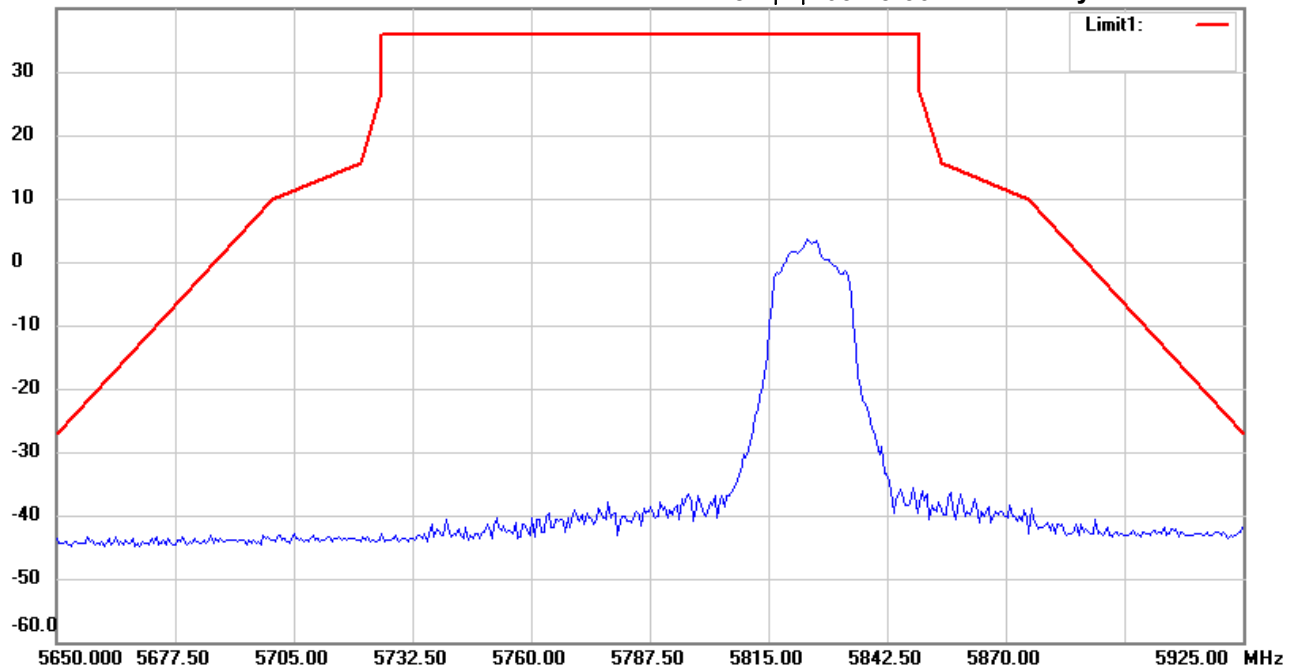
Condition : FCC\_5G Band4 Mask

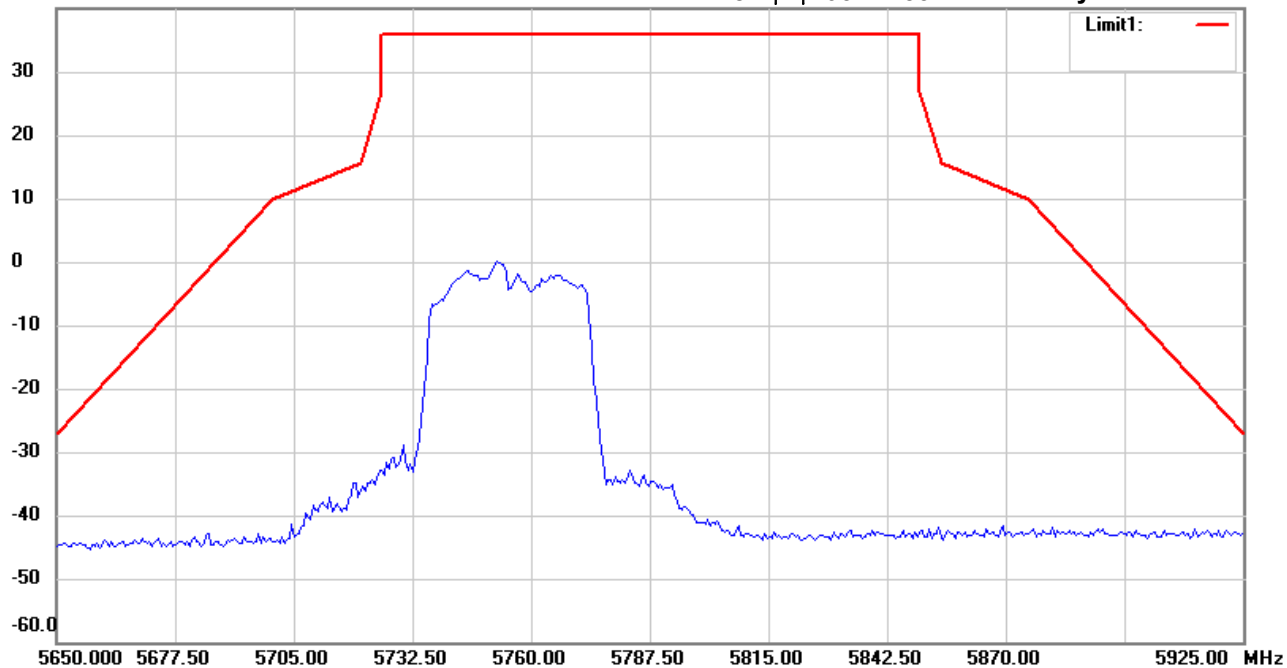
Condition : FCC\_5G Band4 Mask

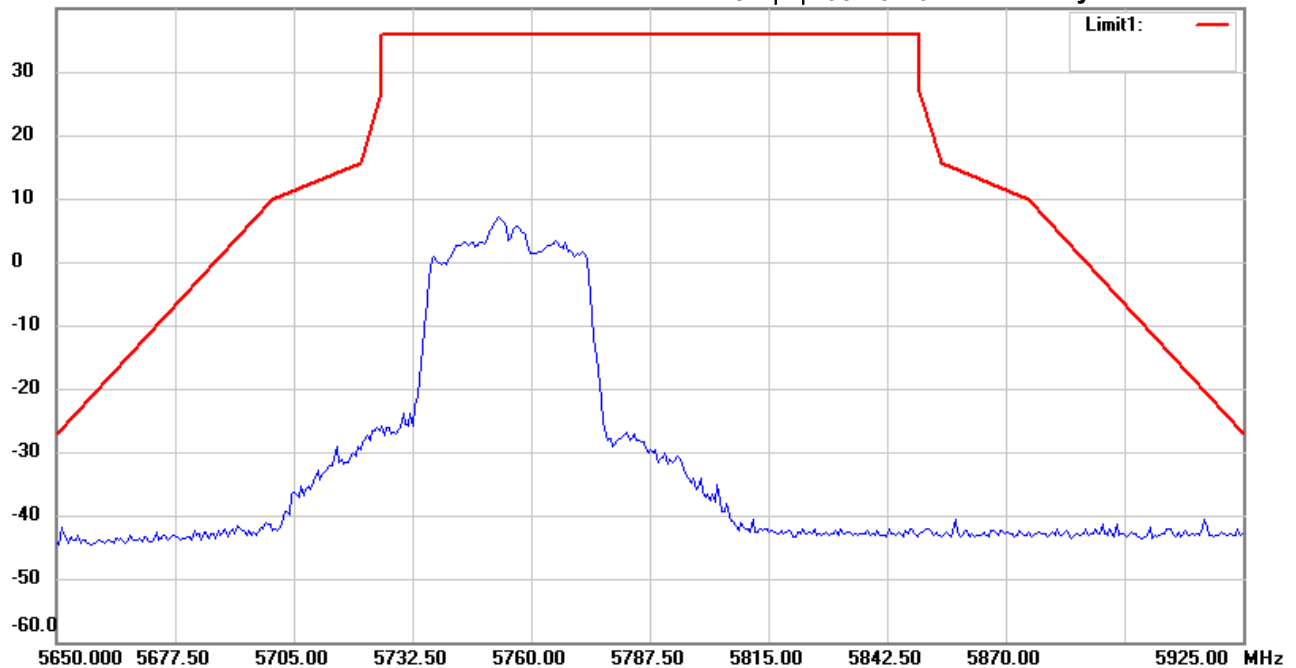
Condition : FCC\_5G Band4 Mask

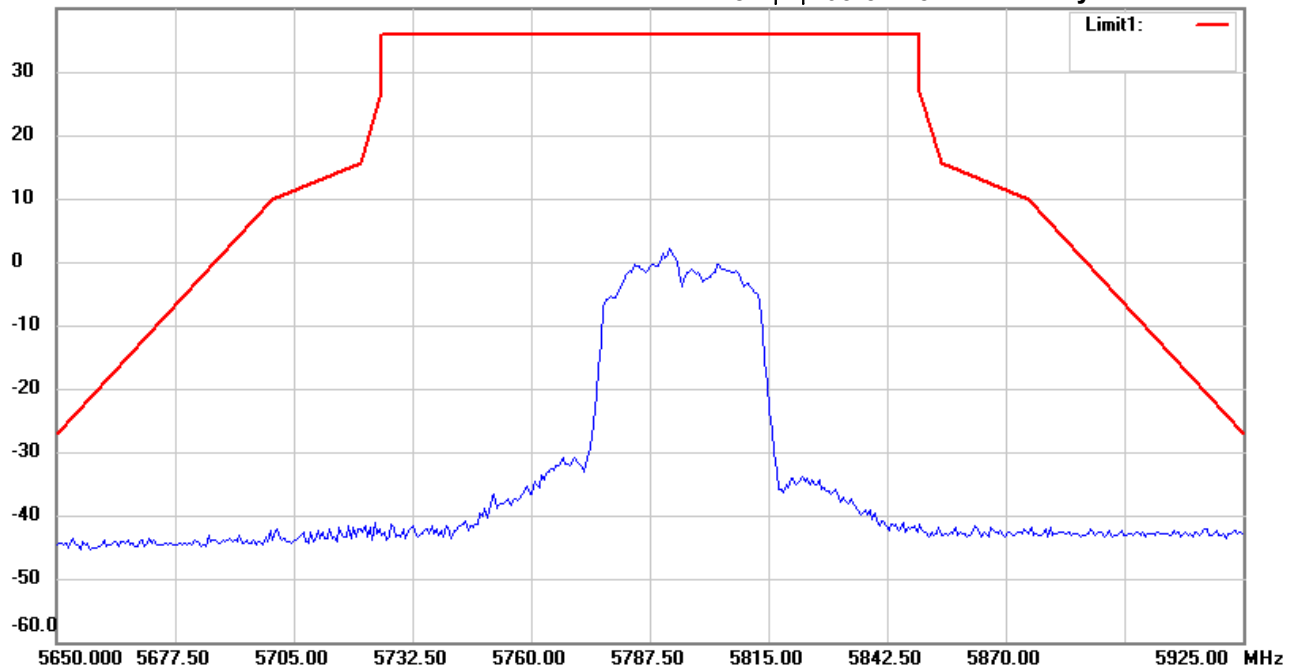
Condition : FCC\_5G Band4 Mask

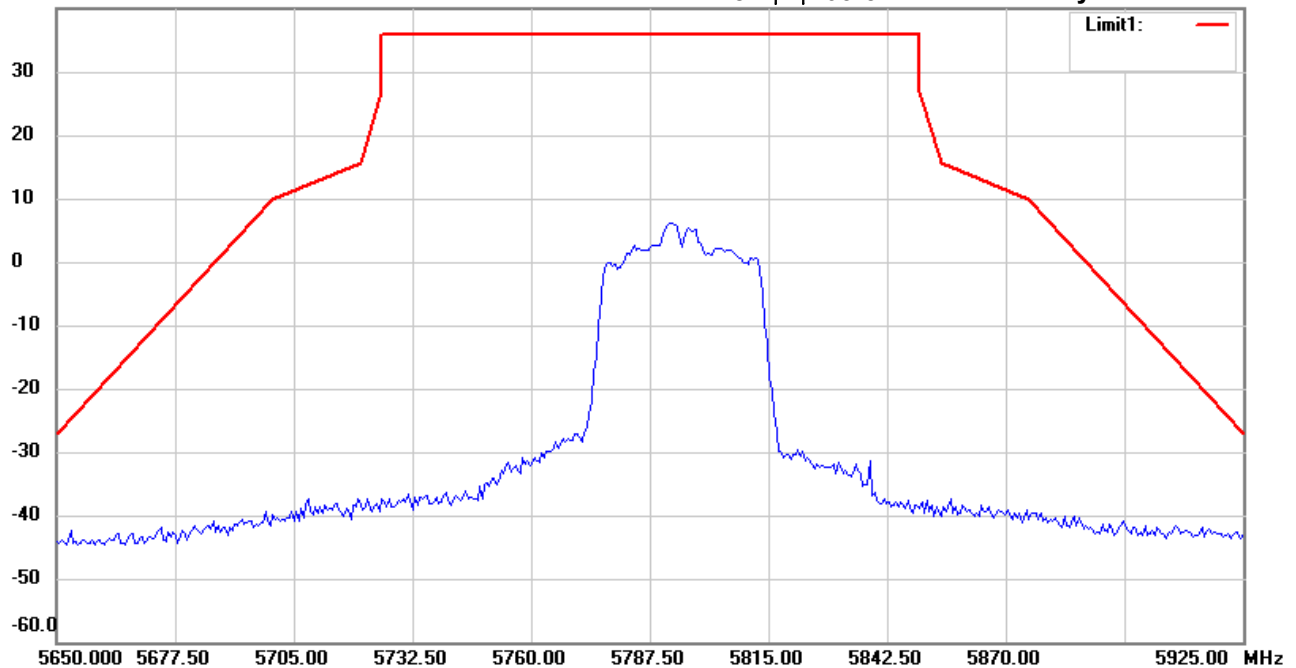
Condition : FCC\_5G Band4 Mask

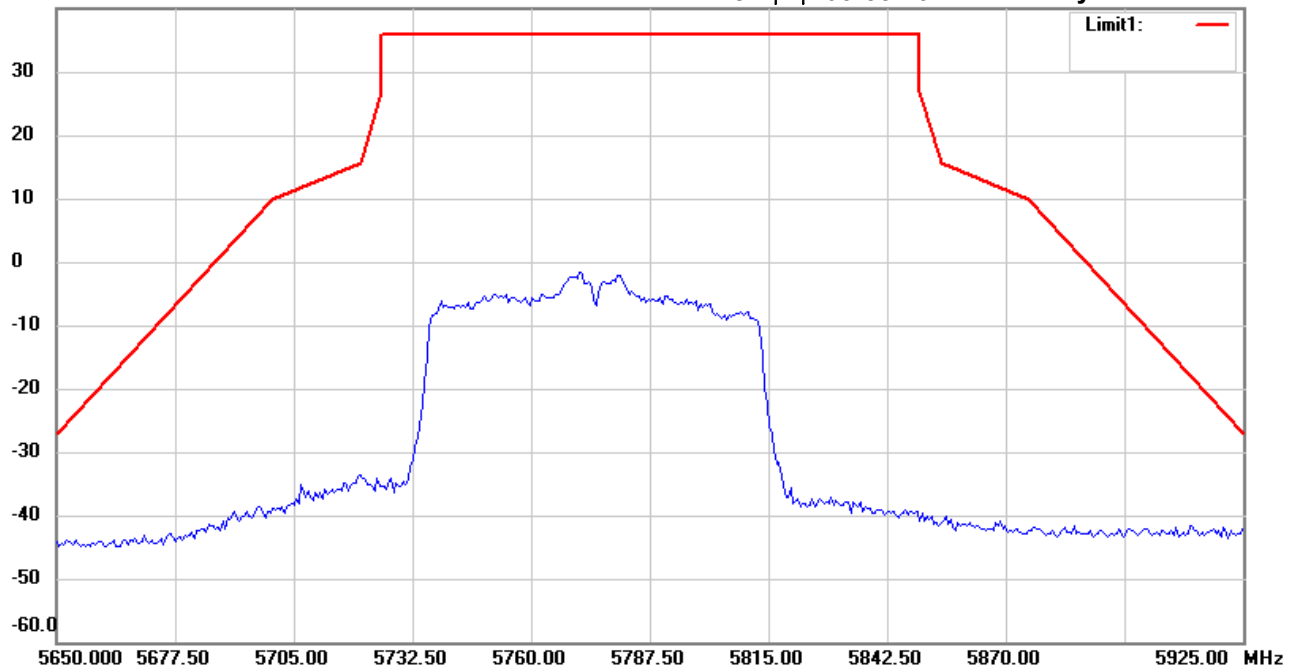
Condition : FCC\_5G Band4 Mask
