# Radiated Emission Measurement

Condition : FCC\_part 15E RE\_Above 1GHz\_PK

EUT : W6M21906-19108

Test Mode : TX 802.11n40 CH159

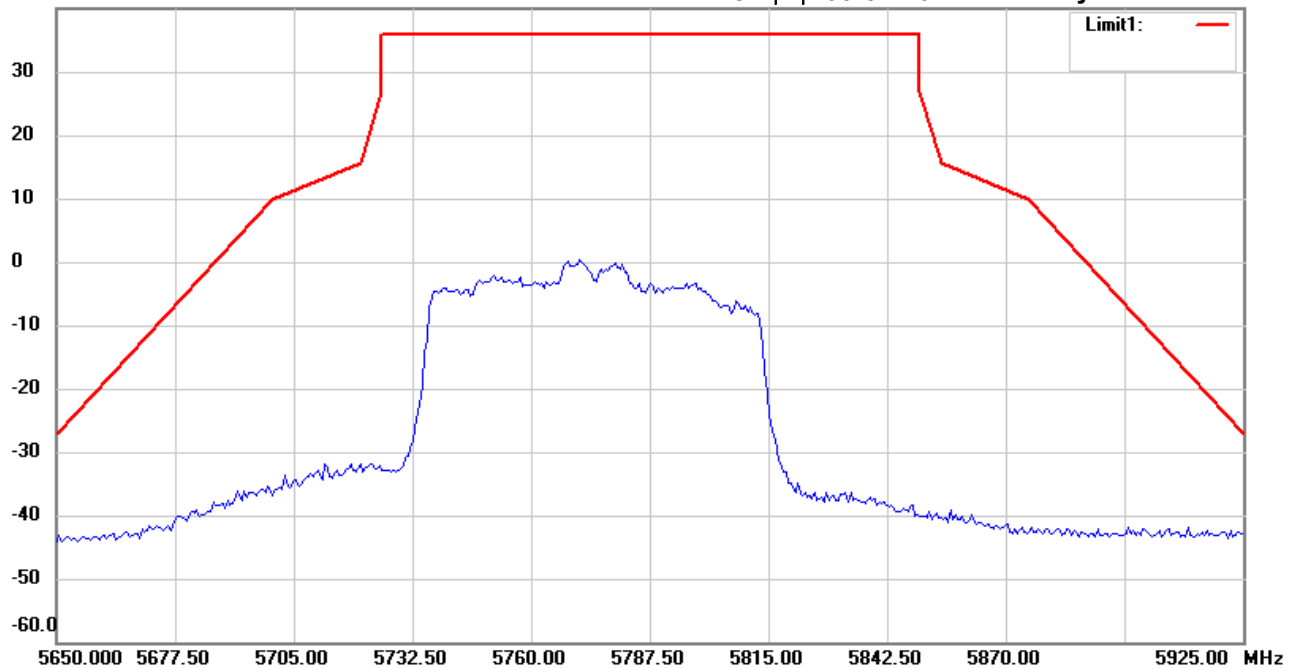
Condition : FCC\_5G Band4 Mask
