Radiated Emission Measurement

Condition : FCC\_part 15E RE\_Above 1GHz\_PK

EUT : W6M22409-23739

Test Mode : TX 802.11a CH93

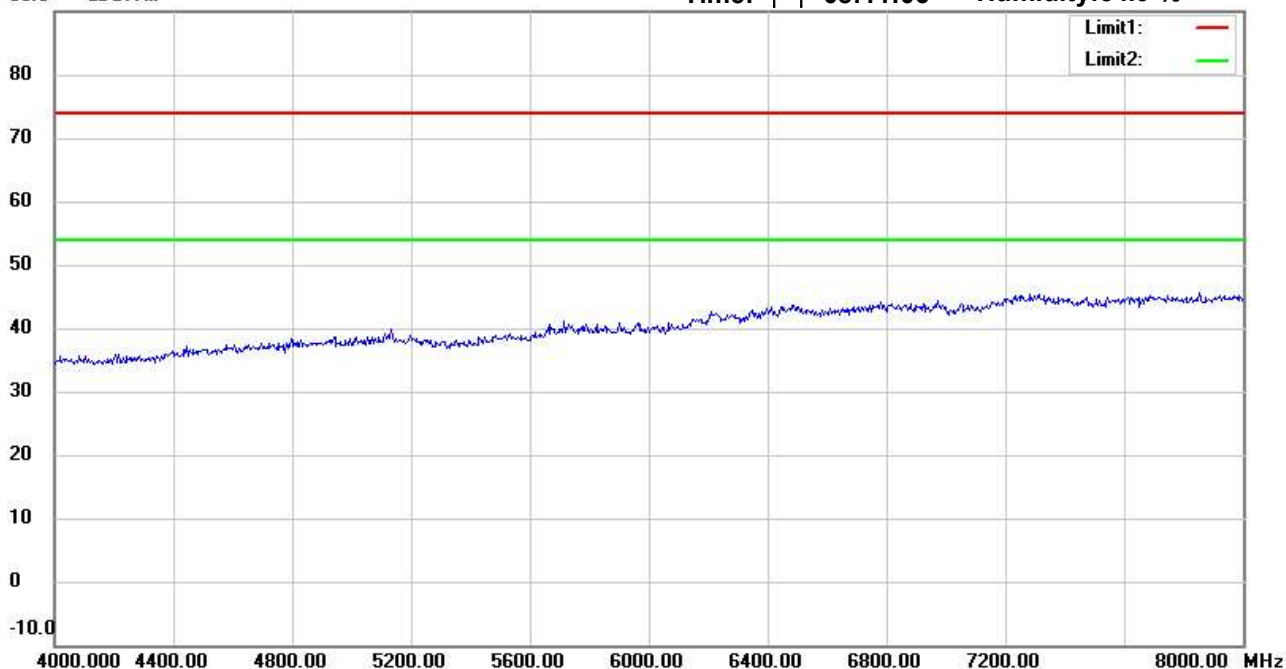
Site : 966A Chamber

Polarization: **Horizontal**

Distance: 3m

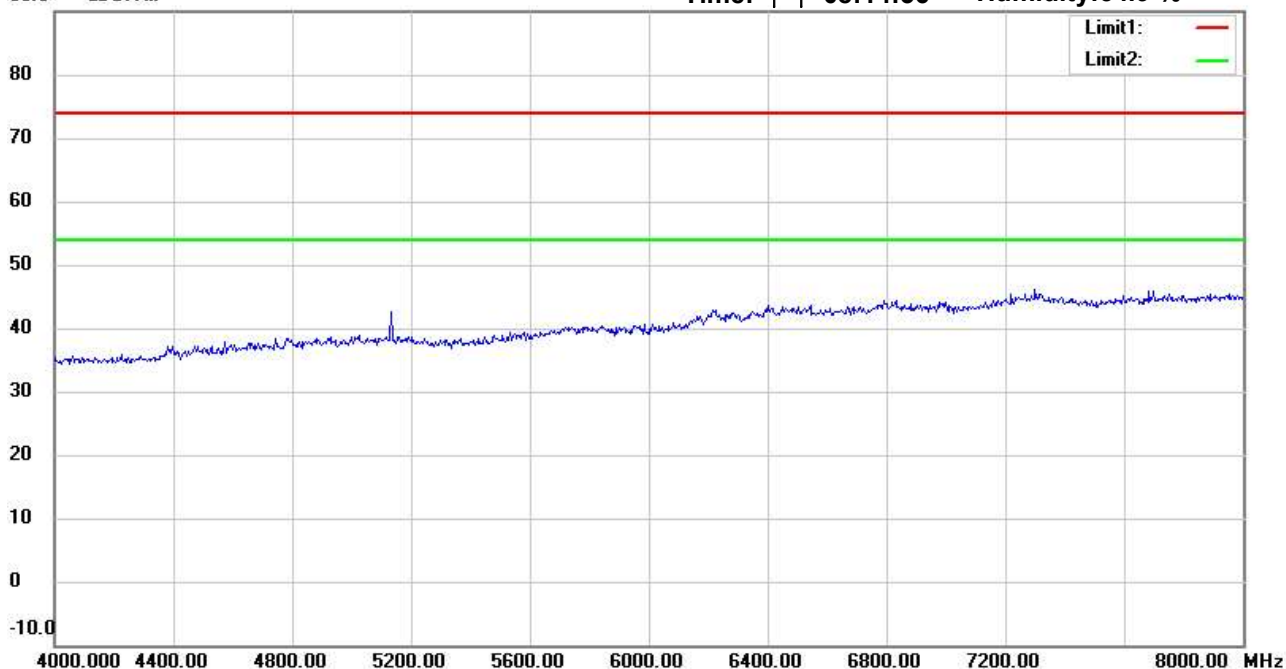
Site : 966A Chamber

Condition : FCC\_part 15E RE\_Above 1GHz\_PK

Test Mode : TX 802.11a CH93

Polarization: **Vertical**

Distance: 3m

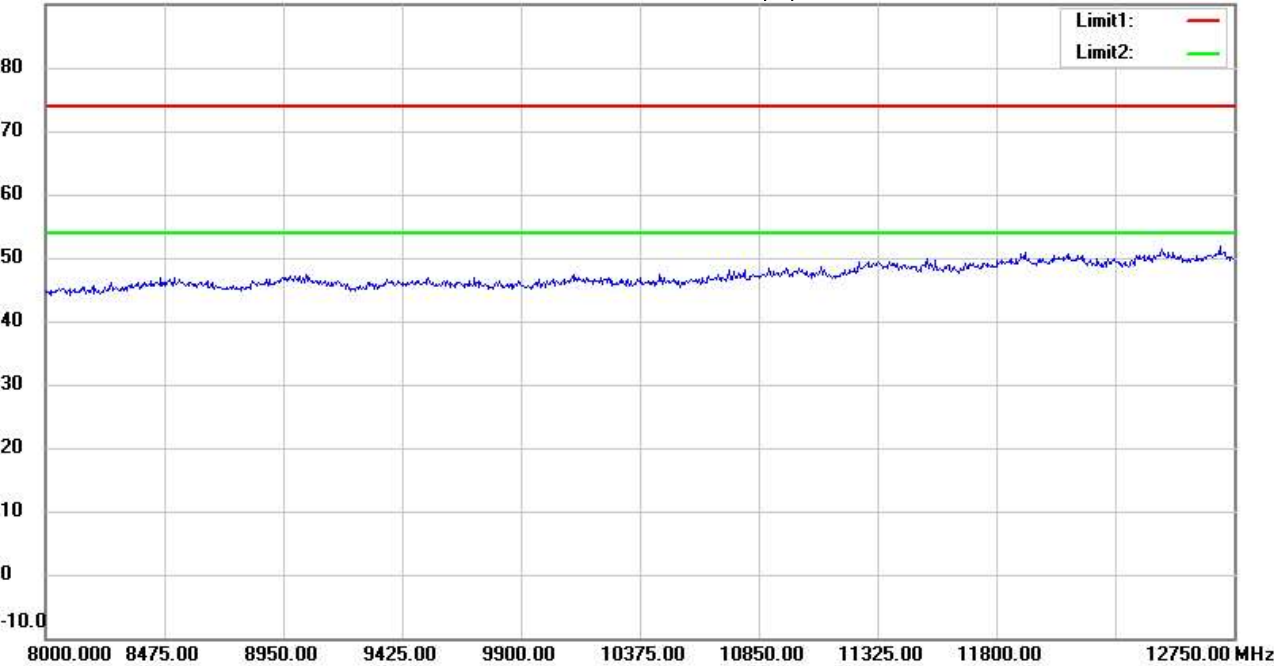
Site : 966A Chamber  
Condition : FCC\_part 15E RE\_Above 1GHz\_PK  
EUT : W6M22409-23739  
M/N:  
Test Mode : TX 802.11a CH93  
Note :

Polarization: **Horizontal**  
Power : 120 V.a.c.  
Distance: 3m

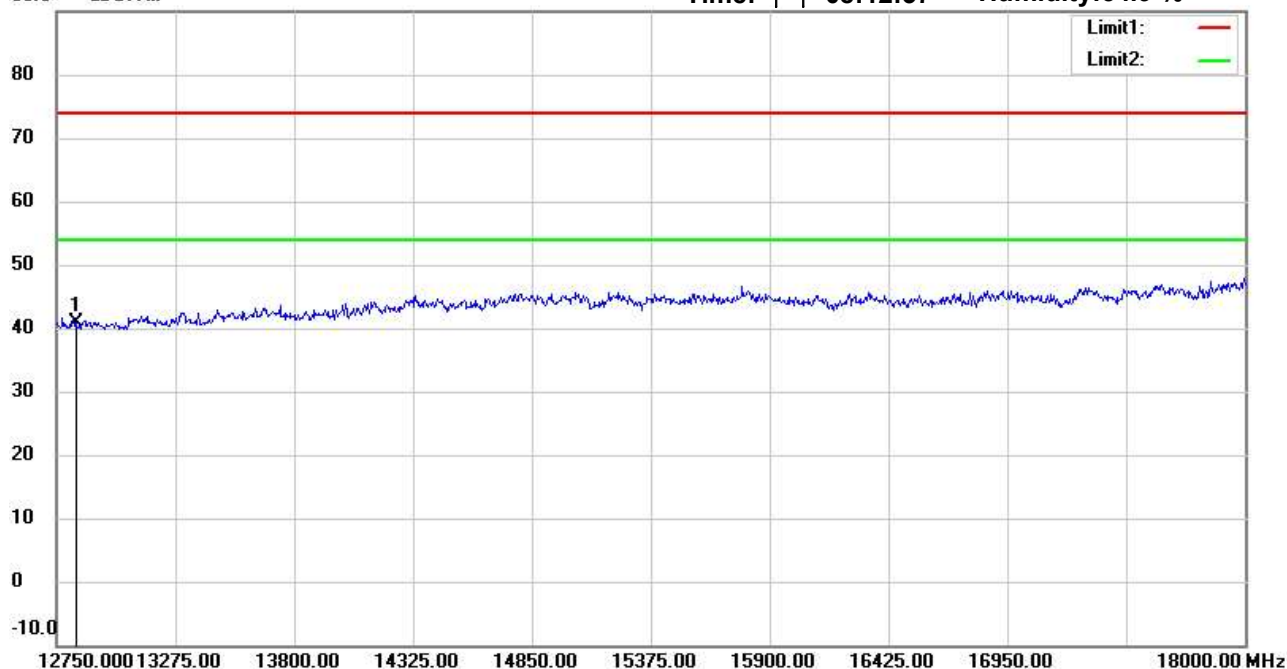
Data : #4

Condition : FCC\_part 15E RE\_Above 1GHz\_PK

Test Mode : TX 802.11a CH93

Polarization: **Horizontal**

| Mk. | Frequency (MHz) | Reading (dBuV) | Detector | Corr. factor (dB/m) | Result (dBuV/m) | Limit (dBuV/m) | Ant.Pos (cm) | Tab.Pos (deg.) | Margin (dB) | Comment |
|---|---|---|---|---|---|---|---|---|---|---|
| * | 12830.000 | 23.86 | peak | 17.09 | 40.95 | 74.00 | 150 | 289 | -33.05 | |

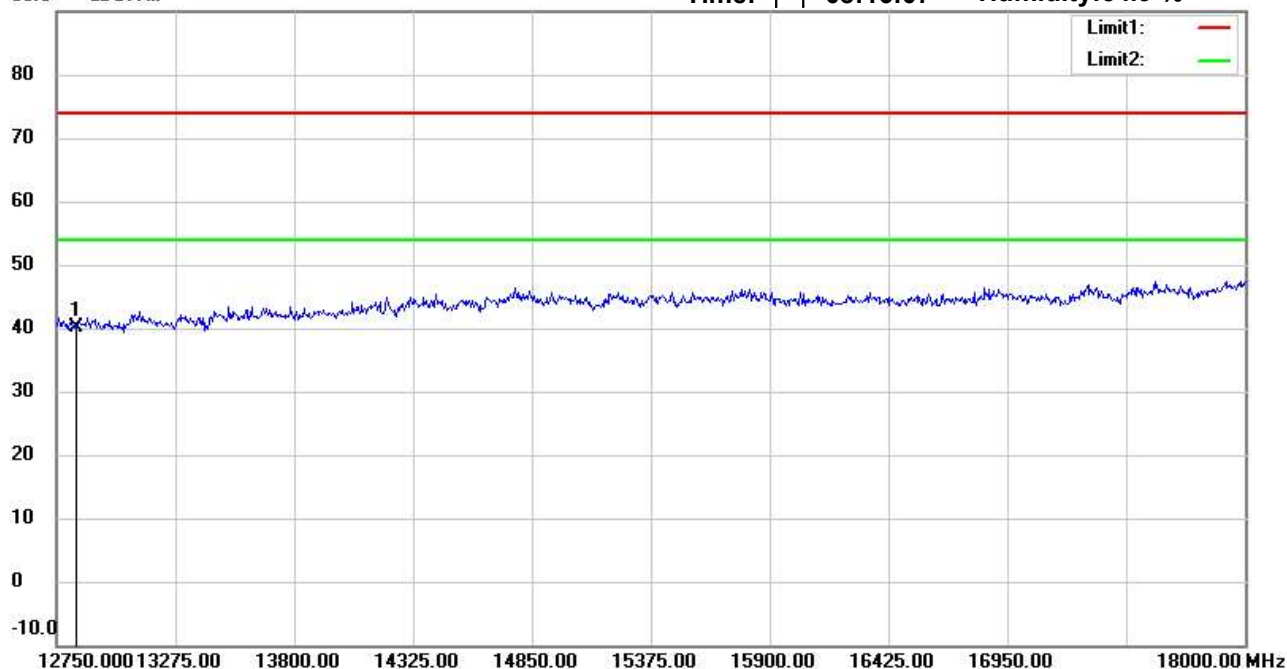
Data : #10

Condition : FCC\_part 15E RE\_Above 1GHz\_PK

Test Mode : TX 802.11a CH93

Polarization: Vertical

| Mk. | Frequency (MHz) | Reading (dBuV) | Detector | Corr. factor (dB/m) | Result (dBuV/m) | Limit (dBuV/m) | Ant.Pos (cm) | Tab.Pos (deg.) | Margin (dB) | Comment |
|---|---|---|---|---|---|---|---|---|---|---|
| * | 12830.000 | 22.96 | peak | 17.09 | 40.05 | 74.00 | 150 | 318 | -33.95 | |

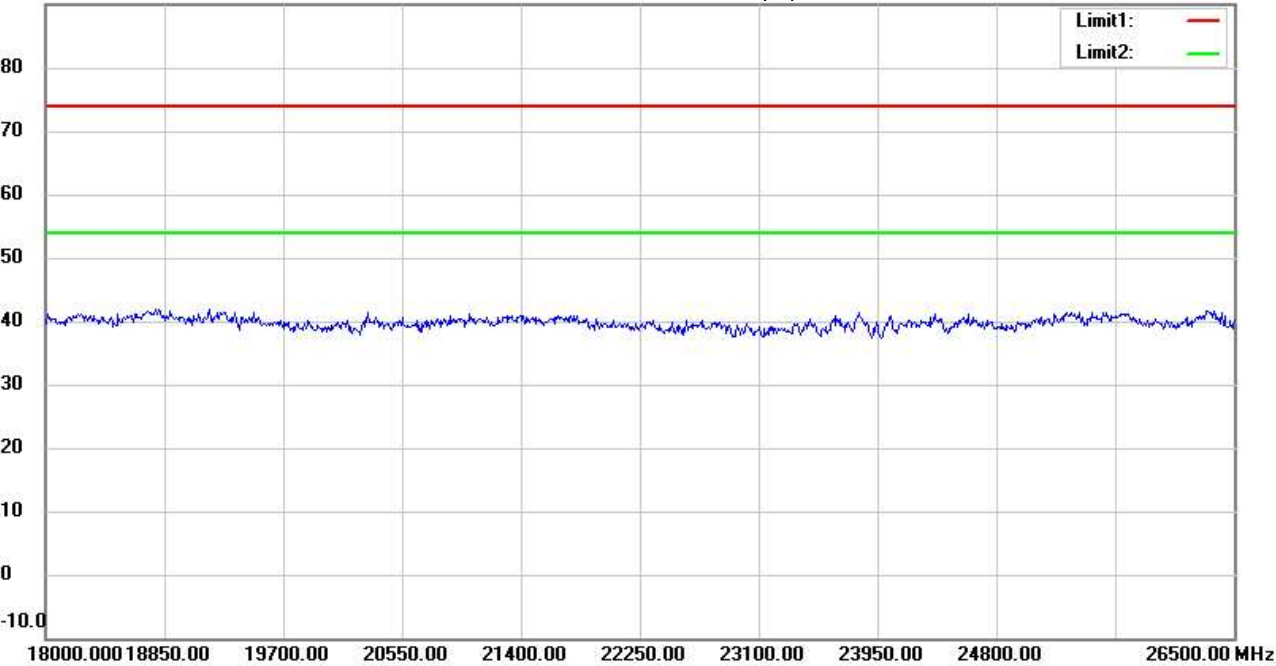
Site : 966A Chamber  
Condition : FCC\_part 15E RE\_Above 1GHz\_PK  
EUT : W6M22409-23739  
M/N:  
Test Mode : TX 802.11a CH93  
Note :

Polarization: *Horizontal*  
Power : 120 Va.c.  
Distance: 3m

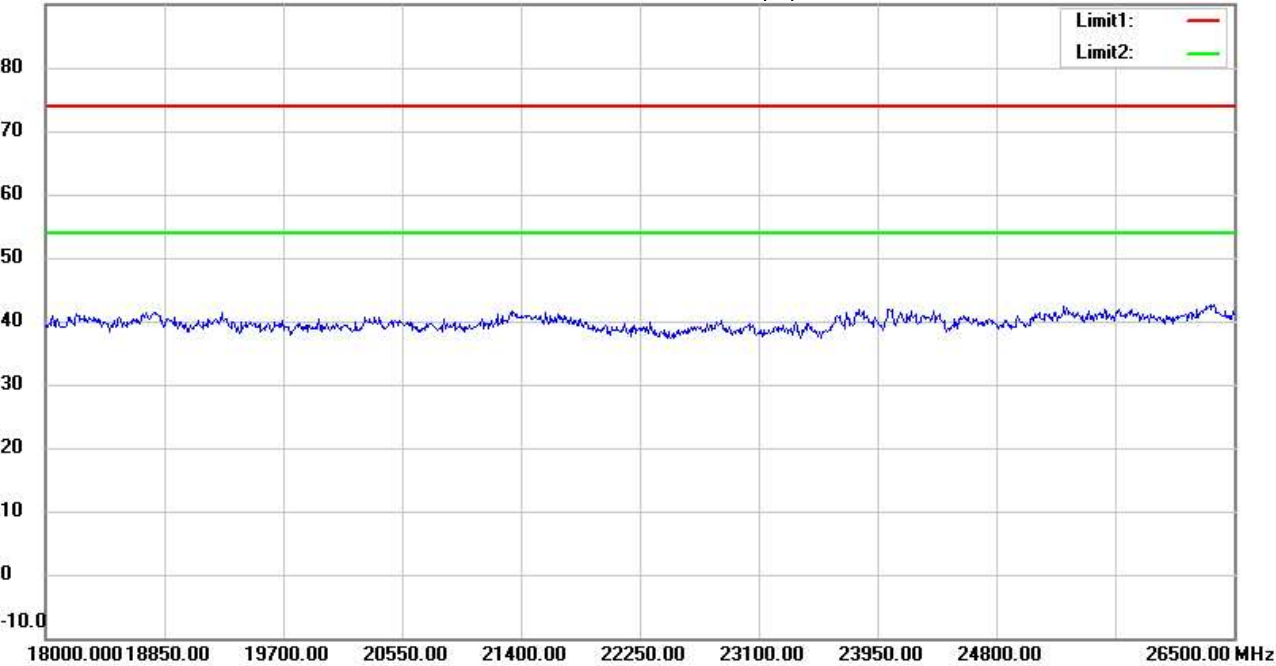
Site : 966A Chamber  
Condition : FCC\_part 15E RE\_Above 1GHz\_PK  
EUT : W6M22409-23739  
M/N:  
Test Mode : TX 802.11a CH93  
Note :

Polarization: Vertical  
Power : 120 Va.c.  
Distance: 3m

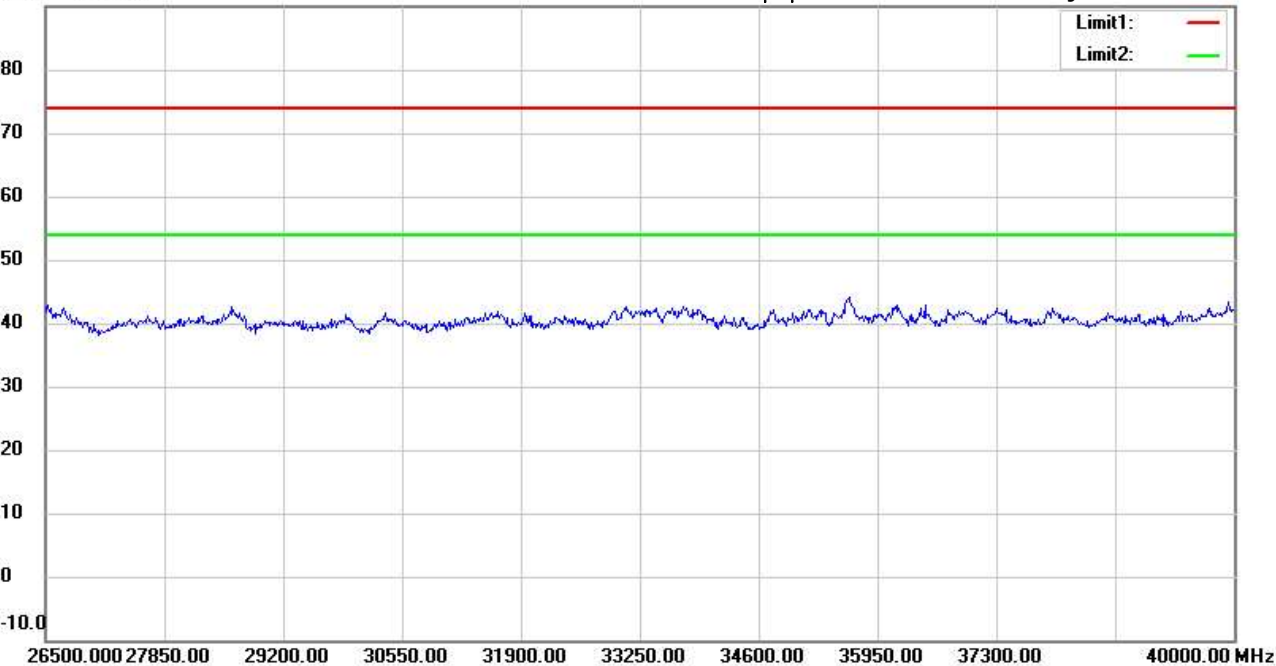
Site : 966A Chamber

Condition : FCC\_part 15E RE\_Above 1GHz\_PK

Test Mode : TX 802.11a CH93

Polarization: **Horizontal**

Distance: 3m

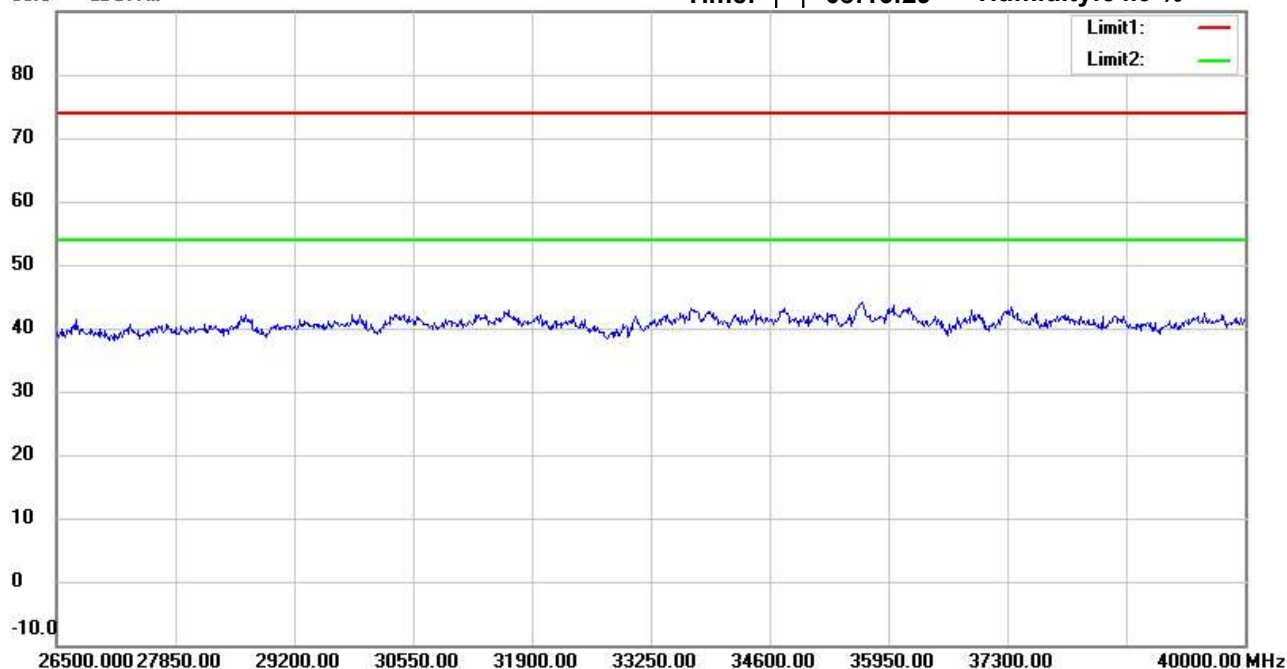
Site : 966A Chamber

Condition : FCC\_part 15E RE\_Above 1GHz\_PK

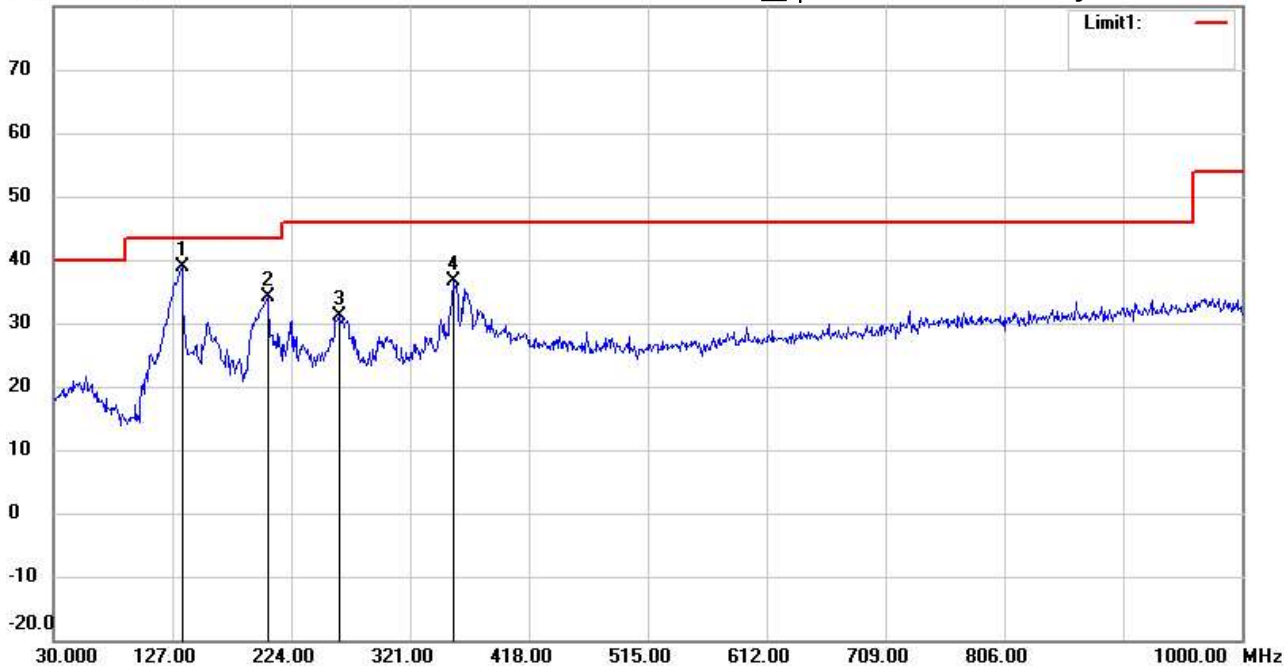
Data :#1

Condition : FCC\_part 15 RE-Class C\_30-1000MHz

Test Mode : TX 802.11a CH1

Polarization: **Horizontal**

| Mk. | Frequency (MHz) | Reading (dBuV) | Detector | Corr. factor (dB/m) | Result (dBuV/m) | Limit (dBuV/m) | Ant.Pos (cm) | Tab.Pos (deg.) | Margin (dB) | Comment |
|---|---|---|---|---|---|---|---|---|---|---|
| * | 134.7600 | 52.26 | peak | -13.33 | 38.93 | 43.50 | 100 | 108 | -4.57 | |
| | 205.0850 | 50.05 | peak | -15.85 | 34.20 | 43.50 | 100 | 208 | -9.30 | |
| | 262.8000 | 44.35 | peak | -13.30 | 31.05 | 46.00 | 100 | 274 | -14.95 | |
| | 355.9200 | 47.61 | peak | -10.98 | 36.63 | 46.00 | 100 | 261 | -9.37 | |

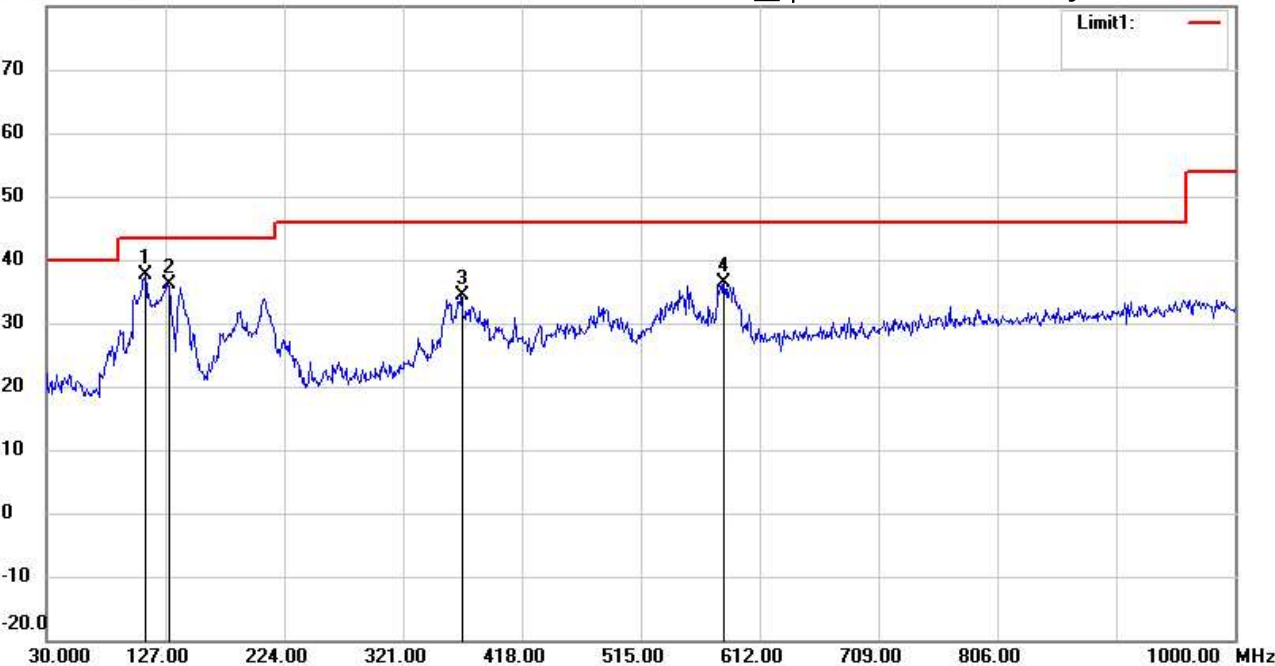
Data :#2

Condition : FCC\_part 15 RE-Class C\_30-1000MHz

Test Mode : TX 802.11a CH1

Polarization: Vertical

| Mk. | Frequency (MHz) | Reading (dBuV) | Detector | Corr. factor (dB/m) | Result (dBuV/m) | Limit (dBuV/m) | Ant.Pos (cm) | Tab.Pos (deg.) | Margin (dB) | Comment |
|---|---|---|---|---|---|---|---|---|---|---|
| * | 110.5100 | 53.14 | peak | -15.57 | 37.57 | 43.50 | 100 | 143 | -5.93 | |
| | 129.4250 | 49.92 | peak | -13.83 | 36.09 | 43.50 | 100 | 237 | -7.41 | |
| | 369.0150 | 45.04 | peak | -10.54 | 34.50 | 46.00 | 100 | 191 | -11.50 | |
| | 582.9000 | 41.87 | peak | -5.59 | 36.28 | 46.00 | 100 | 177 | -9.72 | |

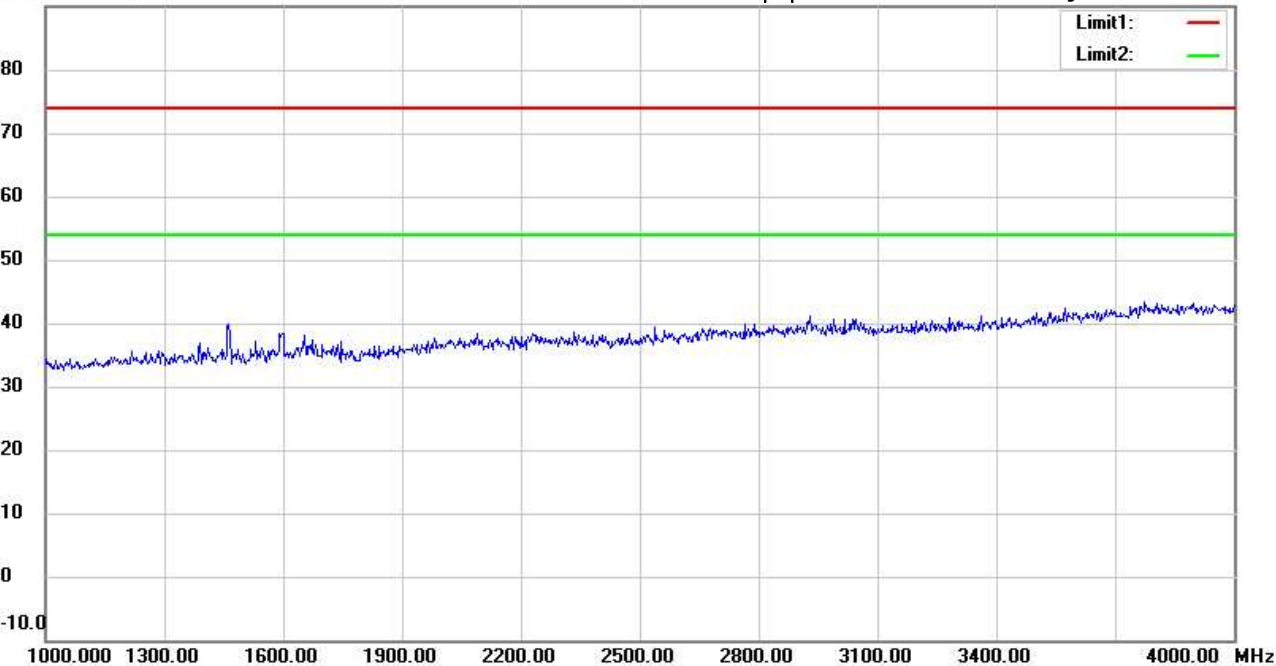
Site : 966A Chamber

Condition : FCC\_part 15E RE\_Above 1GHz\_PK

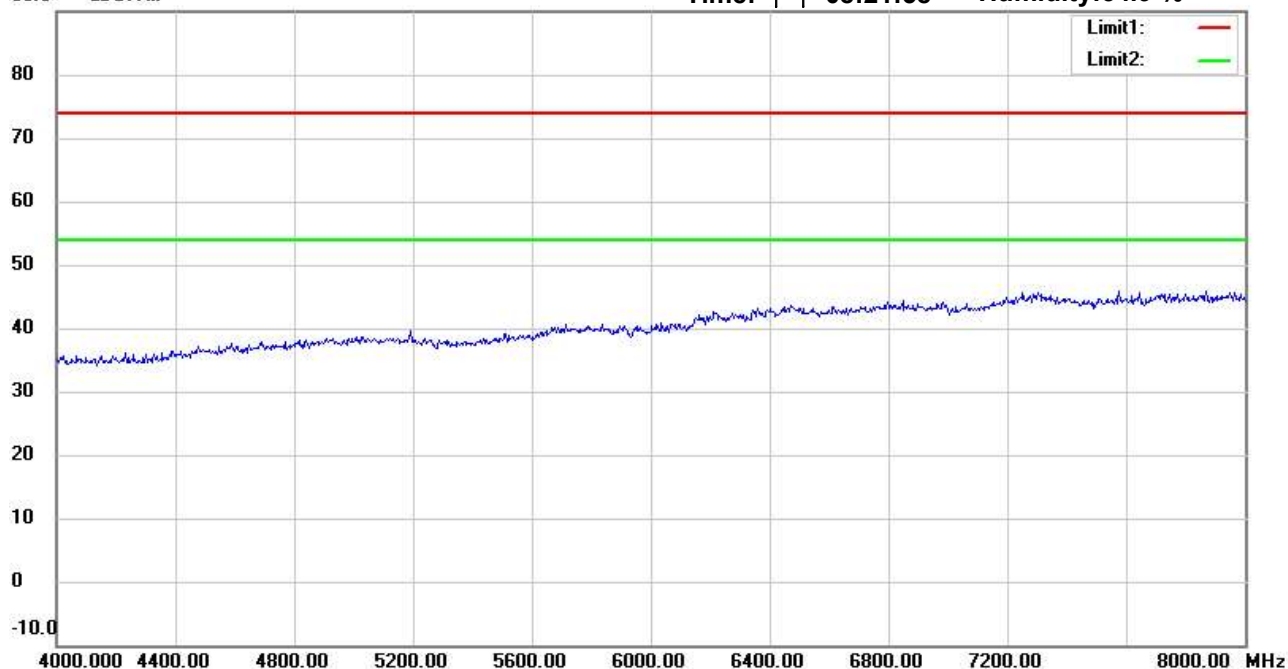
Site : 966A Chamber

Condition : FCC\_part 15E RE\_Above 1GHz\_PK

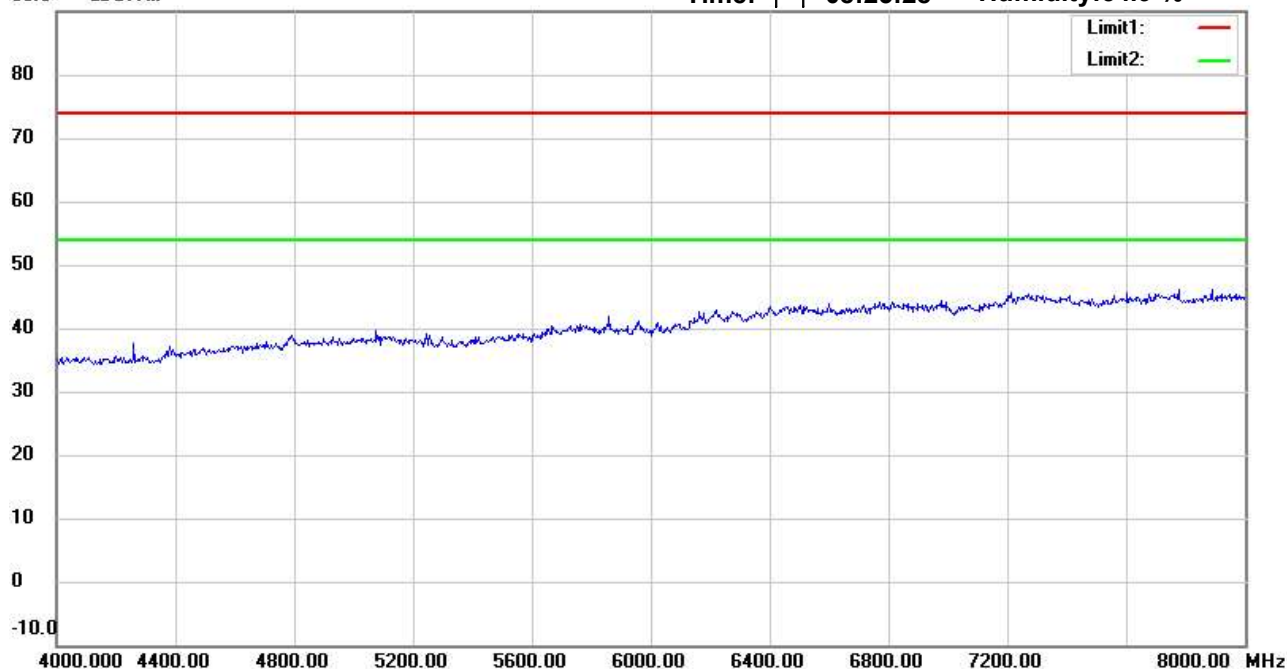
Site : 966A Chamber

Condition : FCC\_part 15E RE\_Above 1GHz\_PK

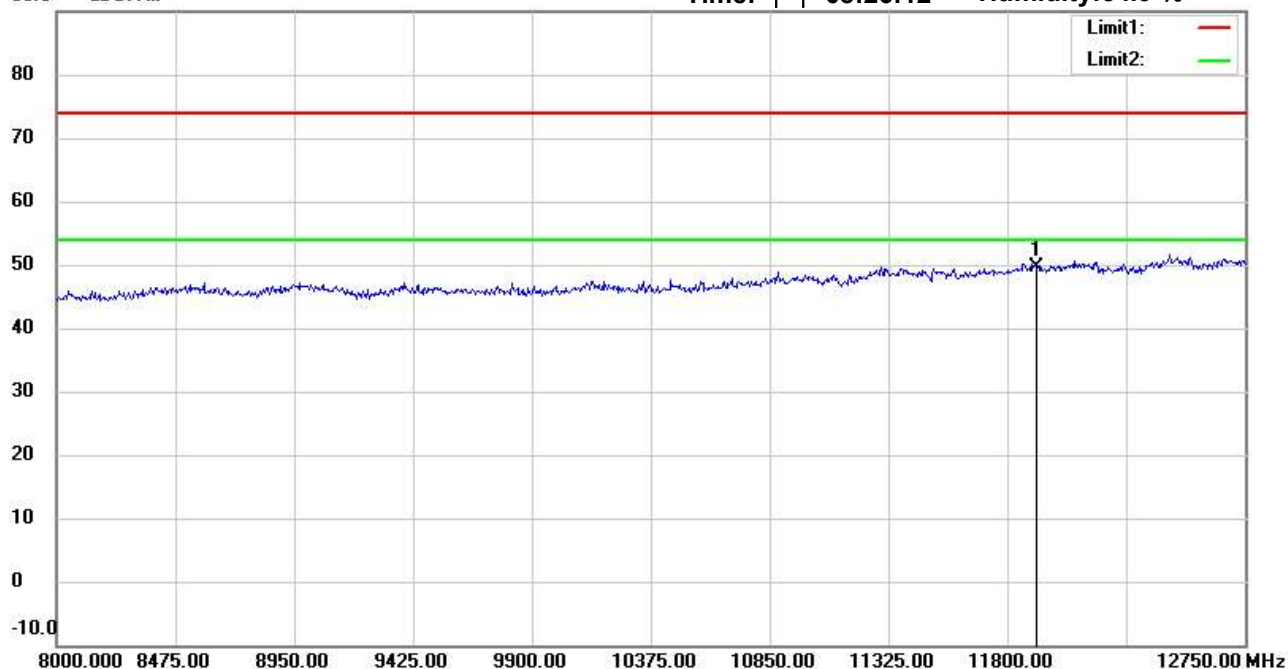
Data : #9

Condition : FCC\_part 15E RE\_Above 1GHz\_PK

Test Mode : TX 802.11a CH1

Polarization: Vertical

| Mk. | Frequency (MHz) | Reading (dBuV) | Detector | Corr. factor (dB/m) | Result (dBuV/m) | Limit (dBuV/m) | Ant.Pos (cm) | Tab.Pos (deg.) | Margin (dB) | Comment |
|---|---|---|---|---|---|---|---|---|---|---|
| * | 11910.000 | 33.55 | peak | 16.09 | 49.64 | 74.00 | 150 | 189 | -24.36 | |

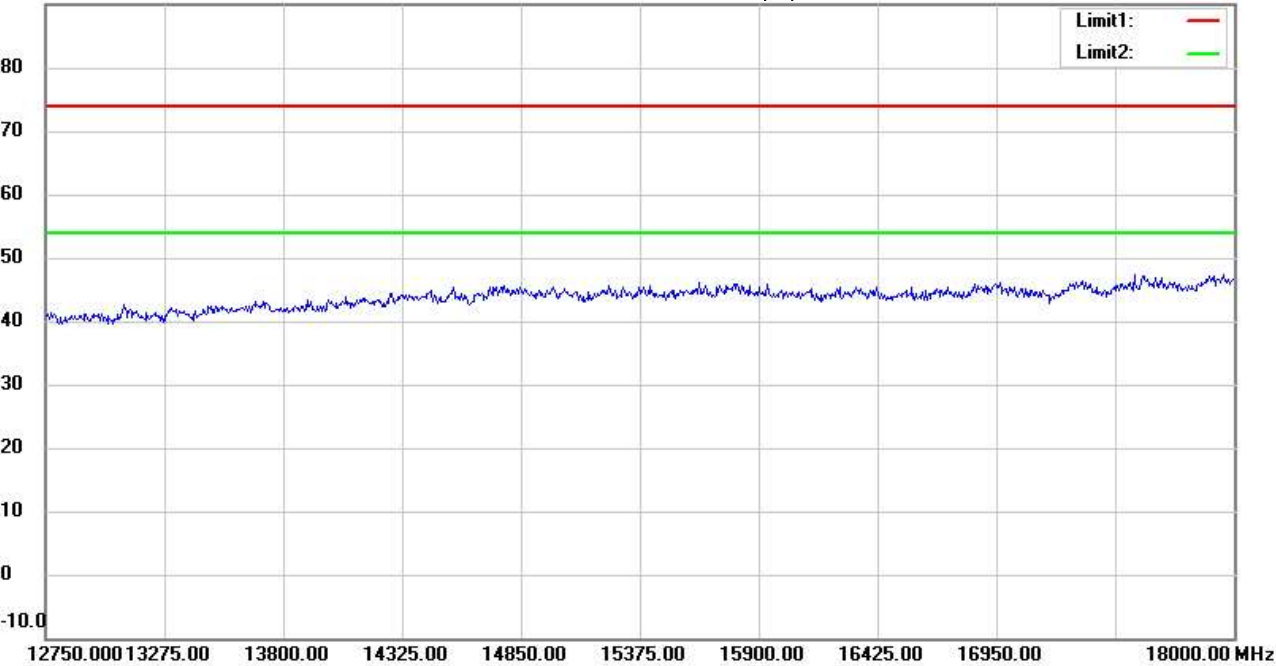
Site : 966A Chamber  
Condition : FCC\_part 15E RE\_Above 1GHz\_PK  
EUT : W6M22409-23739  
M/N:  
Test Mode : TX 802.11a CH1  
Note :

Polarization: Horizontal  
Power : 120 Va.c.  
Distance: 3m

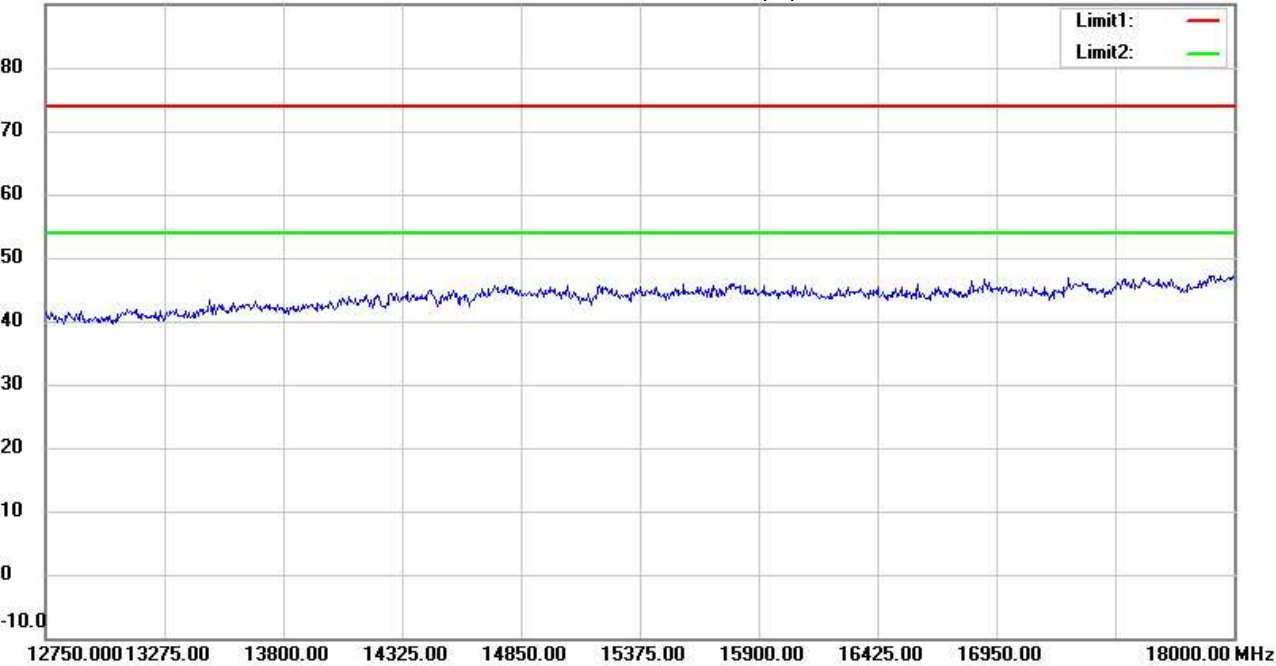
Site : 966A Chamber  
Condition : FCC\_part 15E RE\_Above 1GHz\_PK  
EUT : W6M22409-23739  
M/N:  
Test Mode : TX 802.11a CH1  
Note :

Polarization: Vertical  
Power : 120 Va.c.  
Distance: 3m

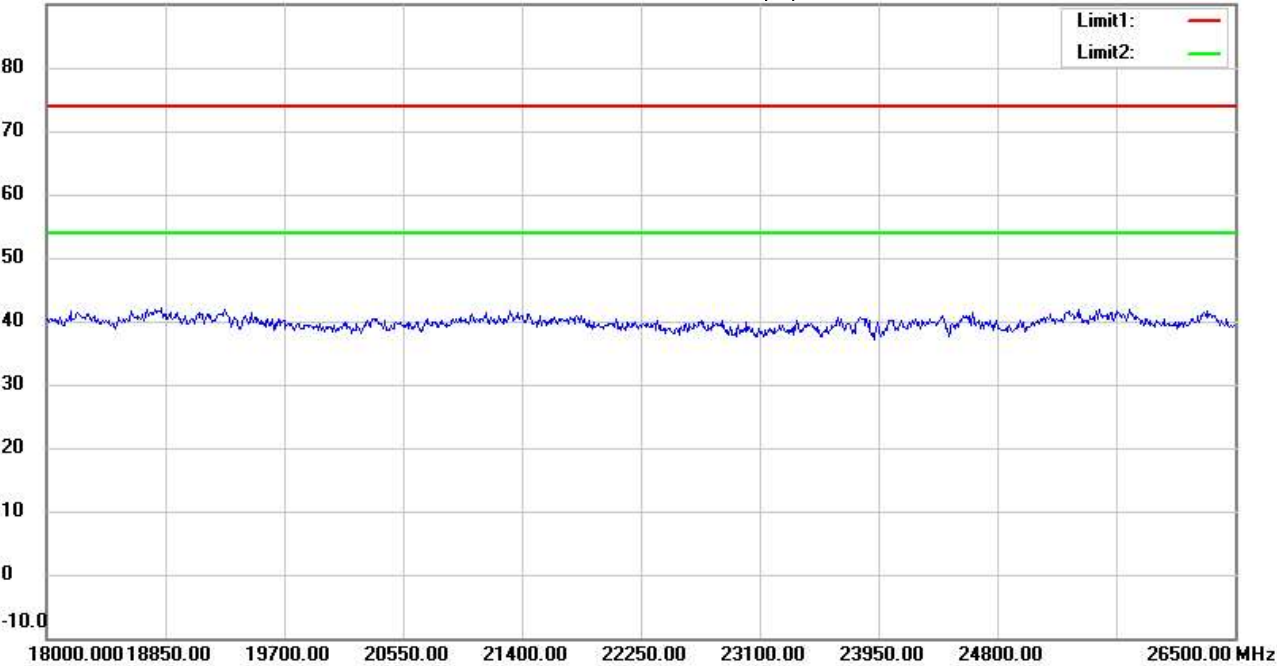
Site : 966A Chamber  
Condition : FCC\_part 15E RE\_Above 1GHz\_PK  
EUT : W6M22409-23739  
M/N:  
Test Mode : TX 802.11a CH1  
Note :

Polarization: *Horizontal*  
Power : 120 Va.c.  
Distance: 3m

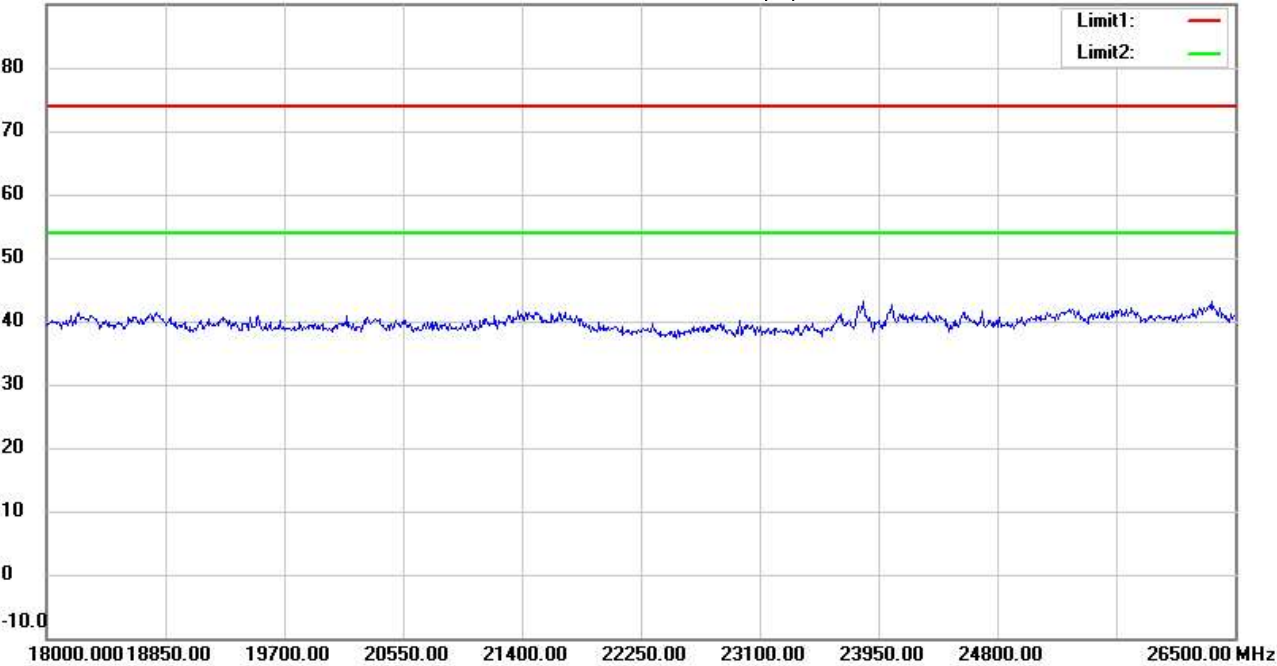
Site : 966A Chamber  
Condition : FCC\_part 15E RE\_Above 1GHz\_PK  
EUT : W6M22409-23739  
M/N:  
Test Mode : TX 802.11a CH1  
Note :

Polarization: Vertical  
Power : 120 Va.c.  
Distance: 3m

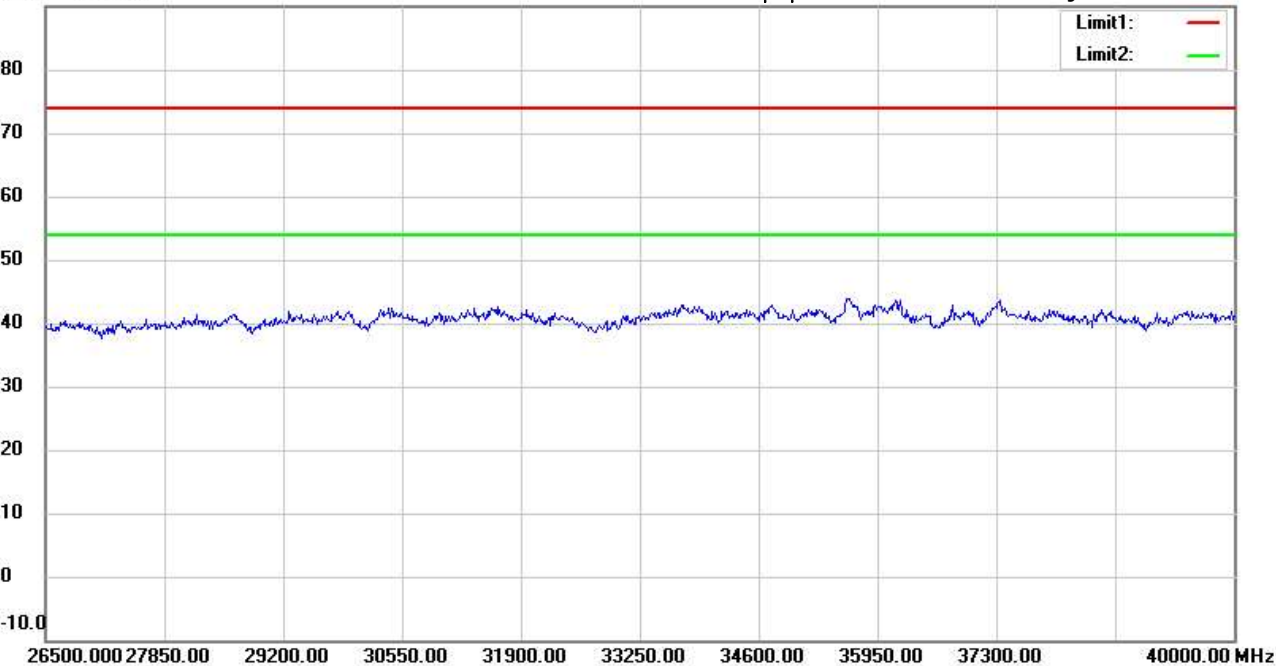
Site : 966A Chamber

Condition : FCC\_part 15E RE\_Above 1GHz\_PK

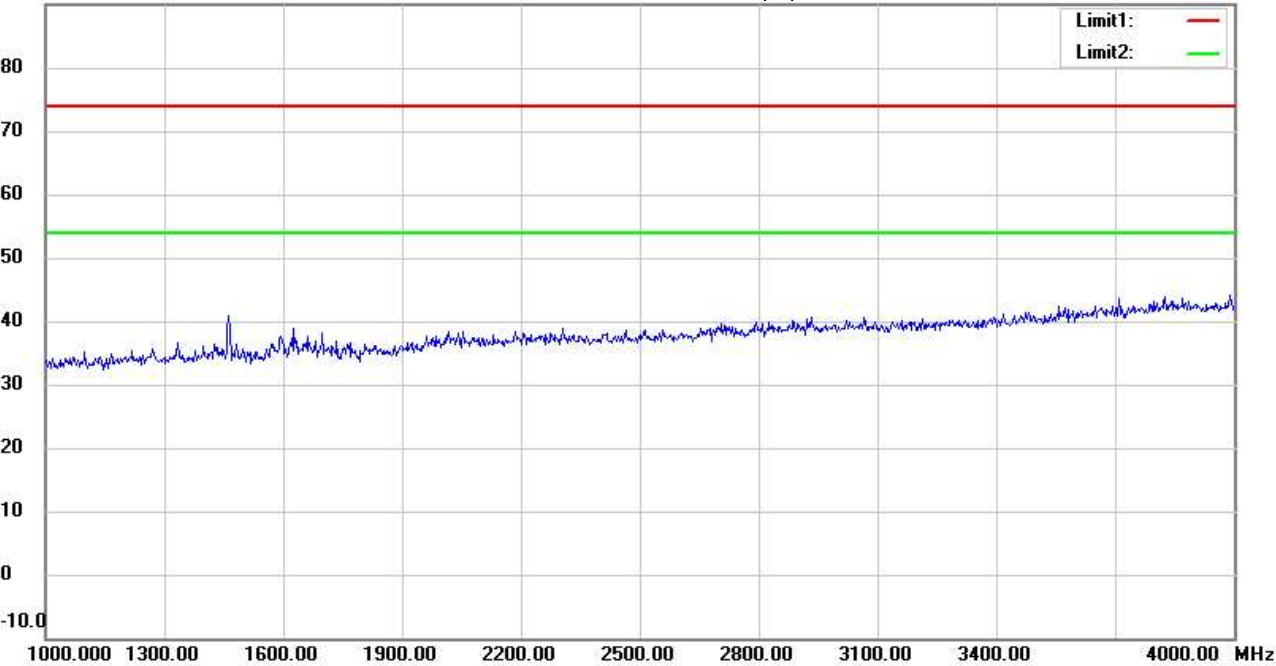
Site : 966A Chamber  
Condition : FCC\_part 15E RE\_Above 1GHz\_PK  
EUT : W6M22409-23739  
M/N:  
Test Mode : TX 802.11a CH45  
Note :

Polarization: Horizontal  
Power : 120 Va.c.  
Distance: 3m

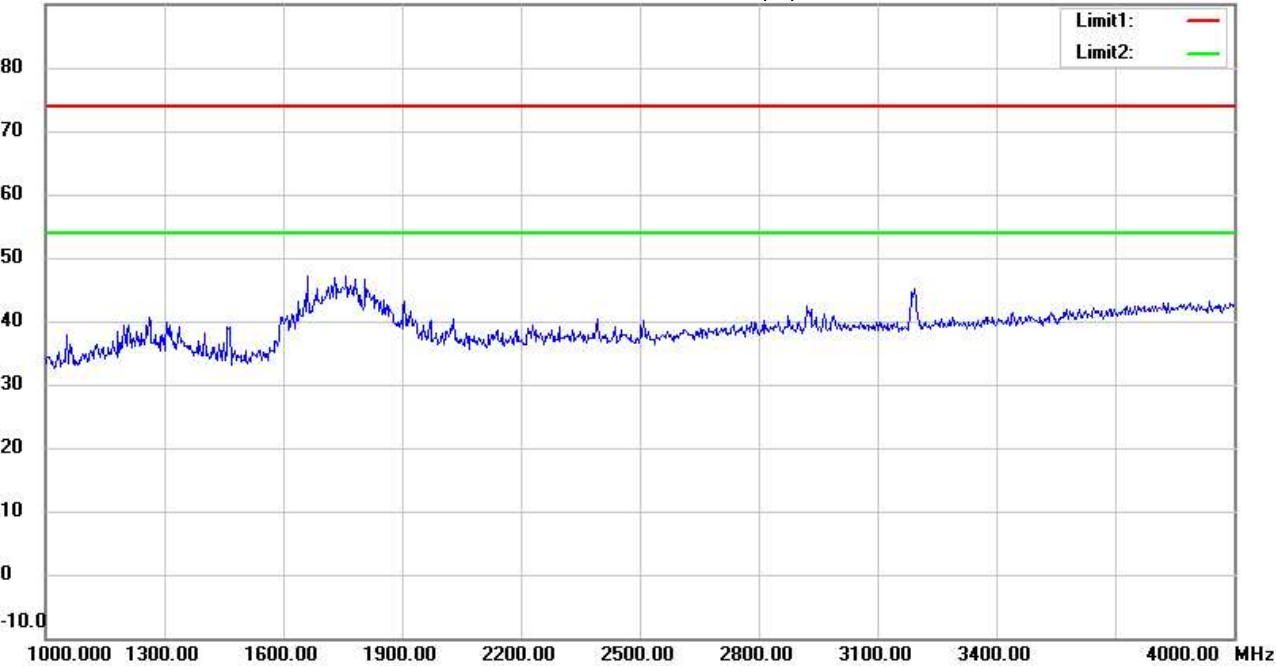
Site : 966A Chamber  
Condition : FCC\_part 15E RE\_Above 1GHz\_PK  
EUT : W6M22409-23739  
M/N:  
Test Mode : TX 802.11a CH45  
Note :

Polarization: Vertical  
Power : 120 Va.c.  
Distance: 3m

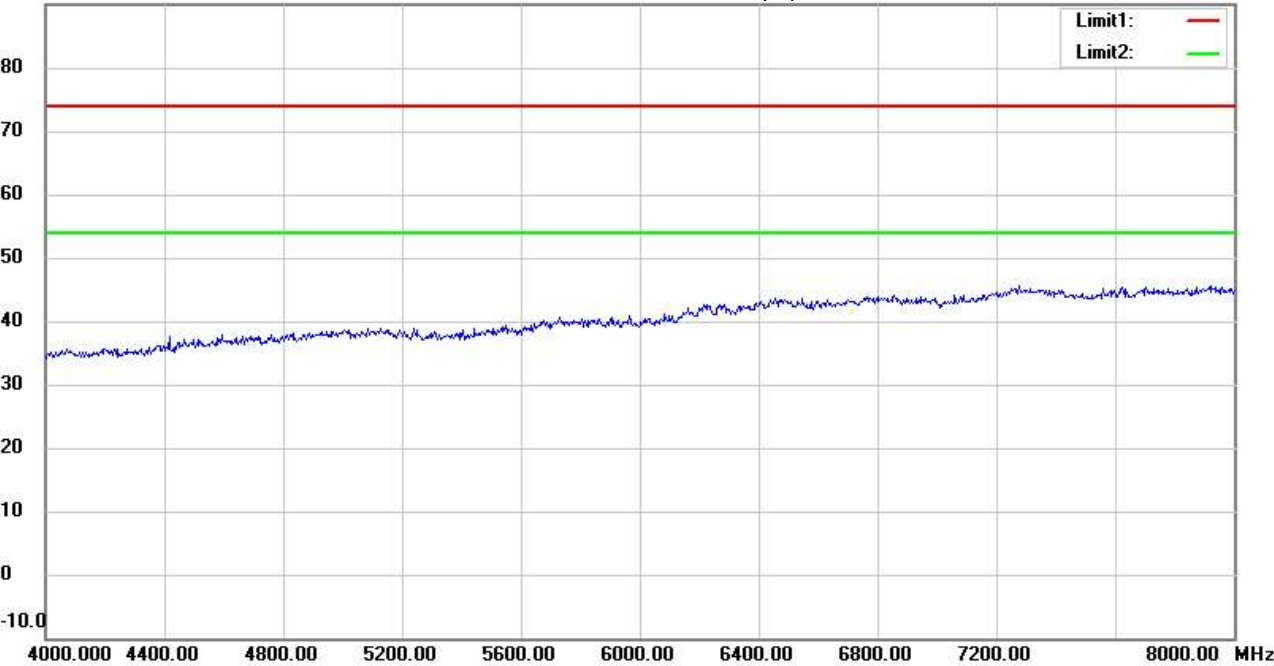
Site : 966A Chamber  
Condition : FCC\_part 15E RE\_Above 1GHz\_PK  
EUT : W6M22409-23739  
M/N:  
Test Mode : TX 802.11a CH45  
Note :

Polarization: **Horizontal**  
Power : 120 Va.c.  
Distance: 3m
