Radiated Emission Measurement

Condition : FCC\_part 15E RE\_Above 1GHz\_PK

EUT : W6M22409-23739

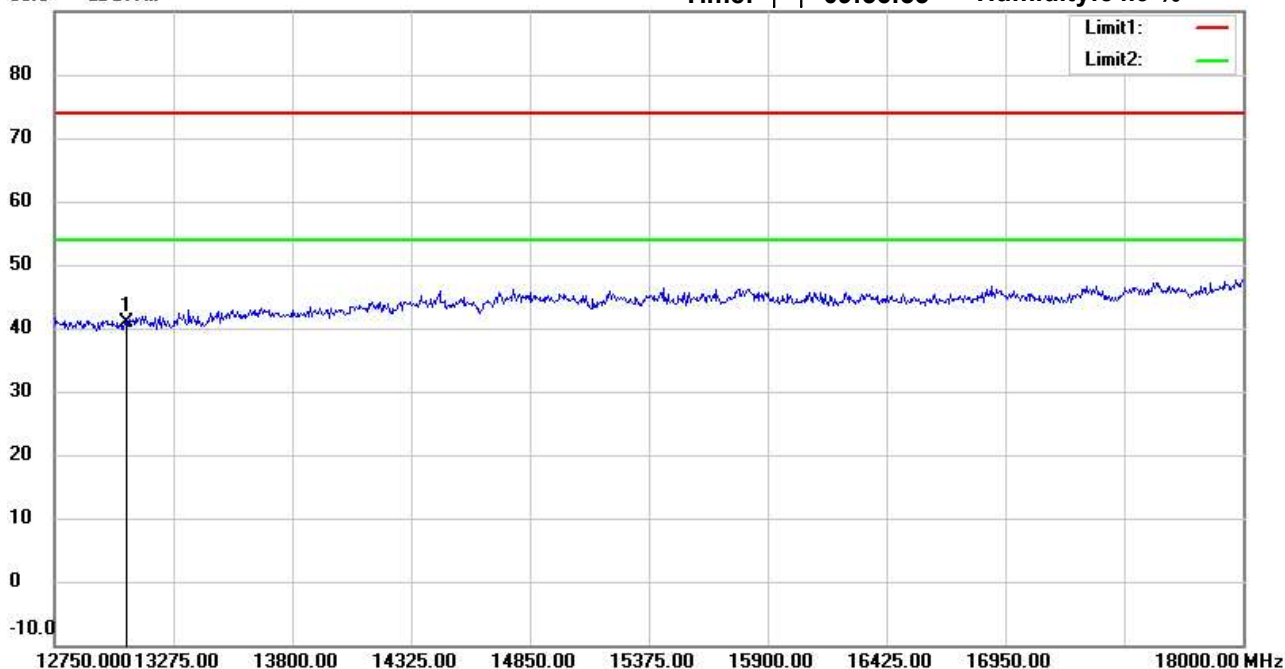
Condition : FCC\_part 15E RE\_Above 1GHz\_PK

Test Mode : TX 802.11a CH117

Polarization: **Vertical**

| Mk. | Frequency (MHz) | Reading (dBuV) | Detector | Corr. factor (dB/m) | Result (dBuV/m) | Limit (dBuV/m) | Ant.Pos (cm) | Tab.Pos (deg.) | Margin (dB) | Comment |
|---|---|---|---|---|---|---|---|---|---|---|
| * | 13070.000 | 23.76 | peak | 17.21 | 40.97 | 74.00 | 150 | 318 | -33.03 | |

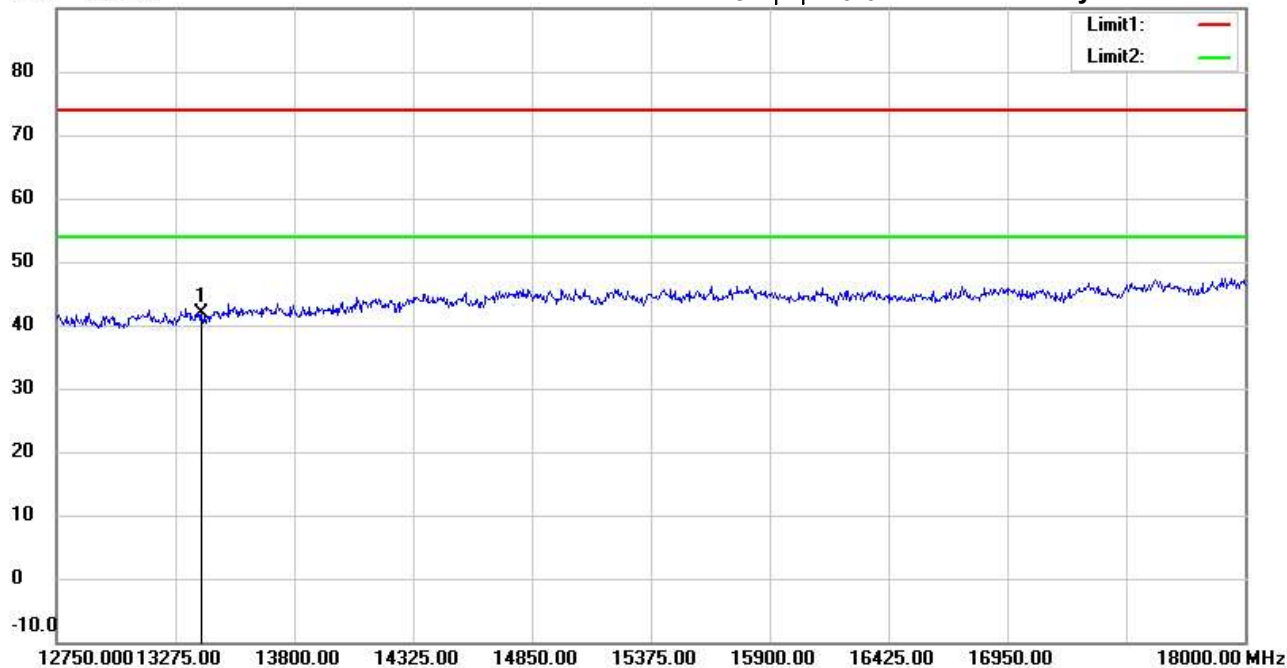
Condition : FCC\_part 15E RE\_Above 1GHz\_PK

Test Mode : TX 802.11a CH149

Polarization: **Horizontal**

| Mk. | Frequency (MHz) | Reading (dBuV) | Detector | Corr. factor (dB/m) | Result (dBuV/m) | Limit (dBuV/m) | Ant.Pos (cm) | Tab.Pos (deg.) | Margin (dB) | Comment |
|---|---|---|---|---|---|---|---|---|---|---|
| * | 13390.000 | 23.67 | peak | 18.10 | 41.77 | 74.00 | 150 | 359 | -32.23 | |

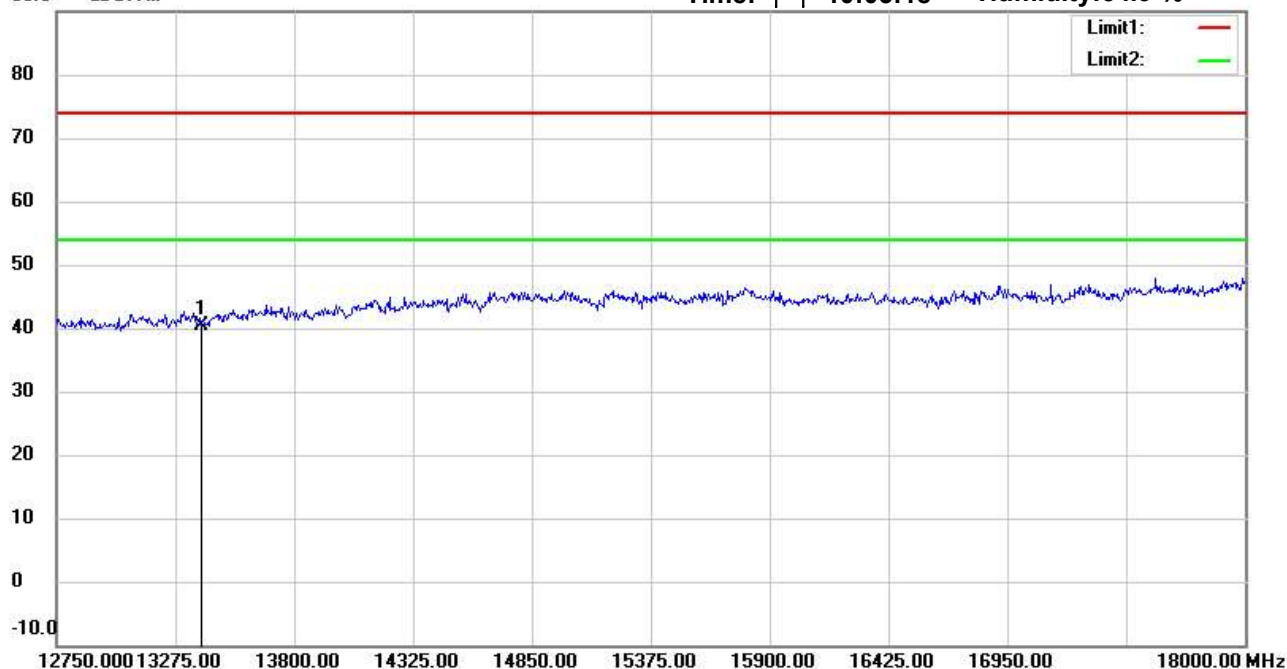
Condition : FCC\_part 15E RE\_Above 1GHz\_PK

Test Mode : TX 802.11a CH149

Polarization: Vertical

| Mk. | Frequency (MHz) | Reading (dBuV) | Detector | Corr. factor (dB/m) | Result (dBuV/m) | Limit (dBuV/m) | Ant.Pos (cm) | Tab.Pos (deg.) | Margin (dB) | Comment |
|---|---|---|---|---|---|---|---|---|---|---|
| * | 13390.000 | 22.32 | peak | 18.10 | 40.42 | 74.00 | 150 | 26 | -33.58 | |
