Radiated Emission Measurement

Condition : FCC\_part 15E RE\_Above 1GHz\_PK

EUT : W6M22409-23739

Test Mode : TX 802.11a CH185

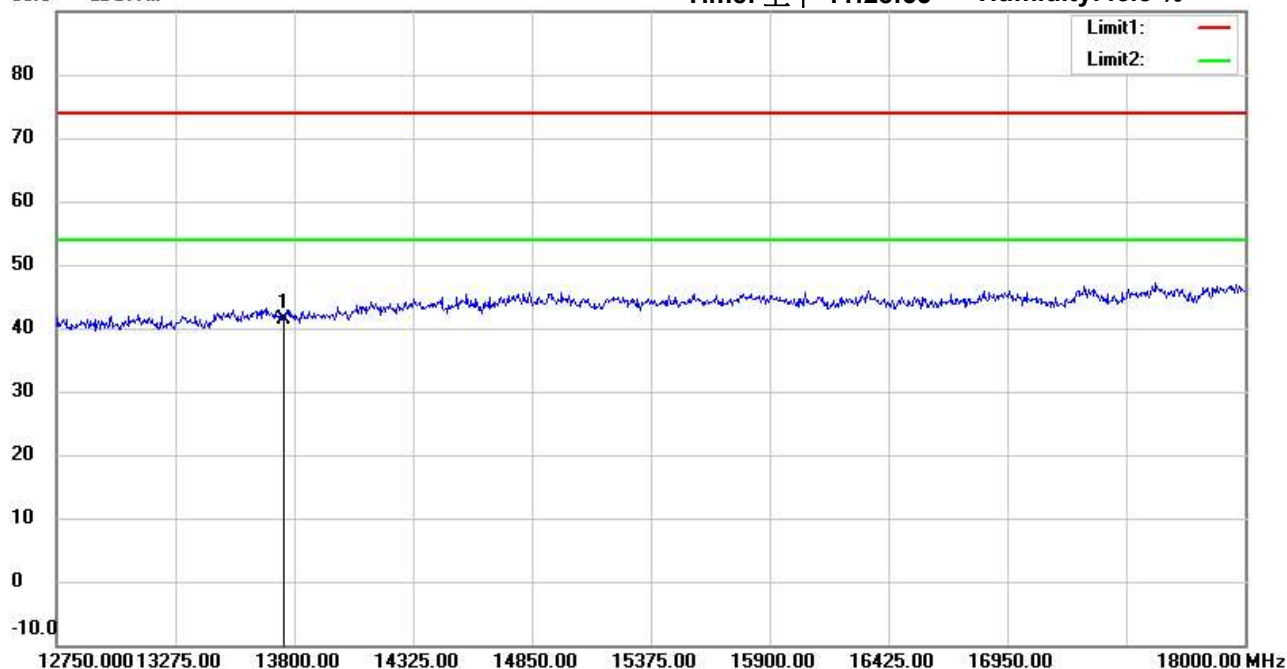
Data : #4

Site : 966A Chamber

Condition : FCC\_part 15E RE\_Above 1GHz\_PK

Test Mode : TX 802.11a CH185

Polarization: **Horizontal**

| Mk. | Frequency (MHz) | Reading (dBuV) | Detector | Corr. factor (dB/m) | Result (dBuV/m) | Limit (dBuV/m) | Ant.Pos (cm) | Tab.Pos (deg.) | Margin (dB) | Comment |
|---|---|---|---|---|---|---|---|---|---|---|
| * | 13750.000 | 21.69 | peak | 19.81 | 41.50 | 74.00 | 150 | 18 | -32.50 | |

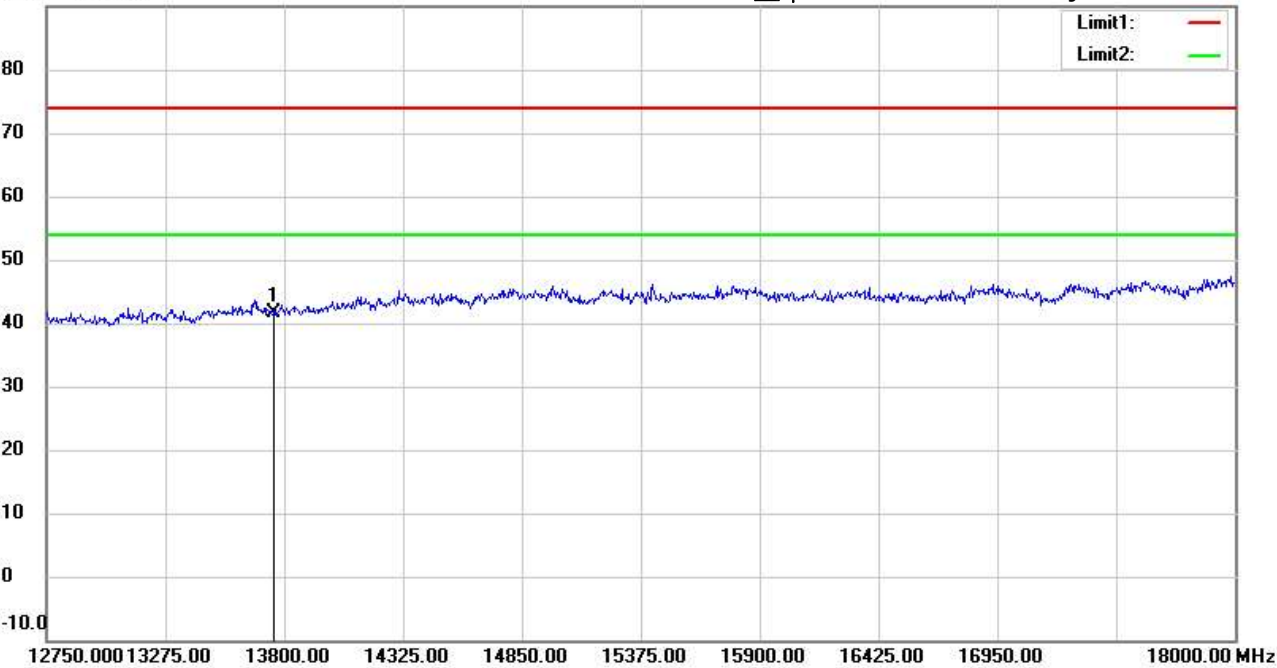
Data :#10

Site : 966A Chamber

Condition : FCC\_part 15E RE\_Above 1GHz\_PK

Test Mode : TX 802.11a CH185

Polarization: **Vertical**

| Mk. | Frequency (MHz) | Reading (dBuV) | Detector | Corr. factor (dB/m) | Result (dBuV/m) | Limit (dBuV/m) | Ant.Pos (cm) | Tab.Pos (deg.) | Margin (dB) | Comment |
|---|---|---|---|---|---|---|---|---|---|---|
| * | 13750.000 | 21.71 | peak | 19.81 | 41.52 | 74.00 | 150 | 359 | -32.48 | |

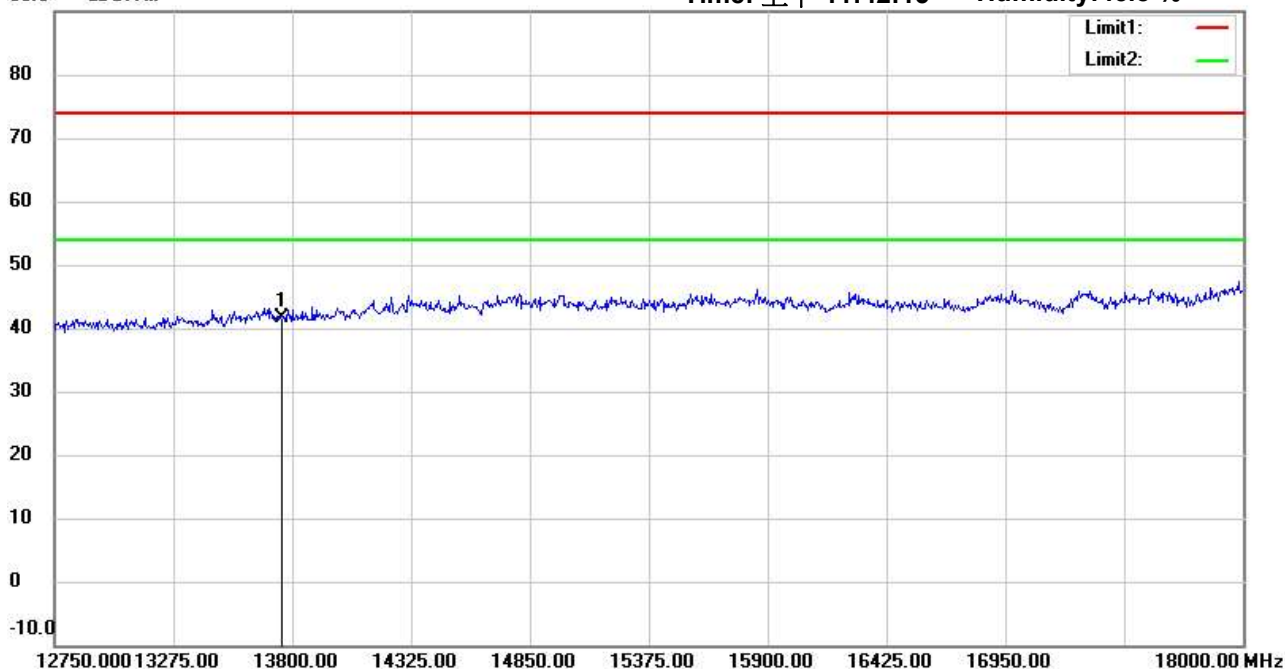
Data : #4

Site : 966A Chamber

Condition : FCC\_part 15E RE\_Above 1GHz\_PK

Test Mode : TX 802.11a CH185

Polarization: **Horizontal**

| Mk. | Frequency (MHz) | Reading (dBuV) | Detector | Corr. factor (dB/m) | Result (dBuV/m) | Limit (dBuV/m) | Ant.Pos (cm) | Tab.Pos (deg.) | Margin (dB) | Comment |
|---|---|---|---|---|---|---|---|---|---|---|
| * | 13750.000 | 21.70 | peak | 19.81 | 41.51 | 74.00 | 150 | 142 | -32.49 | |

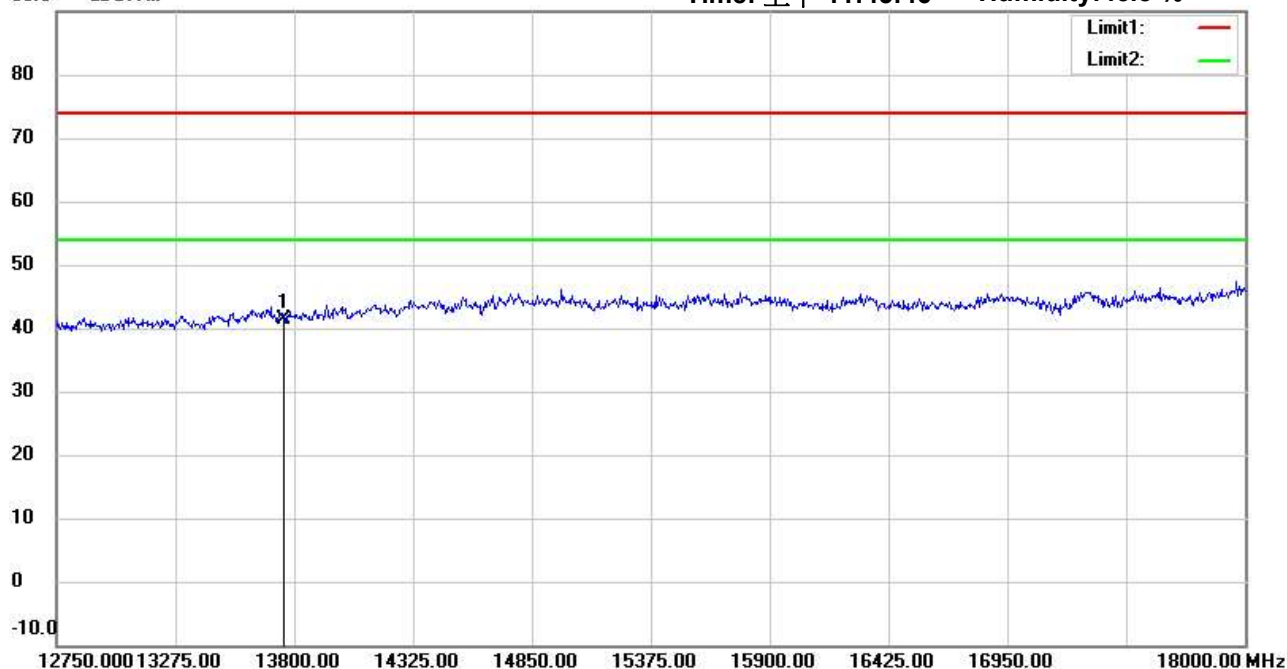
Data : #10

Site : 966A Chamber

Condition : FCC\_part 15E RE\_Above 1GHz\_PK

Test Mode : TX 802.11a CH185

Polarization: Vertical

| Mk. | Frequency (MHz) | Reading (dBuV) | Detector | Corr. factor (dB/m) | Result (dBuV/m) | Limit (dBuV/m) | Ant.Pos (cm) | Tab.Pos (deg.) | Margin (dB) | Comment |
|---|---|---|---|---|---|---|---|---|---|---|
| * | 13750.000 | 21.67 | peak | 19.81 | 41.48 | 74.00 | 150 | 270 | -32.52 | |
